# Inspection Photos

API: 017-06410

Operator: **WILLIFORD ENERGY COMPANY**

Inspection Date: 8/19/2024

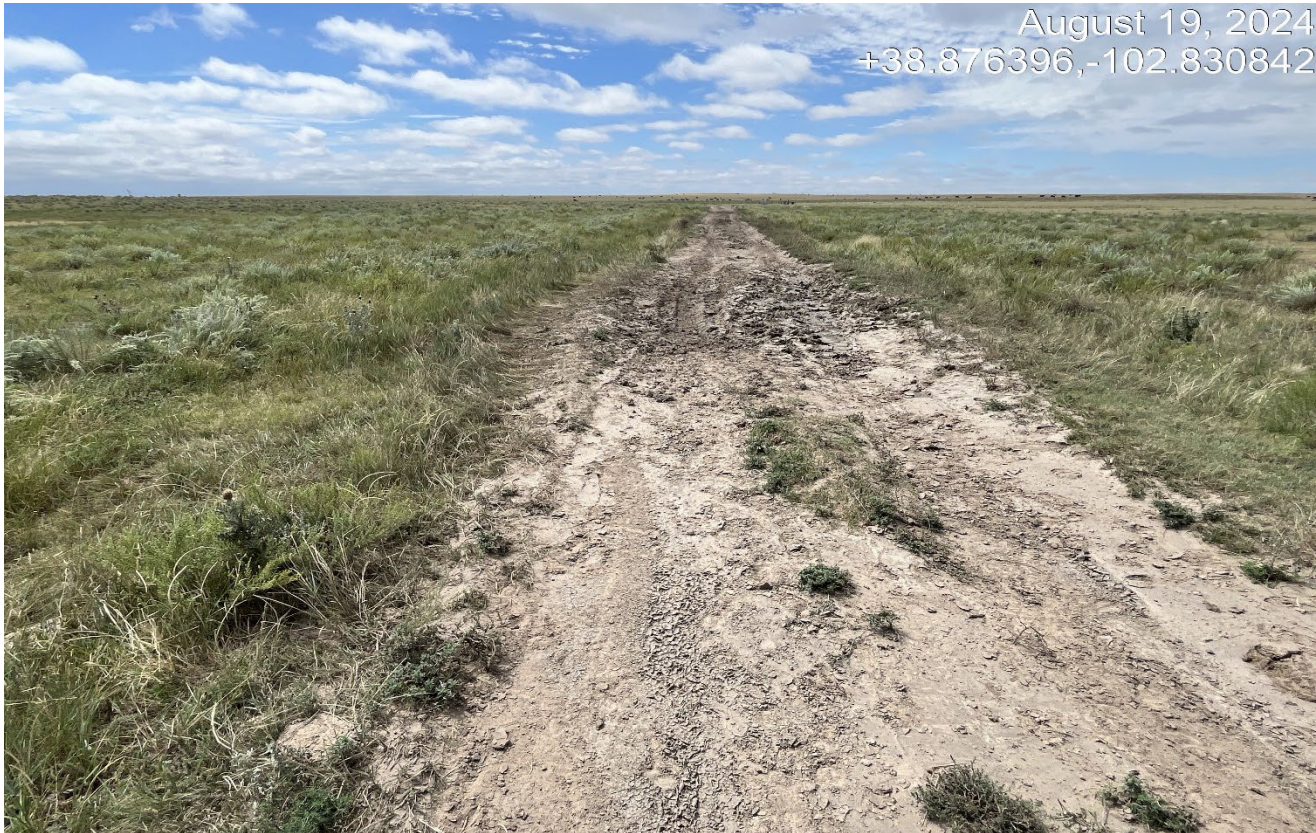
**Photo 1.** Facing south along the access road. Vehicles are causing unnecessary disturbance driving outside of the access road due to stormwater pooling on the road. The access road must be maintained and vehicles shall not drive outside of the access road boundary. Previous corrective action was not completed.

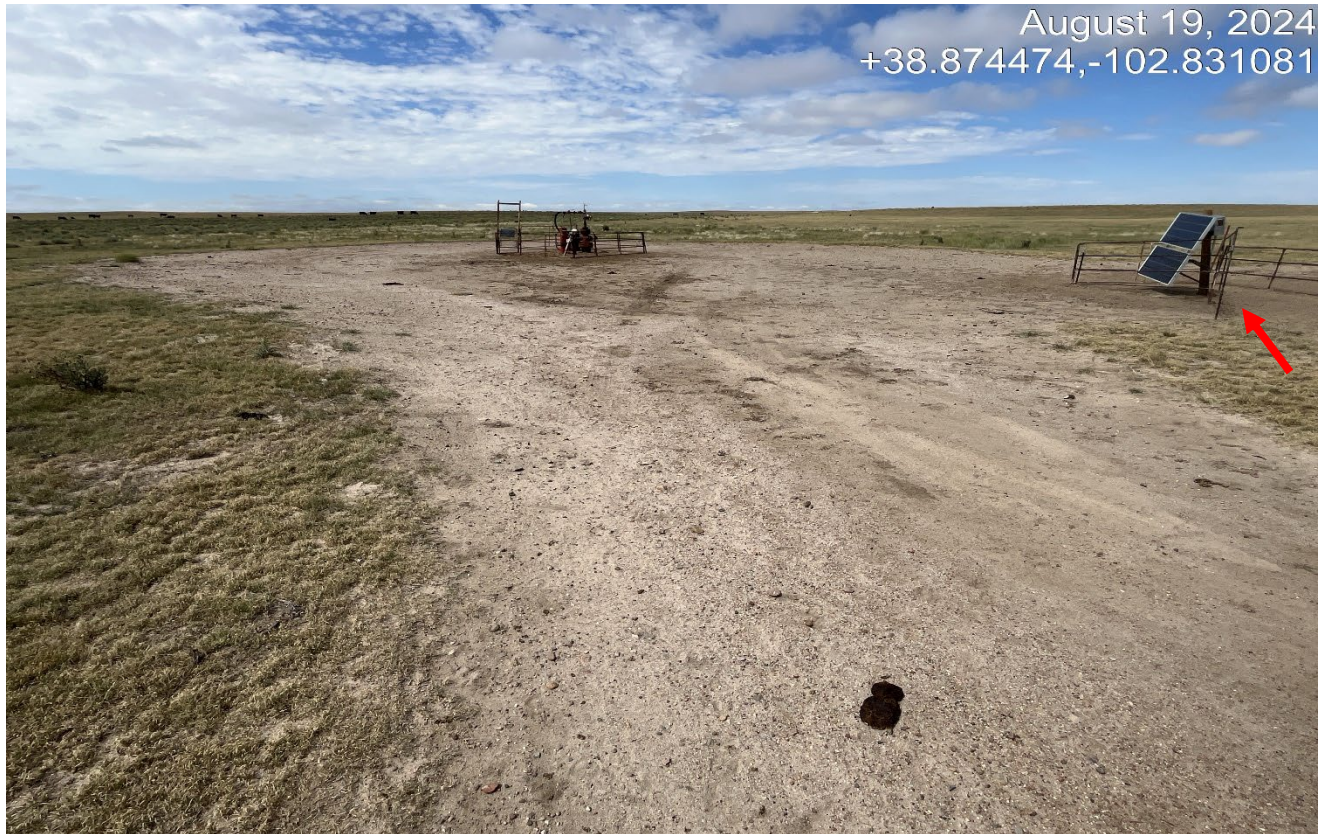
**Photo 2.** Facing southwest toward the wellsite. The fence around the solar panel is not maintained.

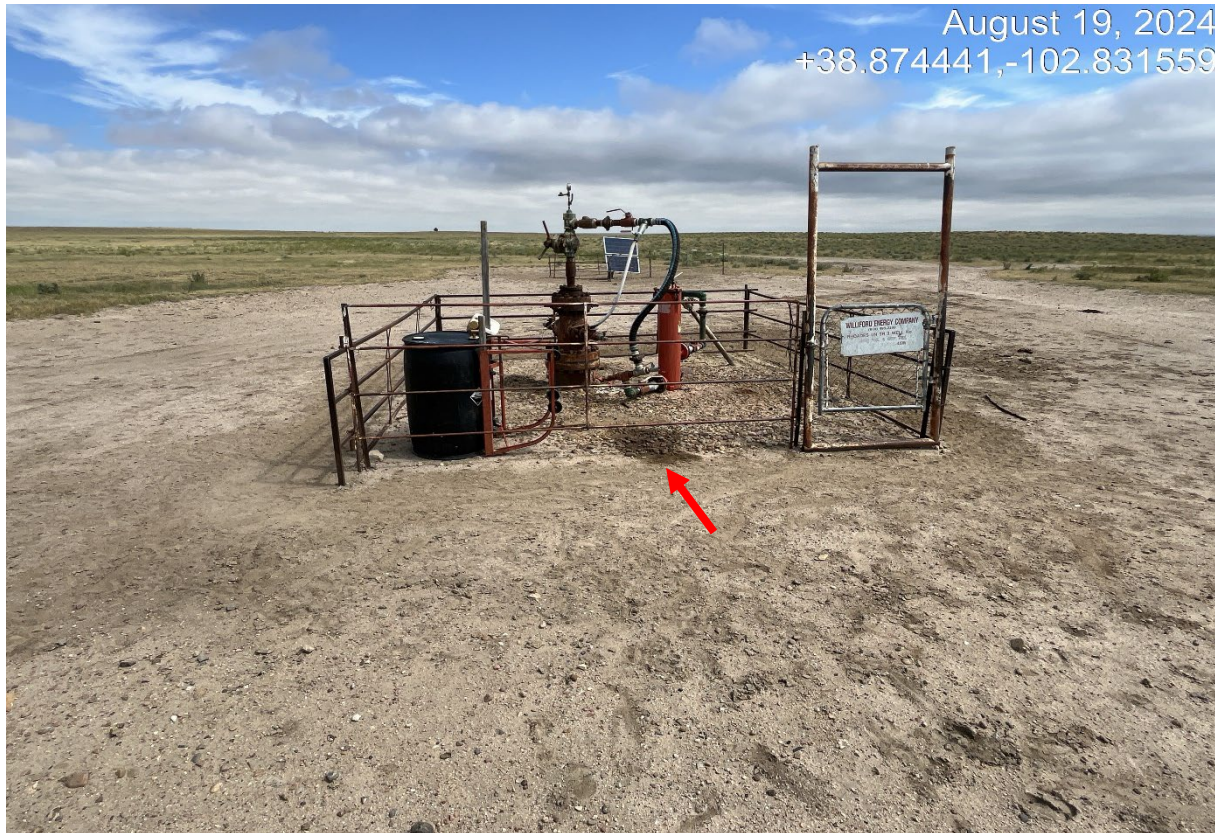
**Photo 3.** The well sign is faded and not legible. There is oil stained soils at red arrow. There is a chemical barrel with no secondary containment..
