# Final Reclamation Inspection

Operator: HIGHPOINT OPERATING CORPORATION - #10071

Location ID: 409326

Location Name: UPRC ANDERSON-610N64W 15NENE

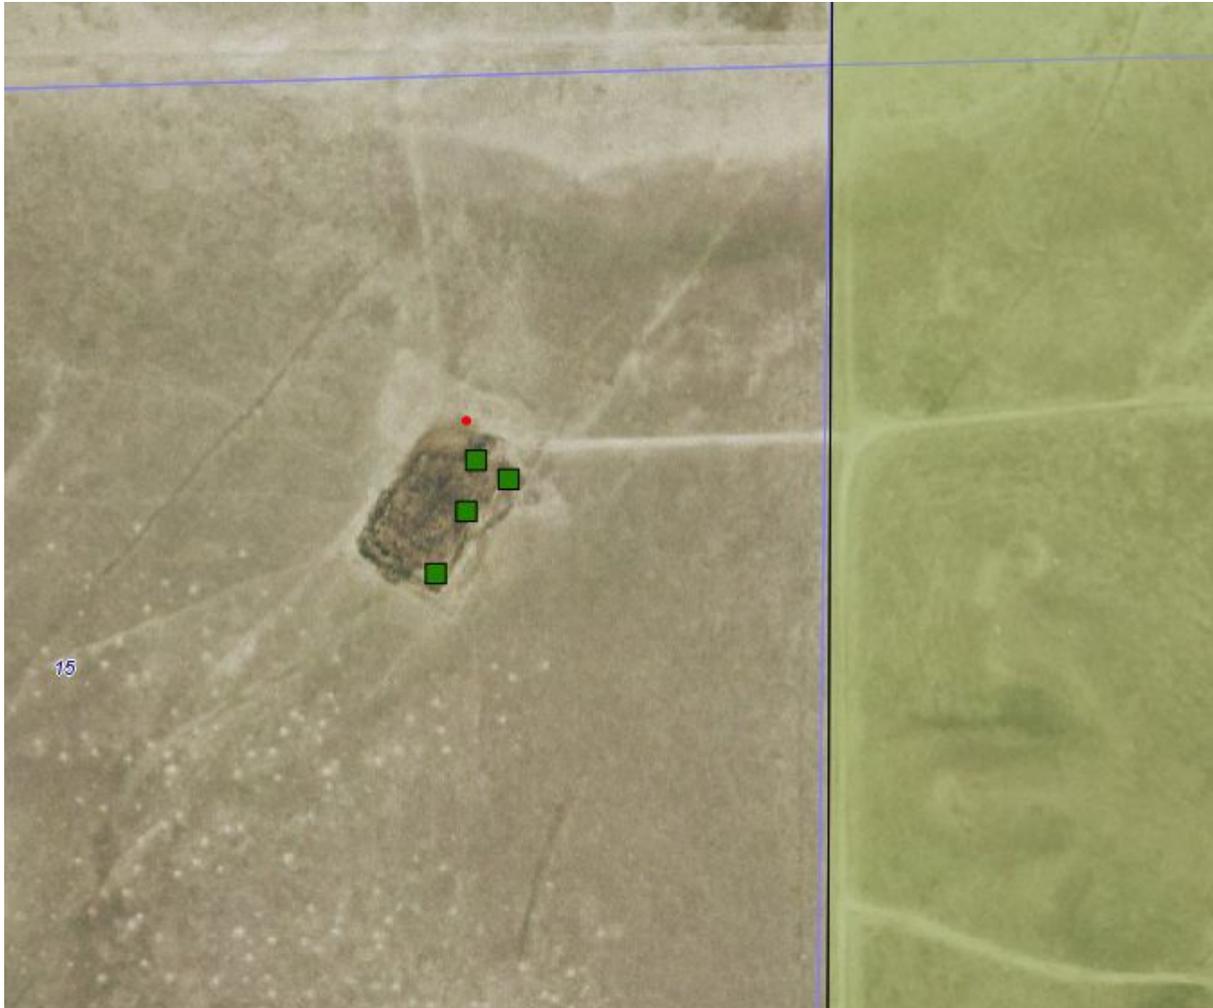
**Photo 1.** 2021 aerial imagery illustrates the pit area that had four (4) different pits- see Photo 2. Operator has assumed responsibility for final reclamation of the pit area.

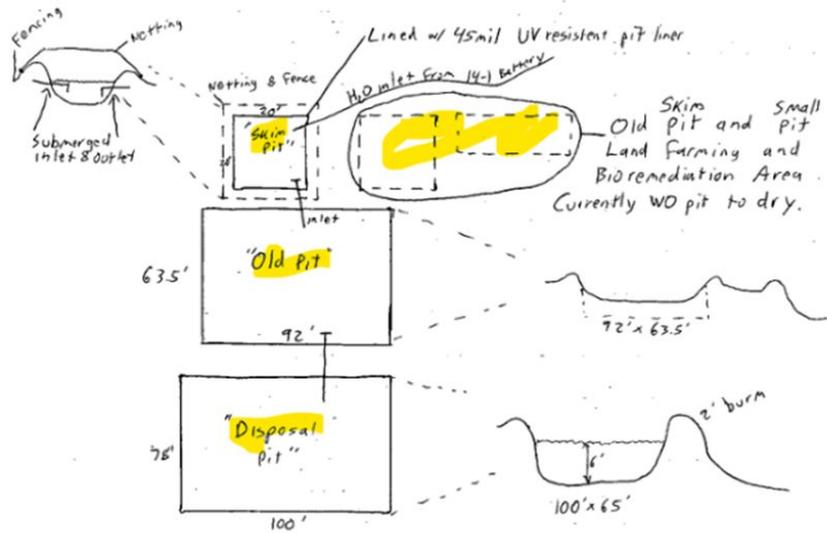
Pawnee Pioneer - Water Disposal Pit  
NeNe Sec. 15- T10N-R64W

Photo 2. Photo illustrates the four (4) different pits.

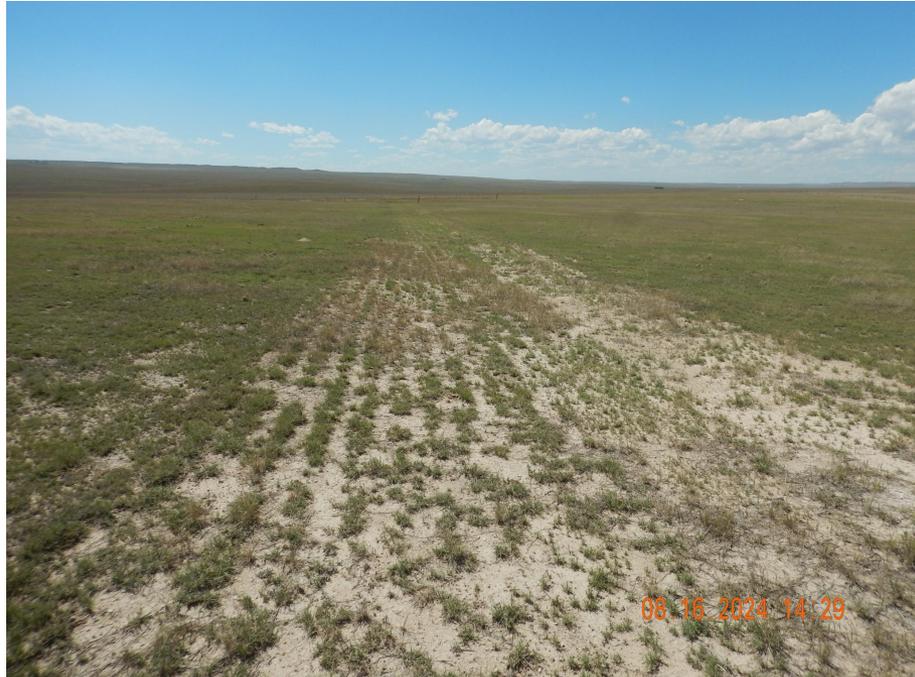
**Photo 3.** Photo taken from the eastern access road, facing West. Photo illustrates vegetation establishment along the access road is in-process but additional reclamation activities would be recommended along the eastern half of the access road.

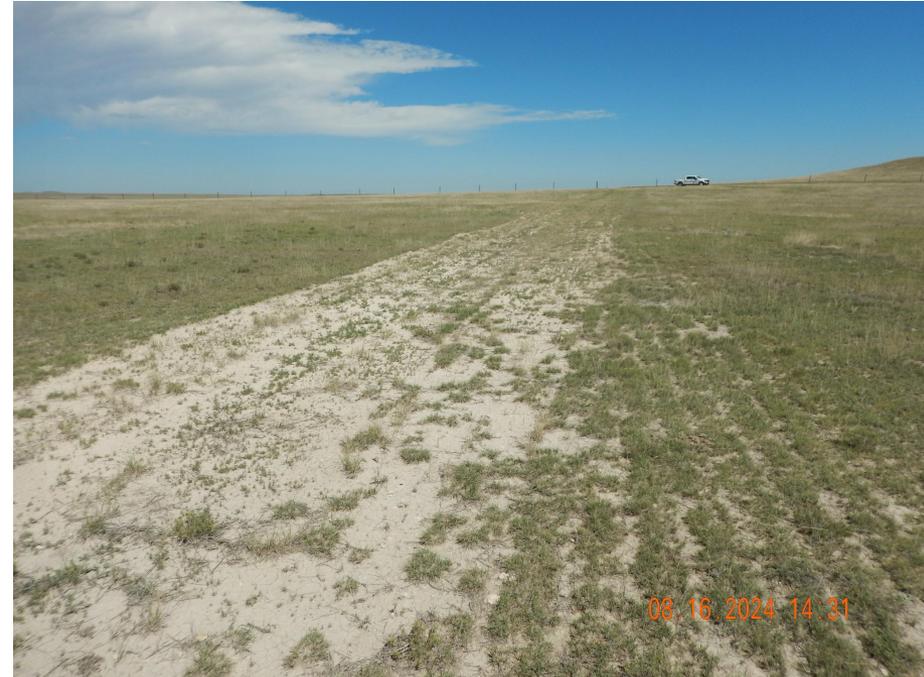
**Photo 4.** Photo taken from the western access road, facing East. See comments under Photo 3. Additional reclamation activities are needed for the western half of the access road.

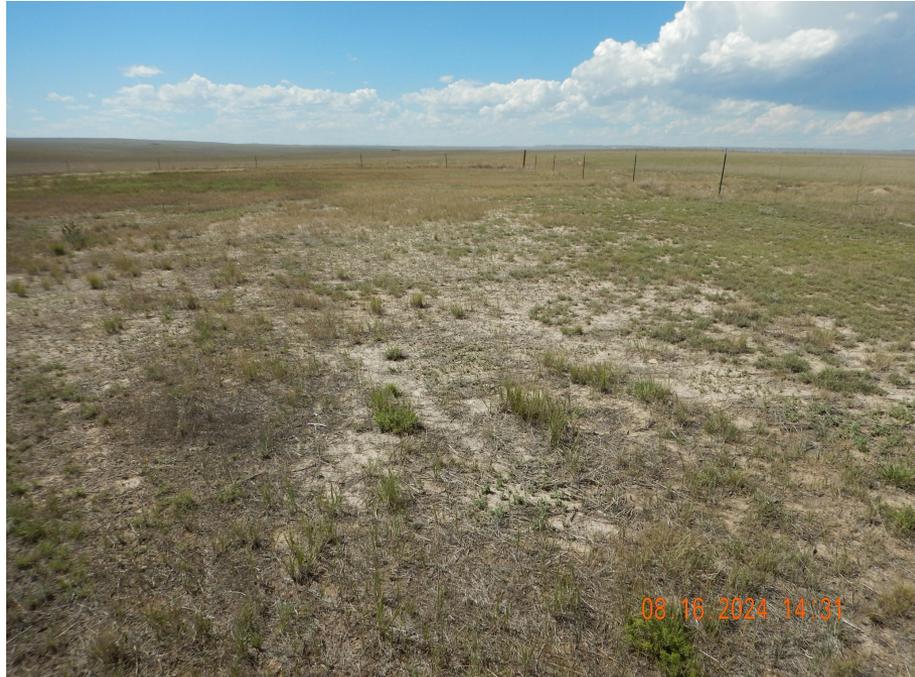
**Photo 5.** Photo taken from the northeastern pit area, facing West. Photo illustrates the northern half is mostly vegetated and reflective of reference areas.

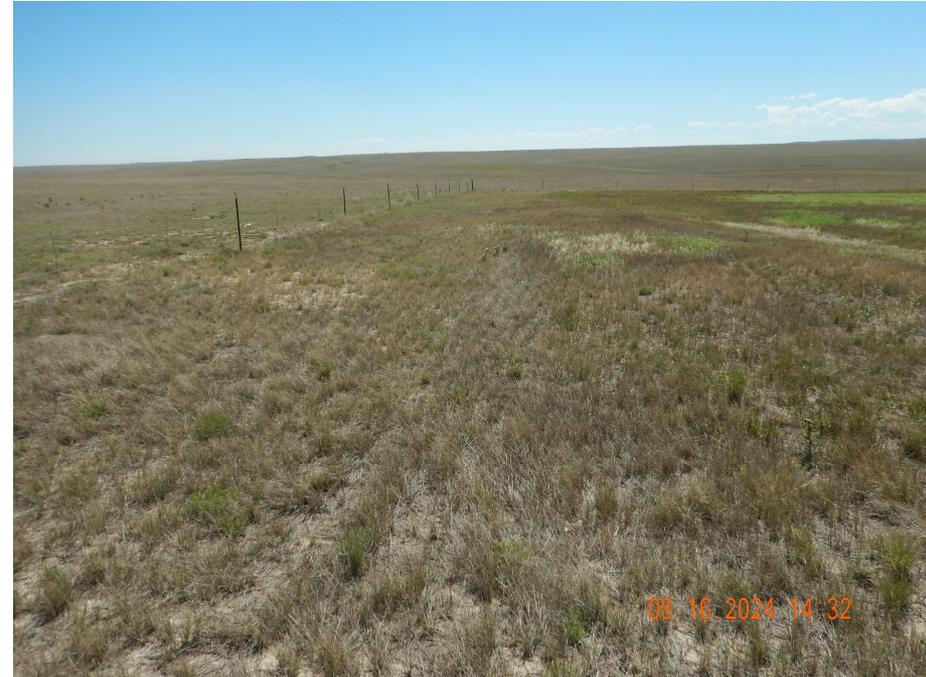
**Photo 6.** Photo taken from the northeastern pit area, facing South. See comments under Photo 5.

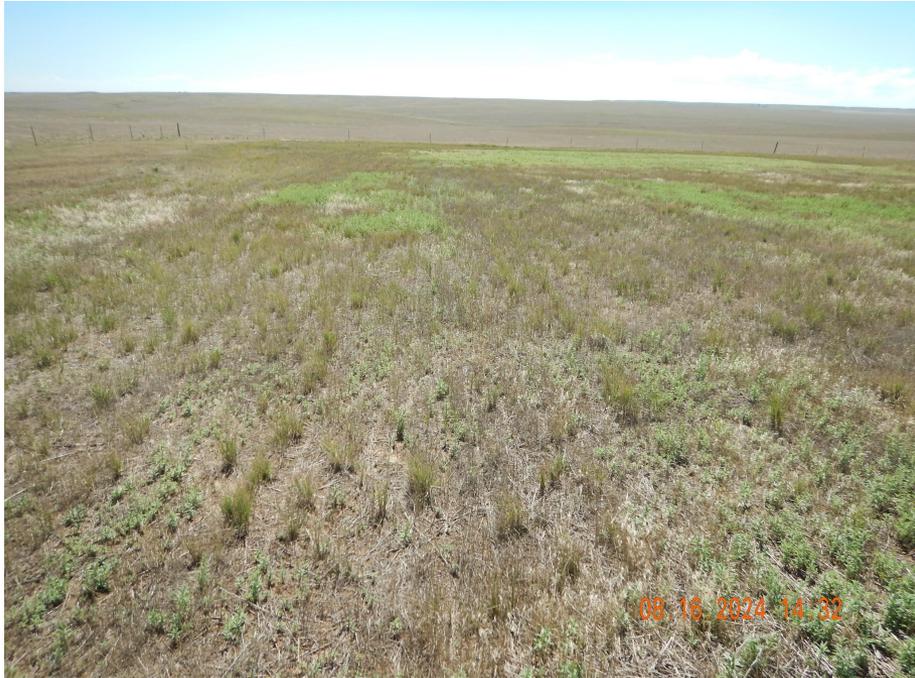
**Photo 7.** Photo taken from the central pit area, facing South. Photo illustrates the southern half has a higher abundance of annual, weedy vegetation of tumbleweeds and cheatgrass.

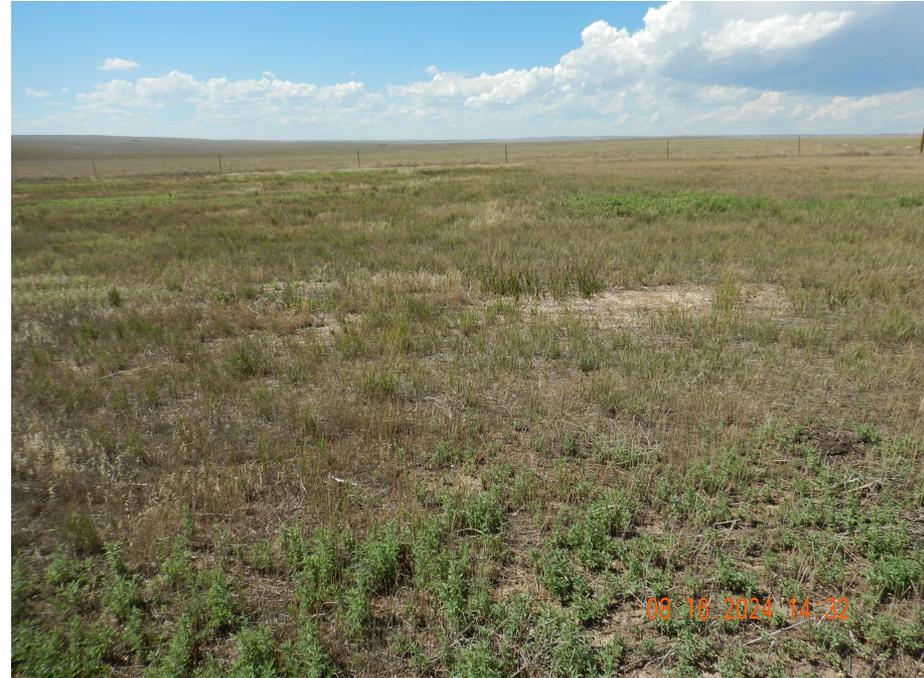
**Photo 8.** Photo taken from the central pit area, facing West. See comments under Photo 7.

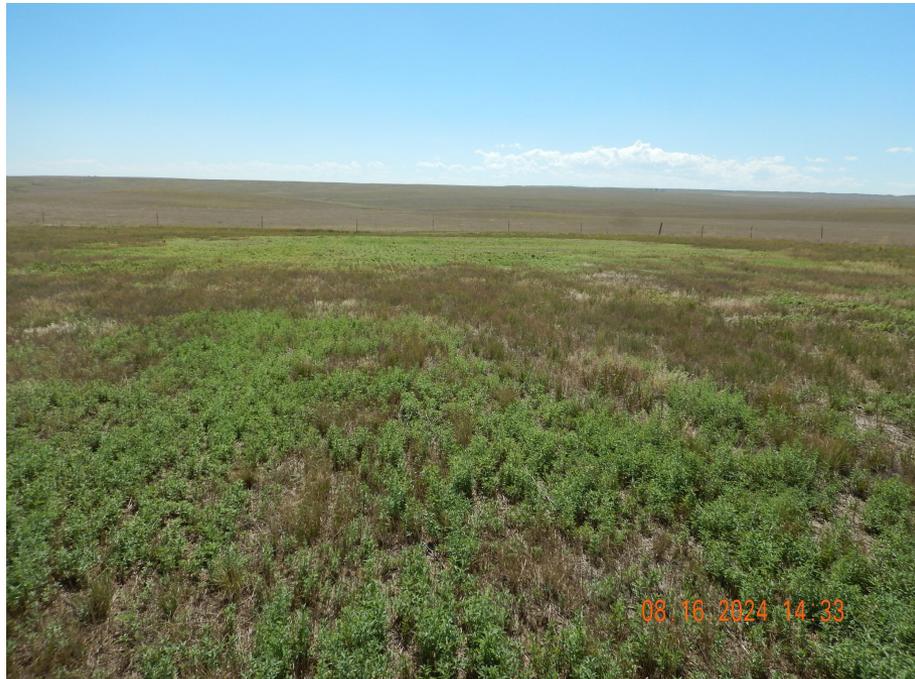
**Photo 9.** Photo taken from the southern pit area, facing South. Photo illustrates a higher abundance of annual, weedy vegetation of tumbleweeds and cheatgrass.

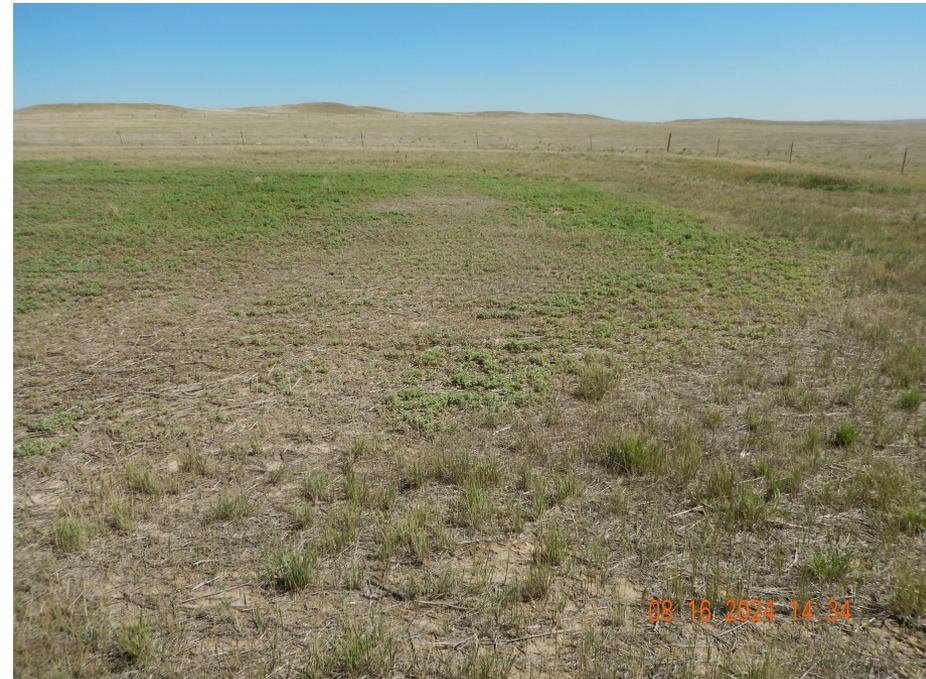
**Photo 10.** Photo taken from the southern pit area, facing East. See comments under Photo 9.
