Final Reclamation Inspection

Operator: COLORADO ENERGY MINERALS INC - #18615

Facility ID: 119030

Pawnee Pioneer - Water Disposal Pit
NeNe Sec. 15- T10N-R64W

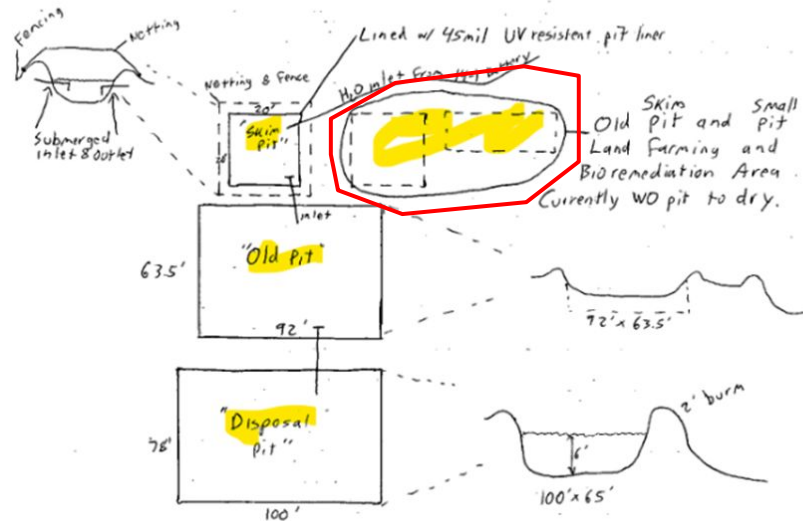
Photo 1. Photo illustrates the four pits utilized for this pit area. The Colorado Energy Minerals pit appears to be the northeastern pit circled in red.

Note- based on the Photo#1, it would appear that the pit disturbance extended beyond the fenced area.

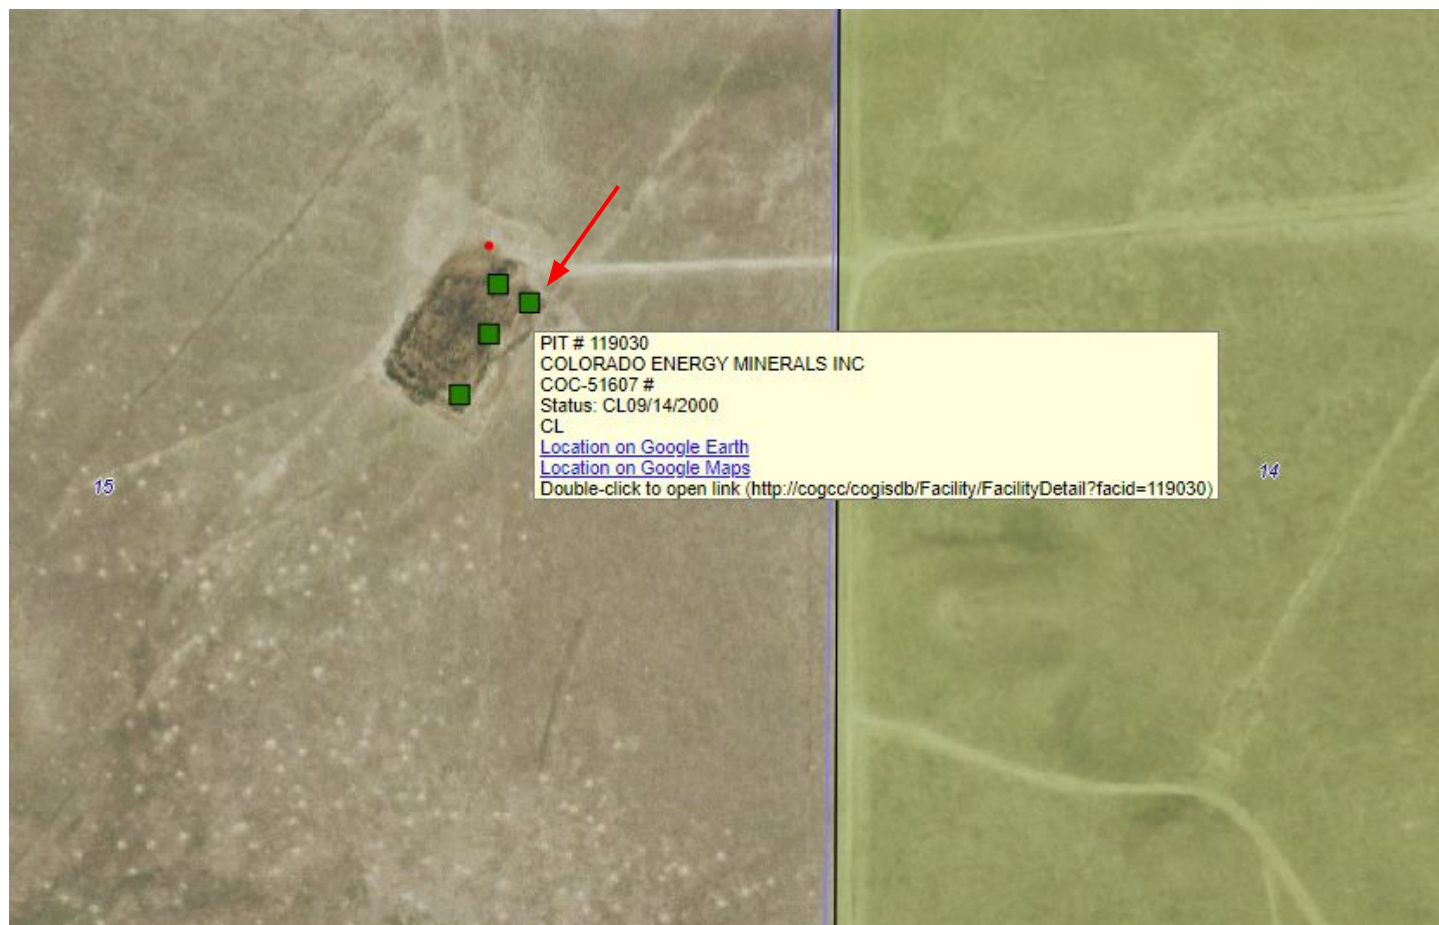
Photo 2. Photo illustrates the ECMC GIS database for this pit area. This pit appears to be the northeastern pit that was identified in Photo #1.

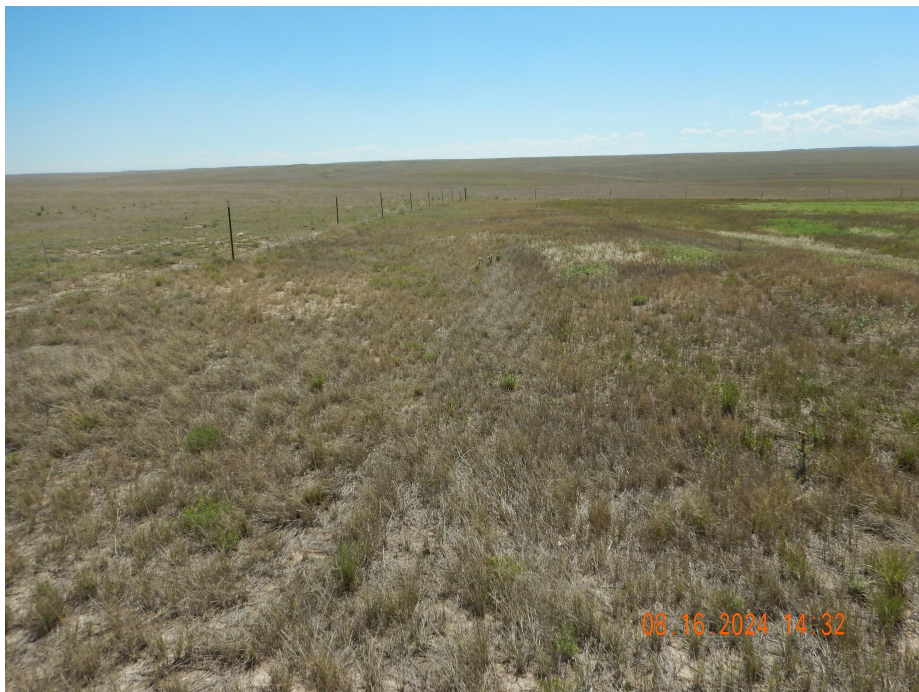
Photo 3. Photo taken from the northeastern pit area within the fenced area, facing South. Photo illustrates the pit area meets vegetation Rule 1004 standards.

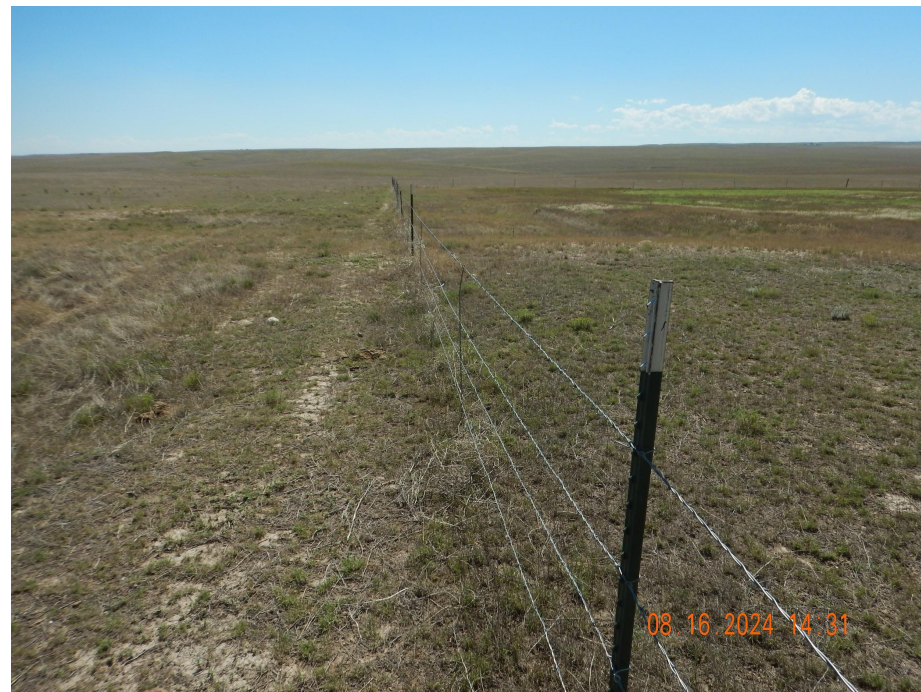
Photo 4. Photo taken from the northeastern pit area outside the fenced area, facing South. Photo illustrates the pit area meets vegetation Rule 1004 standards.
