**Storm Water Management and Erosion control**  
**Location Name: TEP Rocky Mountain LLC CLOUGH RWF 14-13 Pad**  
**Location # 324285**

**Location Overview: Location is within High Priority/Density  
Habitat areas & in close proximity to Bald Eagle Roost site.  
Location is approximately 24 yards from a creek/drainage that  
contributes to the Colorado River.  
Section/Township/Range: 13 6S94W**

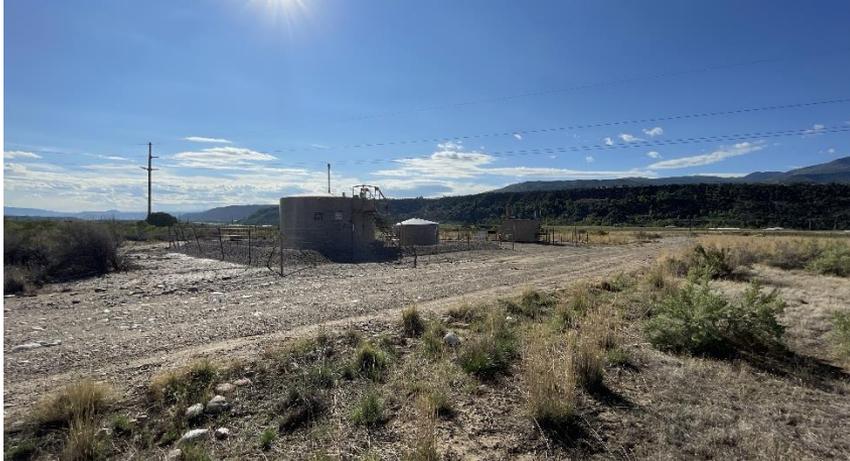
**North West corner of location.**

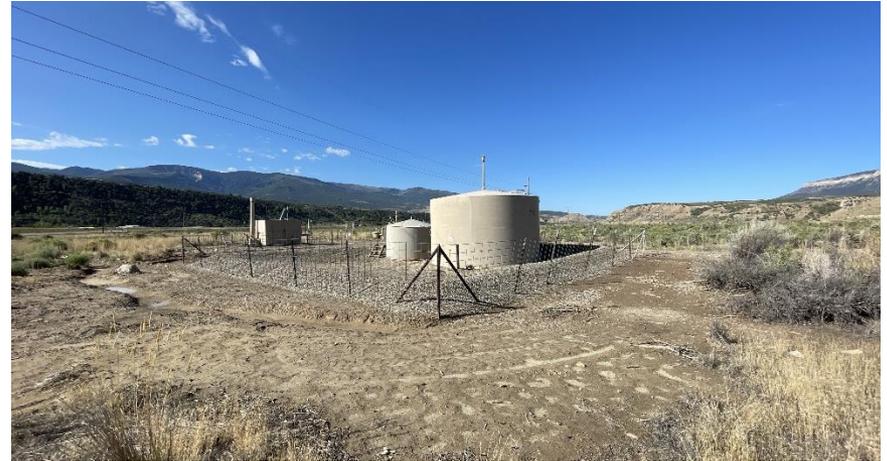
**North East corner of location.**

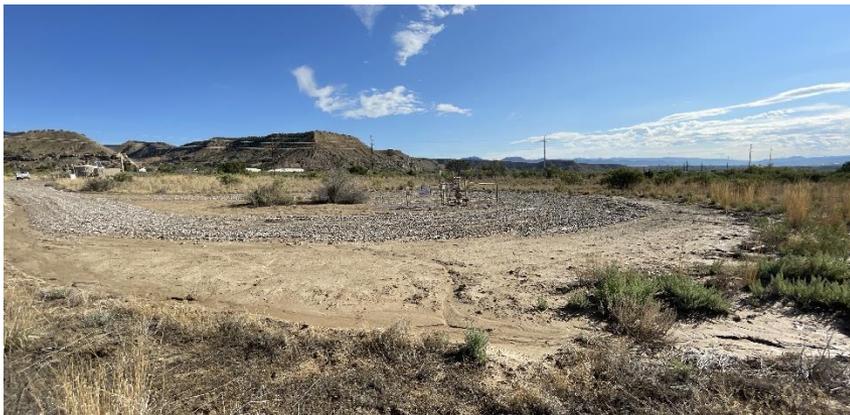
**South West corner of location.**

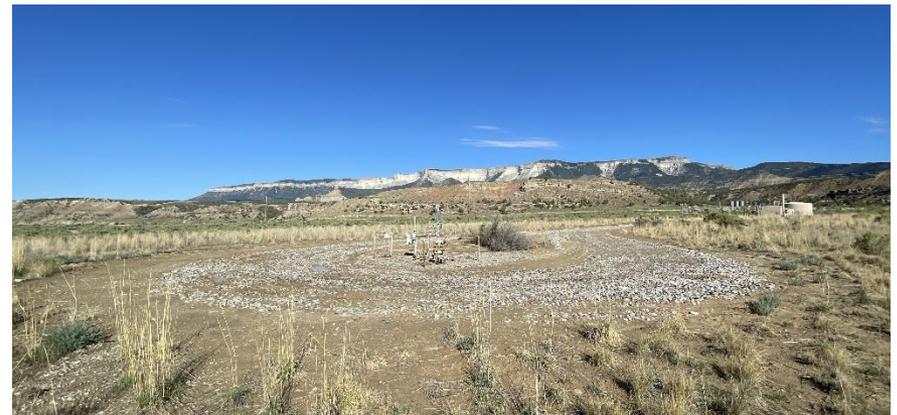
**South East corner of location.**

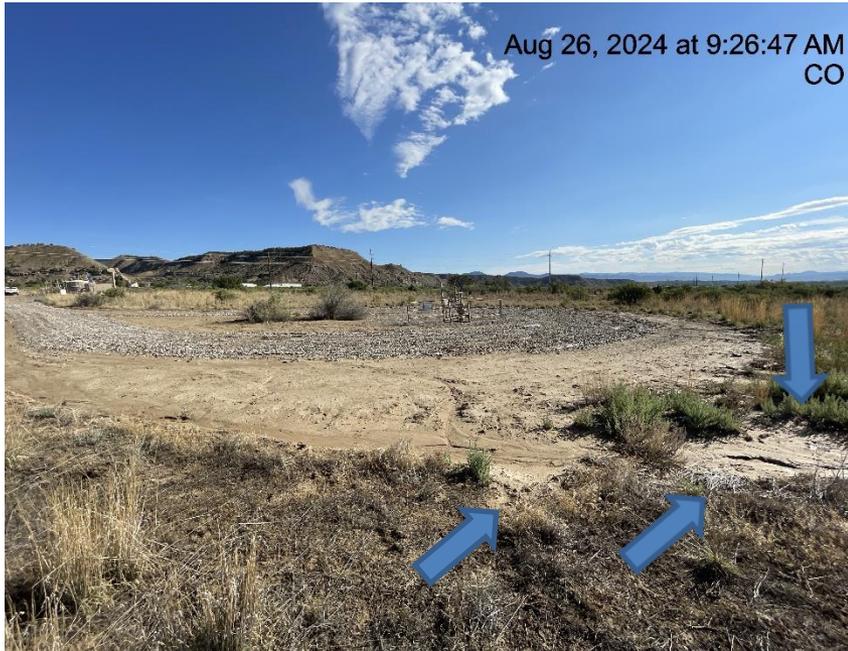
**Photo # 6259 Erosion & transport of sediment off location & into vegetated areas/failure to minimize erosion & the transport of sediment off location (S/SW edge of pad near wellhead)**

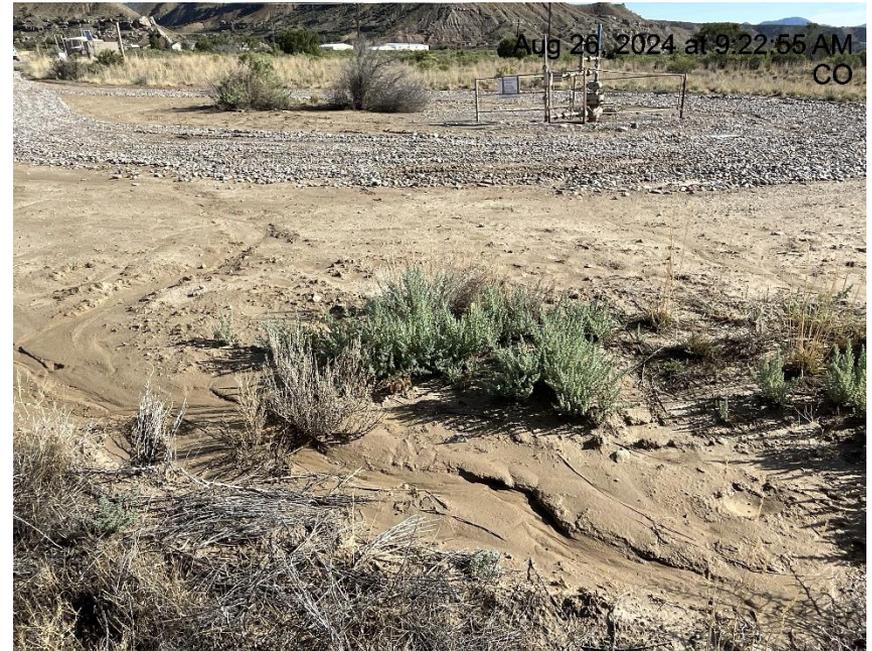
**Photo # 6260 Erosion & transport of sediment off location & into vegetated areas/failure to minimize erosion & the transport of sediment off location (S/SW edge of pad near wellhead)**

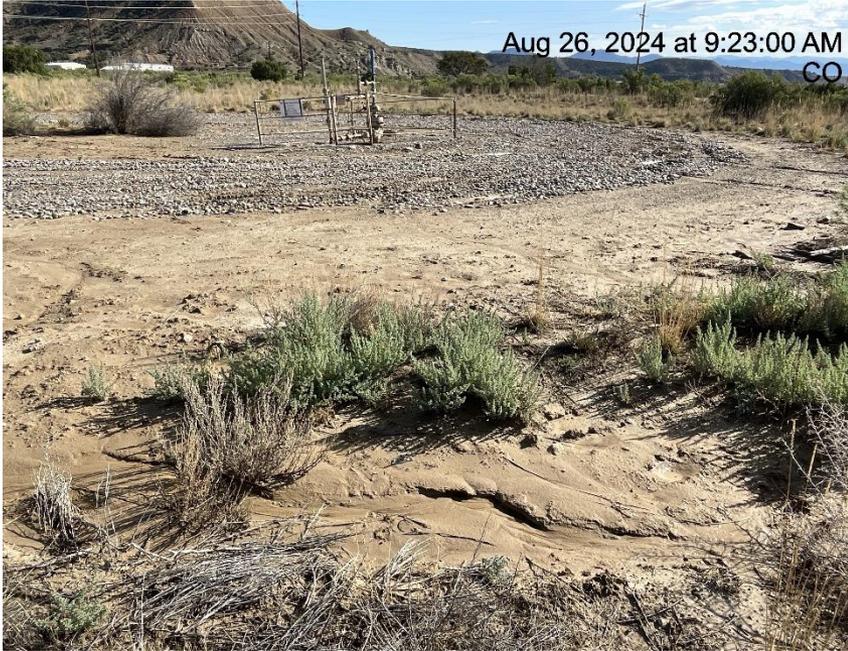
**Photo # 6261 Erosion & transport of sediment off location & into vegetated areas/failure to minimize erosion & the transport of sediment off location (S/SW edge of pad near wellhead)**

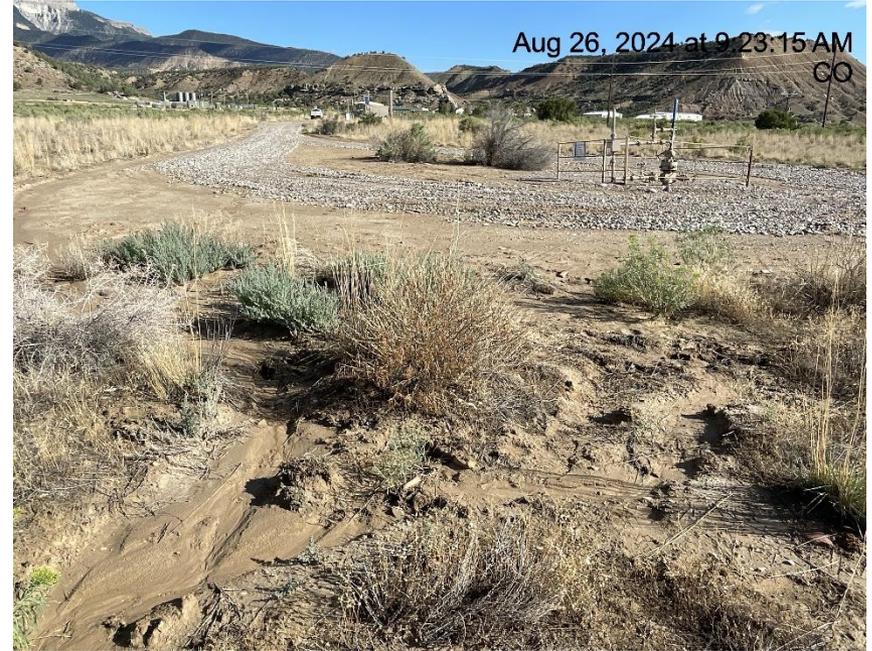
**Photo # 6262 Erosion & transport of sediment off location & into vegetated areas/failure to minimize erosion & the transport of sediment off location (S/SW edge of pad near wellhead)**

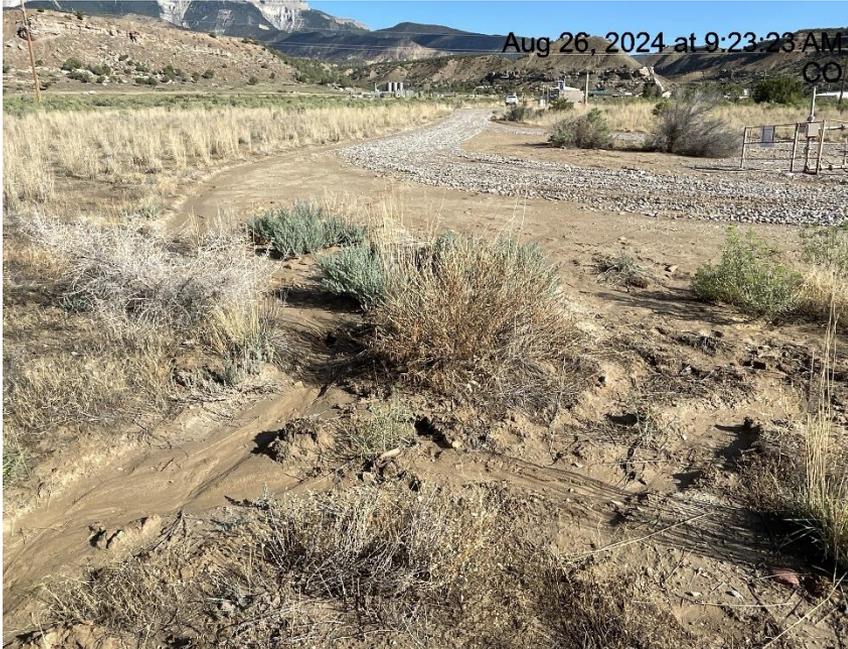
**Photo # 6263 Erosion & transport of sediment off location & into vegetated areas/failure to minimize erosion & the transport of sediment off location (S/SW edge of pad near wellhead)**

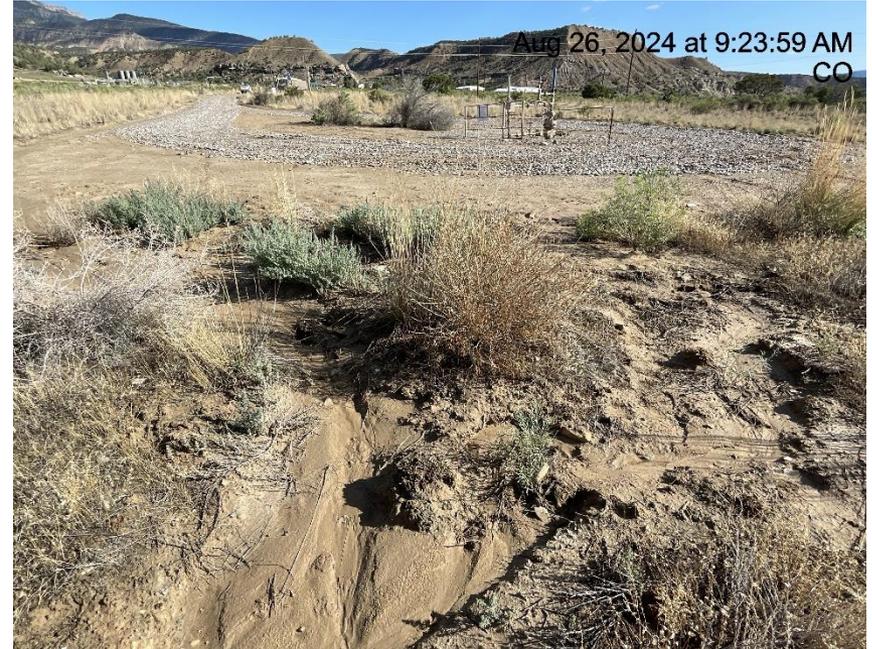
**Photo # 6264 Erosion & transport of sediment off location & into vegetated areas/failure to minimize erosion & the transport of sediment off location (S/SW edge of pad near wellhead)**

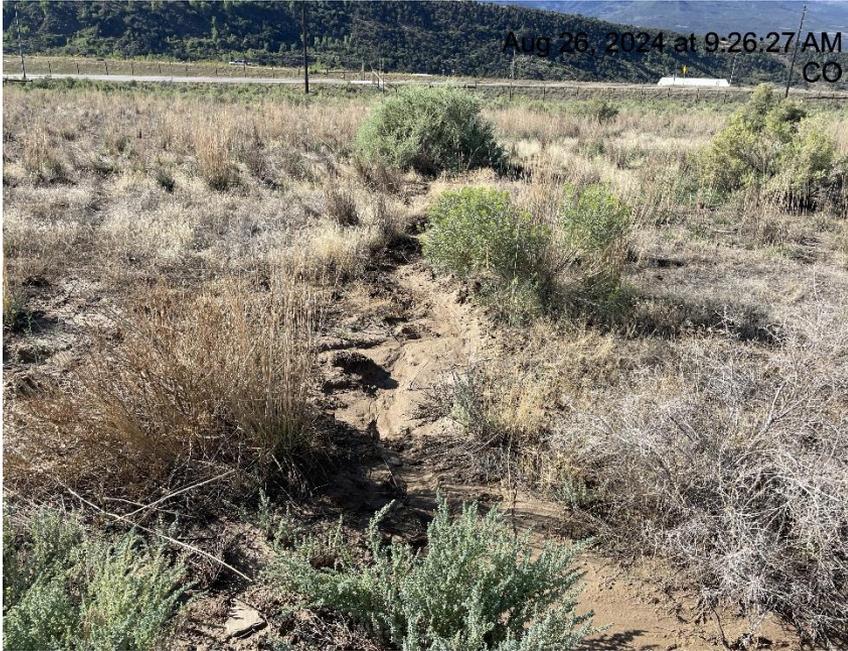
**Photo # 6265 Erosion & transport of sediment off location & into vegetated areas/failure to minimize erosion & the transport of sediment off location**

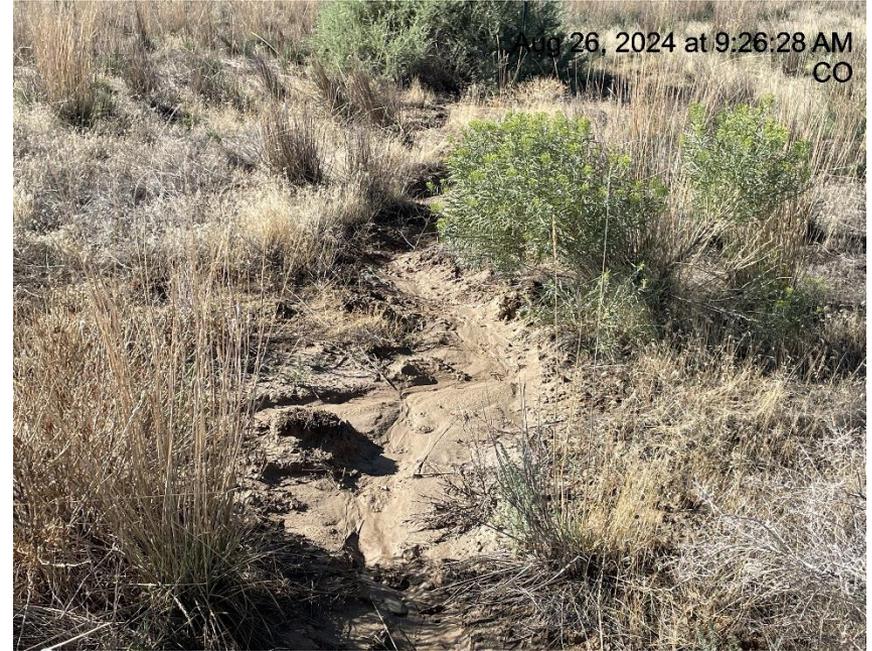
**Photo # 6266 Erosion & transport of sediment off location & into vegetated areas/failure to minimize erosion & the transport of sediment off location**

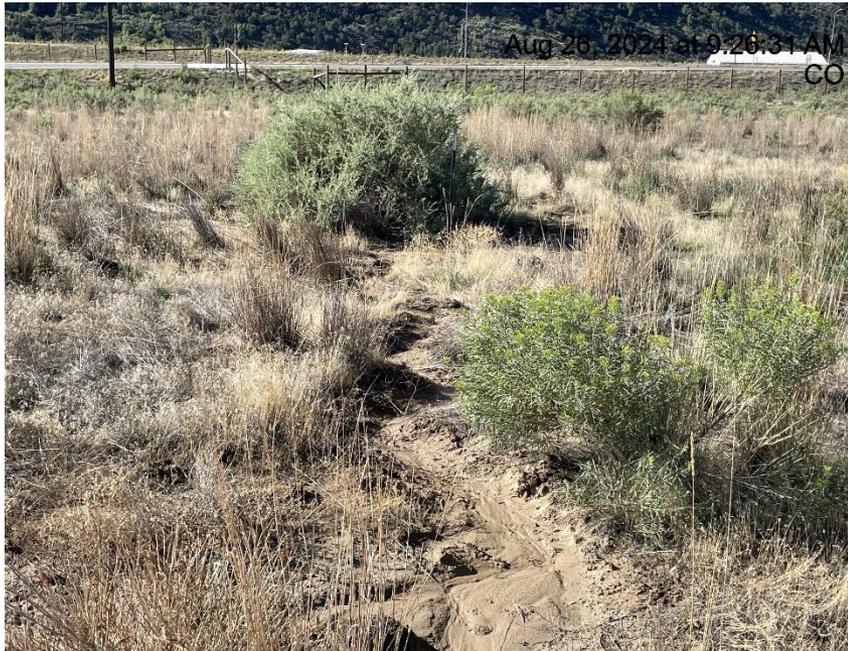
**Photo # 6267 Erosion & transport of sediment off location & into vegetated areas/failure to minimize erosion & the transport of sediment off location**

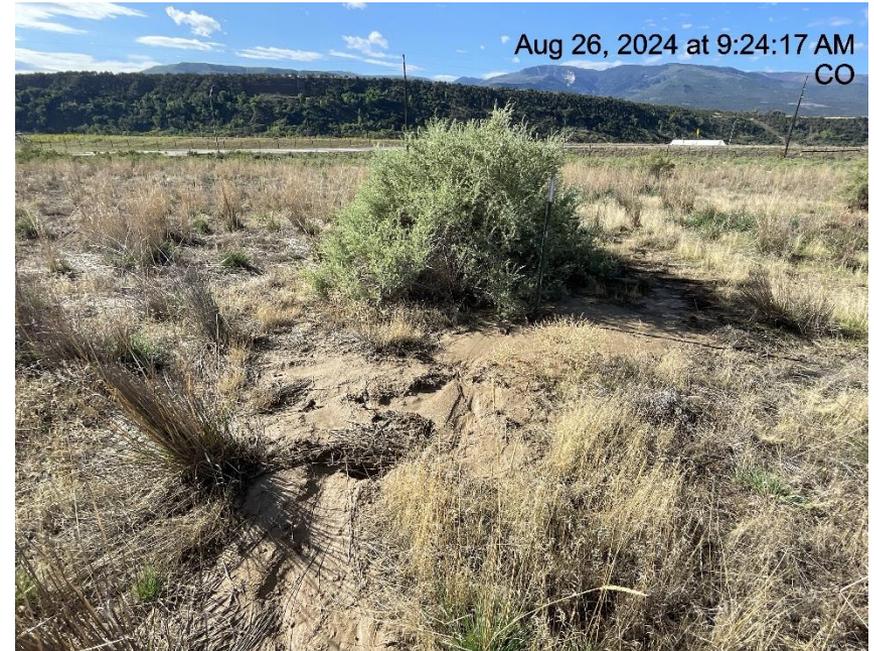
**Photo # 6268 Erosion & transport of sediment off location & into vegetated areas/failure to minimize erosion & the transport of sediment off location**

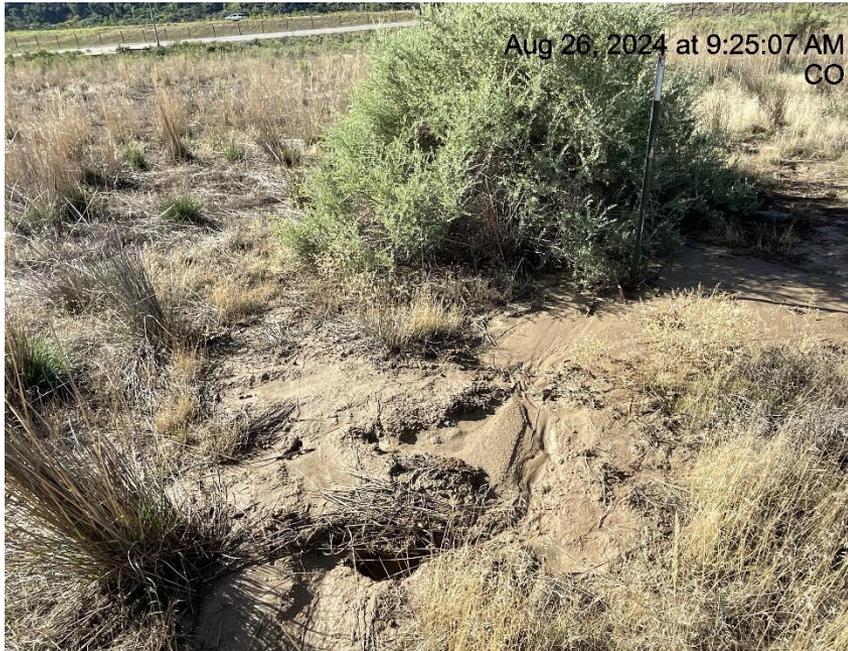
**Photo # 6269 Erosion & transport of sediment off location & into vegetated areas/failure to minimize erosion & the transport of sediment off location**
