Final Reclamation and Stormwater Inspection

Operator: PDC ENERGY INC - 69175

Location ID: 333296

Inspection Photos
Location Name: Great Western 66N67W
Location ID: 333296

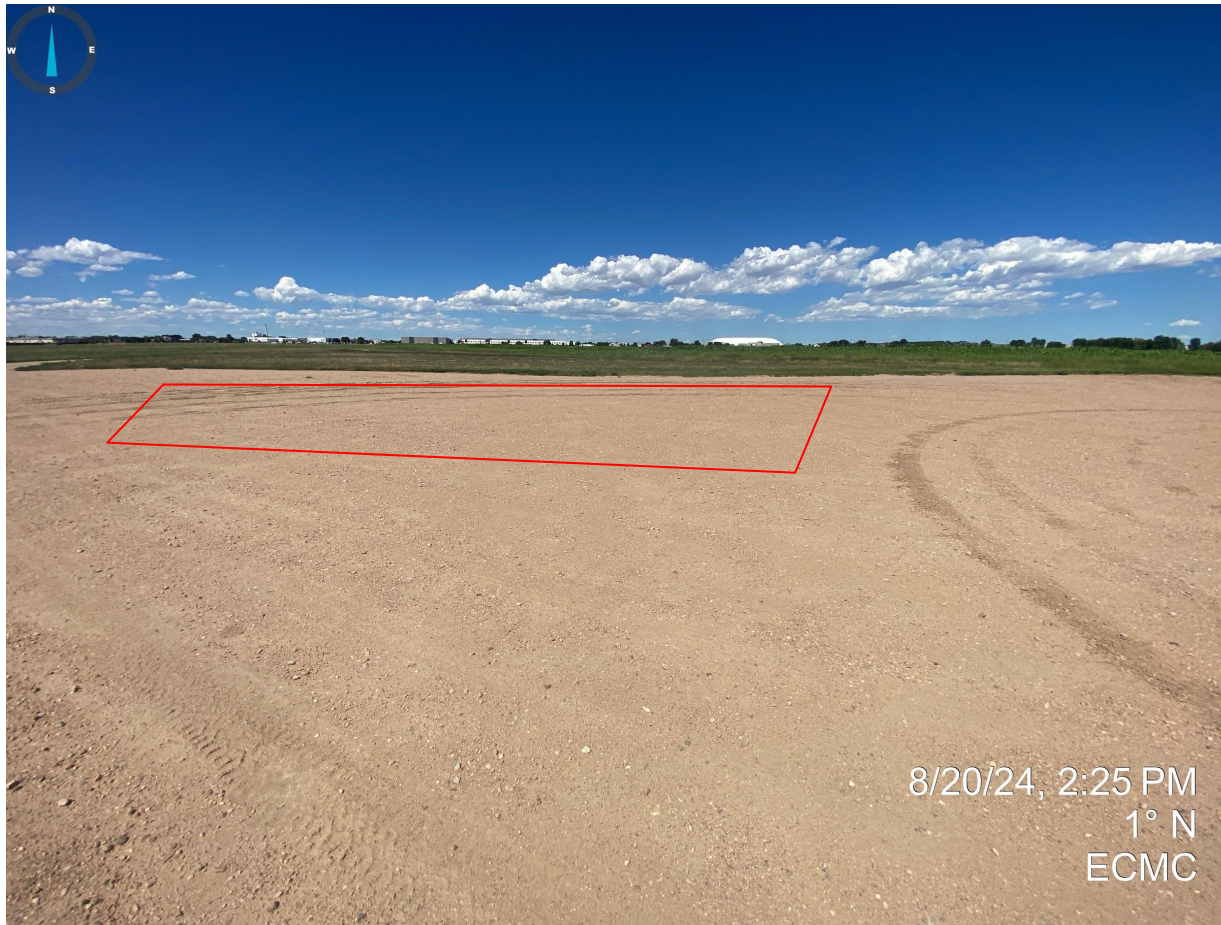
Photo 1. Red polygon illustrates approximate location of former PDC wells. It does not appear that the former well location has been reclaimed with evidence of road base material still observed. This portion of the former location does not appear to be in use by the active tank battery operated by Extraction Oil & Gas.

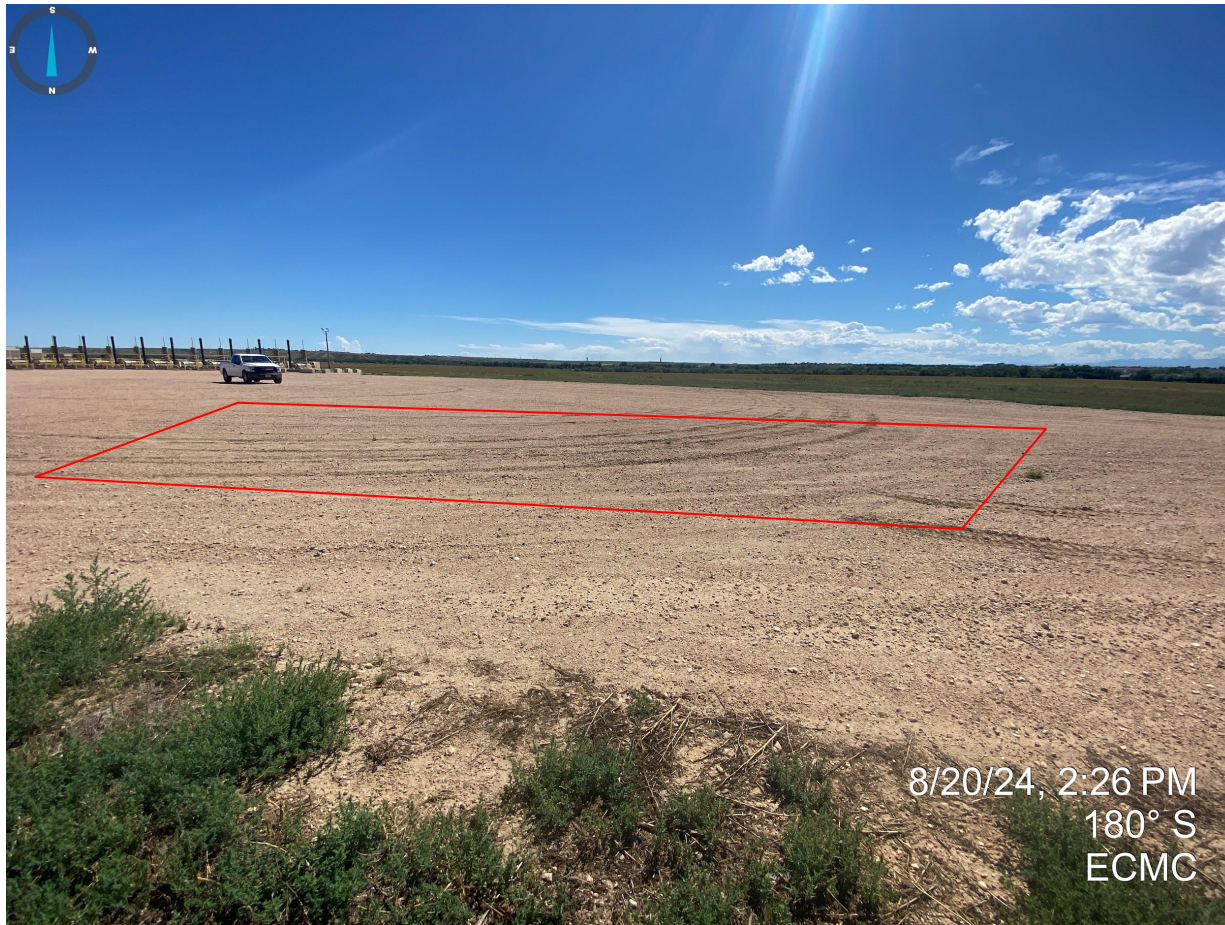
Photo 2. Facing south; see comments in Photo 2.

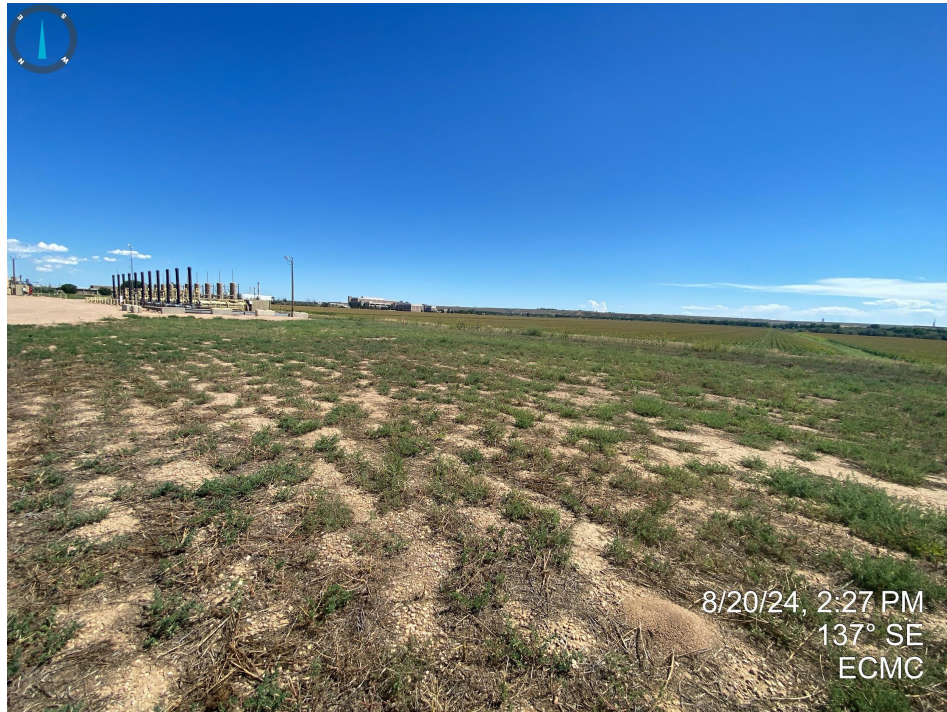
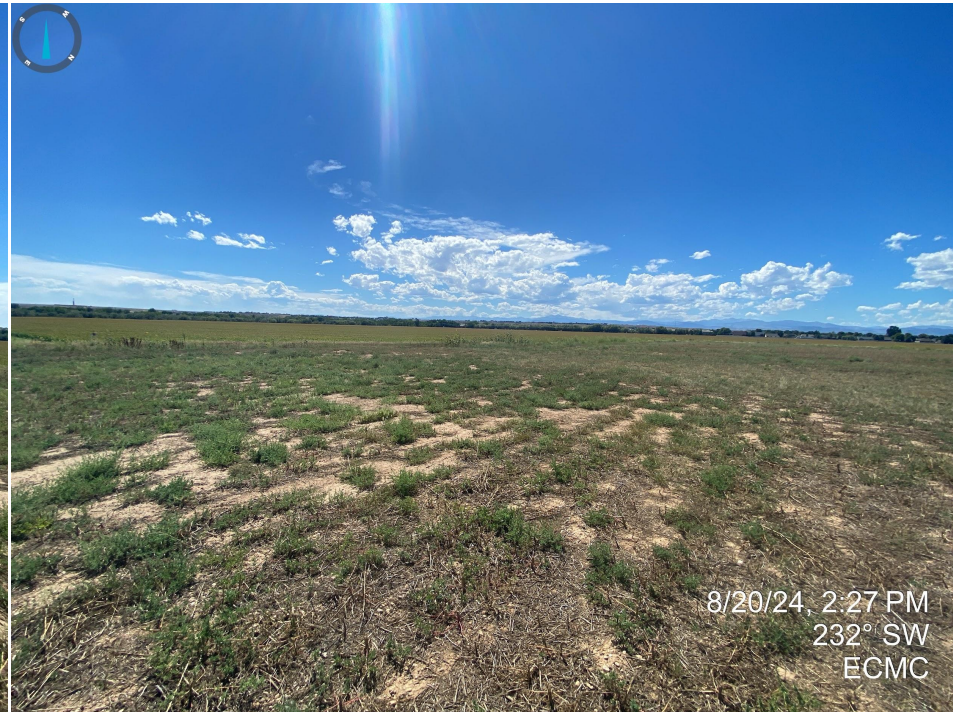
Photos 3 & 4. Facing southeast and southwest at the former tank battery. The tank battery does not appear to be progressing towards Rule 1004 standards with evidence of undesirable vegetation (kochia and russian thistle) observed throughout.

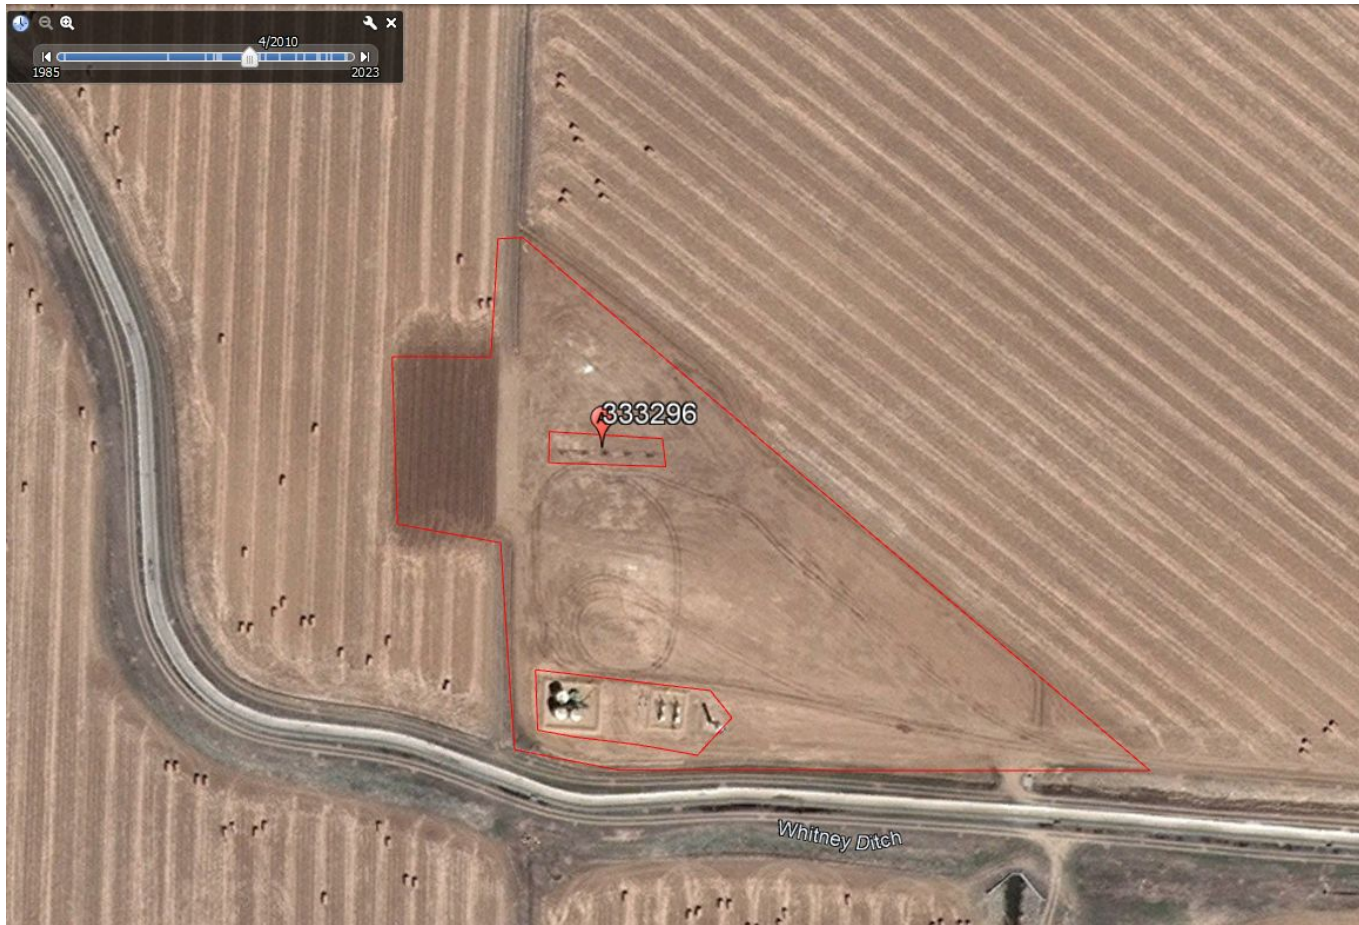
Photo 5. Google Earth aerial imagery (circa 04/2010) illustrating the Great Western/PDC location footprint prior to any additional oil and gas activity. Red outlines indicated wells, tank battery, and approximate extent of original disturbance.

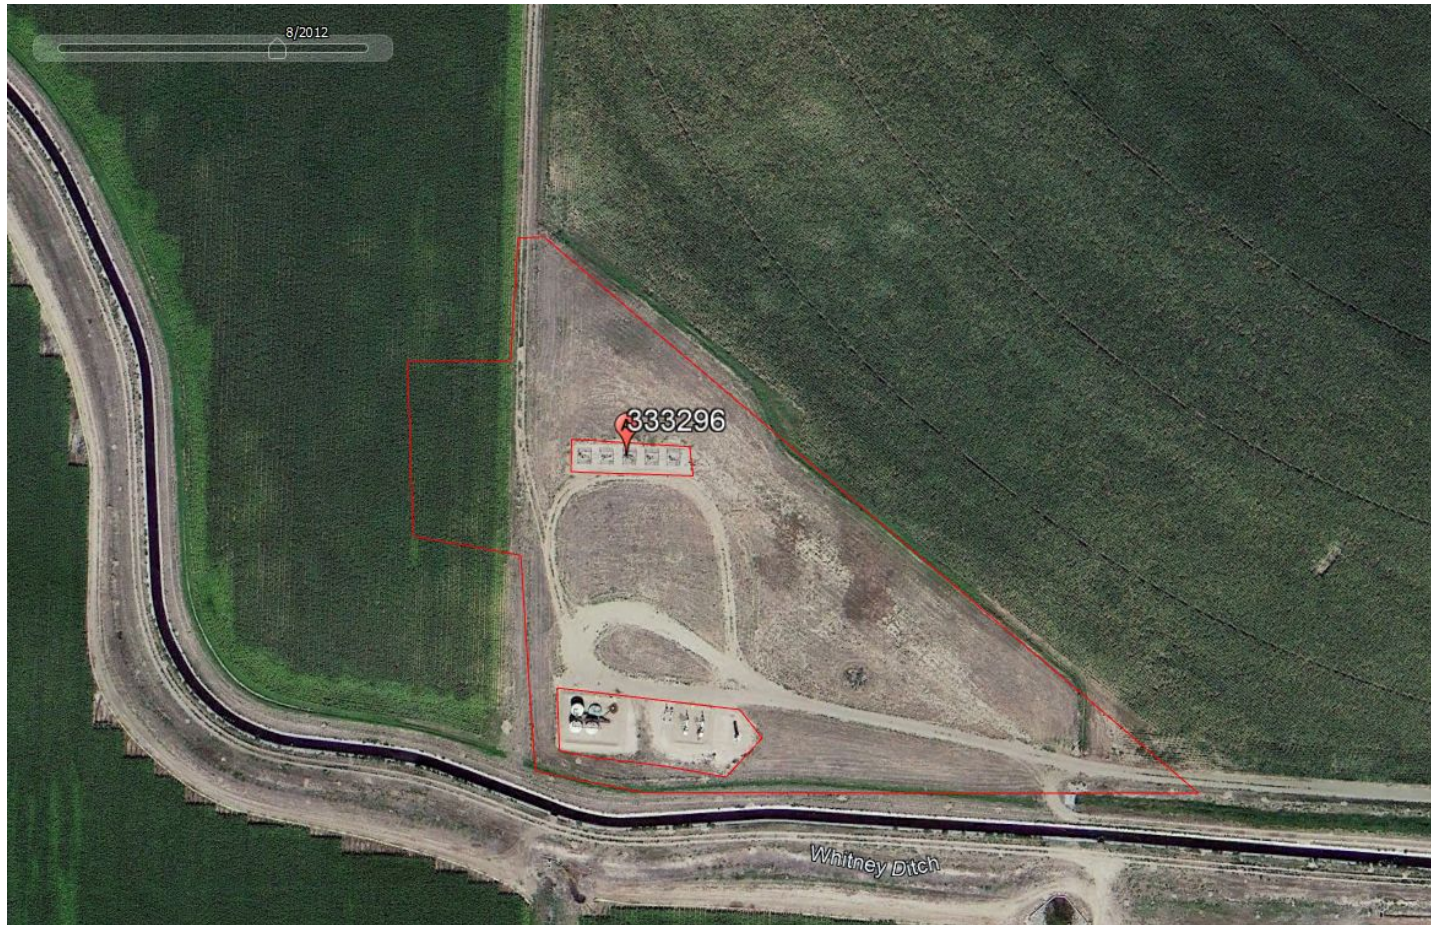
Photo 6. Google Earth aerial imagery (circa 08/2012) illustrating the Great Western/PDC location after interim reclamation activities were performed.

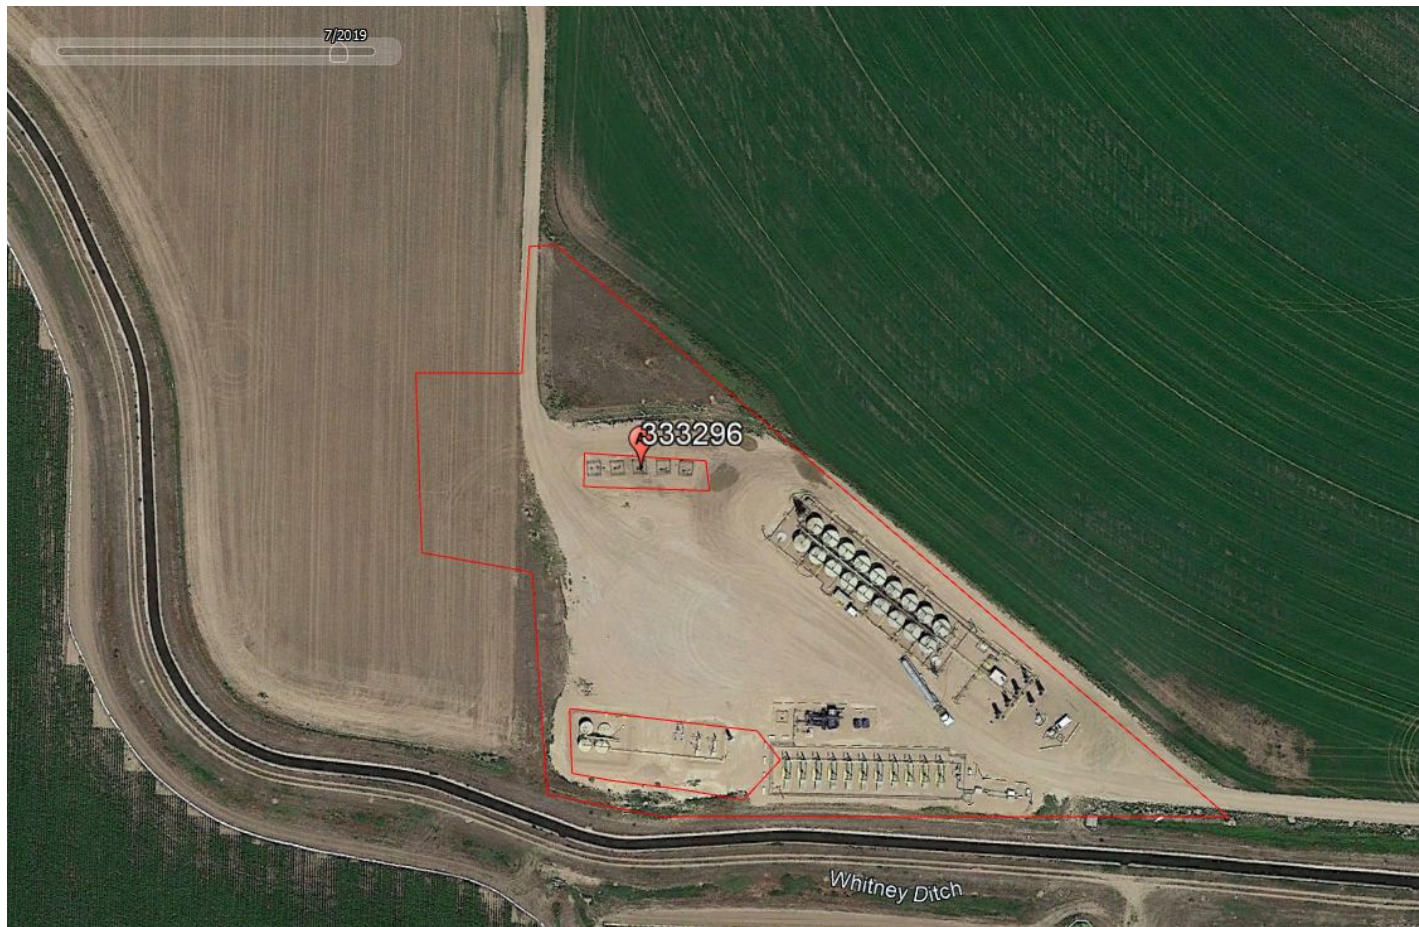
Photo 7. Google Earth aerial imagery (circa 07/2019) illustrating the Great Western/PDC location after the active tank battery operated by Extraction Oil & Gas was constructed and before the Great Western/PDC location underwent final reclamation.

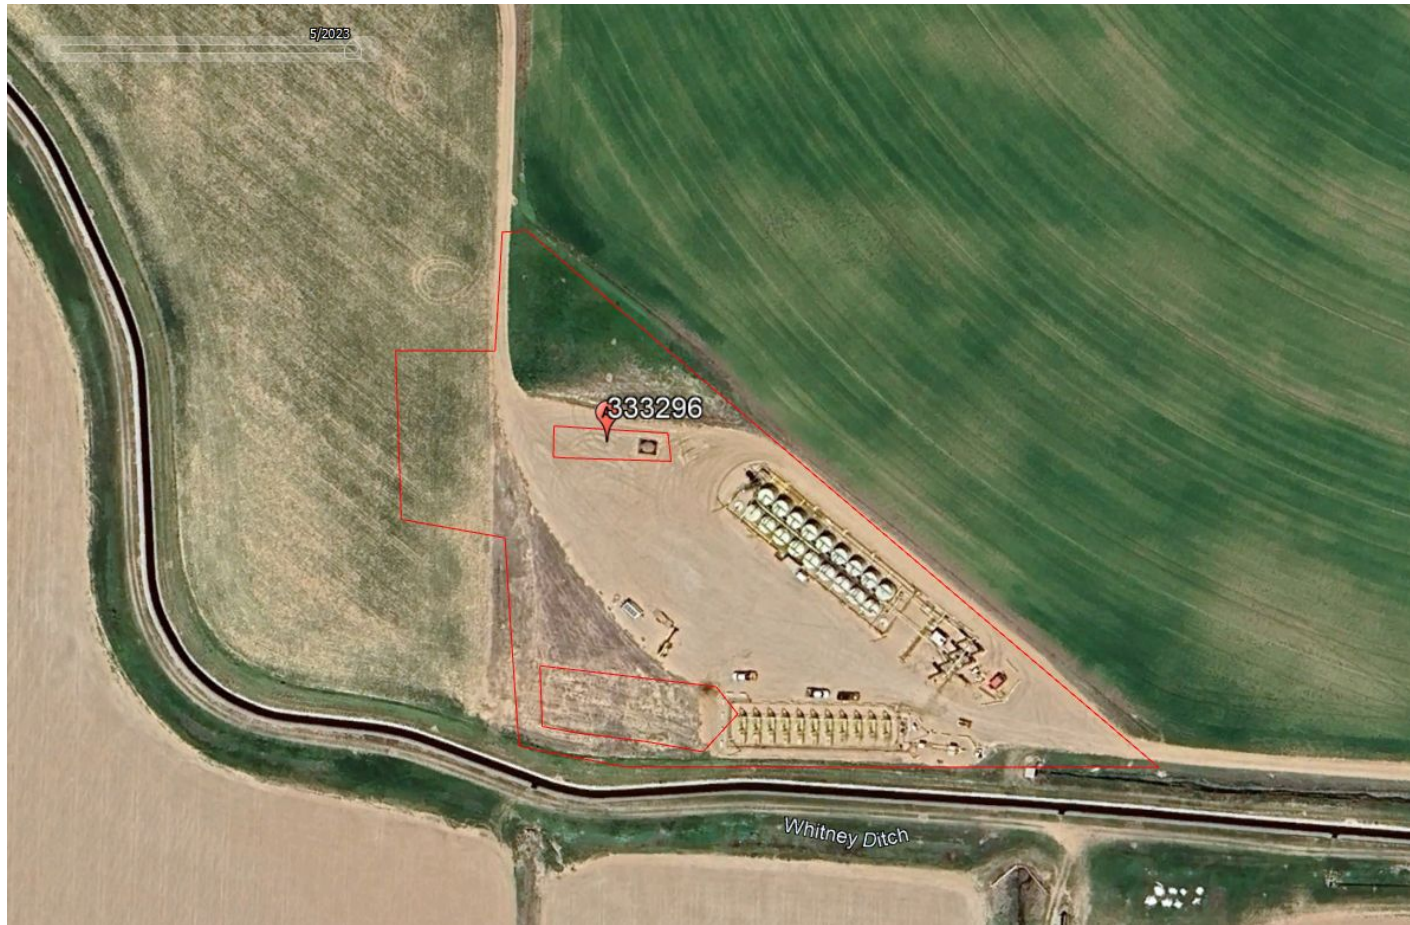
Photo 8. Google Earth aerial imagery (circa 05/2023) illustrating the Great Western/PDC location after the wells and tank battery were decommissioned.

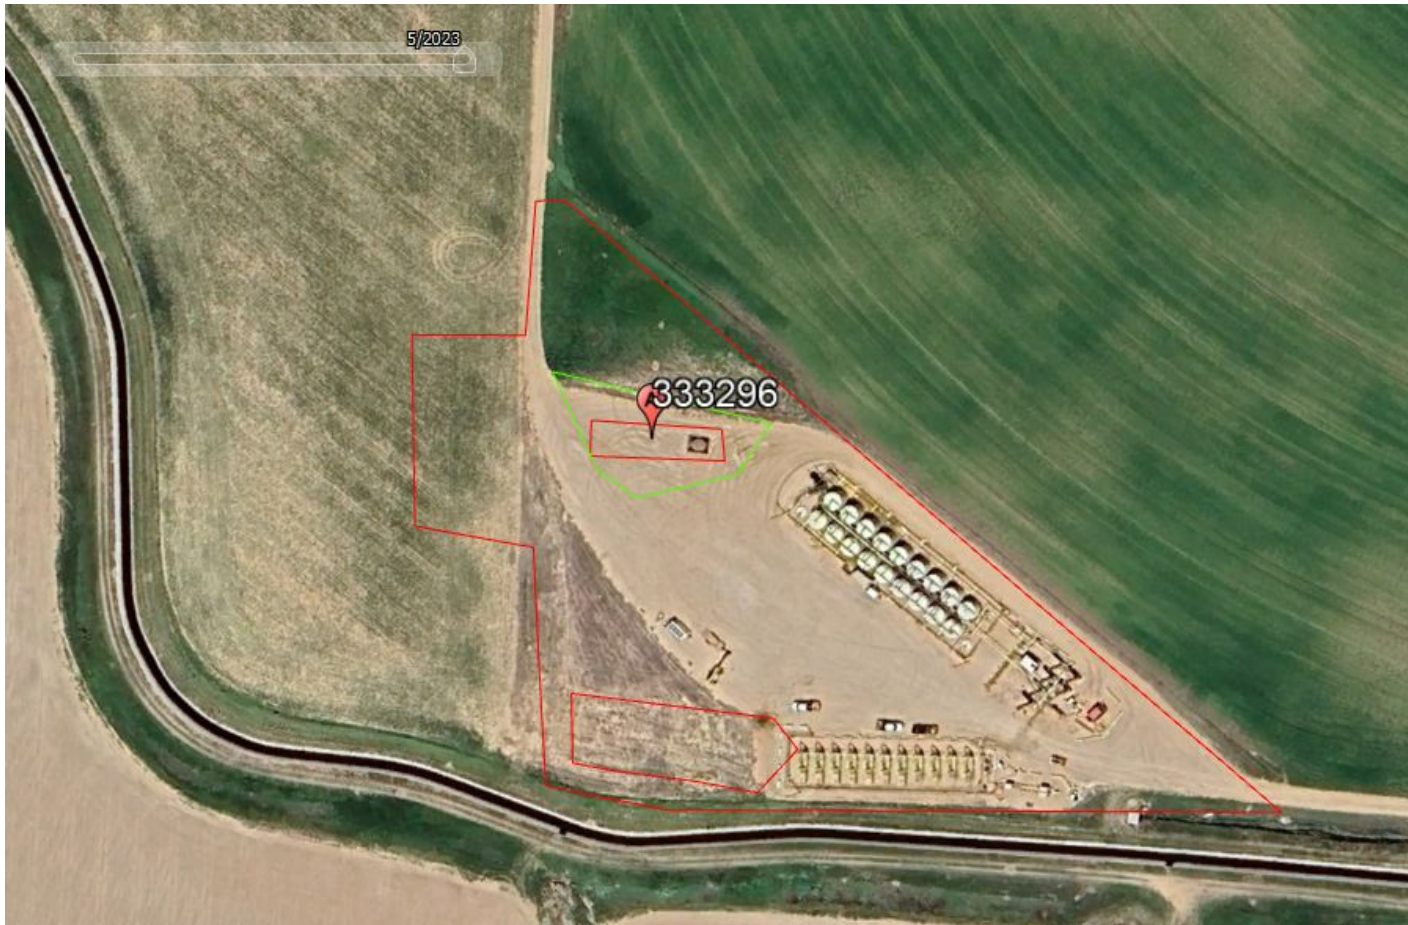
Photo 9. Green polygon illustrates areas that require additional final reclamation activities. Note - green polygon is only approximate as this area does not appear to be in use by the active tank battery location.

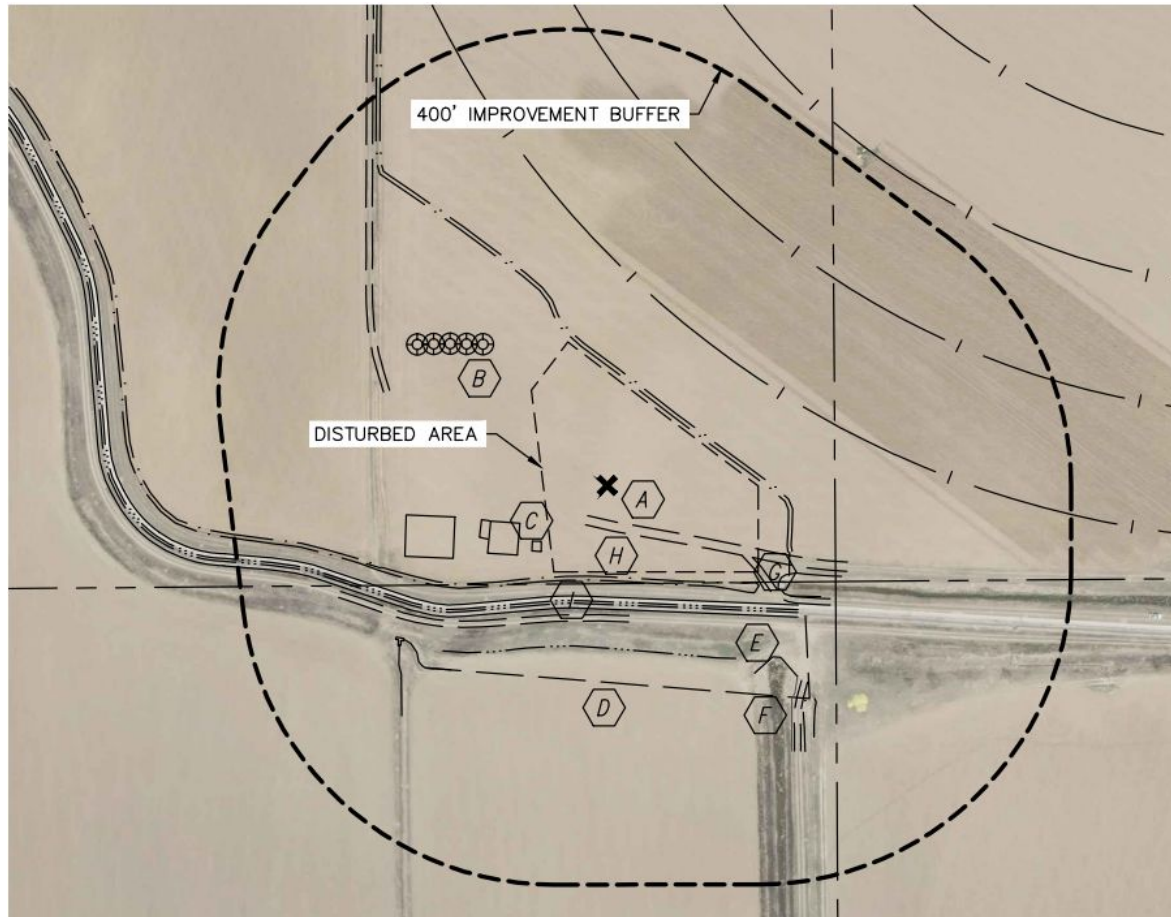
Photo 10. Construction layout drawings from active tank battery location operated by Extraction Oil & Gas (doc #400380371). Photo illustrates the disturbance area for the Extraction Oil & Gas tank battery with the preexisting Great Western/PDC location to the west of the outlined disturbance area.
