**Storm Water Management and Erosion control**  
**Location Name: CAERUS PICEANCE LLC Federal 7007E-2 (H2SW) Pad**  
**Location ID: 324340**

**Location Overview: Location is within Black Bear Habitat area  
& in close proximity to High Priority/NSO Habitat areas.  
Location is approximately 400 yards from Middle Mamm  
Creek.**

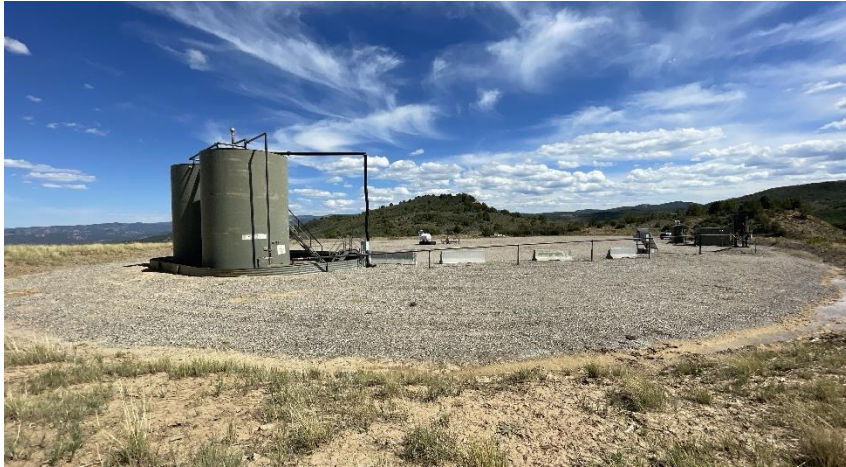
**North West corner of location.**

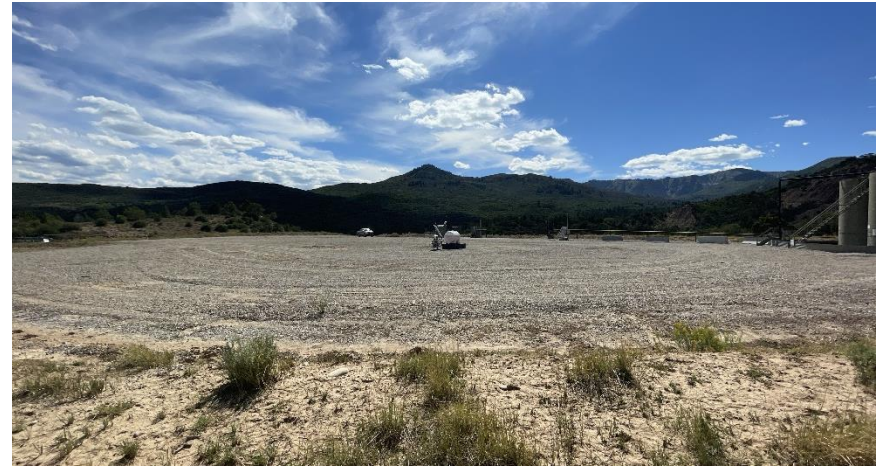
**North East corner of location.**

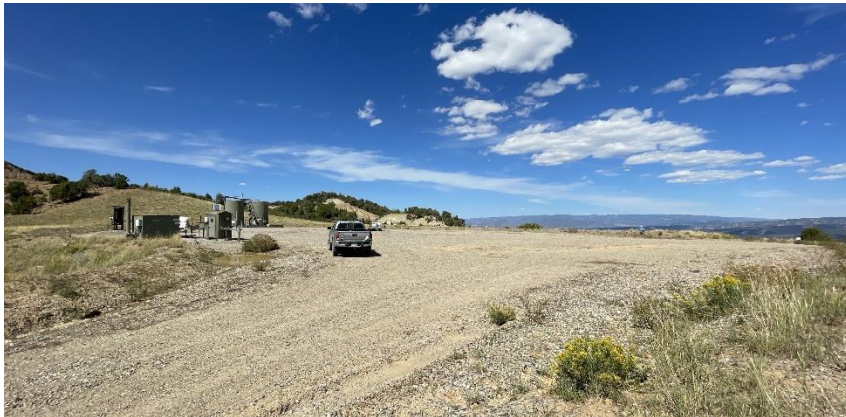
**South West corner of location.**

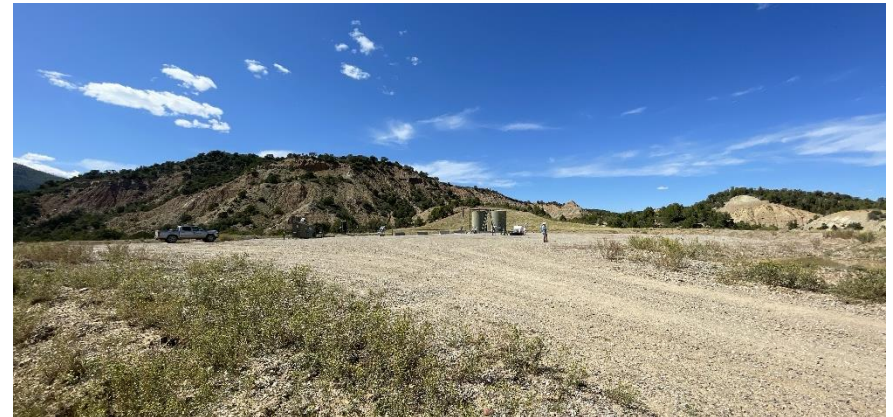
**South East corner of location.**

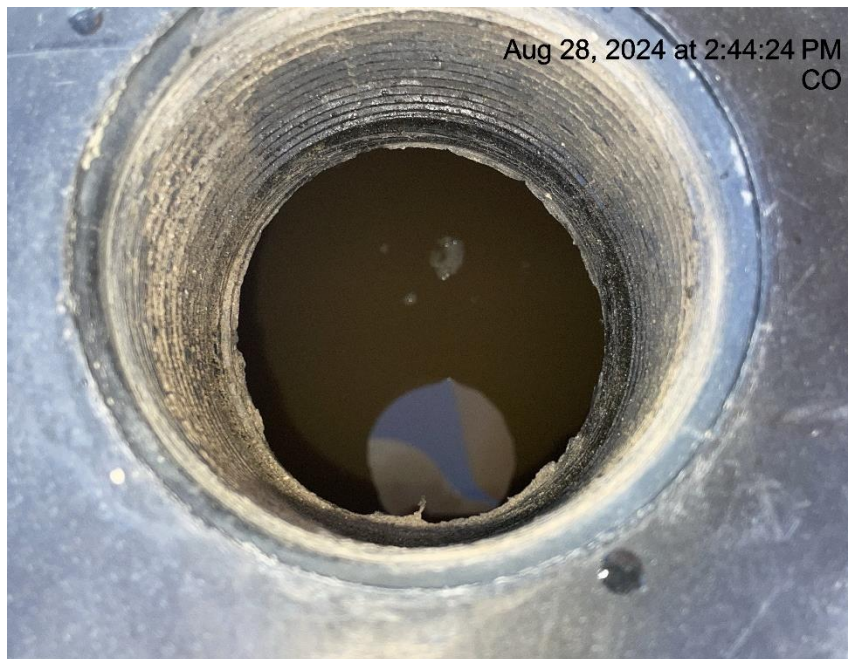
**Photo # 7116 Failure to maintain chemical BMP - Chemical tank containment approximately 3/4 full of fluid/BMP insufficient to contain possible spill.**

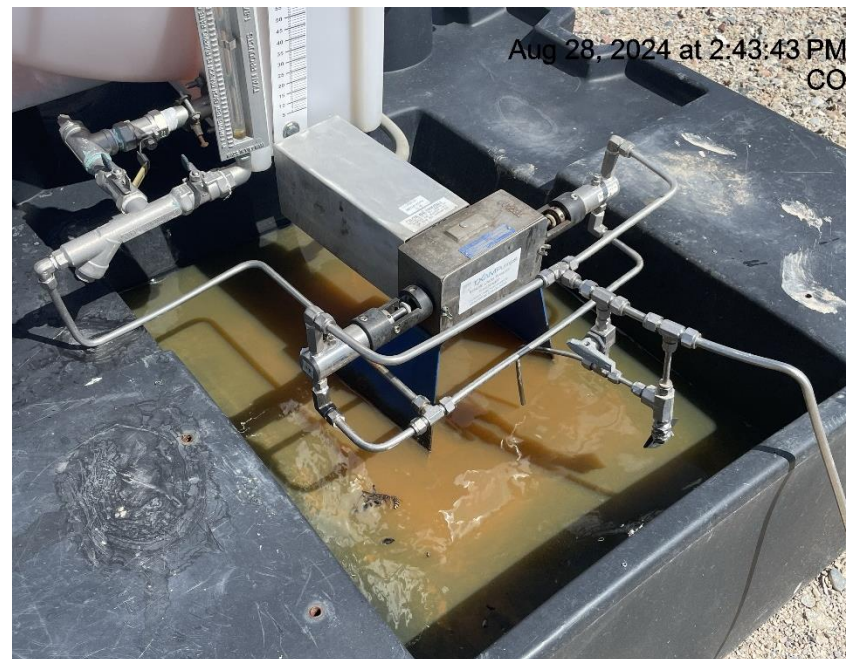
**Photo # 7117 Failure to maintain chemical BMP - Chemical tank containment approximately 3/4 full of fluid/BMP insufficient to contain possible spill. (Standing fluid on chemical containment is also a wildlife hazard)**

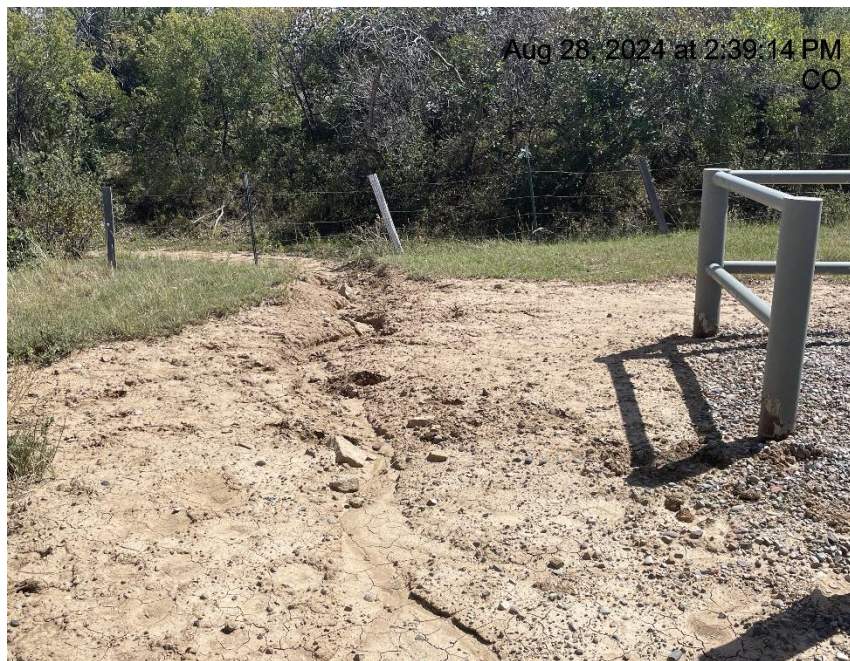
**Photo # 7118 Erosion & transport of sediment off location/failure to minimize erosion & transport of sediment (near pig station at entrance to location)**

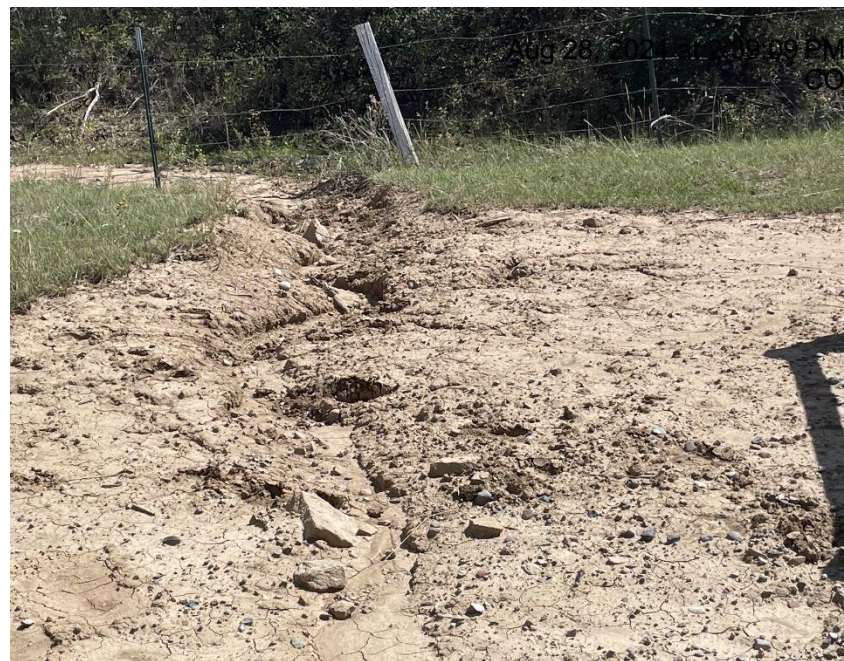
**Photo # 7119 Erosion & transport of sediment off location/failure to minimize erosion & transport of sediment (near pig station at entrance to location)**

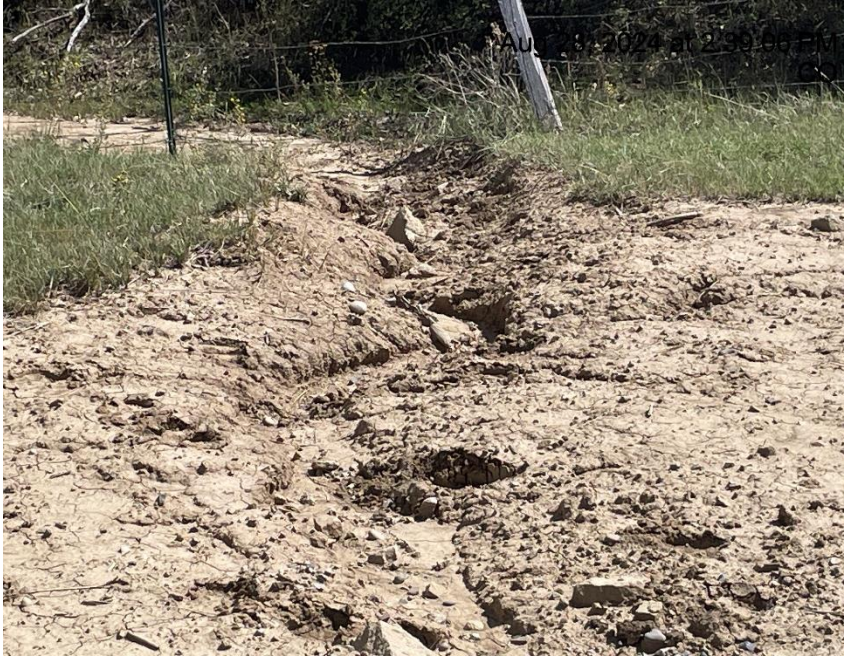
**Photo # 7120 Erosion & transport of sediment off  
location/failure to minimize erosion & transport of sediment  
(near pig station at entrance to location)**
