Storm Water Management and Erosion control
Location Name: TEP ROCKY MOUNTAIN LLC CLOUGH RWF 34-14 Pad
Location ID: 324214

Location Overview: Location is within High Priority/Density Habitat areas & in close proximity to Bald Eagle Roost Sites. Location is approximately 110 yards from a creek/drainage that contributes to the Colorado River.

Section/Township/Range: 14 6S94W

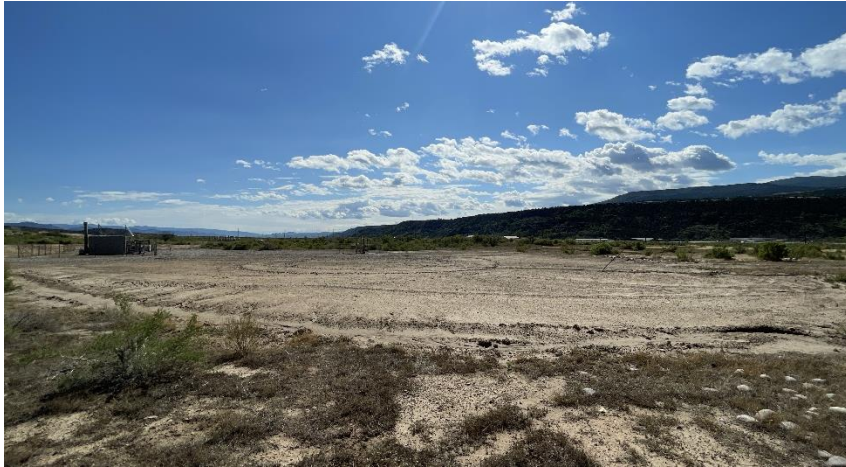
North West corner of location.

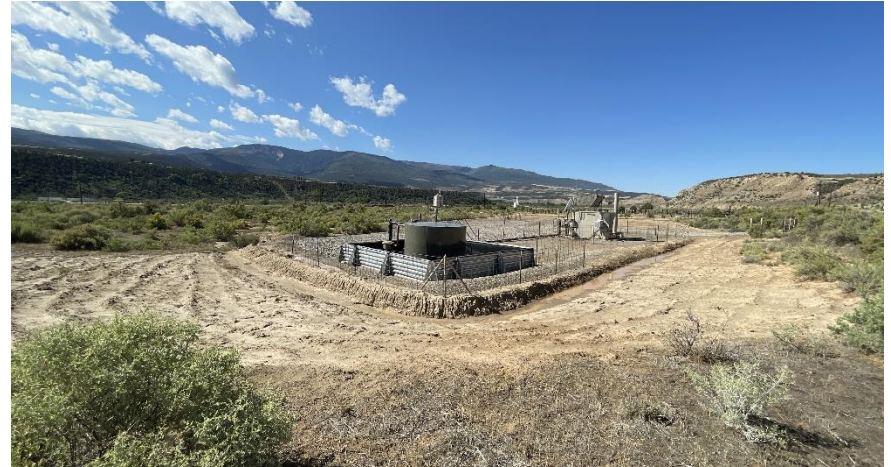
North East corner of location.

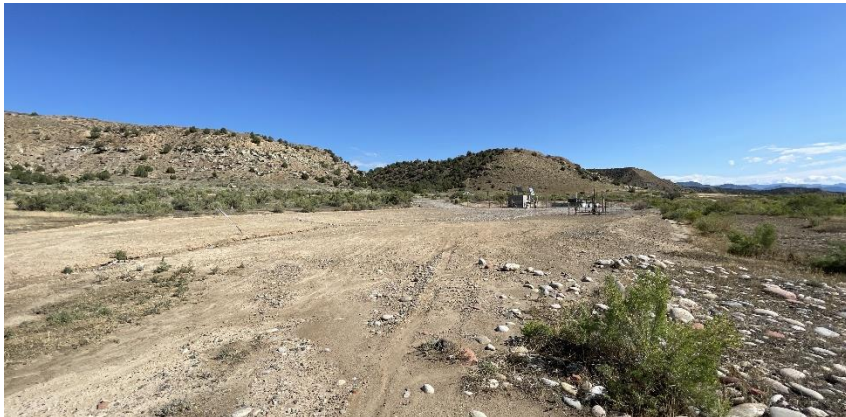
South West corner of location.

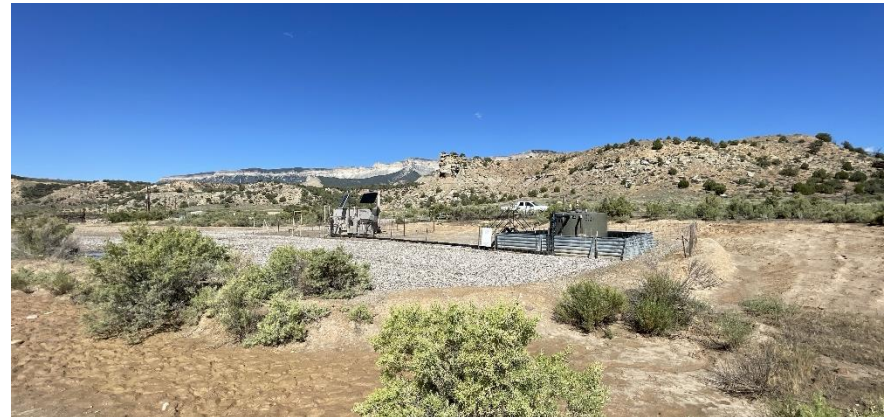
South East corner of location.

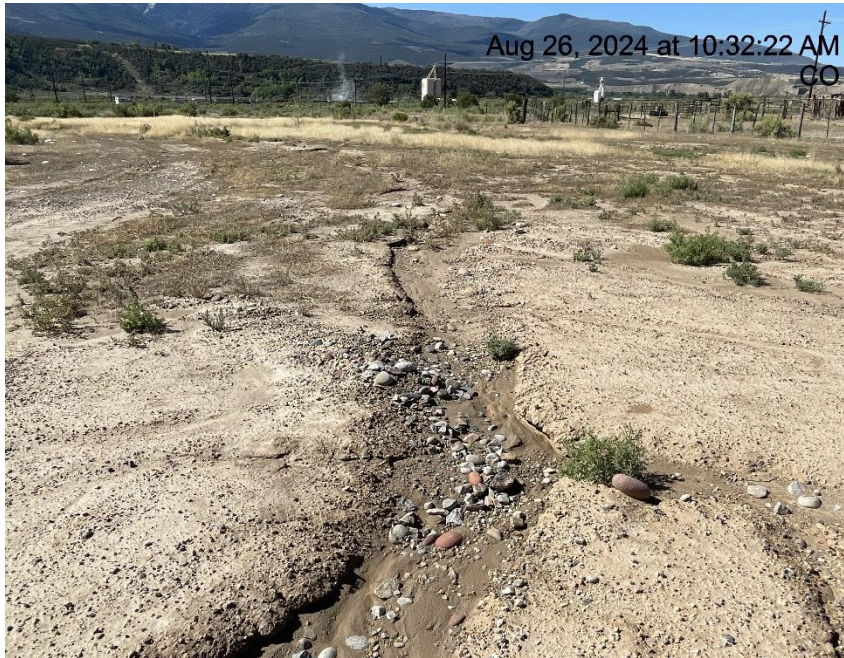
Photo # 6451 Erosion & transport of sediment off location & into a vegetated area/failure to minimize erosion & transport of sediment

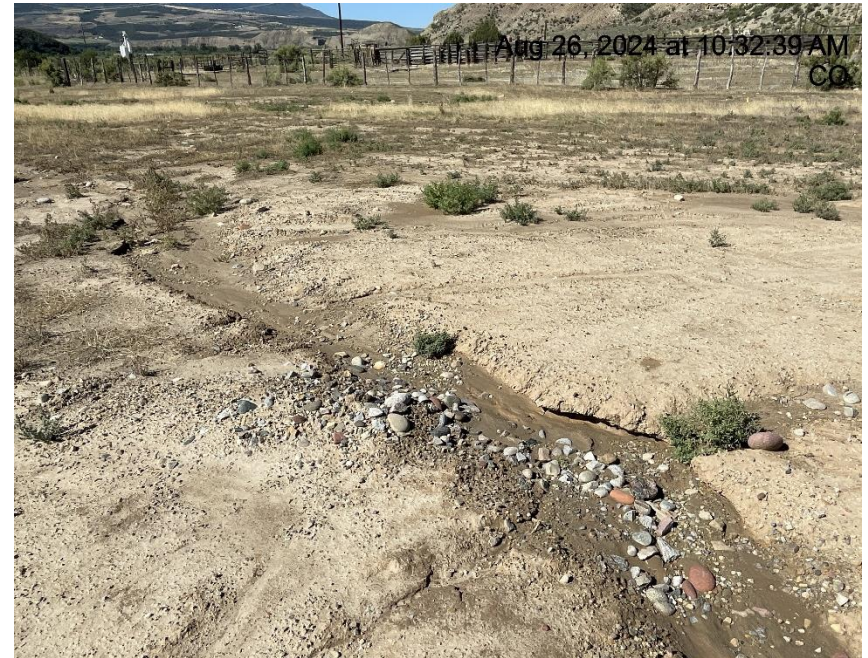
Photo # 6452 Erosion & transport of sediment off location & into a vegetated area/failure to minimize erosion & transport of sediment

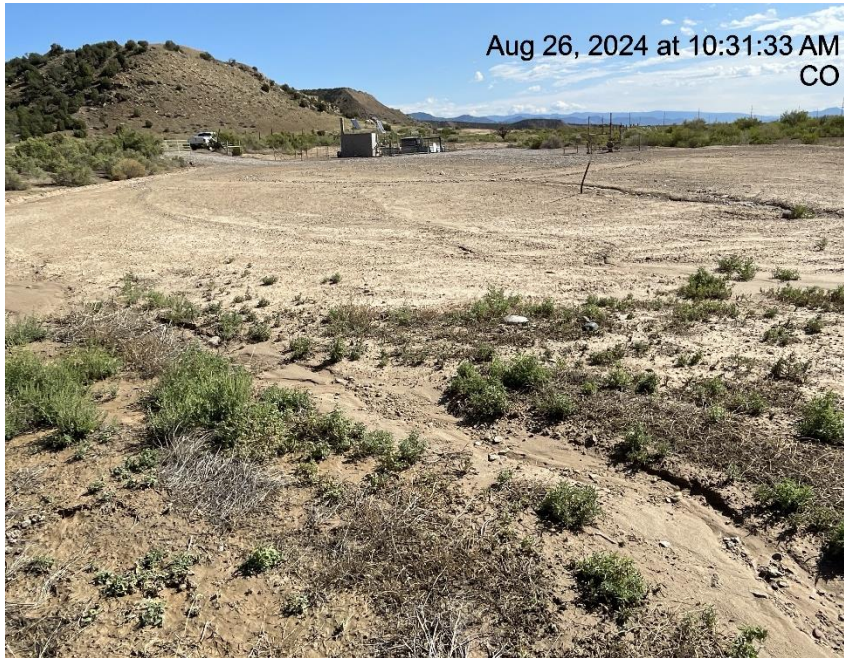
Photo # 6453 Erosion & transport of sediment off location & into a vegetated area/failure to minimize erosion & transport of sediment

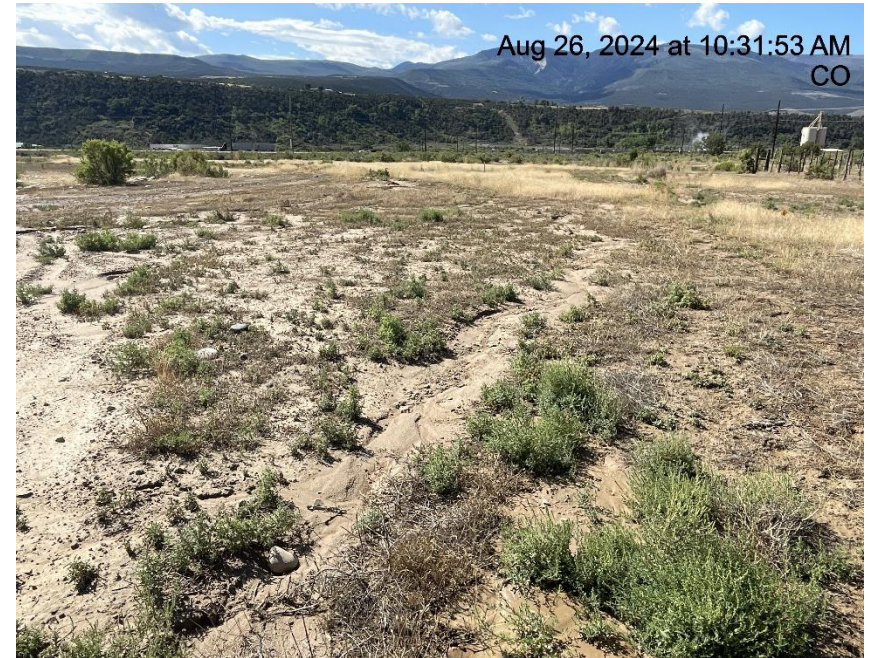
Photo # 6454 Erosion & transport of sediment off location & into a vegetated area/failure to minimize erosion & transport of sediment

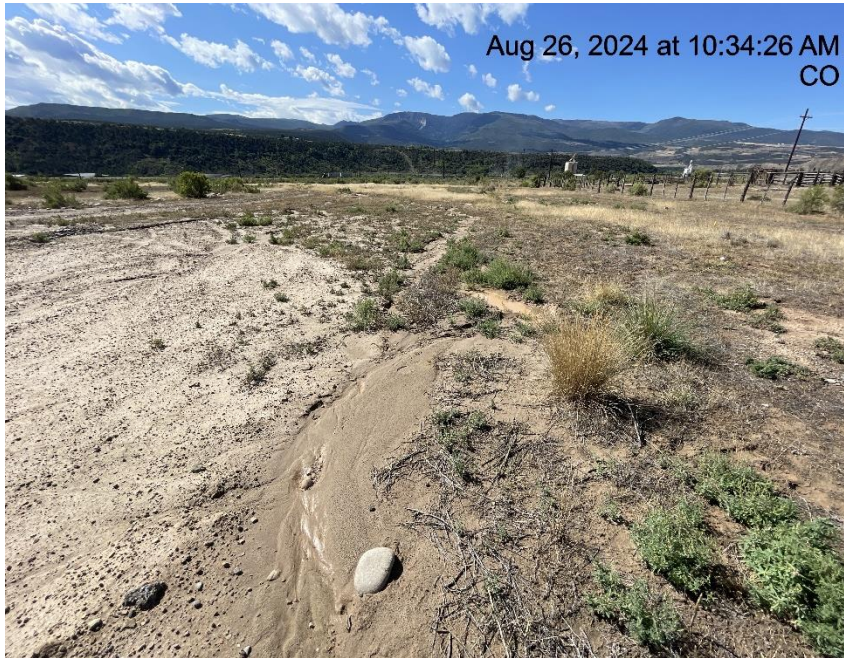
Photo # 6455 Erosion & transport of sediment off location & into a vegetated area/failure to minimize erosion & transport of sediment

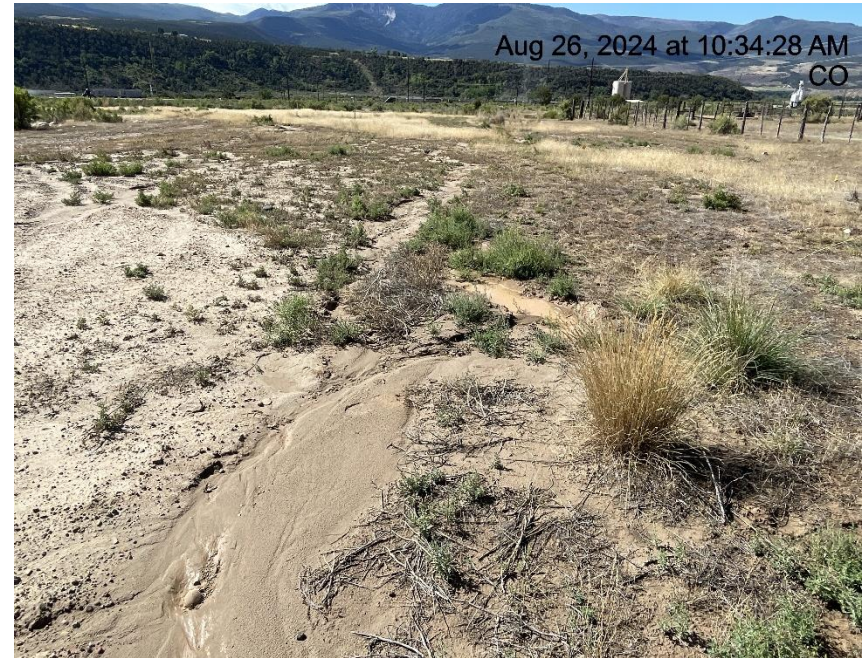
Photo # 6456 Erosion & transport of sediment off location & into a vegetated area/failure to minimize erosion & transport of sediment

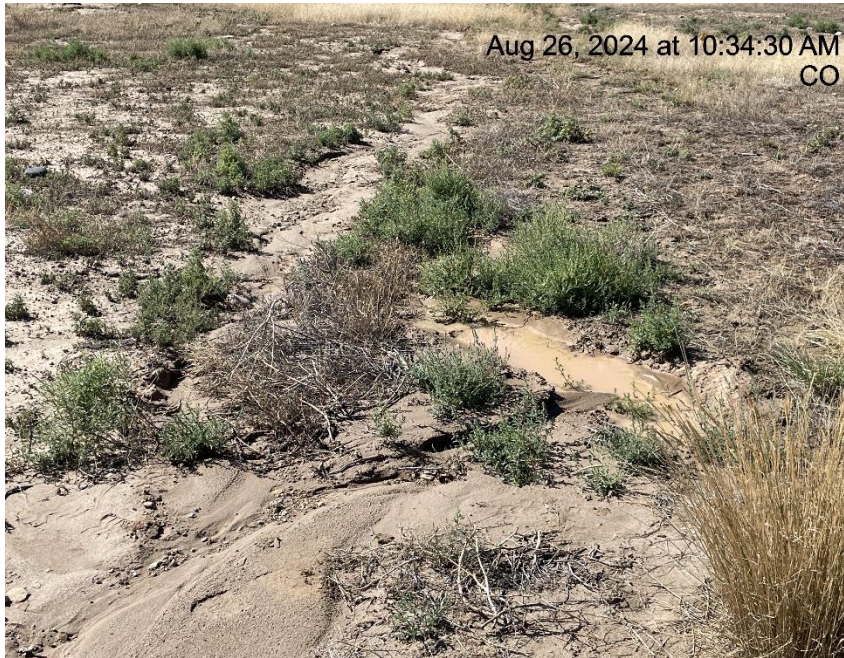
Photo # 6457 Erosion & transport of sediment off location & into a vegetated area/failure to minimize erosion & transport of sediment

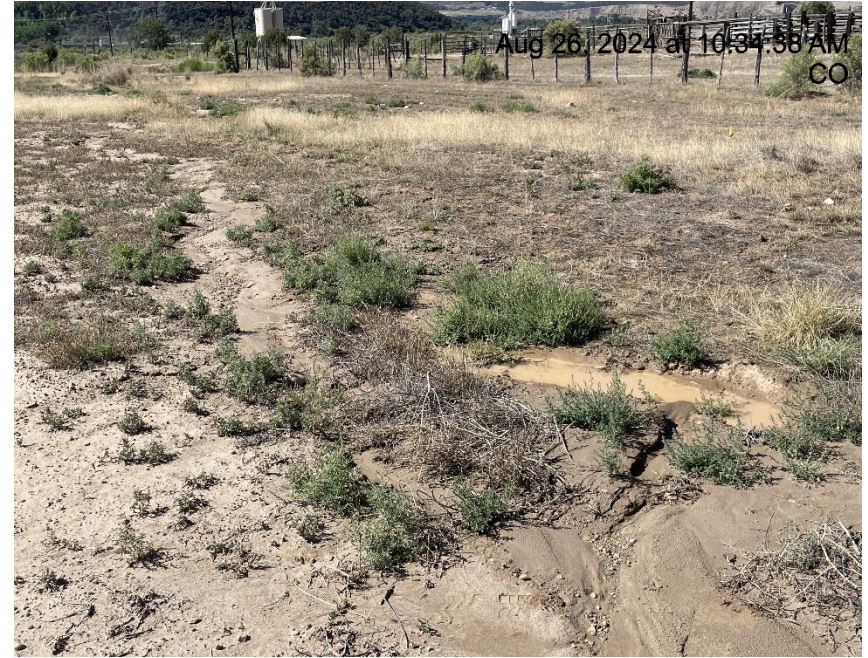
Photo # 6458 Erosion & transport of sediment off location & into a vegetated area/failure to minimize erosion & transport of sediment
