WILDLIFE PROTECTION PLAN

TULIP OIL AND GAS LOCATIONS
WELD COUNTY, CO

Wetland Delineation Report

TULIP OIL AND GAS LOCATIONS

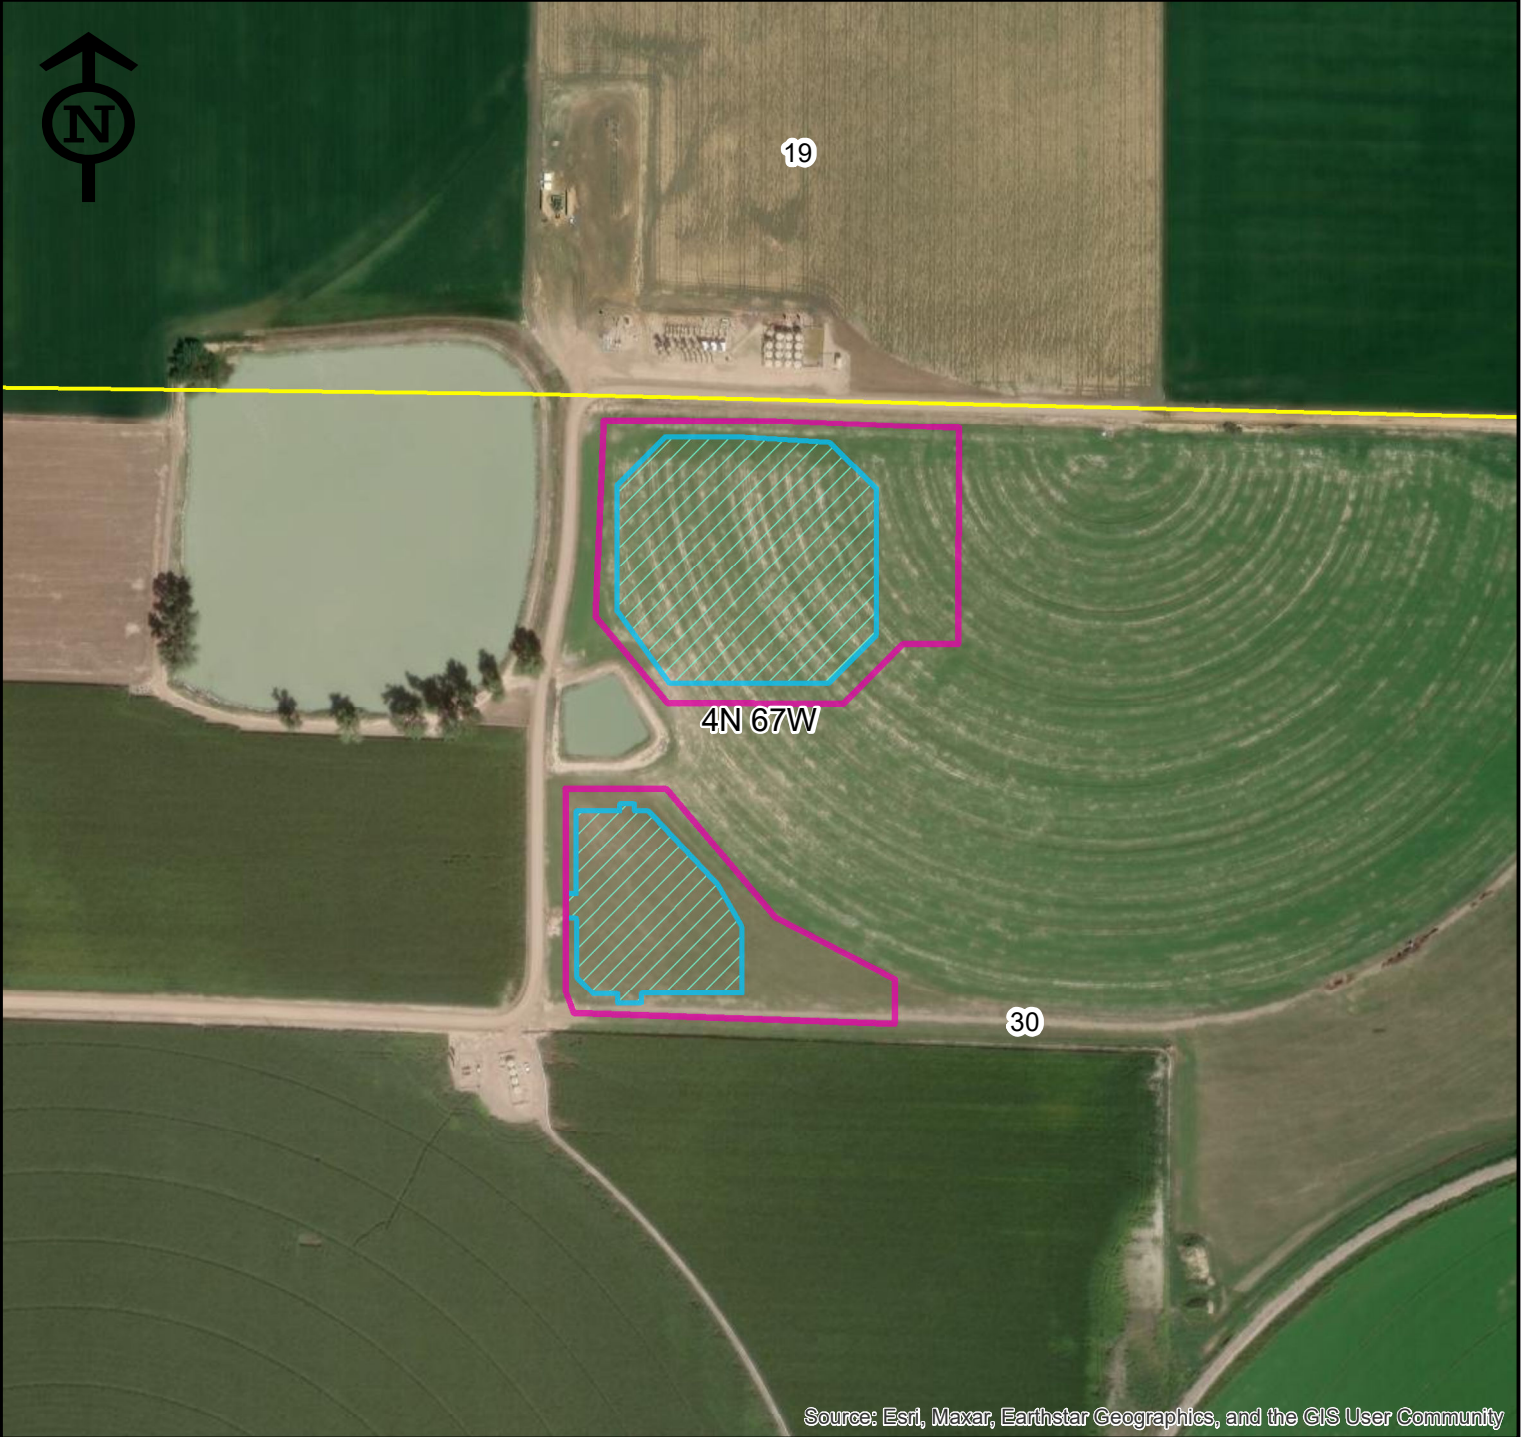
Wildlife Protection Plan
Figure 1

The Site is located in Section 30, Township 4 North, Range 67 West, in Weld County. Total acreages for the Site’s working pad surface (WPS) is 8.32 acres and the Site’s disturbance area (DA) is 14.18 acres (**Appendix I:** Figure 1). Land use within the Site is agricultural as depicted in the photographic log in **Appendix II.** KMOG anticipates pad construction and drilling to begin in the second quarter of 2025, followed by completion in the third quarter of 2025. Existing access roads will be utilized to the extent practicable.

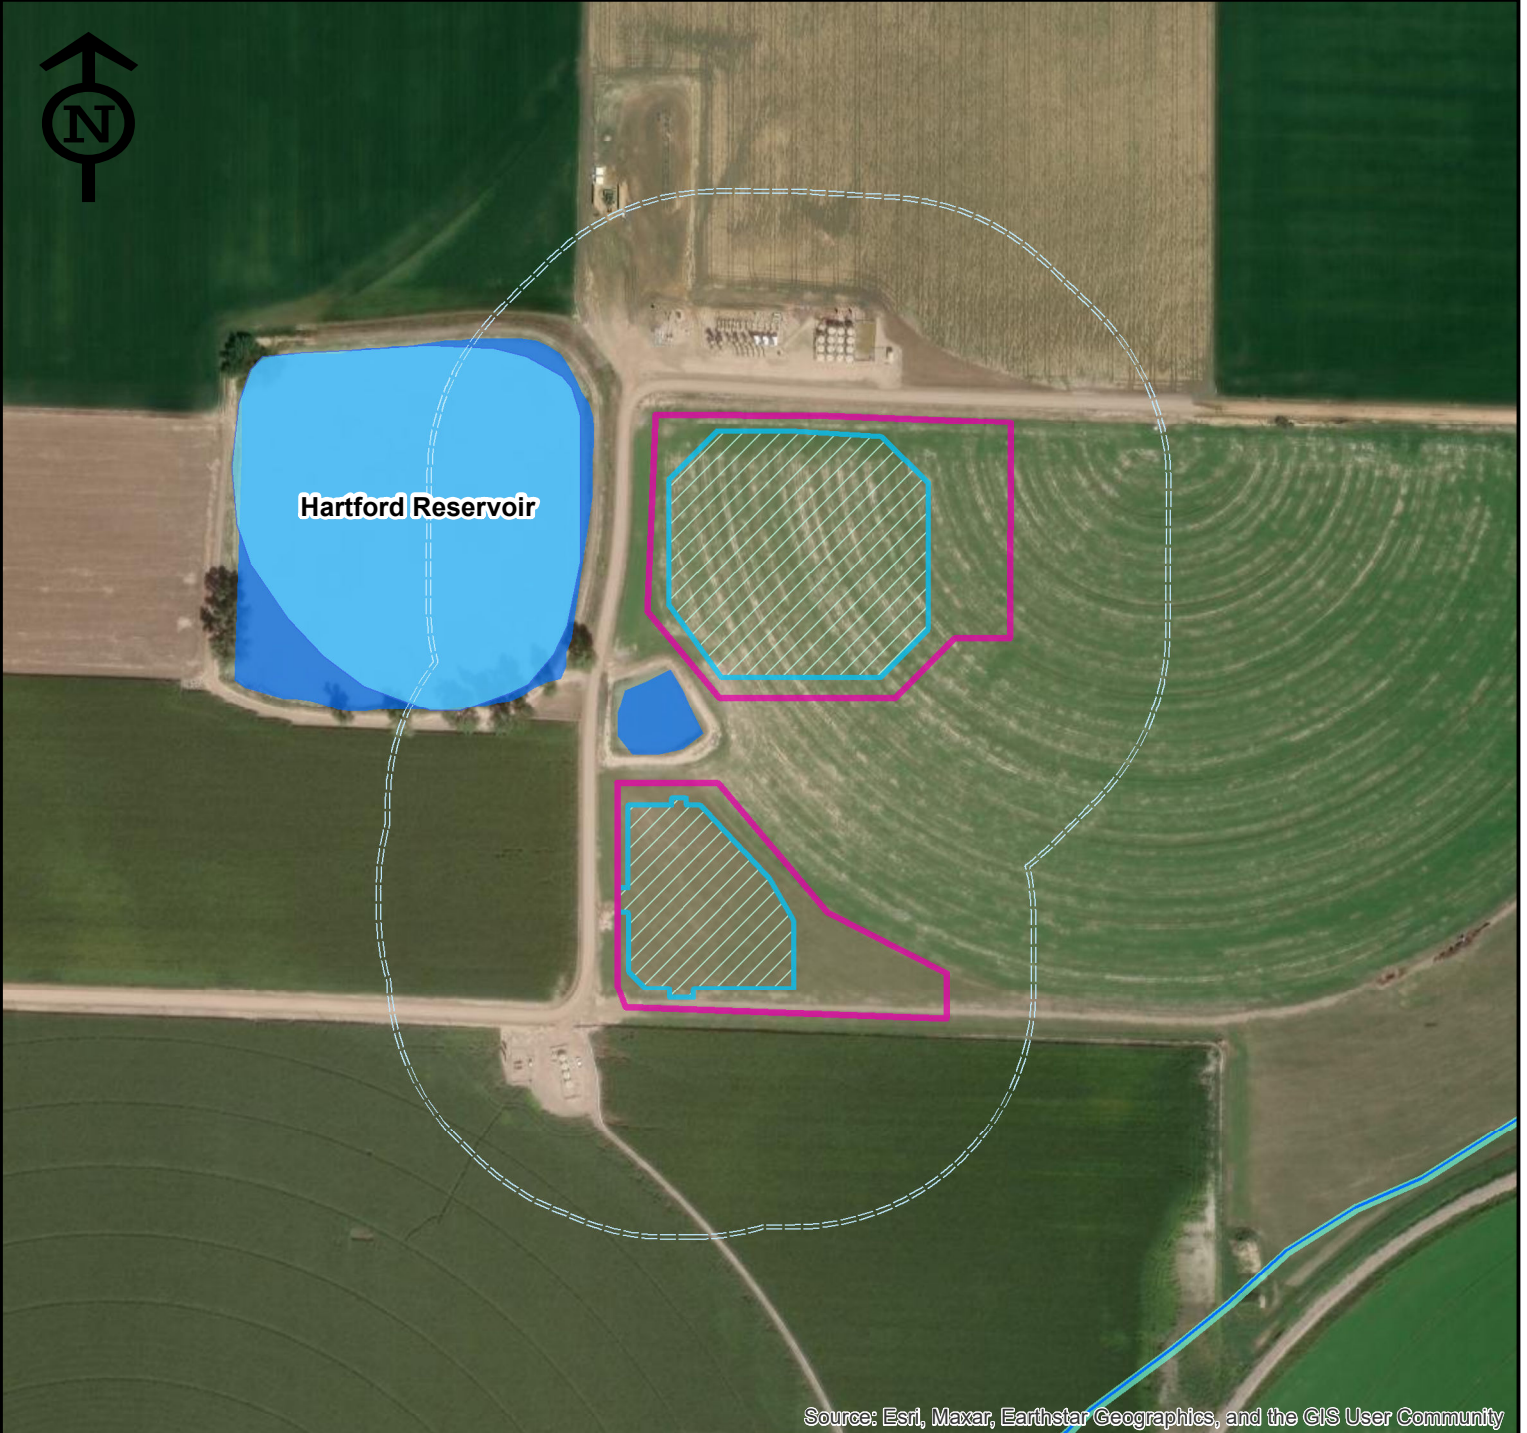
Wildlife Protection Plan
Figure 2

During the site assessment on 9/5/23, 2DOT verified two man-made water features, upgradient of the Site, with an ordinary high-water mark (OHWM) within 500 feet of the Site. One NHD/NWI-mapped pond (Hartford Reservoir), characterized as an excavated intermittently exposed unconsolidated palustrine pond is within 500 feet of the Site. The Hartford Reservoir is privately owned and primarily used for irrigation of agriculture. The second NWI-mapped pond, characterized as an excavated, semi permanently flooded, unconsolidated palustrine pond (**Appendix I:** Figure 2) is also within 500 feet of the Site. This resource appears to have been constructed sometime between 2008 and 2010 and serves a catchment for the pivot irrigation in the down gradient agricultural field to the east. The Colorado Water Conservation Board for Weld County, CO indicates the nearest 100-year floodplain (Zone A) is over 1.46 miles to the north of the Site.

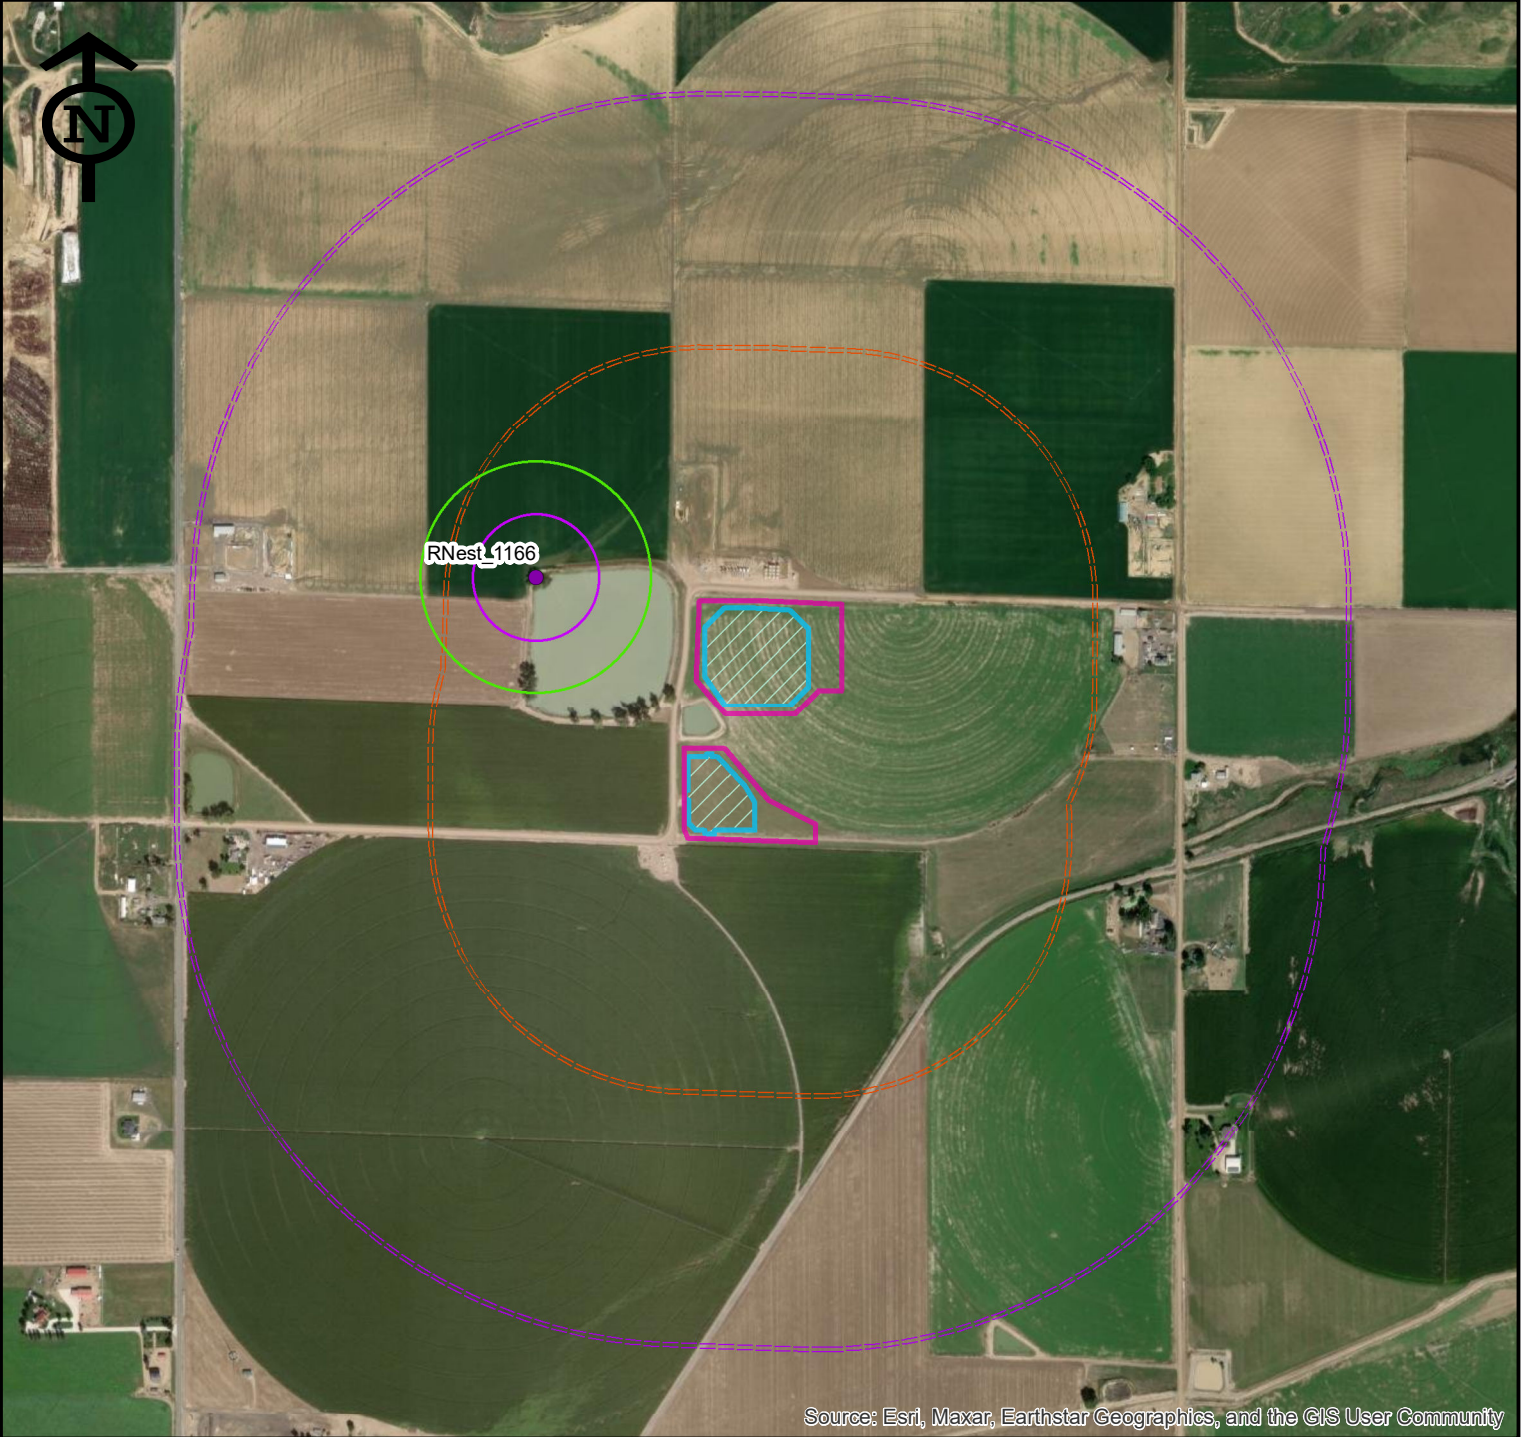
Wildlife Protection Plan
Figure 3

2DOT confirmed the presence of suitable habitat for migratory and protected avian species approximately 172 ft, west/northwest of the Site. One historic great horned owl (*Bubo virginianus*) nest previously active in 2020 (RNest_1166) was unoccupied as of 9/5/2023 (**Appendix I**: Figure 3). During the site visit on 9/5/2023, RNest_1166 was not occupied, however, one adult bald eagle (*Haliaeetus leucocephalus*) was perched in the nest tree prior to flying south. Pre-construction CPW protocol raptor nest surveys will be conducted prior to vegetation removal if planned during the nesting season. If an active nest(s) is identified and operations fall within a CPW recommended species buffer, KMOG will consult with CPW.

2DOT confirmed the presence of suitable habitat for migratory and protected avian species approximately 172 ft, west/northwest of the Site. There is a potential for adverse impacts to occur if migratory and protected avian species nest within line of sight to the Site.

1. Construction is currently scheduled to begin in the second quarter of 2025 and coincides with the raptor nesting season (December 1 – July 15). Pre-construction CPW protocol raptor nest surveys will be conducted prior to vegetation removal if planned during the nesting season. If an active nest(s) is identified and operations fall within a CPW recommended species buffer, KMOG will consult with CPW.

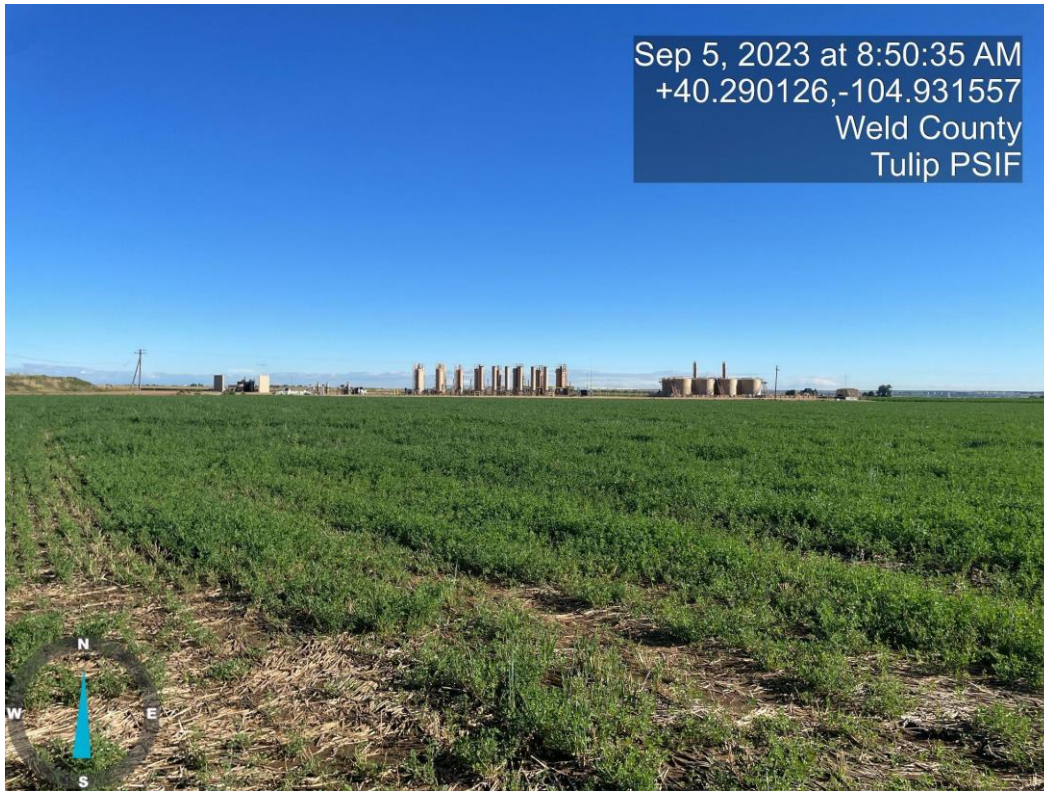
Photograph 1. Representative photo of the Site, viewing North.

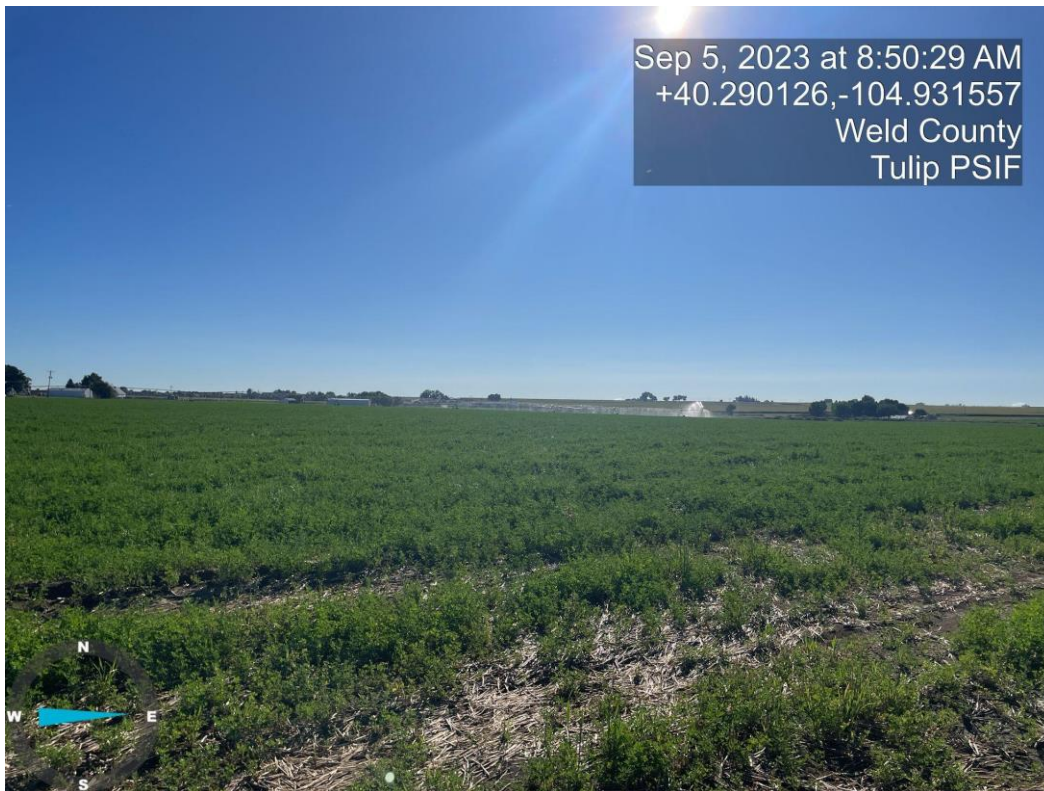
Photograph 2. Representative photo of the Site, viewing East.

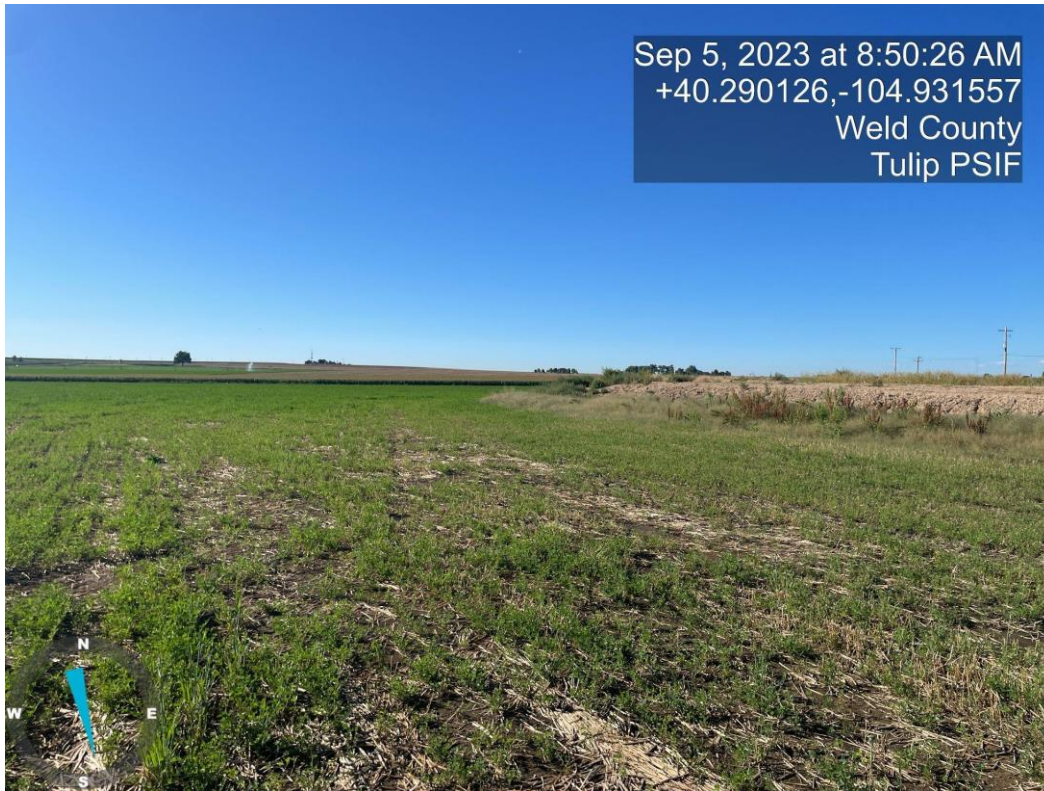
Photograph 3. Representative photo of the Site, viewing South.

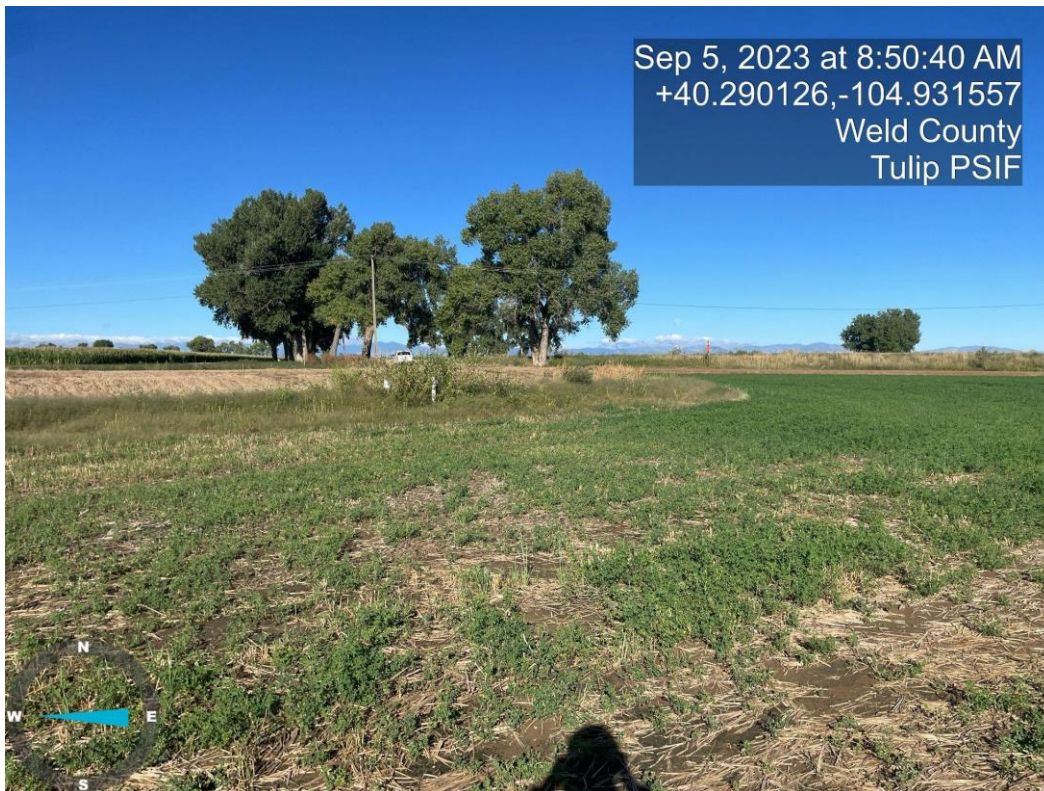
Photograph 4. Representative photo of the Site, viewing West.

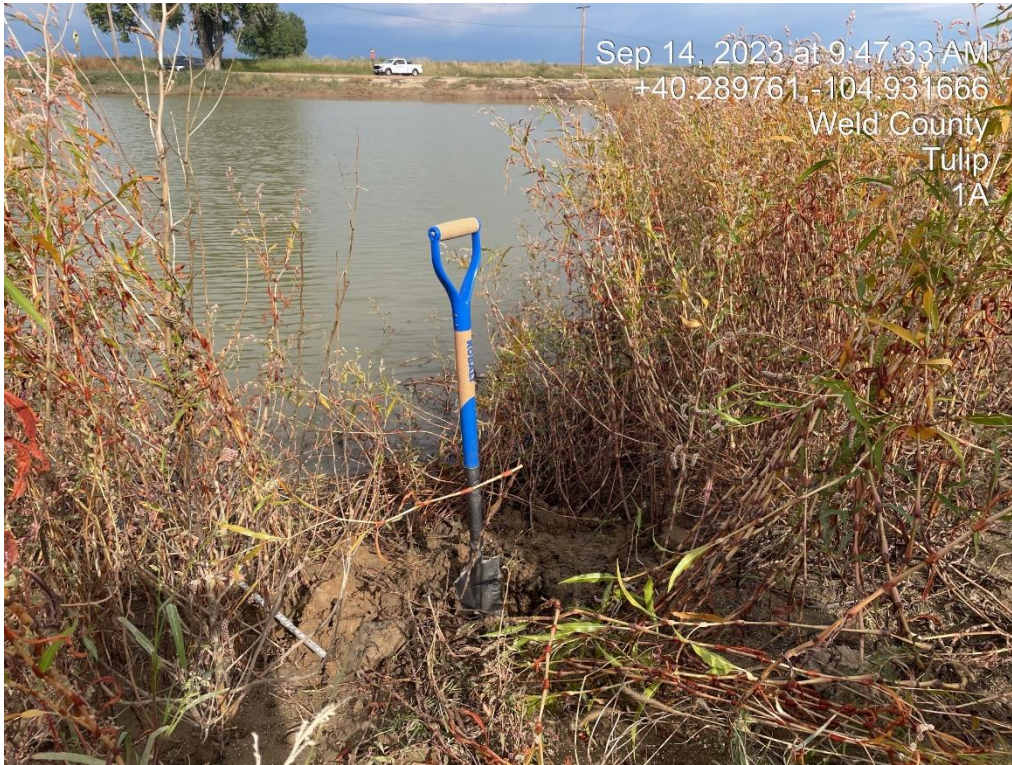
Two wetlands and one ditch were delineated in the immediate vicinity of the Site. Wetland 1 is an NWI-mapped freshwater pond which was confirmed to be present. Two sets of paired wetland determination forms were recorded to determine the extent of this feature. Wetland 2 is a roadside swale immediately west of Wetland 1. One man-made earthen ditch was identified immediately south of the preliminary survey area. The ditch was dry at the time of the survey and no characteristics of an Ordinary High Water Mark (OHWM) were observed.

Photo 1. Representative view of Wetland 1

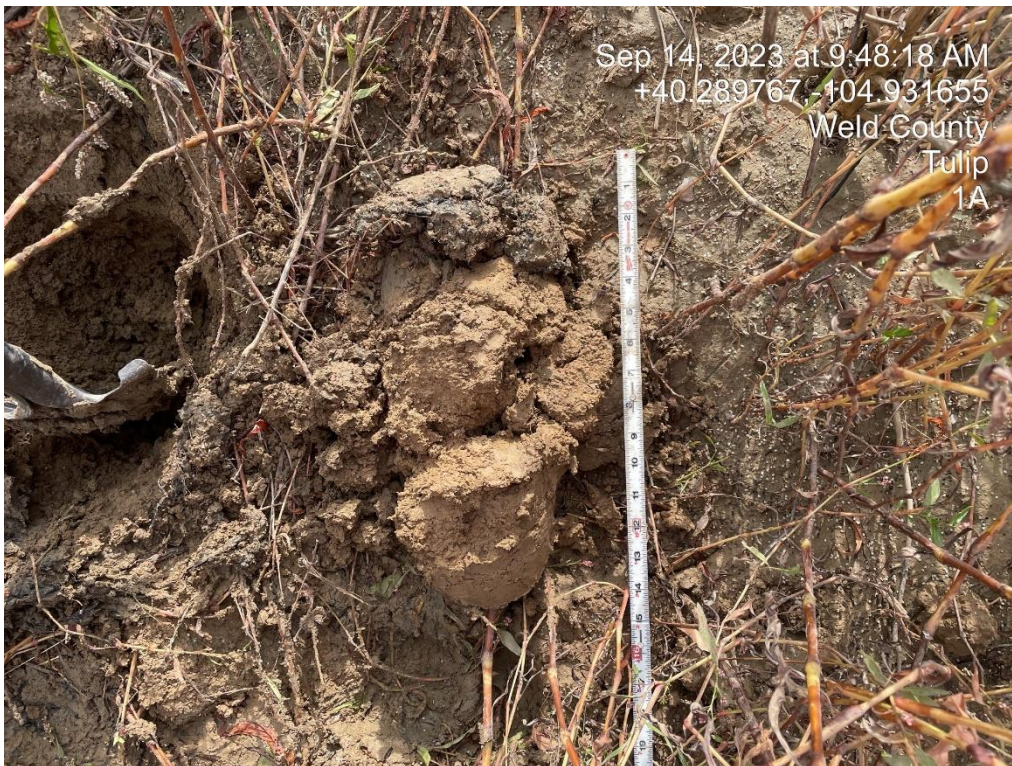
The wetland soils were noted as predominantly silty clay loam. Primary hydric soil indicators observed included hydrogen sulfide(A4) and depleted matrix (F3). Redox concentrations were observed predominantly as concentrations in the soil matrix. Hydric soil indicators were primarily observed in the upper soil profile due to a clay loam lining approximately 2 inches from the soil surface.

Photo 2. Sample point 1A soil profile

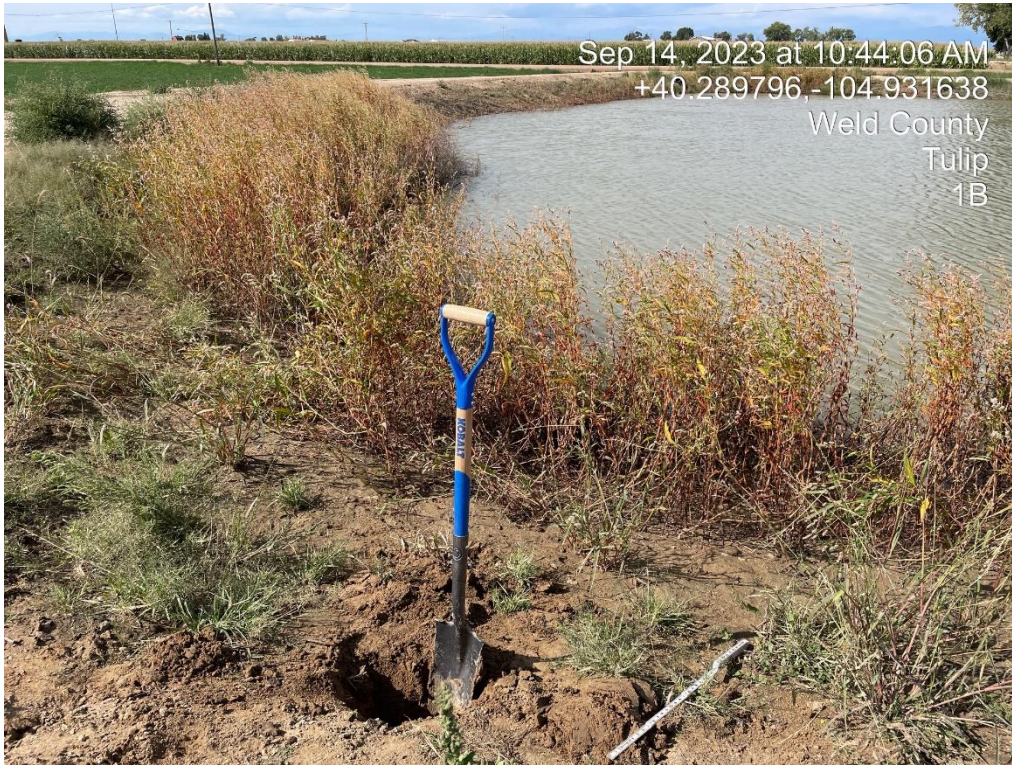
Photo 3. Representative view of upland adjacent to Wetland 1

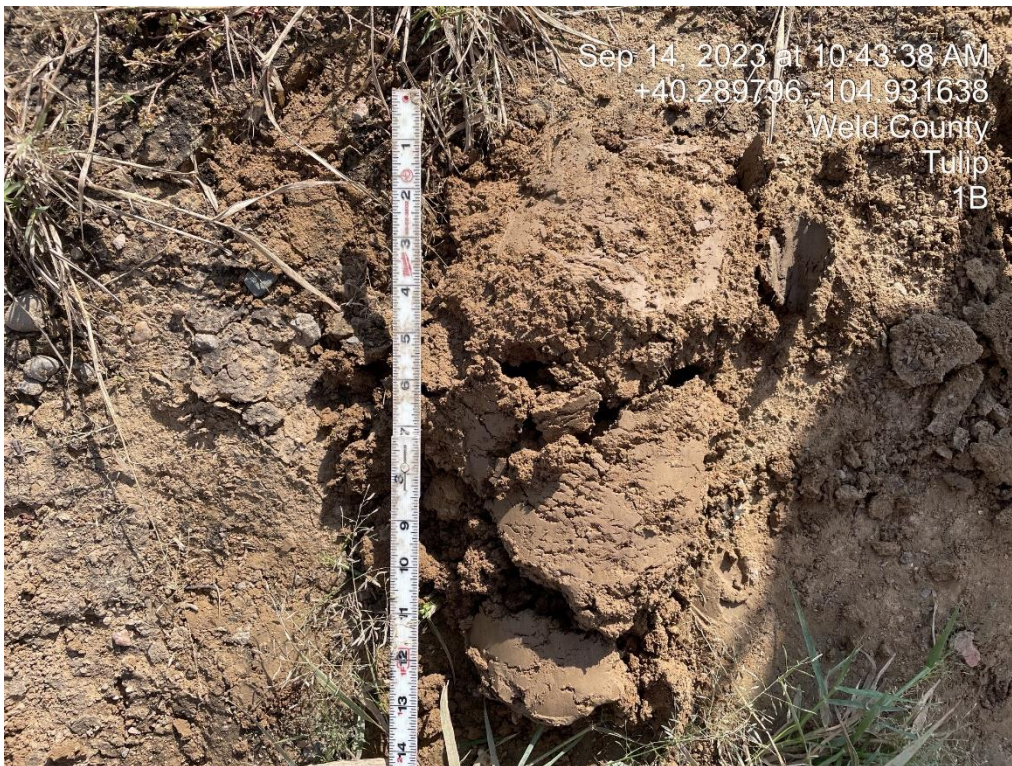
Photo 4. Sample point 1B soil profile

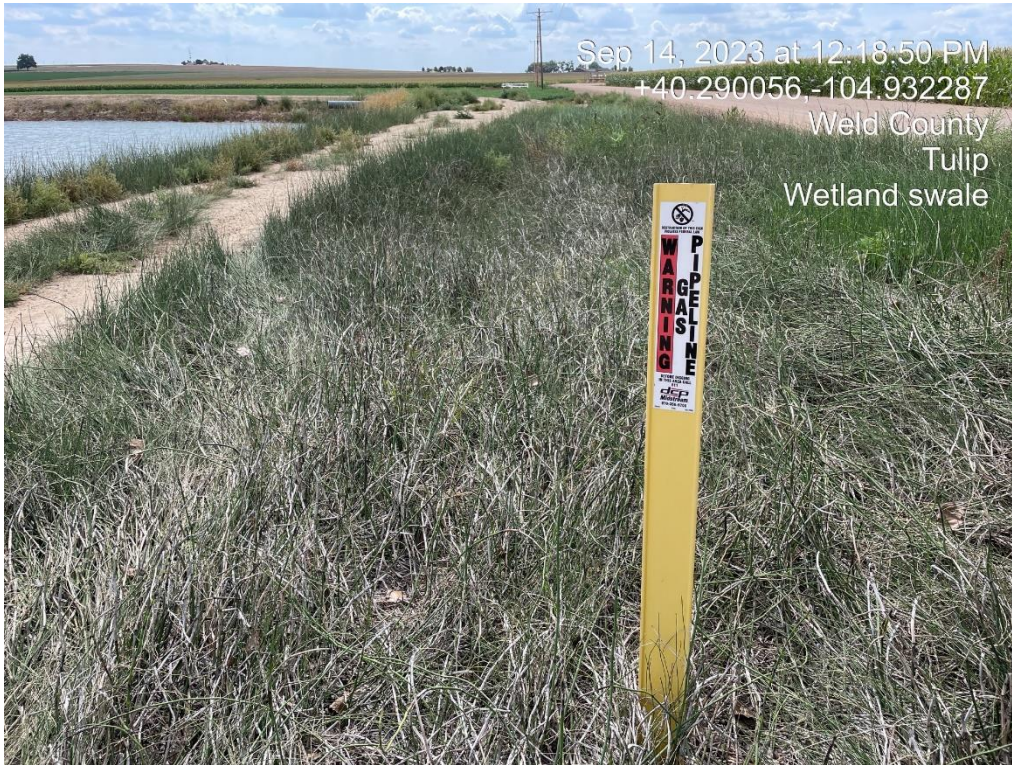
Sep 14, 2023 at 12:18:50 PM
+40.290056,-104.932287
Weld County
Tulip
Wetland swale

Photo 5. Representative view of Wetland 2

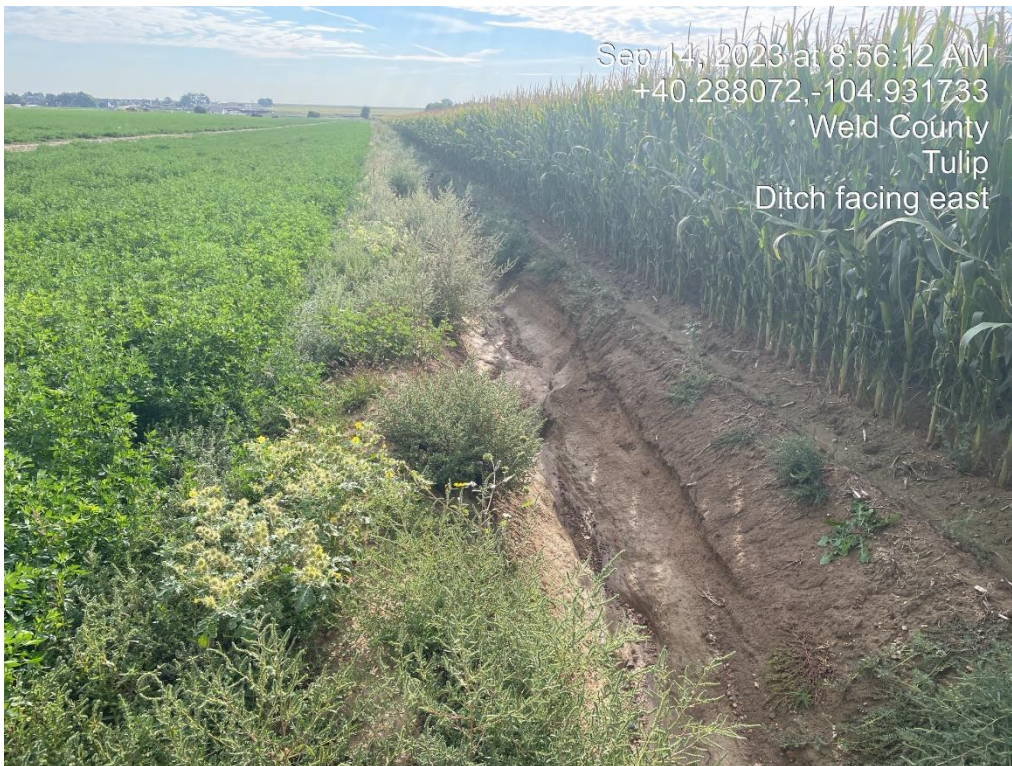
Sep 14, 2023 at 8:56:12 AM
+40.288072,-104.931733
Weld County
Tulip
Ditch facing east

Photo 6. Representative view of earthen ditch
