Final Reclamation Inspection

Operator: S & D LLC - #10362

Location ID: 320737

Inspection Photos
Location Name: KISSLER, DAN #1-10
Location ID: 320737

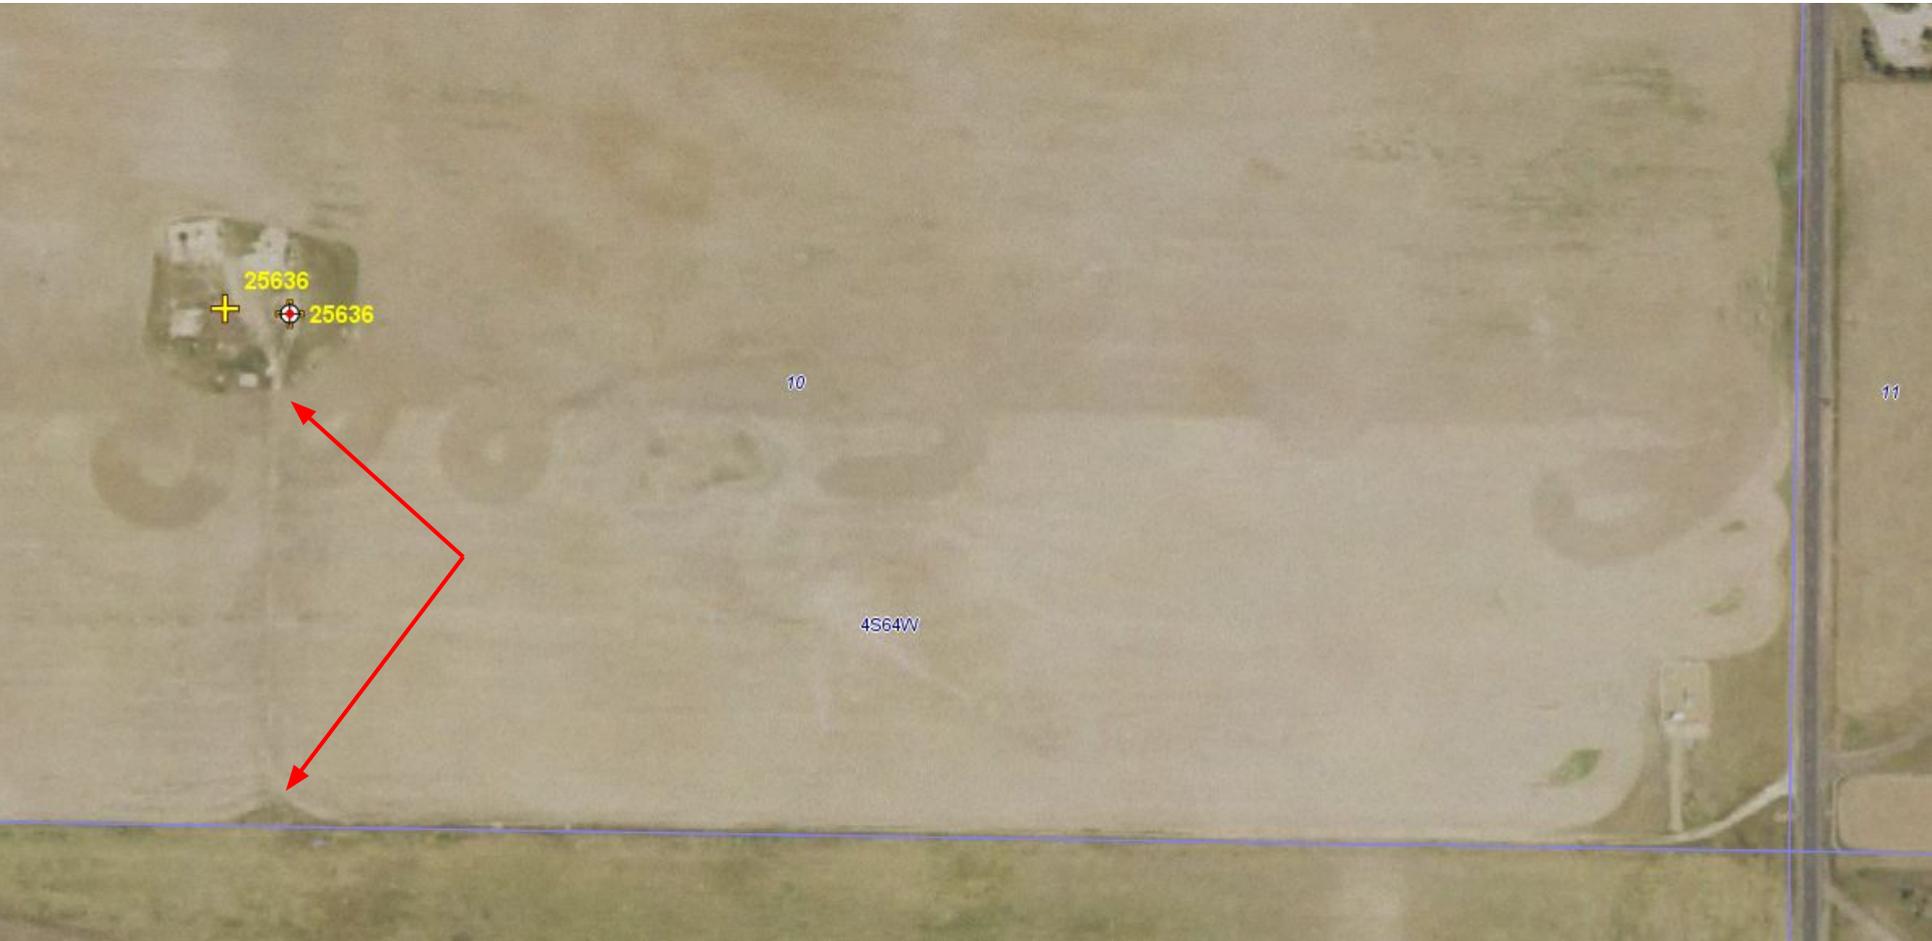
Photo 1. 2021 aerial imagery illustrates a portion of the access road between the red arrows where gravel has not been removed; therefore, decompaction has not been performed. Refer to Photo #2. In addition, the location has not been recontoured and decompaction has not been performed.

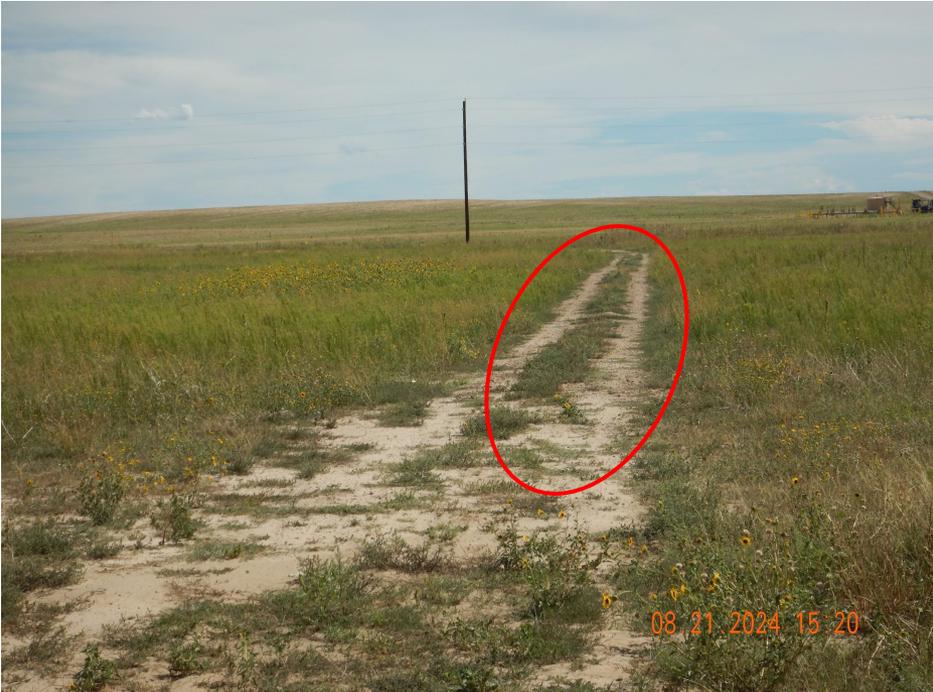
Photo 2. Photo taken from the southern location, facing South. Photo illustrates the approximate area where gravel has not been removed.

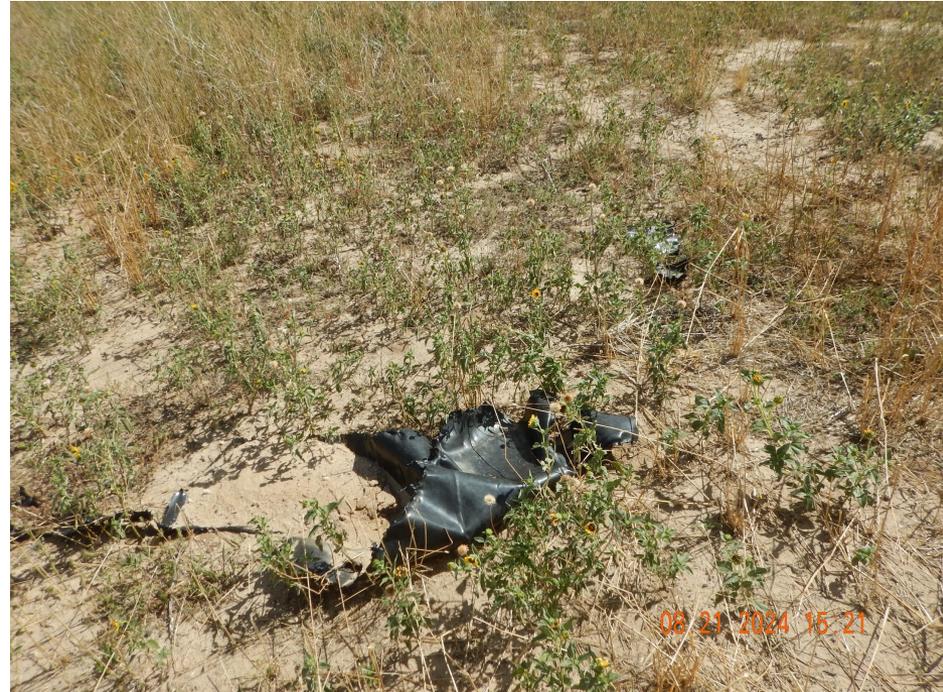
Photo 3. Photo taken from a portion of the location. Photo illustrates partially buried plastic which was observed throughout portions of the location.

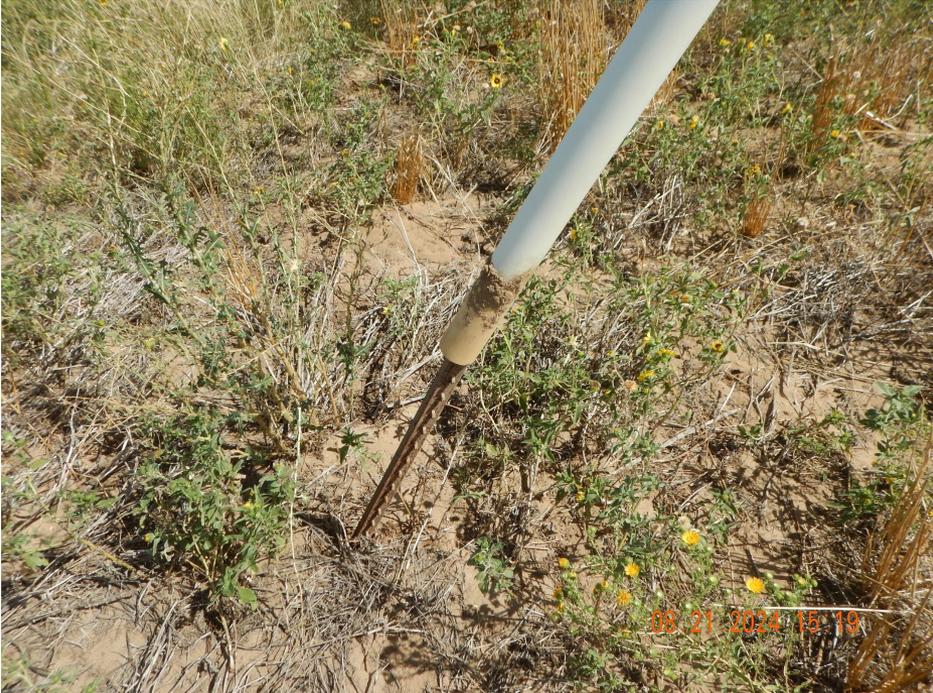
Photo 4. Photo taken from the eastern location. Photo illustrates unused equipment/debris that remains.

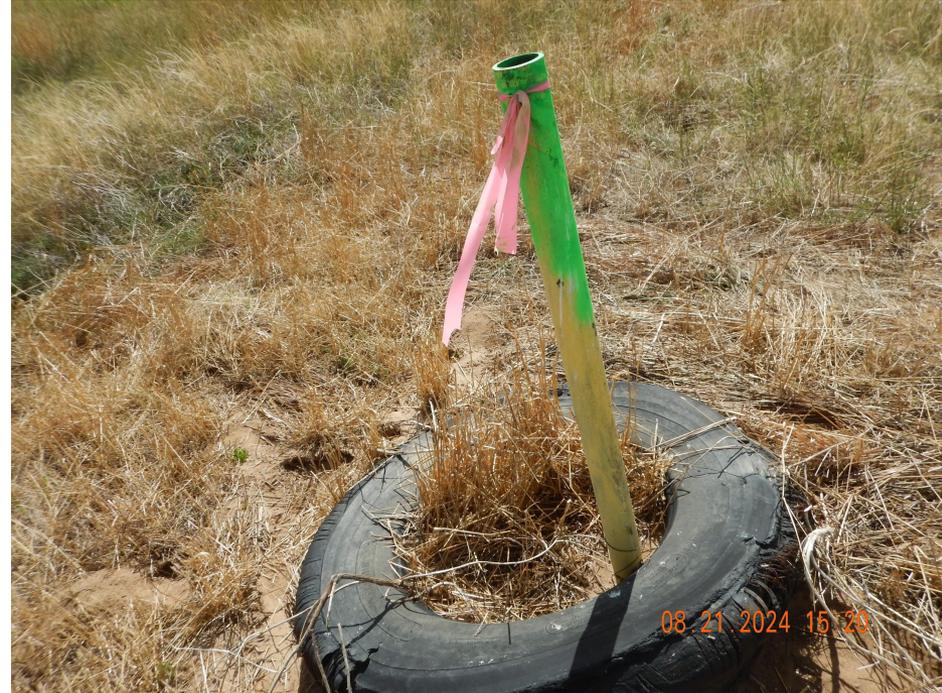
Photo 5. Photo taken from the southern location. Photo illustrates unused equipment/debris that remains.

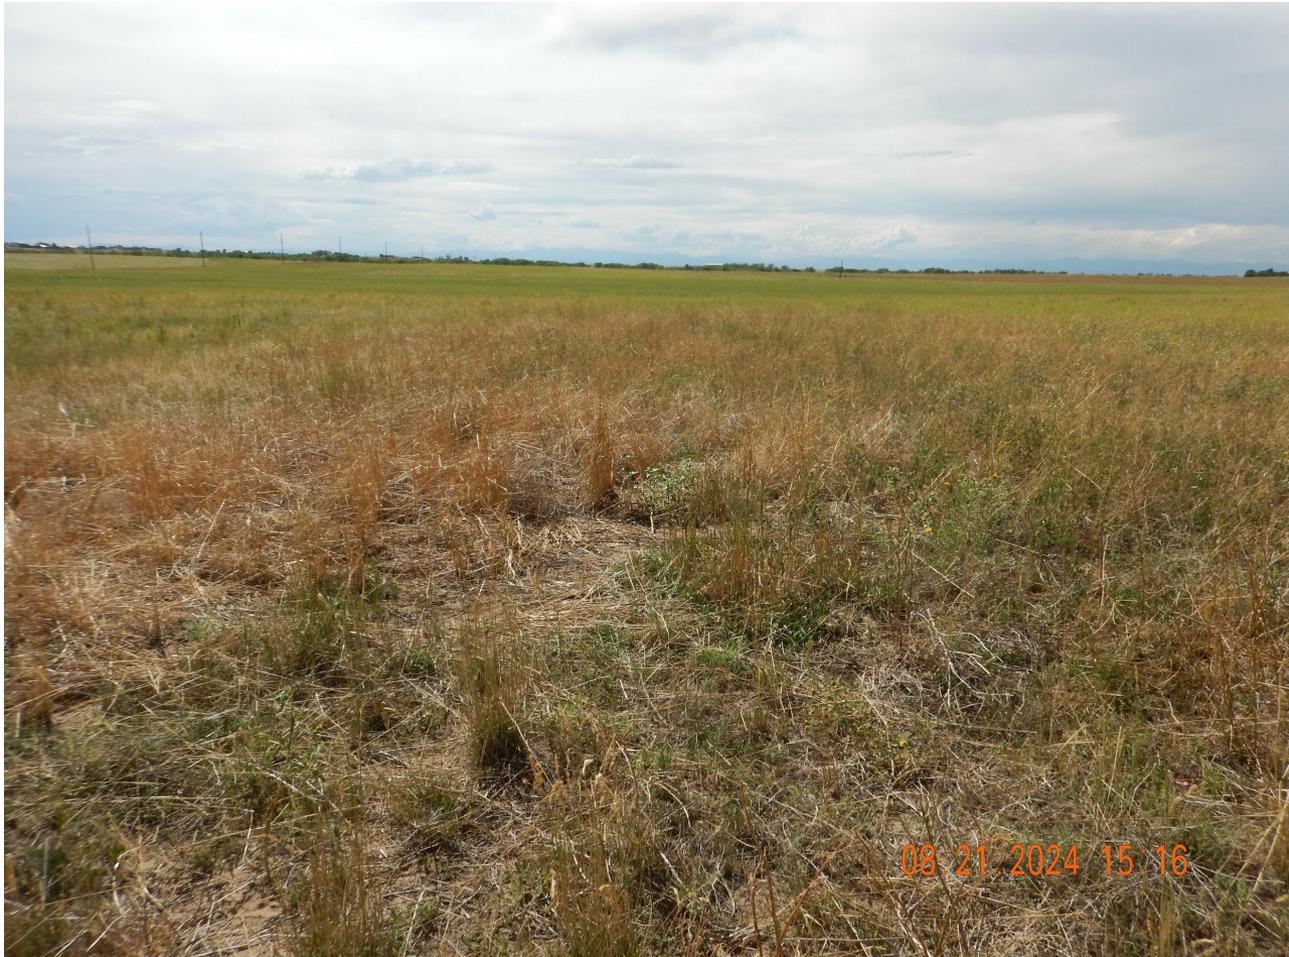
Photo 6. Photo taken from the southern location, facing West. Photo is trying to illustrate the location has not been recontoured but it is difficult to identify.
