Inspection Photos

ID: 480511

Operator: **CITATION OIL & GAS CORP**

Inspection Date: 8/28/2024

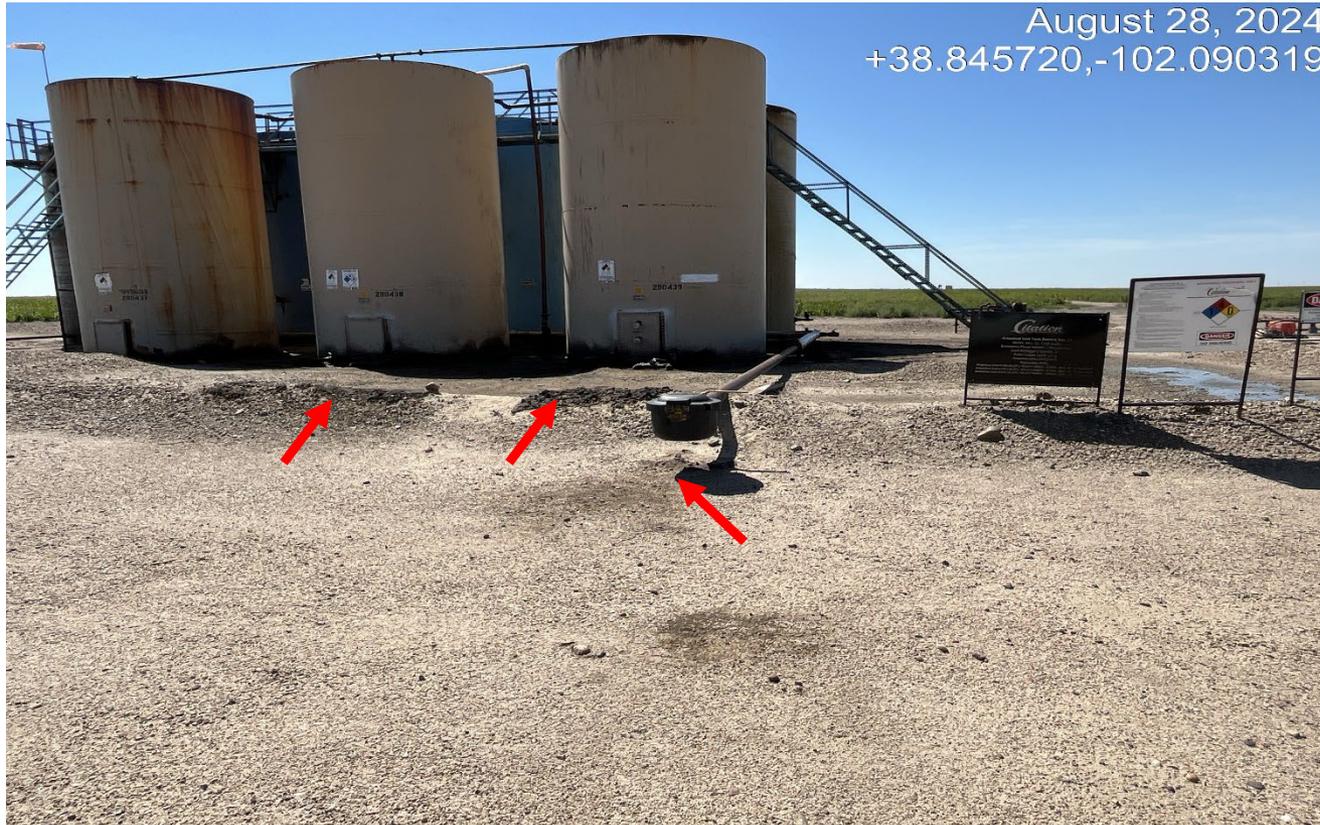
Photo 1. Facing southwest toward the Arapahoe Unit Tank Battery/Sec. 27. There is oily material along the berm at red arrows and at the truck load out pipe.

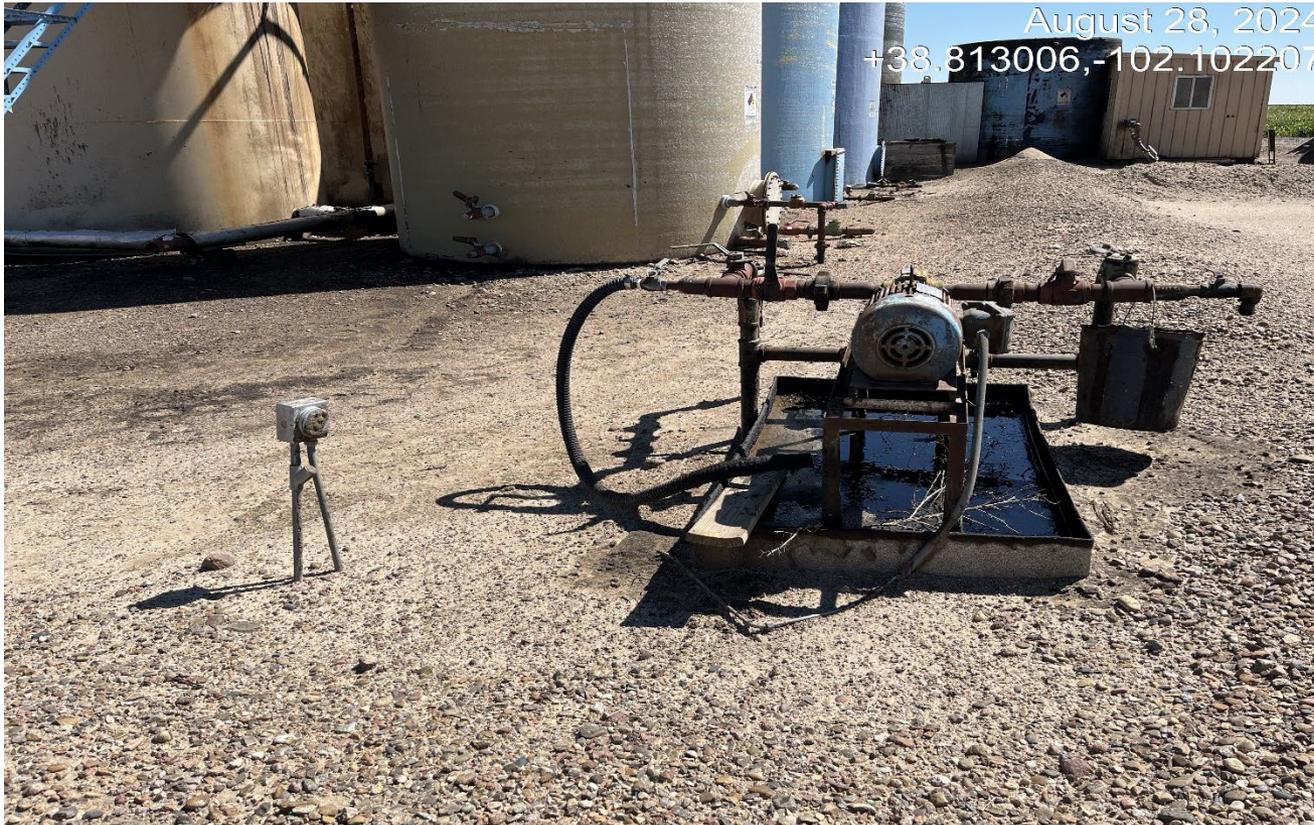
Photo 2. This secondary containment is full of oil with no wildlife protections/netting. This needs to be immediately drained and properly disposed.

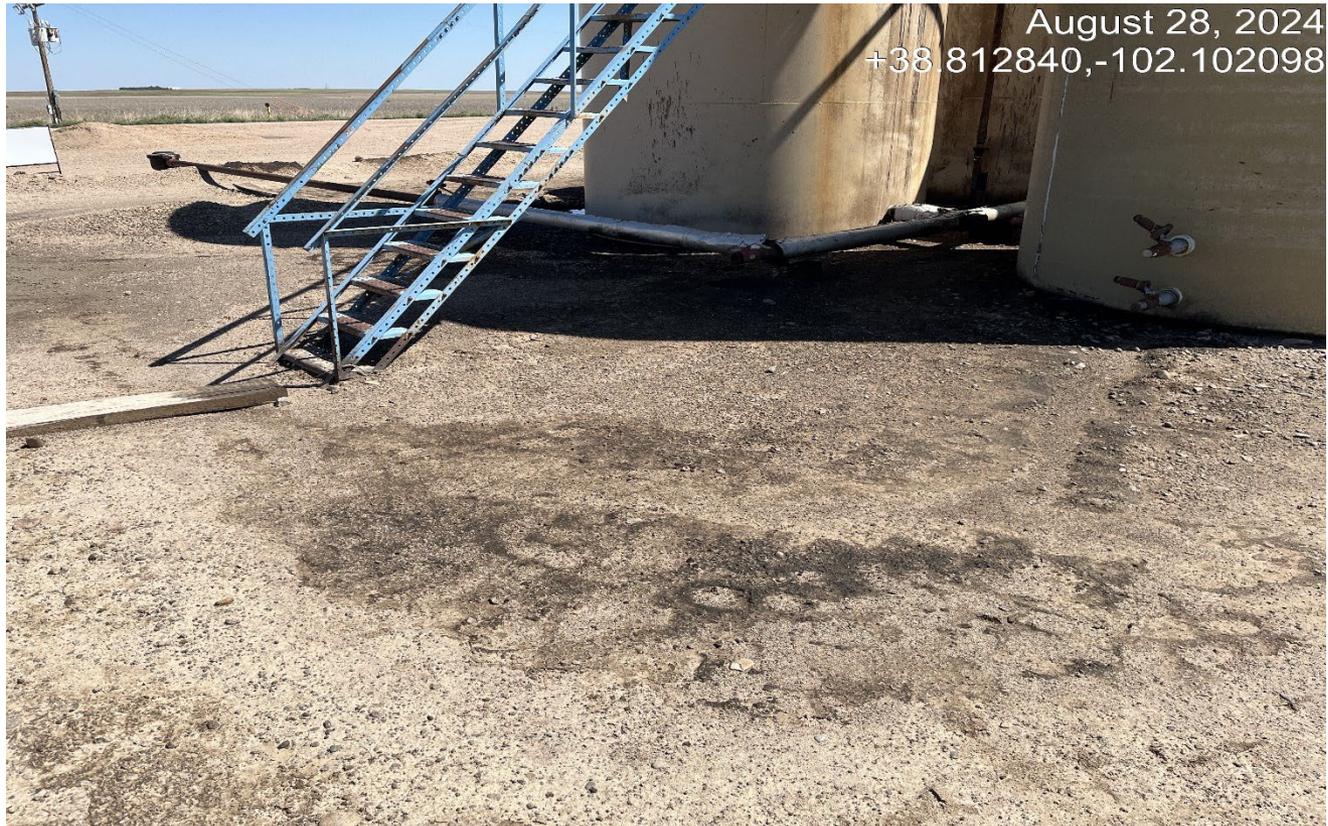
Photo 3. On the west side of the tanks there is oil staining from a leak that occurred.

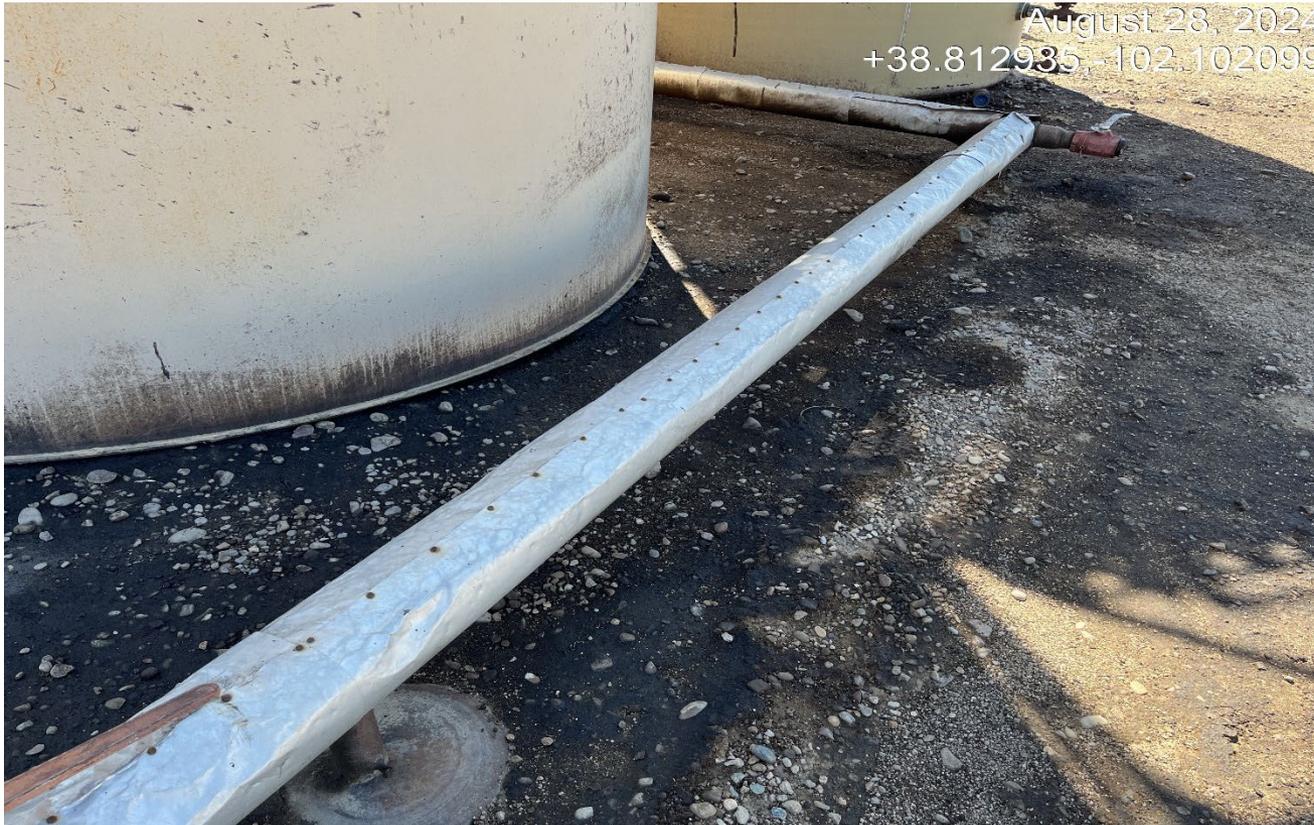
Photo 4. There is oil saturated soils at the base of the tank that must be cleaned up.

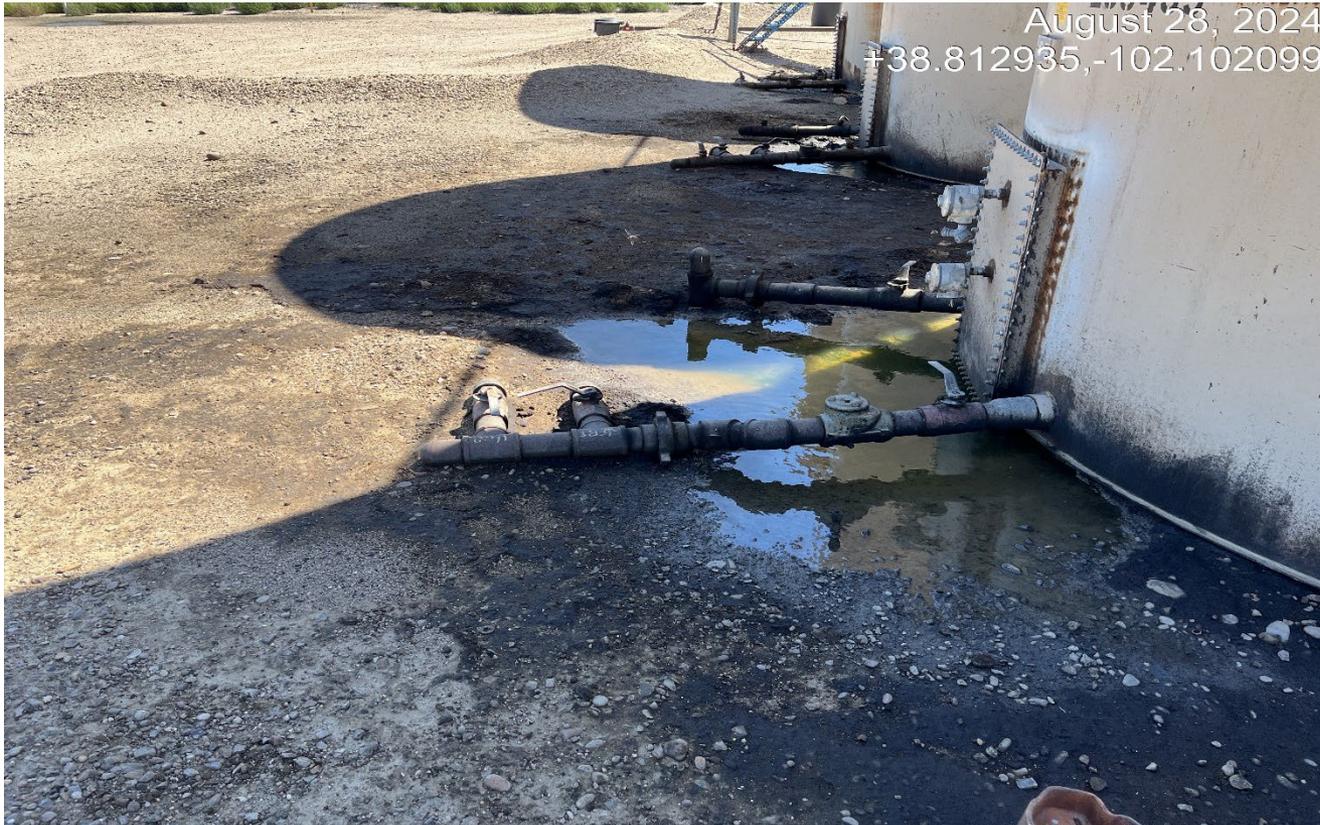
Photo 5. Facing east at the north side of the tanks. There is oil saturated soils at the base of the tank that must be cleaned up.
