Storm Water Management and Erosion control
Location Name: CAERUS PICEANCE LLC SHIDELER 1-7 (G1SW) Pad
Location #: 334069

**Location Overview: Location is within Black Bear Habitat area
& in close proximity to High Priority/NSO Habitat areas.
Location is approximately 500 yards from Middle Mamm
Creek.**

Section/Township/Range: 1 8S93W

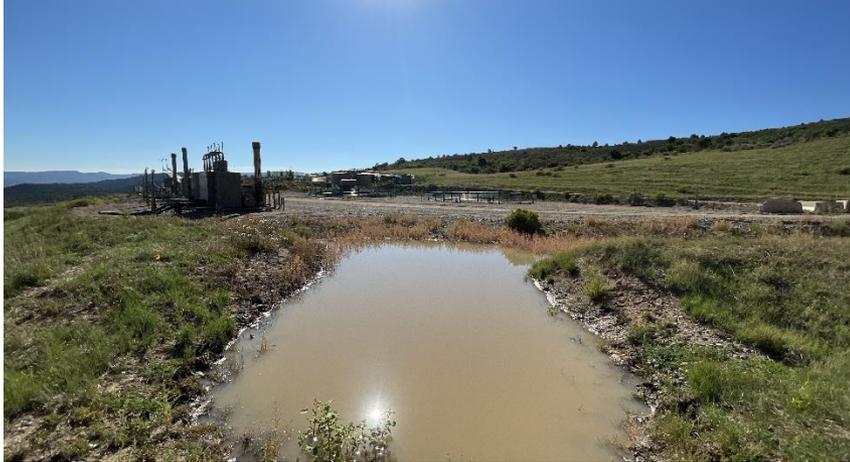
North West corner of location.

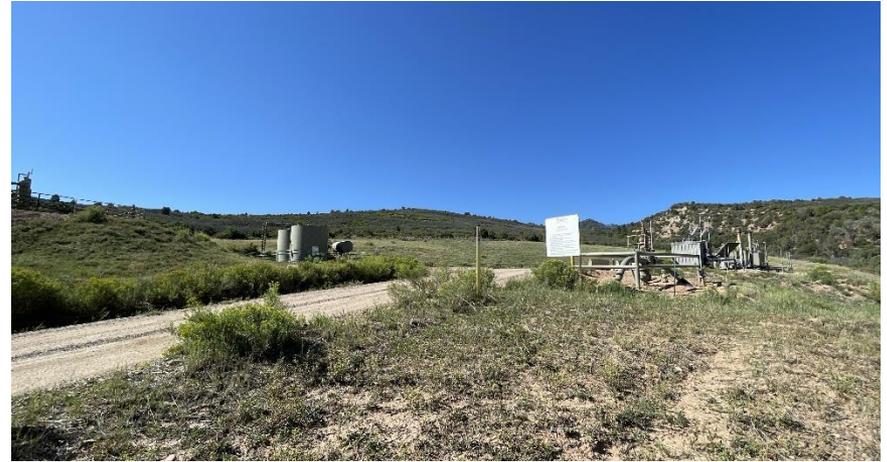
North East corner of location.

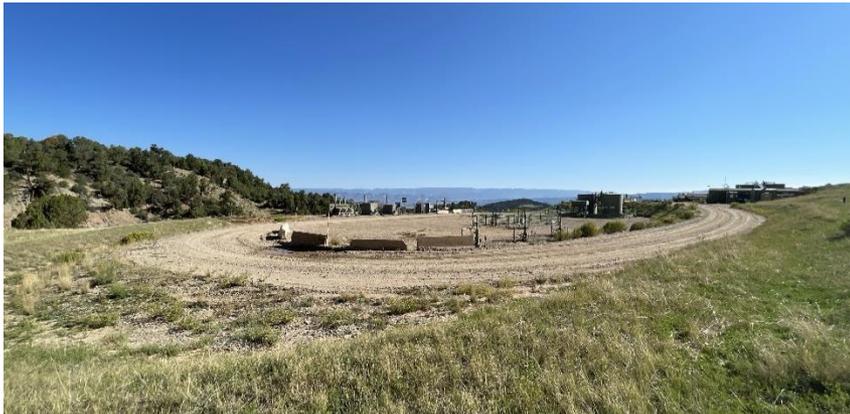
South West corner of location.

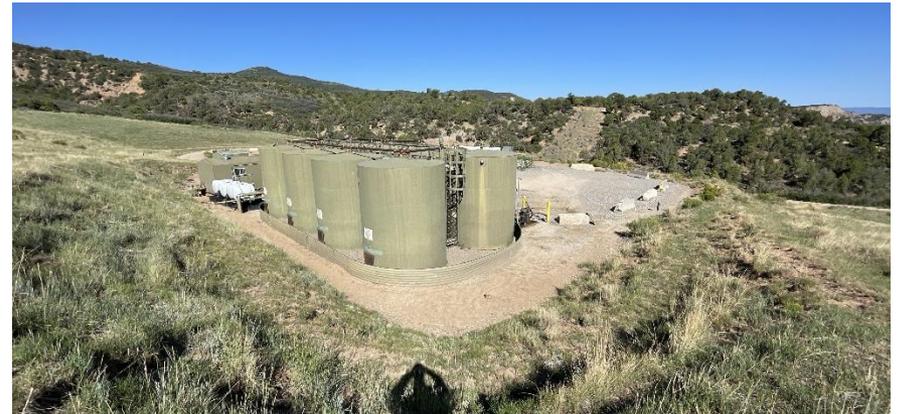
South East corner of location.

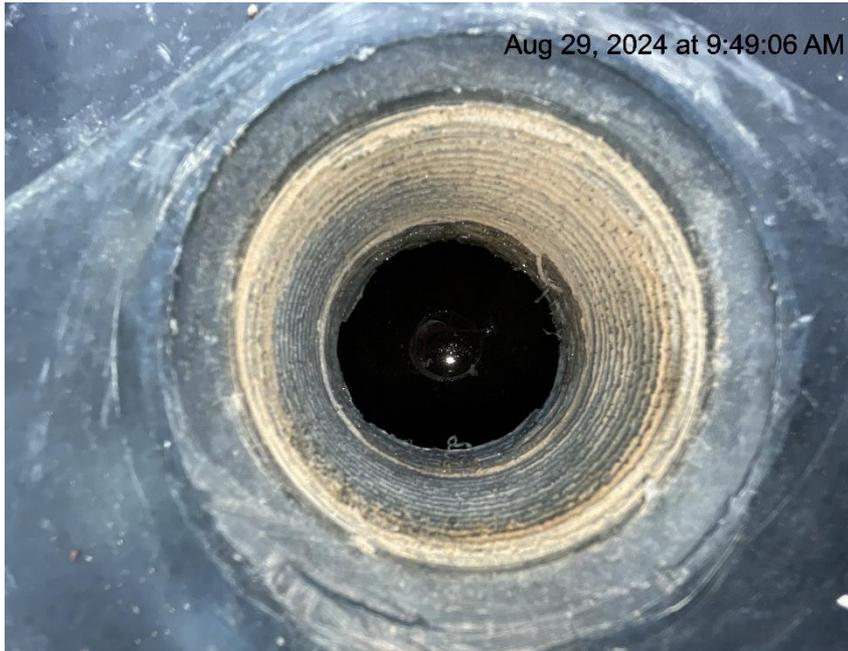
Photo # 7324 Failure to maintain chemical BMP - Chemical tank containment approximately 3/4 full of fluid/BMP insufficient to contain possible spill

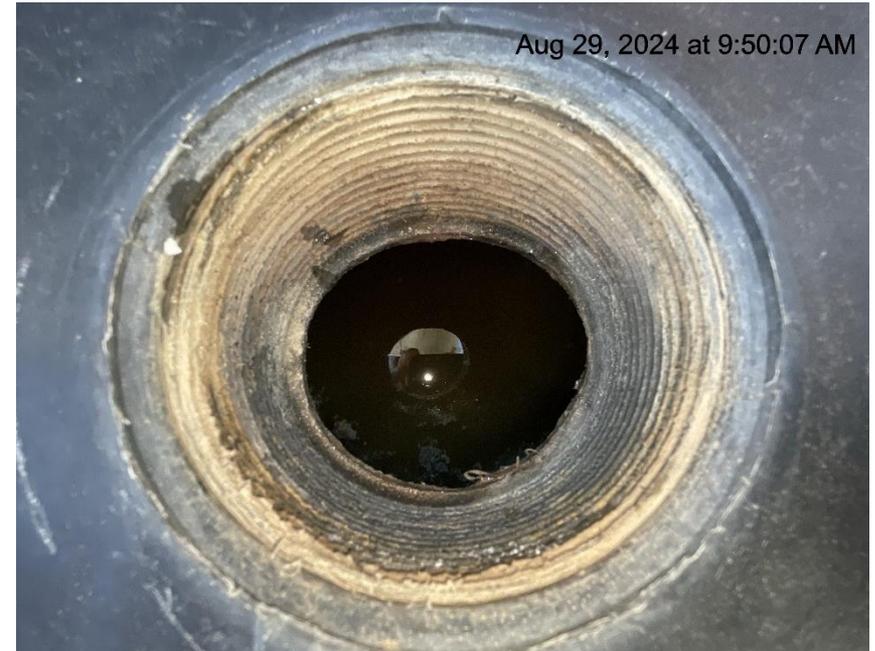
Photo # 7325 Failure to maintain chemical BMP - Chemical tank containment approximately 3/4 full of fluid/BMP insufficient to contain possible spill

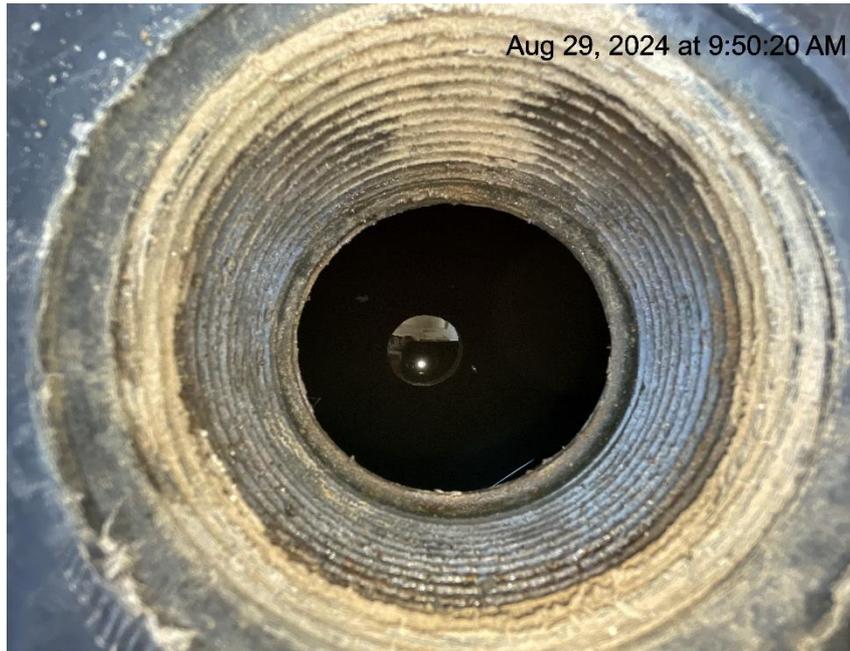
Photo # 7326 Failure to maintain chemical BMP - Chemical tank containment approximately 3/4 full of fluid/BMP insufficient to contain possible spill

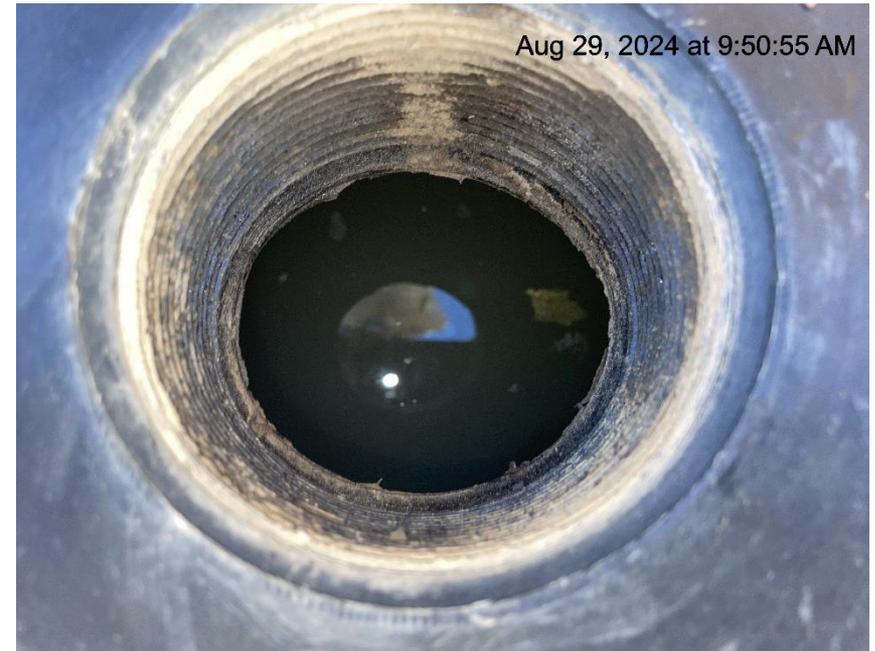
Photo # 7327 Failure to maintain chemical BMP - Chemical tank containment approximately 3/4 full of fluid/BMP insufficient to contain possible spill
