Inspection Photos

Operator: SWN PRODUCTION COMPANY LLC

Location ID: 313326

Inspection Doc: 696206160

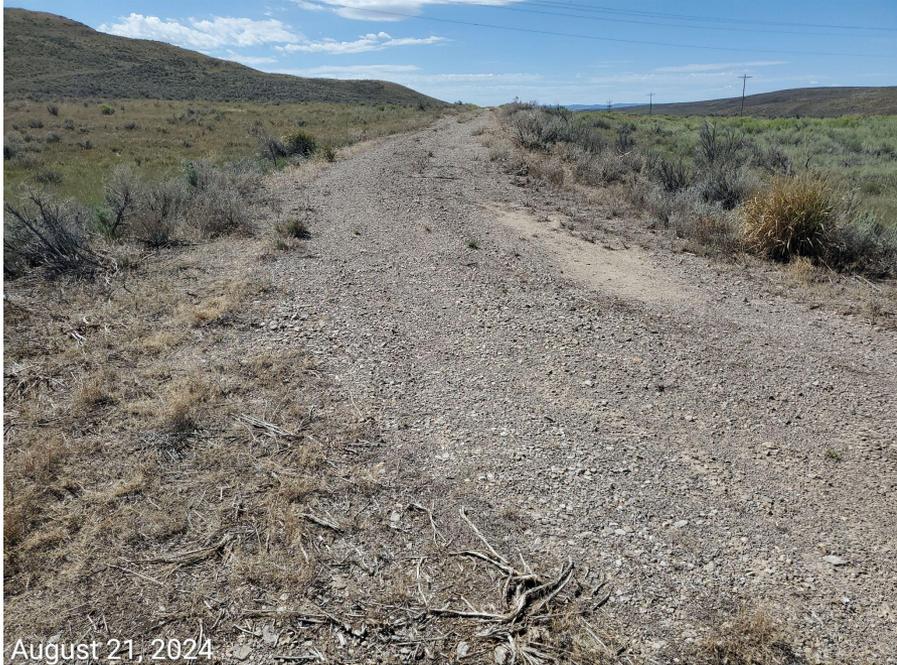
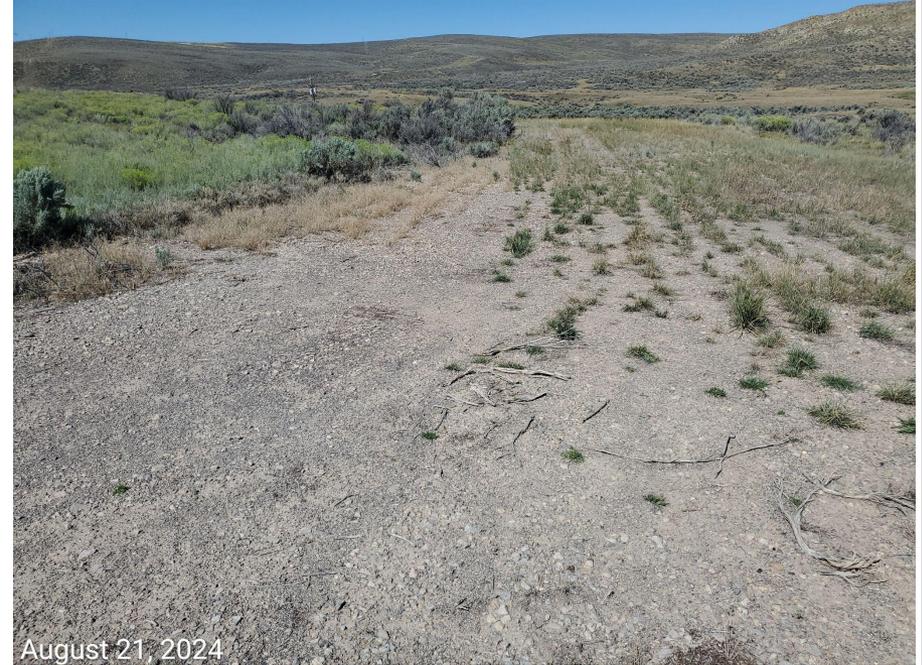
Photo 1: Photos taken from the southeast end of the Location, facing south and east. Photos show access road has not been reclaimed in accordance with 1004 Requirements.

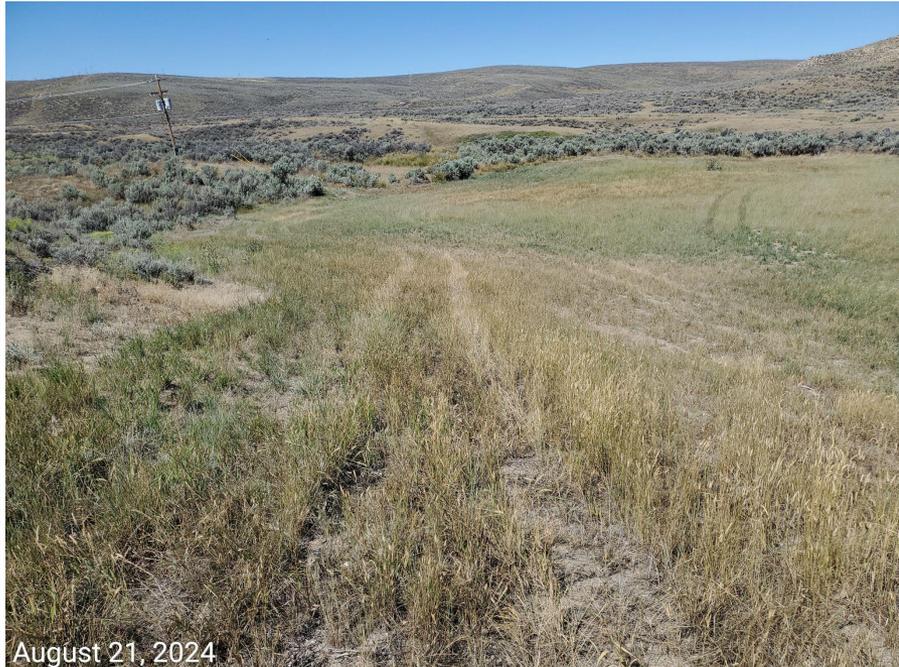
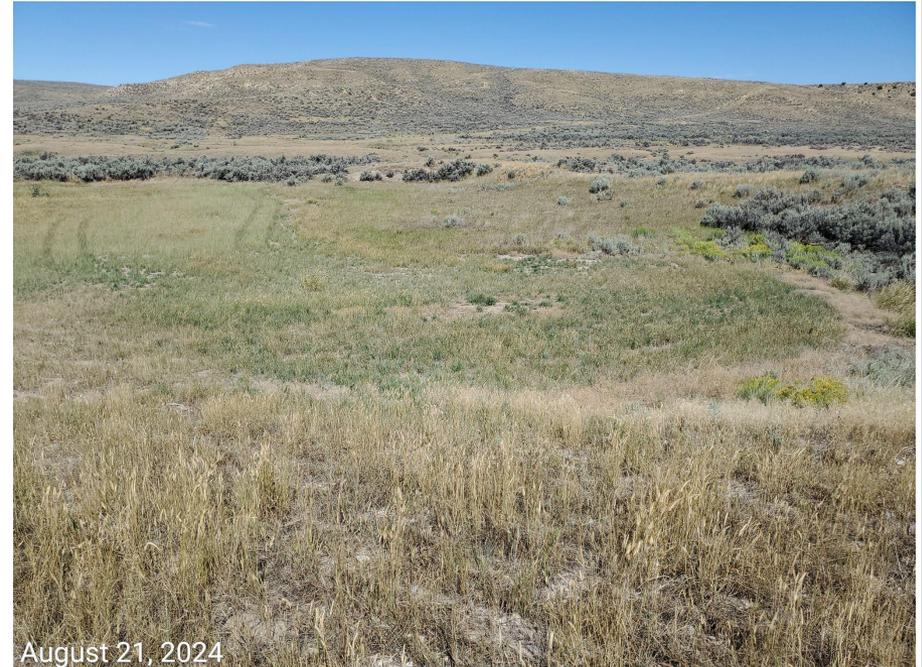
Photo 2: Photos taken from the east end of the well site location, facing southwest and northwest. Location has been seeded with non-native species that are not reflective of the reference area.

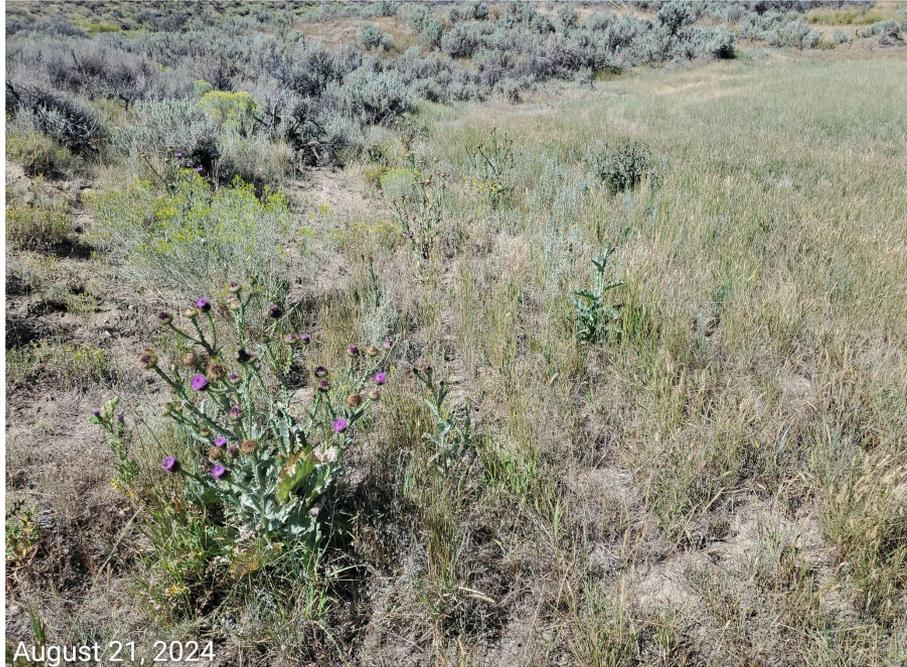
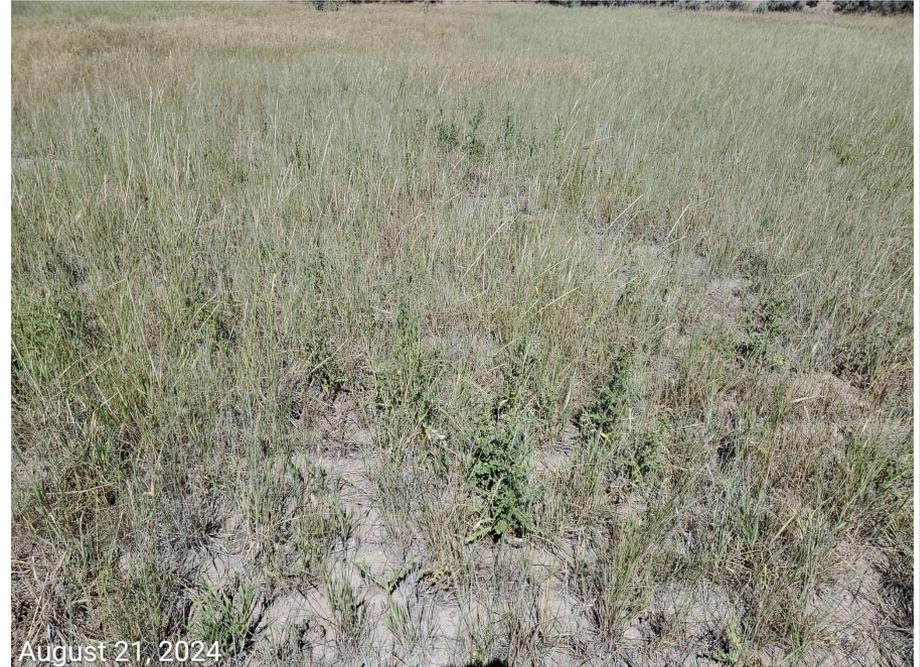
Photo 3: Photos taken from the well site Location. Photos examples showing Noxious weeds (Scotch thistle, Canada thistle) observed established throughout the Location.

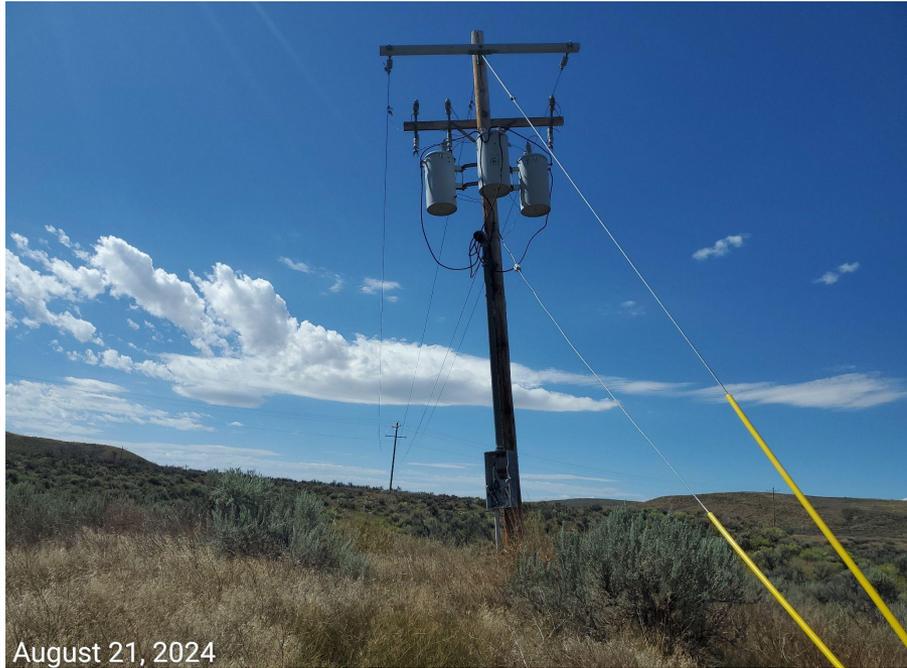
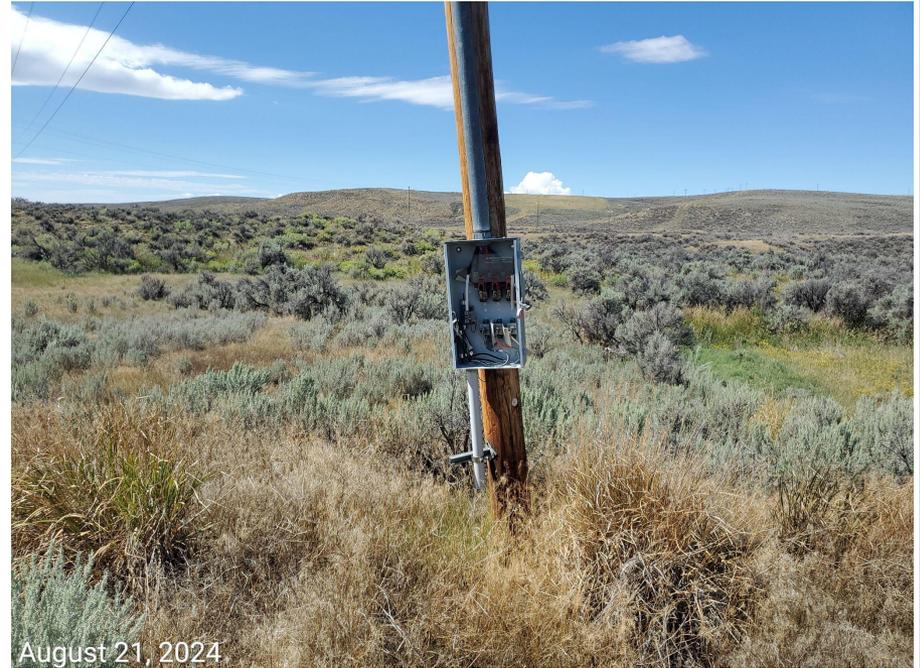
Photo 4: Photos taken from the south end of the Location. Photos show utility equipment on and leading to location has not been removed.

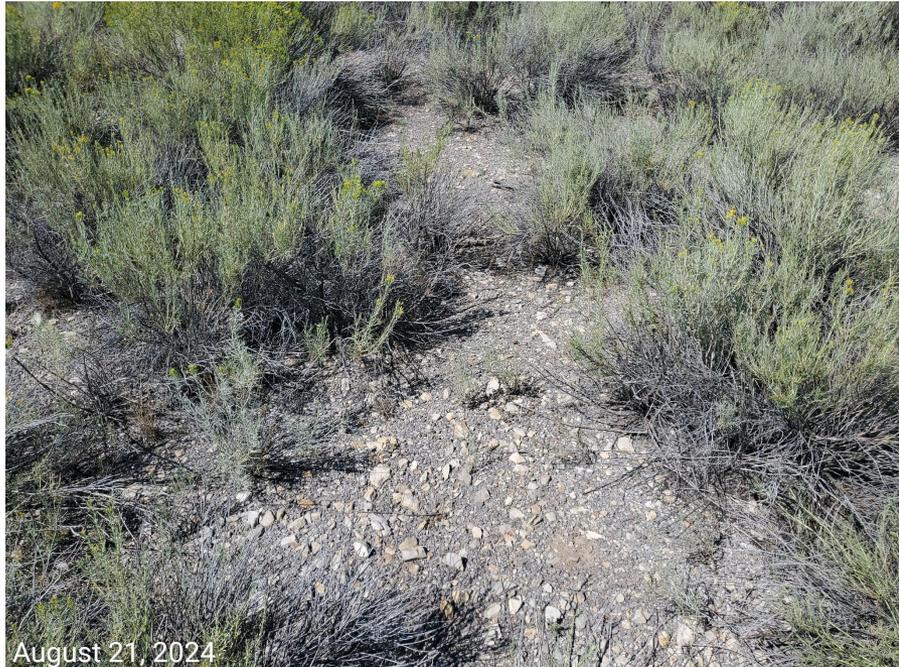
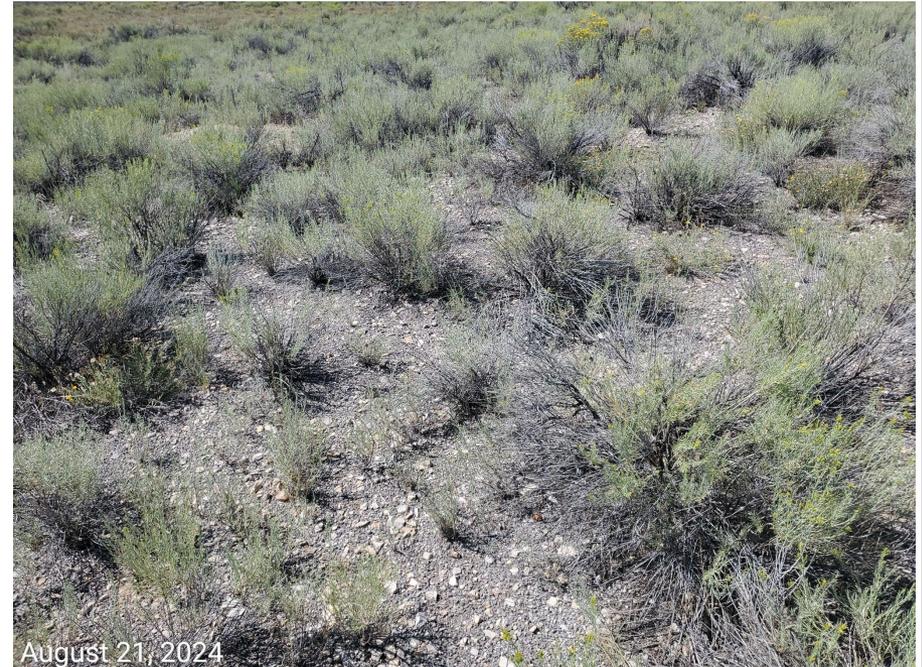
Photo 5: Photos taken from the 2nd pad adjacent to the well site on the southeast end of the Location. Though vegetated, it is apparent that road base/gravel material removal and compaction alleviation had not been performed and area reclaimed pursuant to 1004 requirements

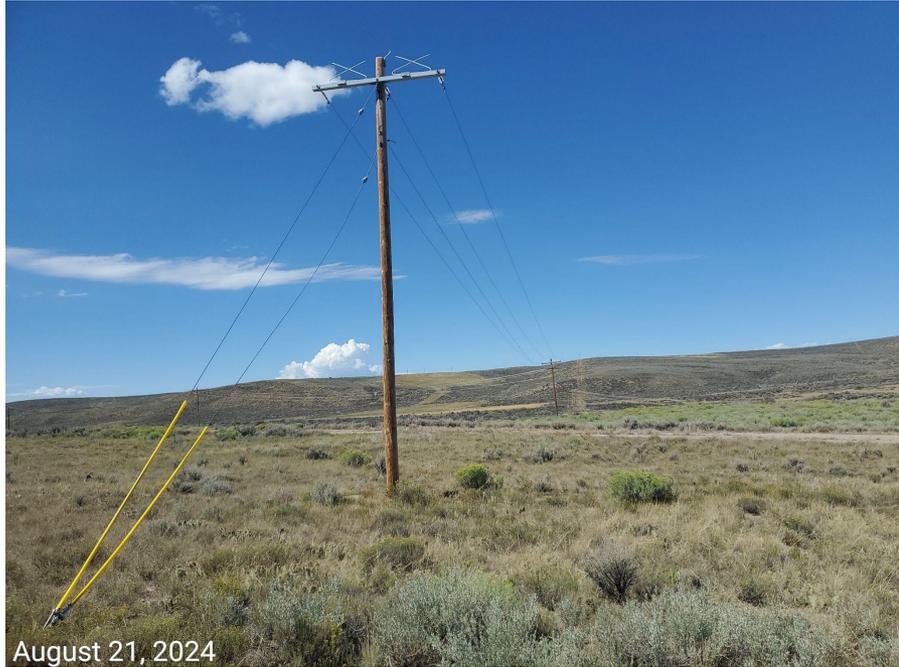
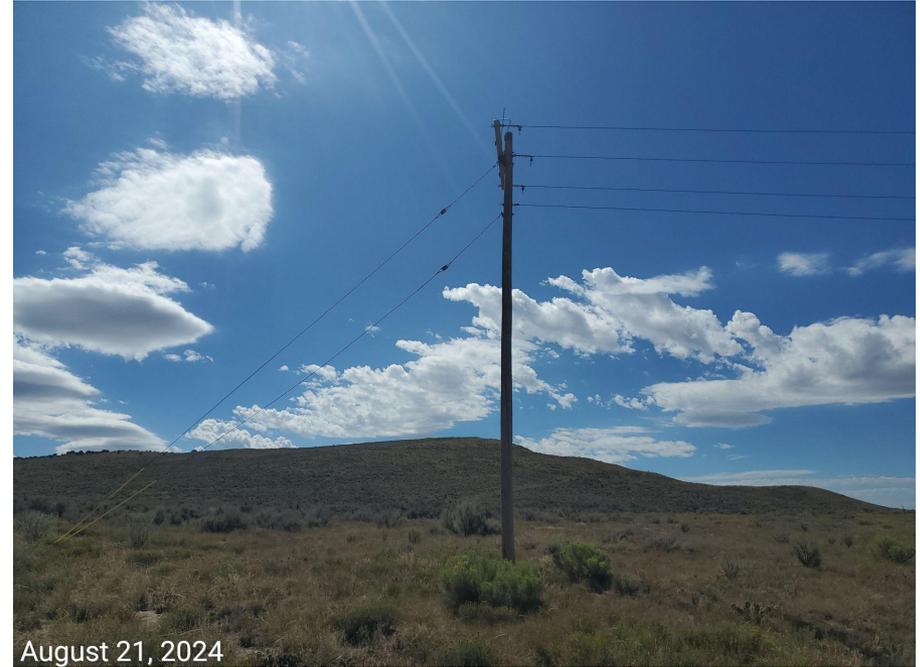
Photo 6: Photo taken from the southeast end of the Location, next to the 2nd graveled pad. Photos show utility equipment on and leading to location has not been removed.
