# Inspection Photos

**Operator:** SWN PRODUCTION COMPANY LLC  
#10396

**Location ID:** 313146

**Inspection Doc:** 696206165

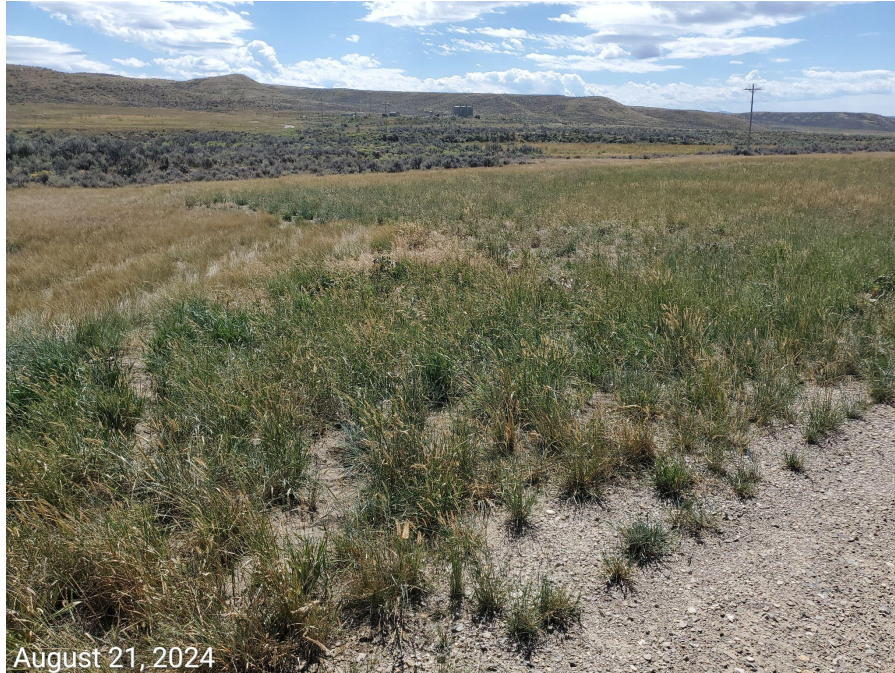
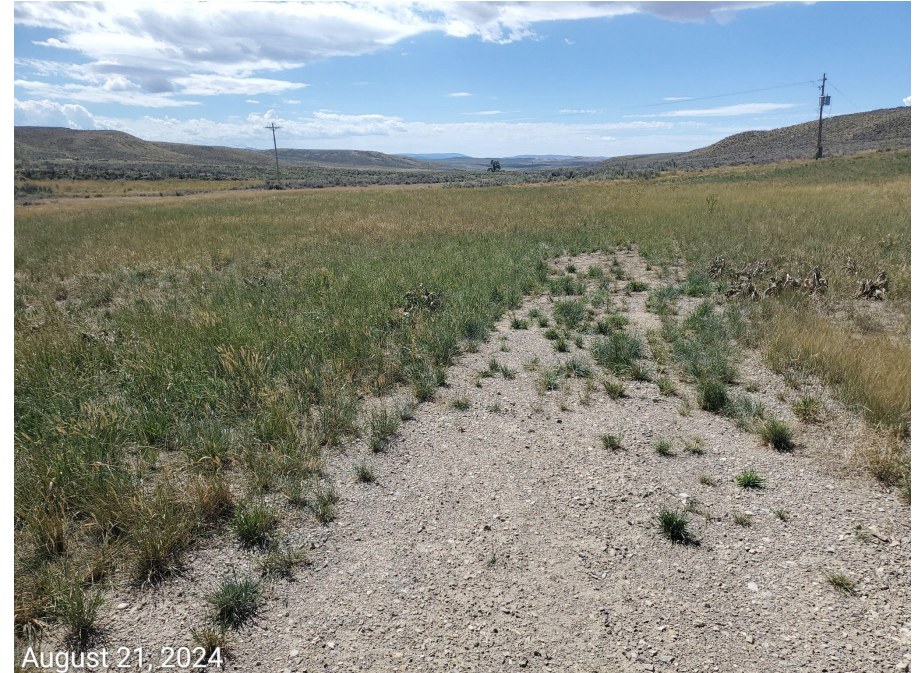
**Photo 1:** Photos 1-2 taken from the north end of the well site Location. Photos provide an overview from east, southeast, southwest to west.

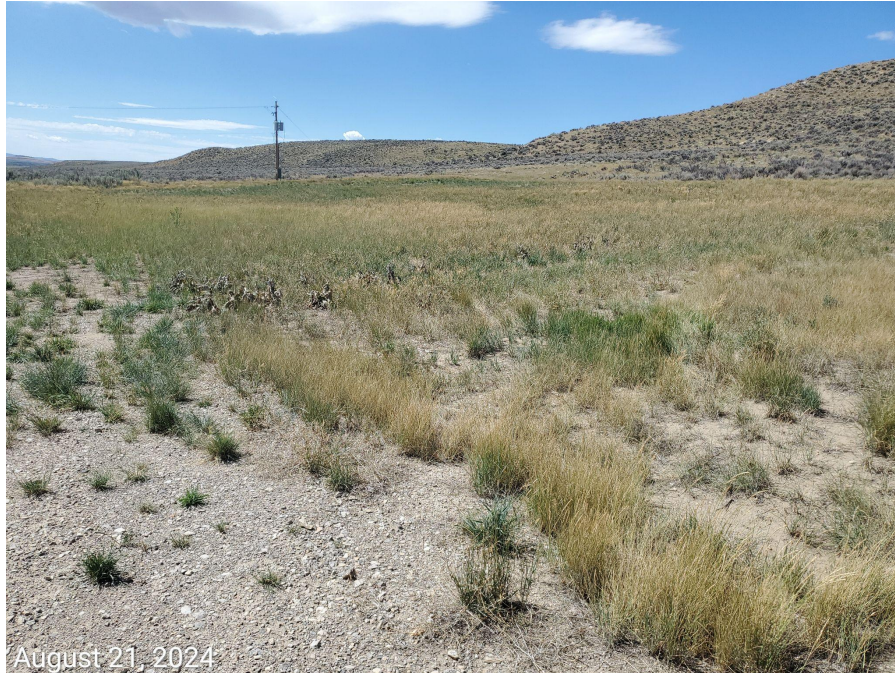
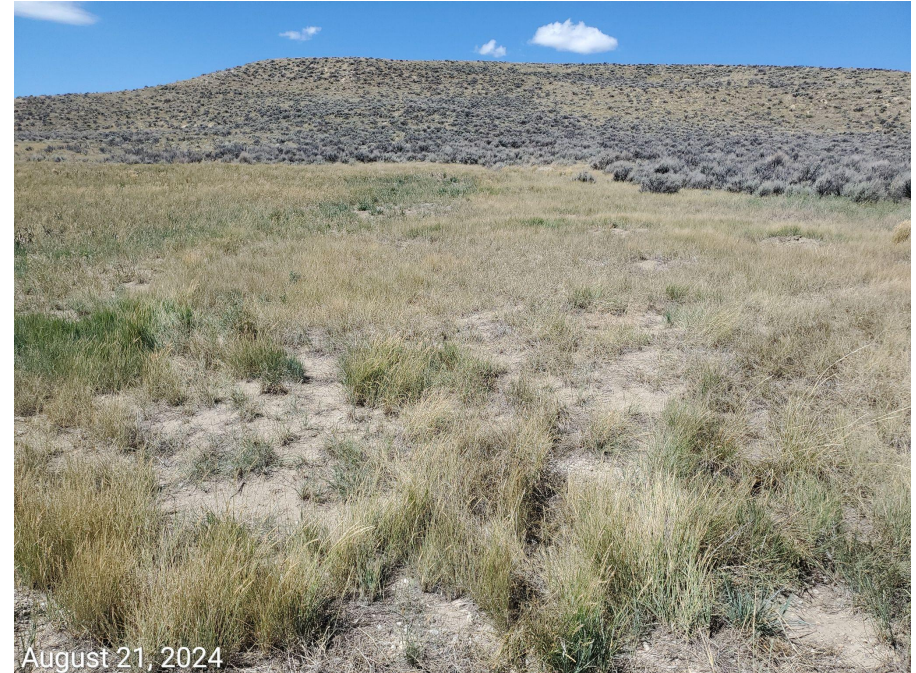
**Photo 2:** See comments under photo 1.

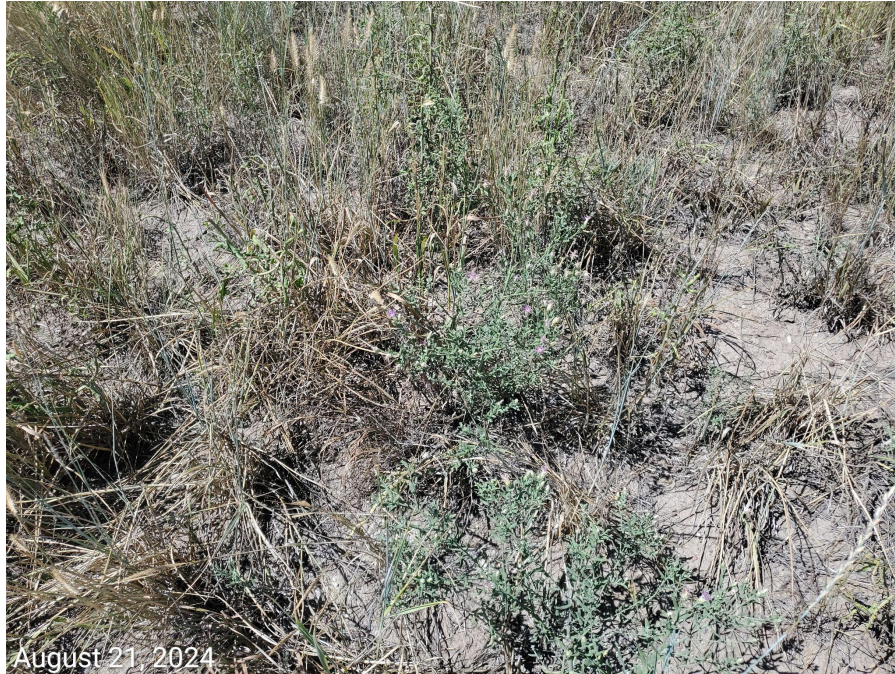
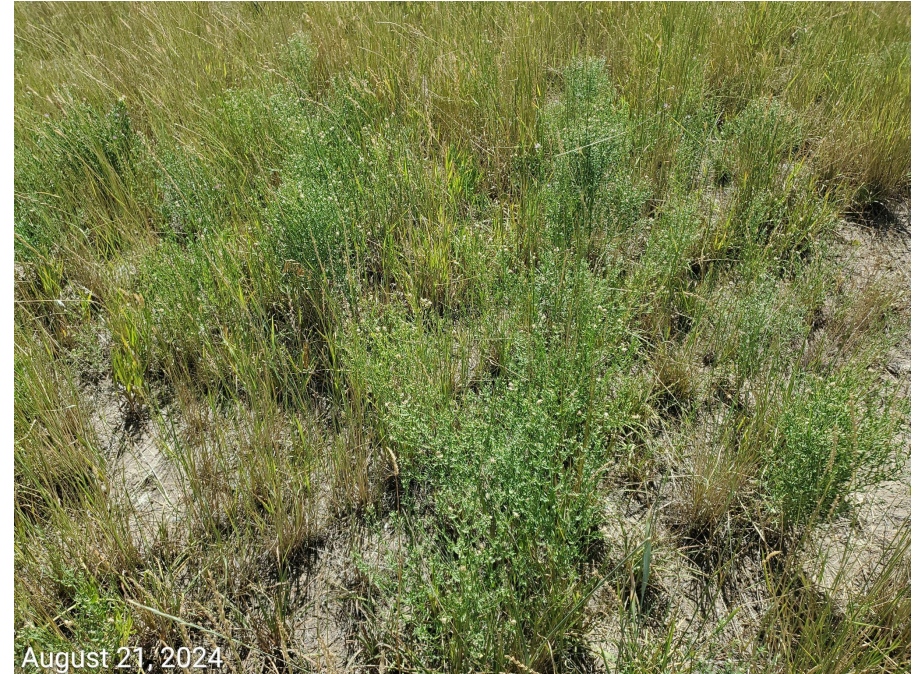
**Photo 3:** Photos taken from the well site Location. Photos examples showing Noxious weeds (Scotch thistle, Knapweed) observed established throughout the Location.

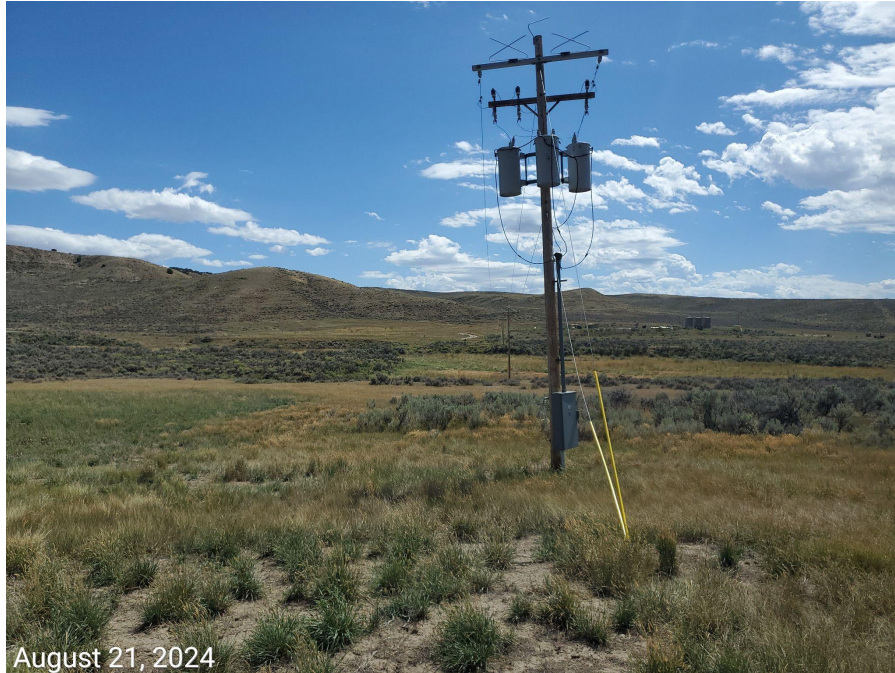
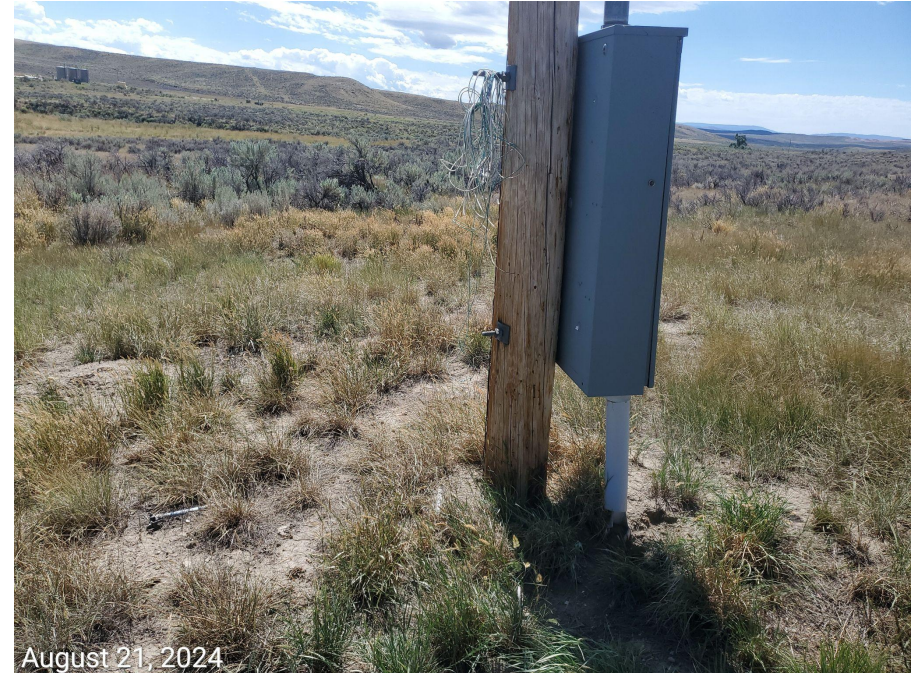
**Photo 4:** Photos taken from the south end of the Location. Photo show Utility equipment on, and leading to the Location has not been removed.

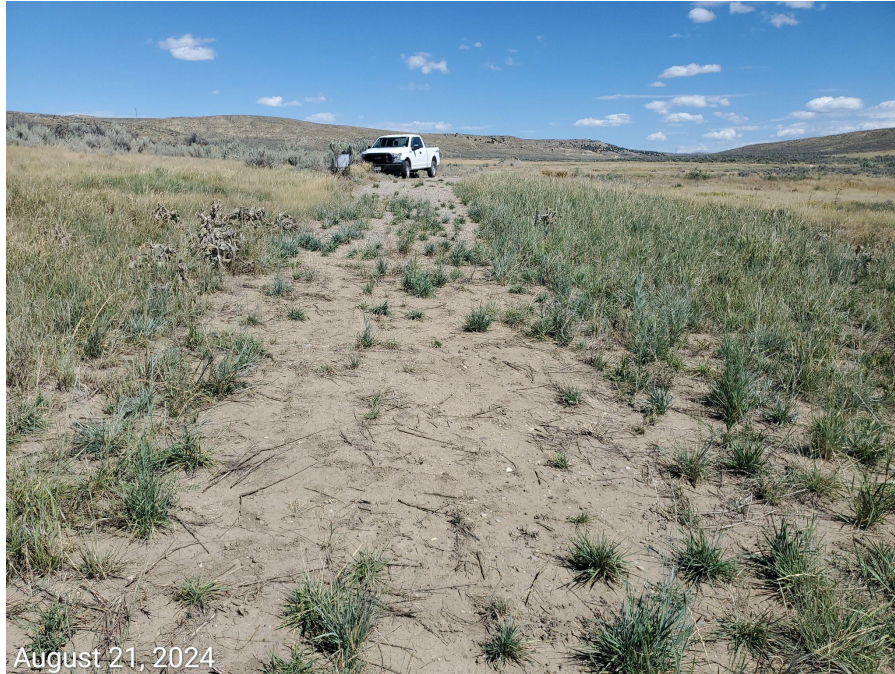
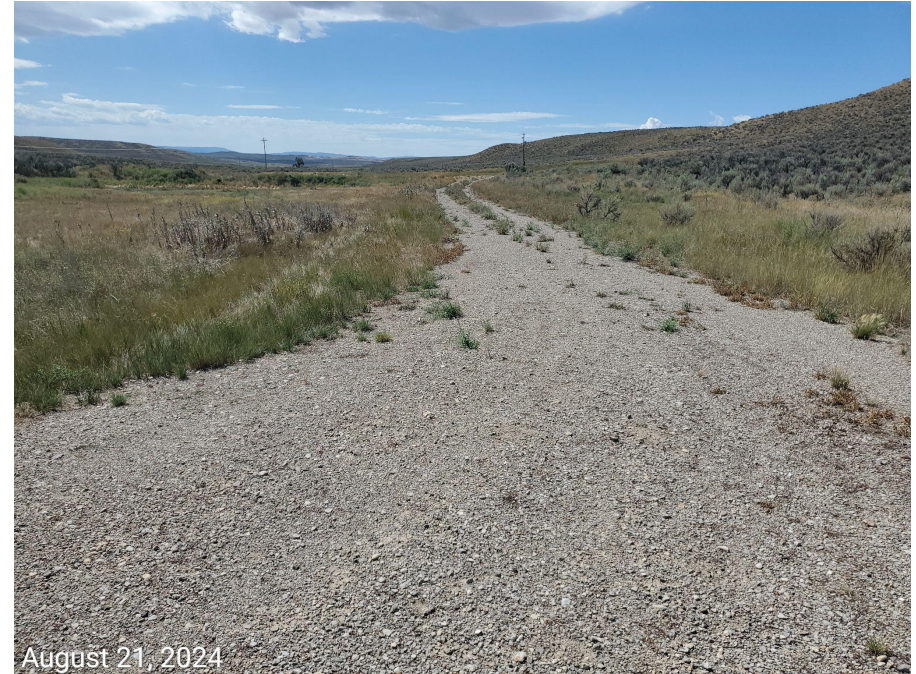
**Photo 5:** Photo left taken from the north end of the Location, facing north. Photo right taken from the access road, facing south. Photos show access road to the Location has not been reclaimed in accordance with 1004 Rules.

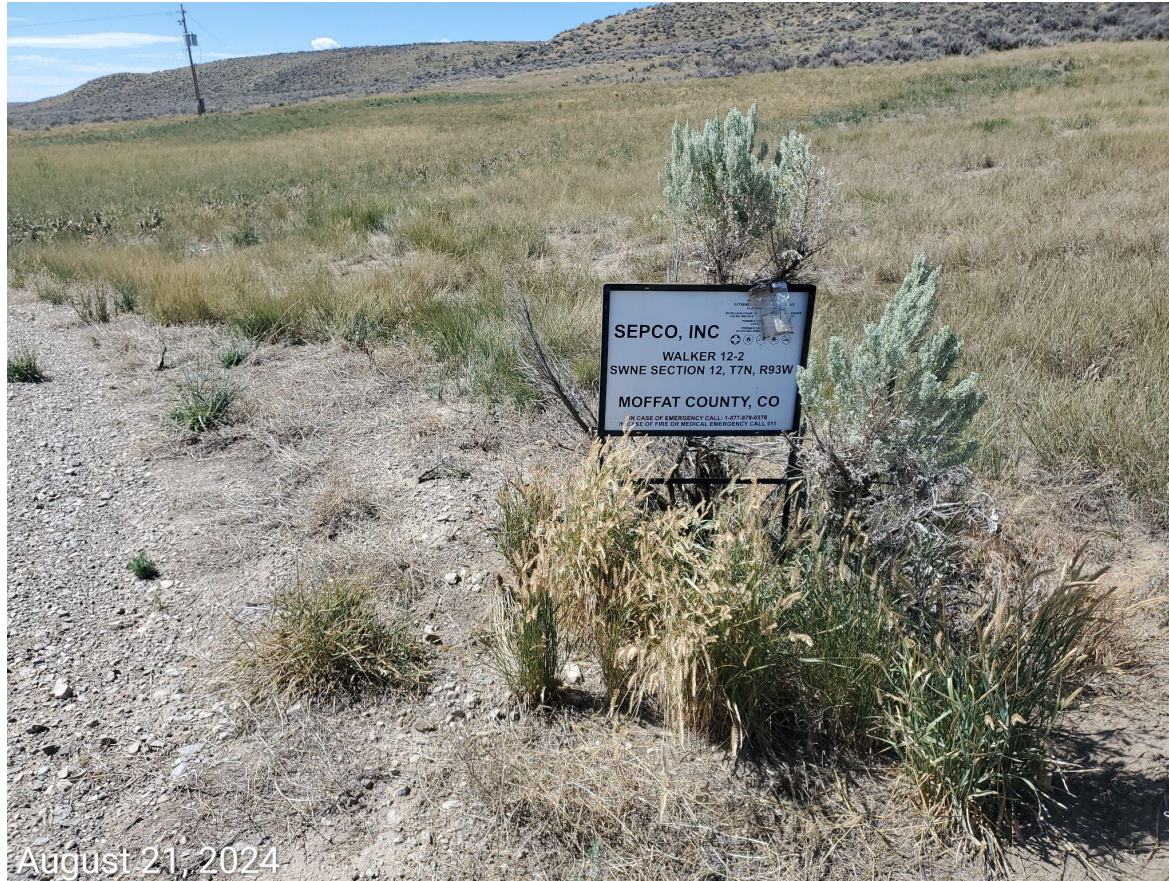
**Photo 6:** Location entrance signage posted with incorrect Operator information.
