Inspection Photos

Operator: SWN PRODUCTION COMPANY LLC
#10396

Location ID: 313148

Inspection Doc: 696206167

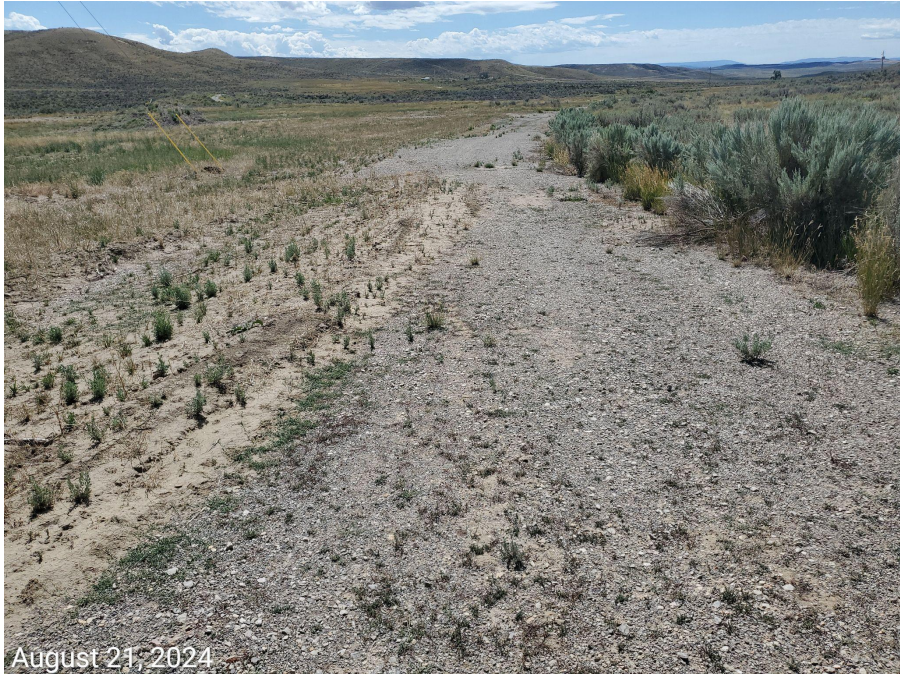
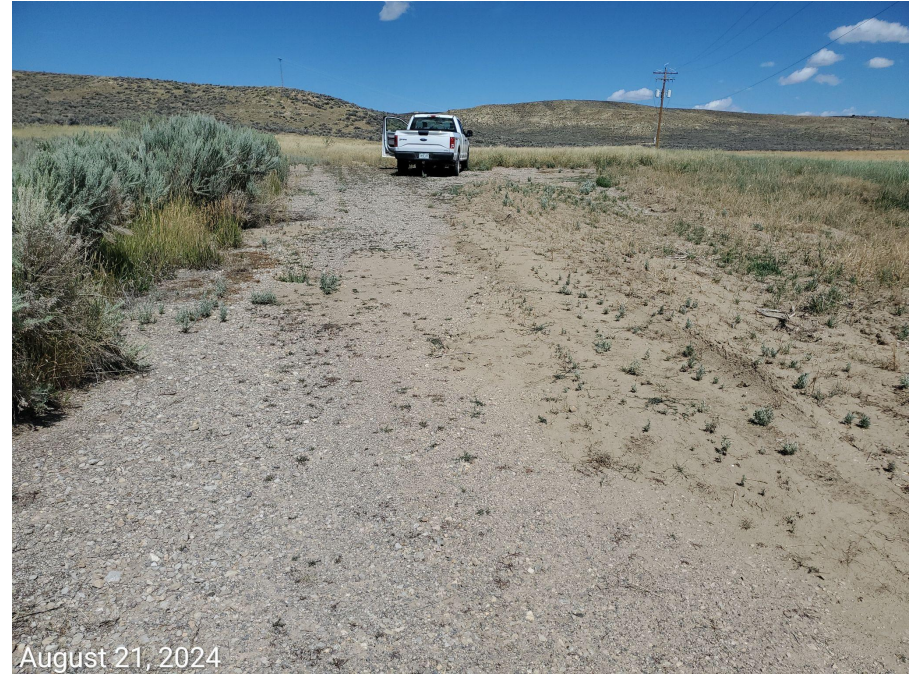
Photo 1: Photos from the Location entrance on the south end of hte Location; photo left facing south, photo right facing north. Photos show access road has not been reclaimed. Photos also show areas of the access road where work is evident, and where Operator appears to have only pushed/dumped/placed soil on top of of the road prior to performing seeding activities; gravel/compaction evident beneath placed soils.

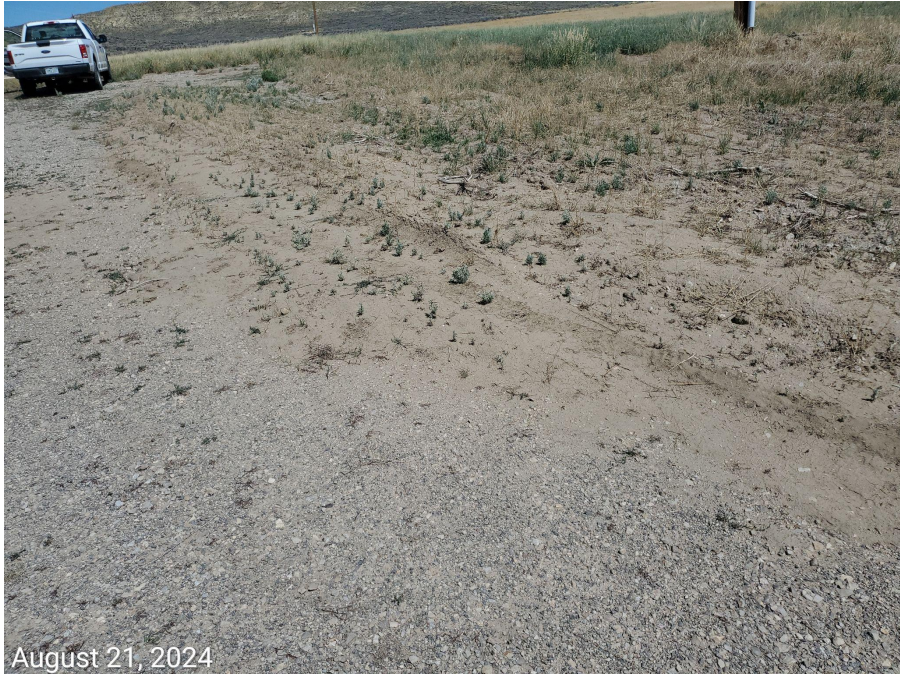
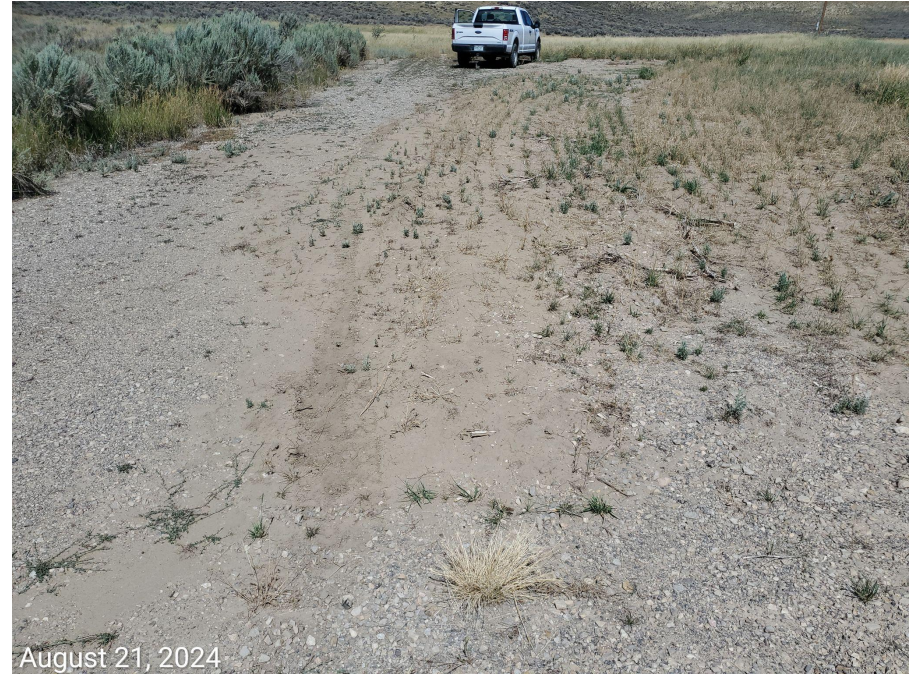
Photo 2: Continued from photo 1. Photos show areas of the access road where work is evident, and where Operator appears to have only pushed/dumped/placed soil on top of of the road prior to performing seeding activities; gravel/compaction evident beneath placed soils.

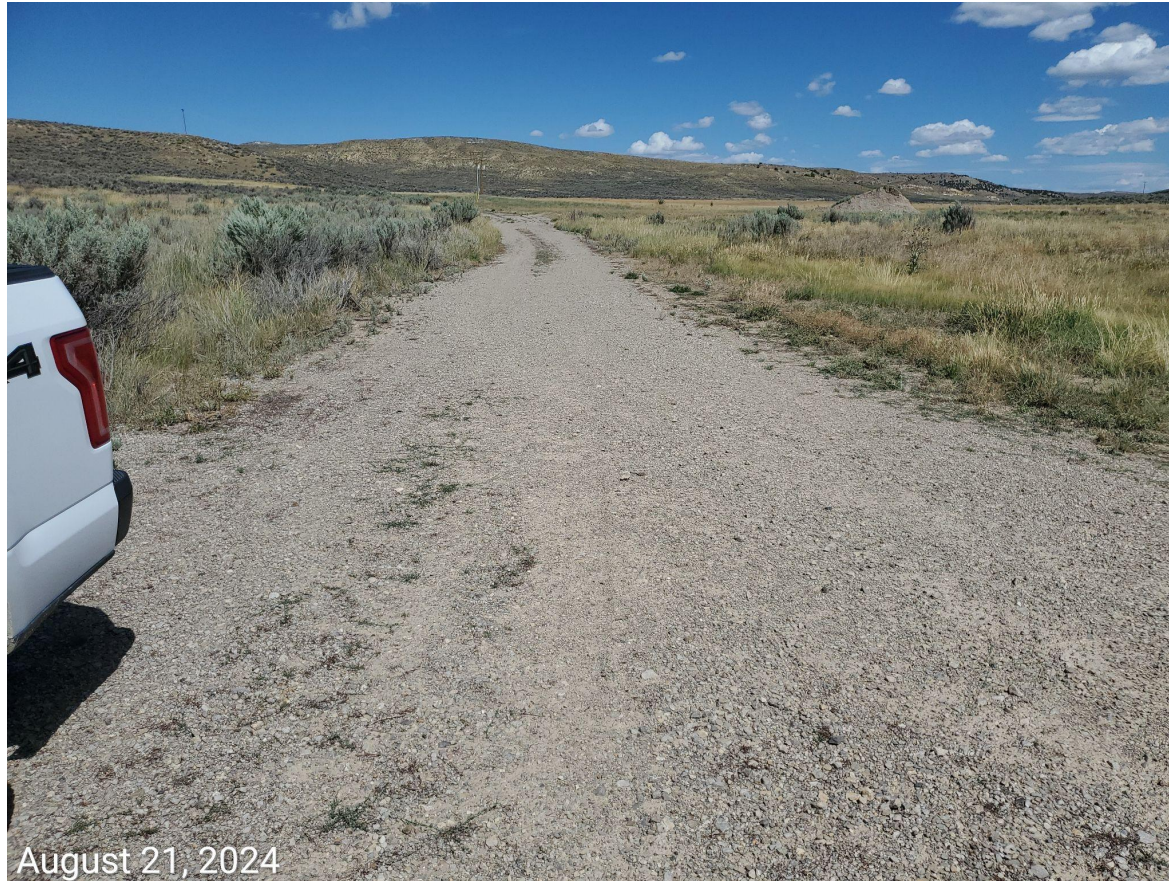
Photo 3: Photos show access road has not been reclaimed.

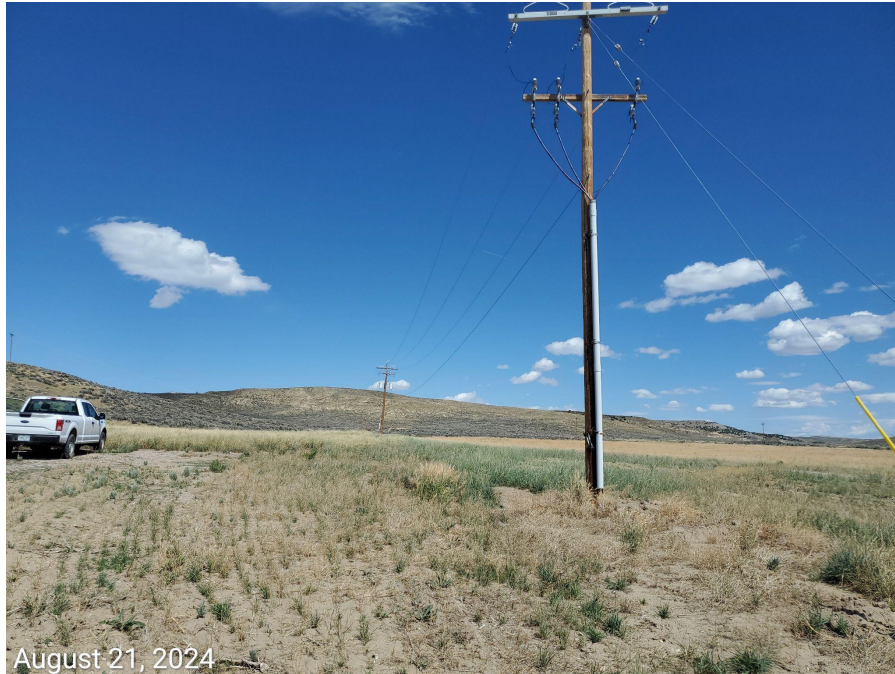
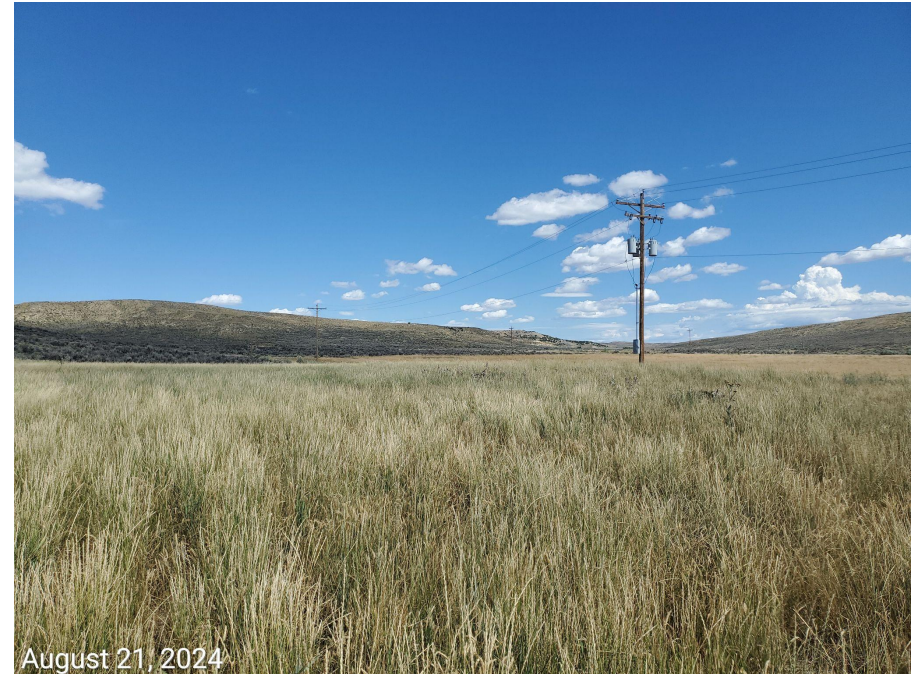
Photo 4: Photos show Utility equipment on, and leading to, the Location has not been removed.

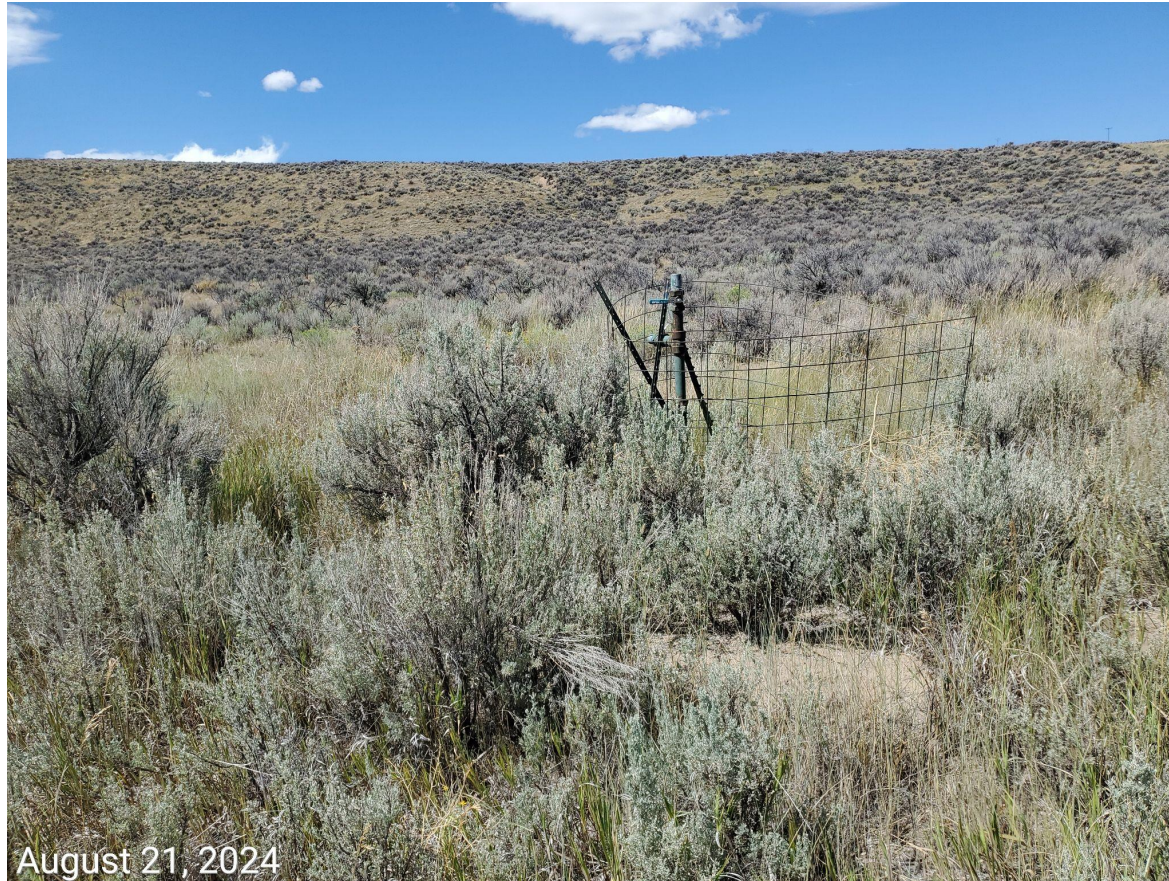
Photo 5: Photo taken from the south end of the Location, adjacent to the access road. Photo shows riser equipment remaining.

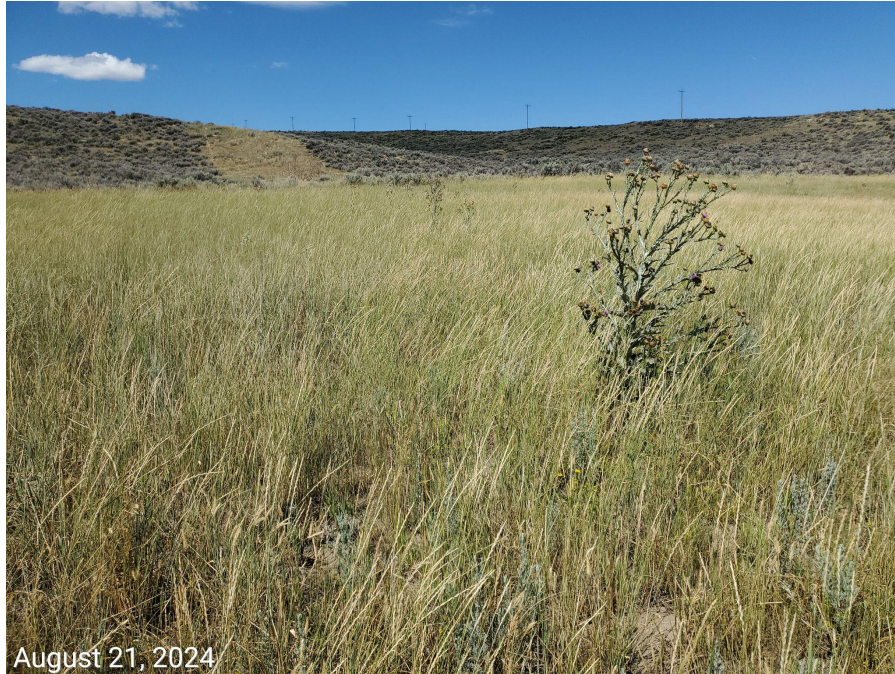
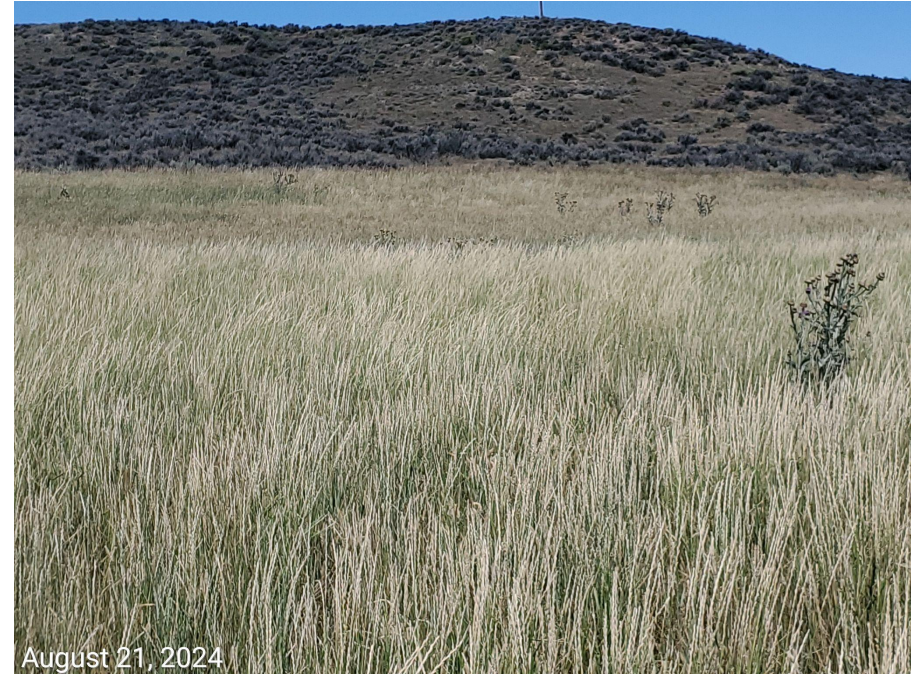
Photo 6: Photos taken from the Location. Photos examples showing Noxious weeds (Scotch thistle) observed established throughout the Location.
