# Inspection Photos

**Operator:** SWN PRODUCTION COMPANY LLC -  
10396

**Location ID:** 313350

**Inspection Doc:** 696206182

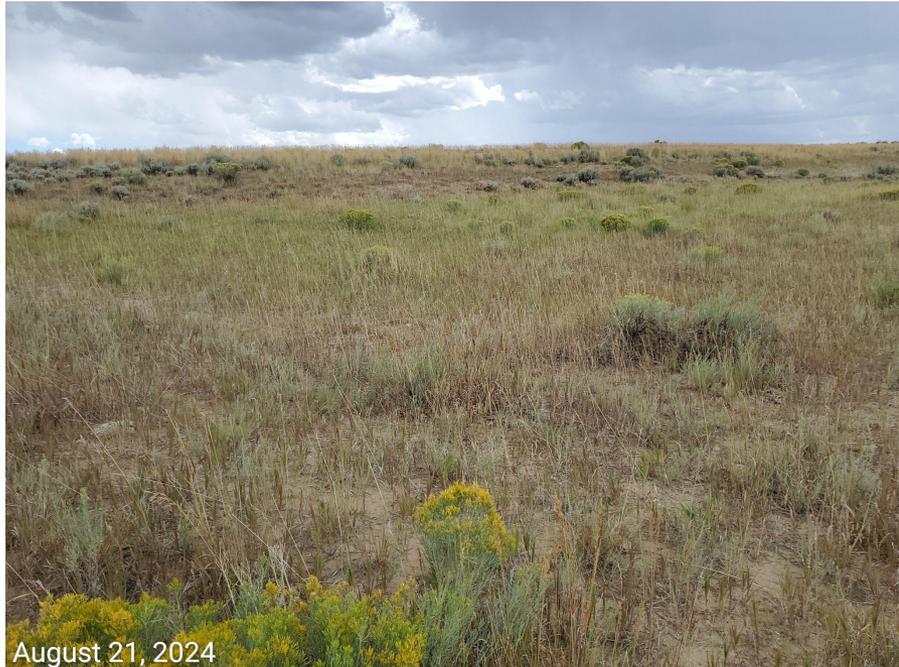
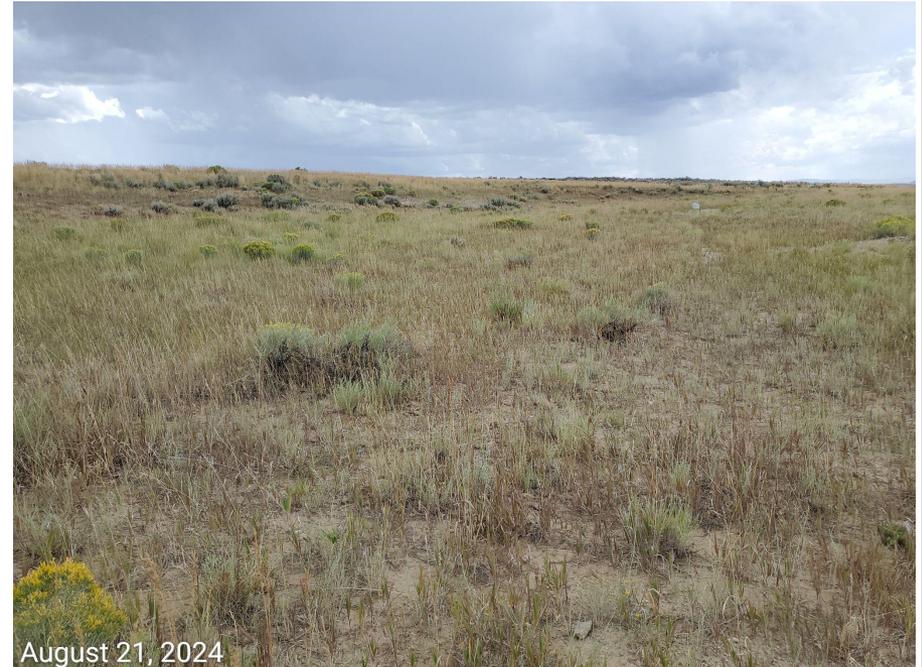
**Photo 1:** Photos 1-2 taken from the Location entrance on the northeast end of the Location. Photos provide an overview from southeast, south, west to northwest. Photos also show Location has not been recontoured/regraded pursuant to 1004 requirements; cut/fill slopes remain.

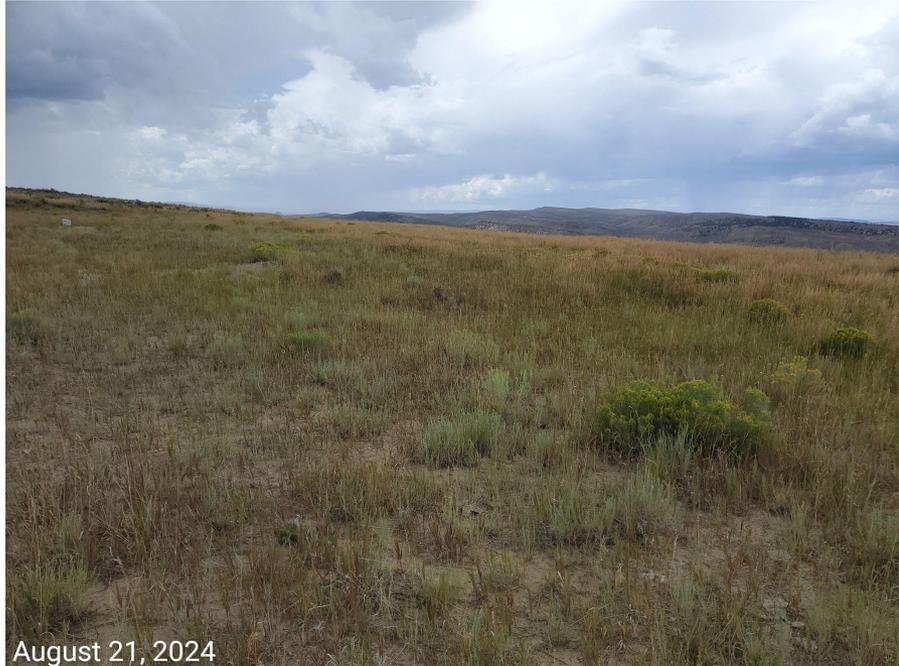
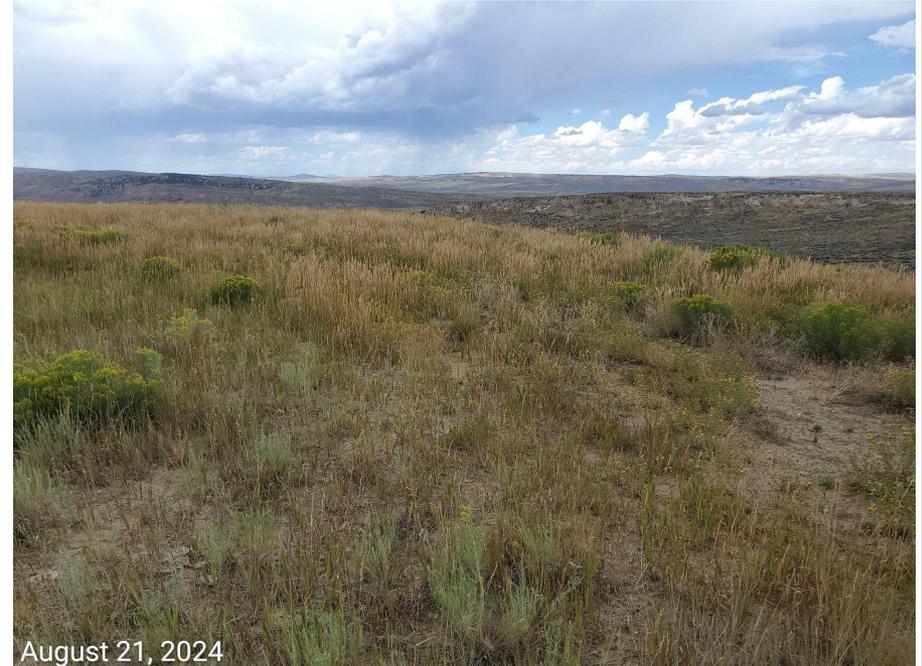
**Photo 2:** See comments under photo 1.

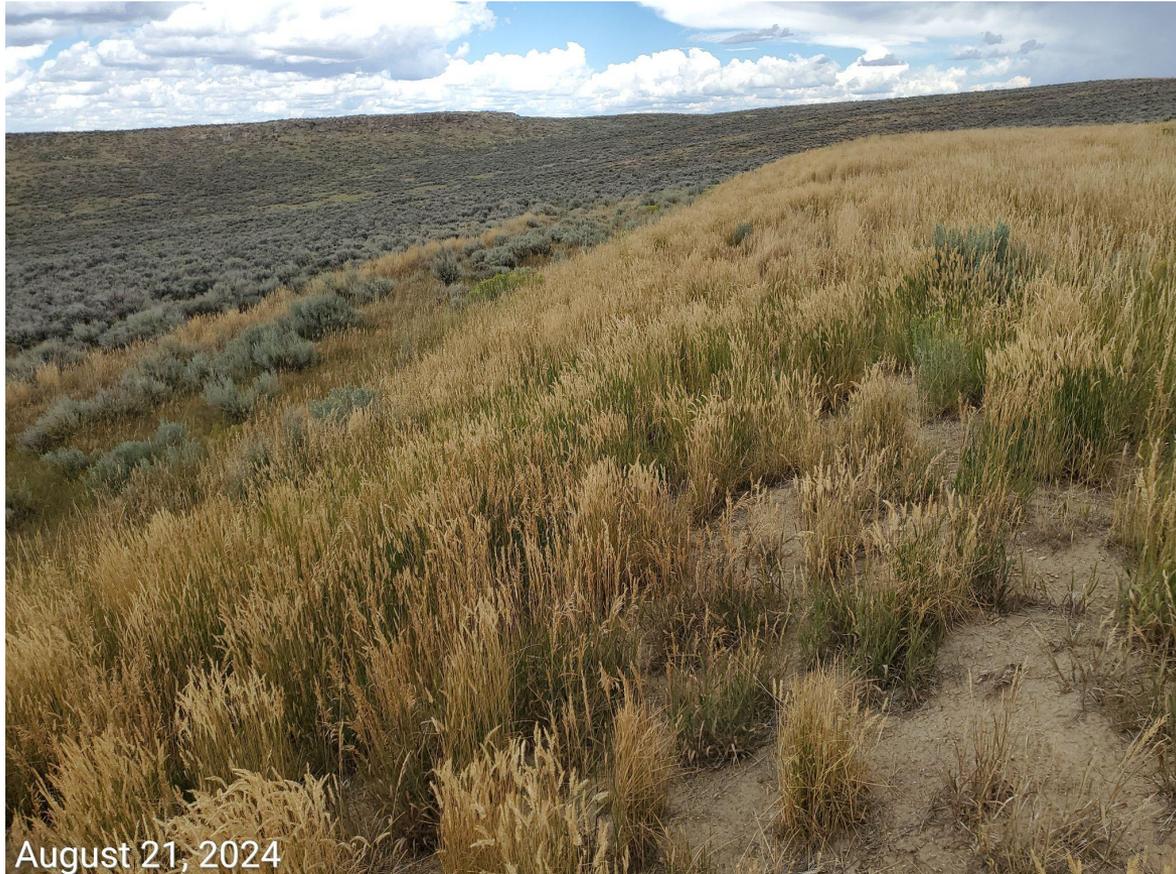
**Photo 3:** Photo example showing fill slopes remaining. Location has not been recontoured/regraded and reclaimed in accordance with 1004 Rules.

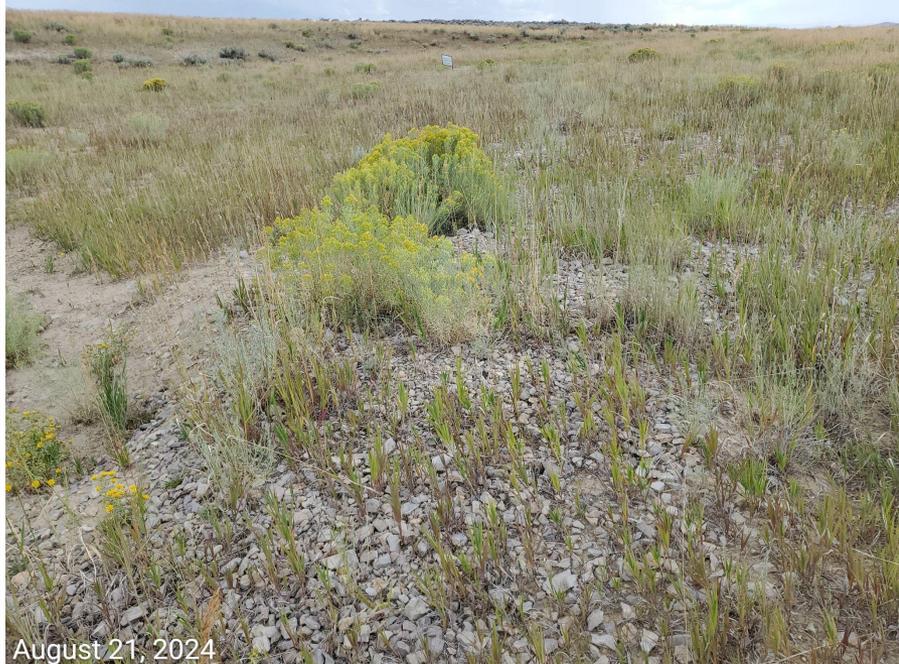
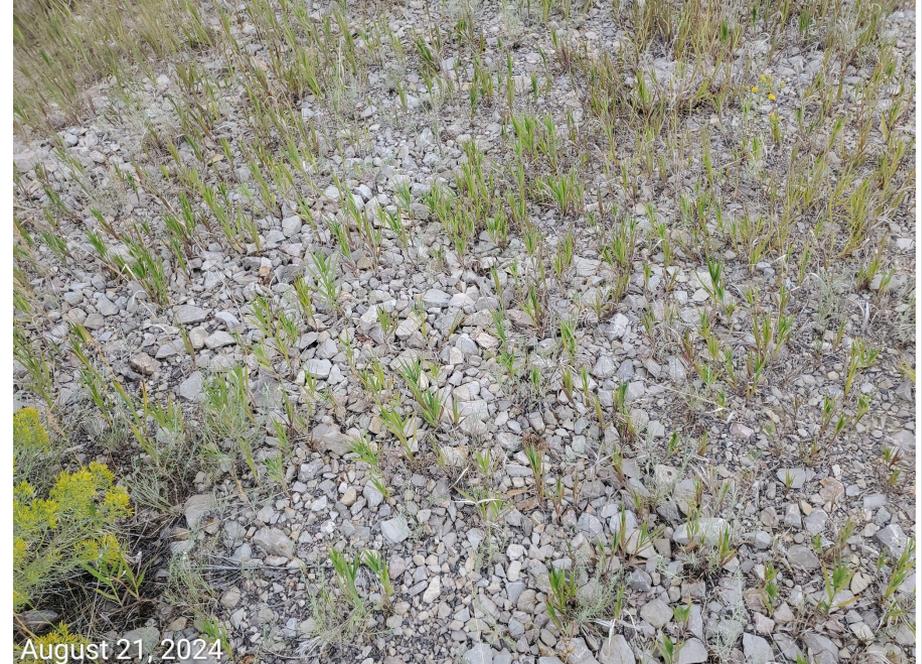
**Photo 4:** Photo taken from the Location. Photo example showing gravel/road base material remaining on the Location.

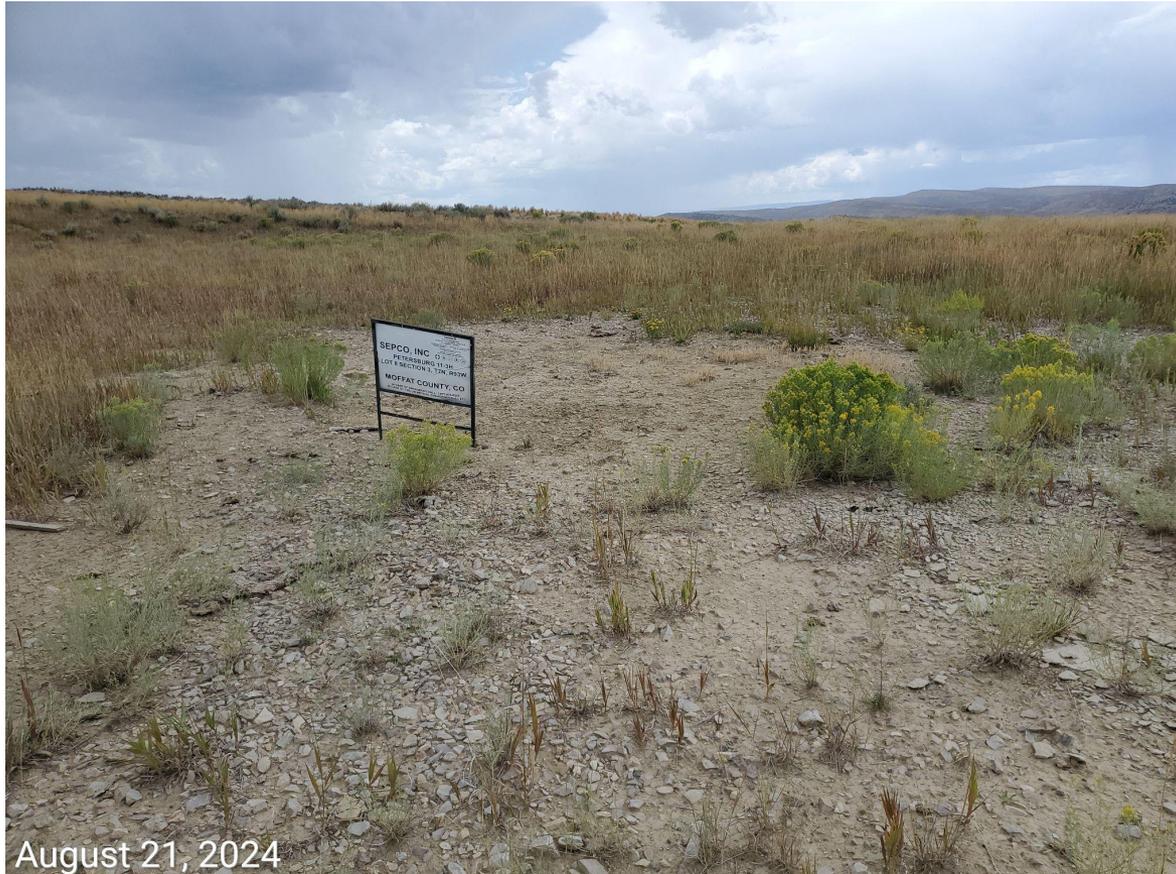
**Photo 5:** Signage on Location posted with incorrect Operator information.

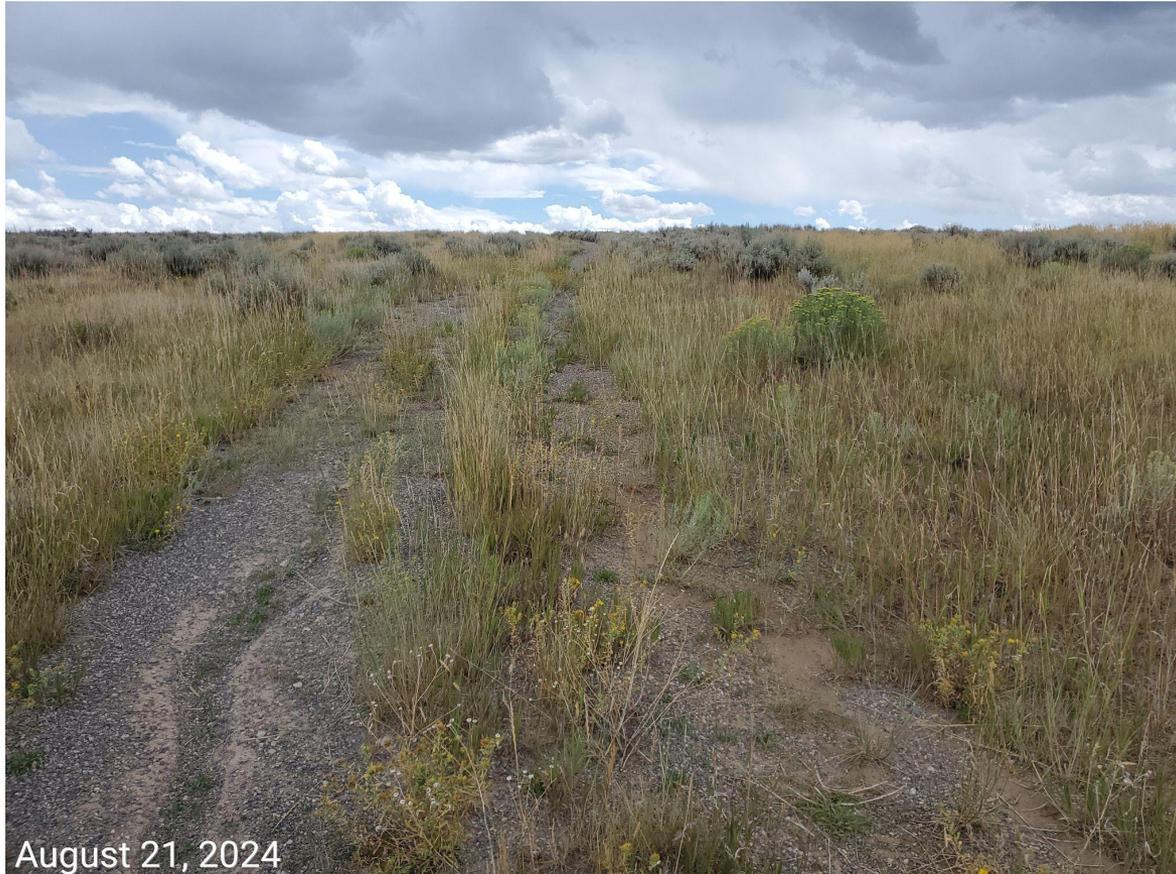
**Photo 6:** Photo taken from the northeast end of the Location, facing southeast. Photo shows access road leading to the Location has not been reclaimed.

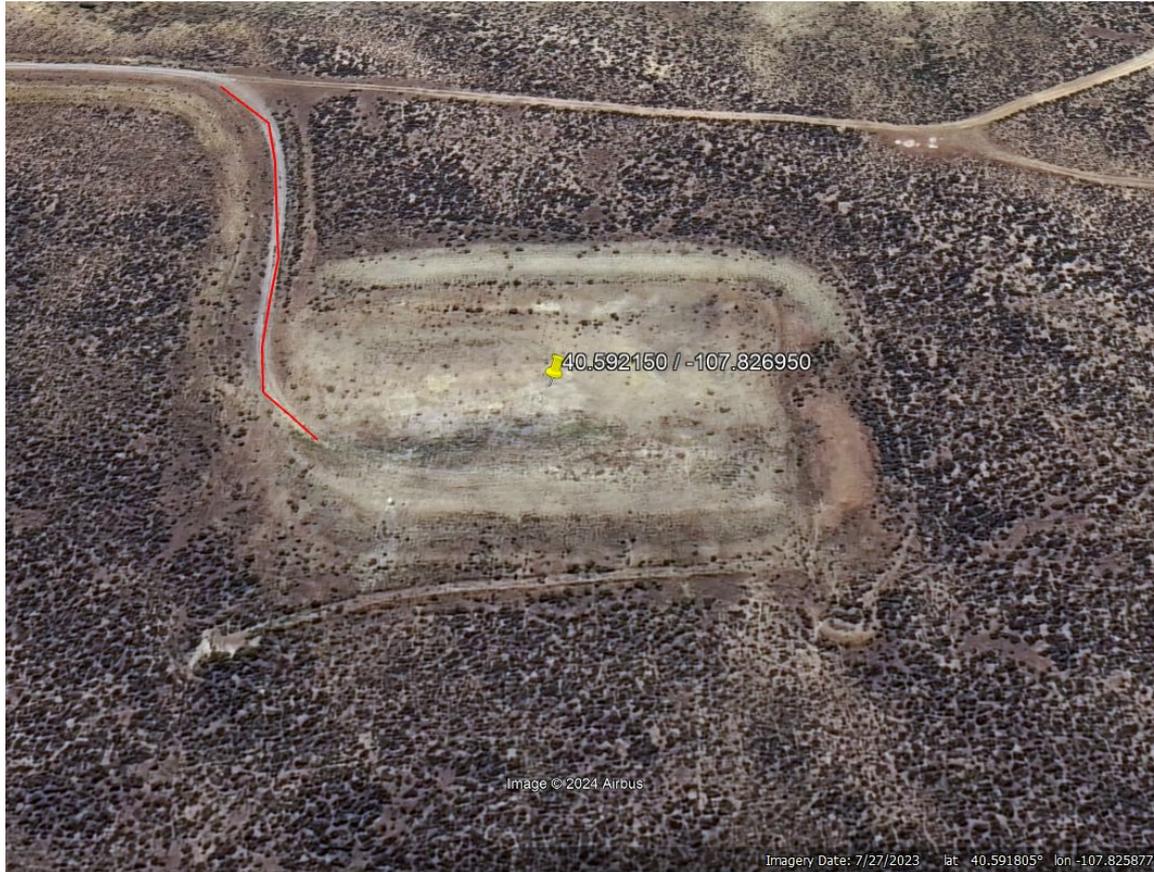
**Photo 7:** 2023 Google Earth aerial imagery. Location and access road (red line) has not been decompacted, recontoured/regraded and reclaimed.
