Inspection Photos

Operator: SWN PRODUCTION COMPANY LLC -
10396

Location ID: 313156

Inspection Doc: 696206186

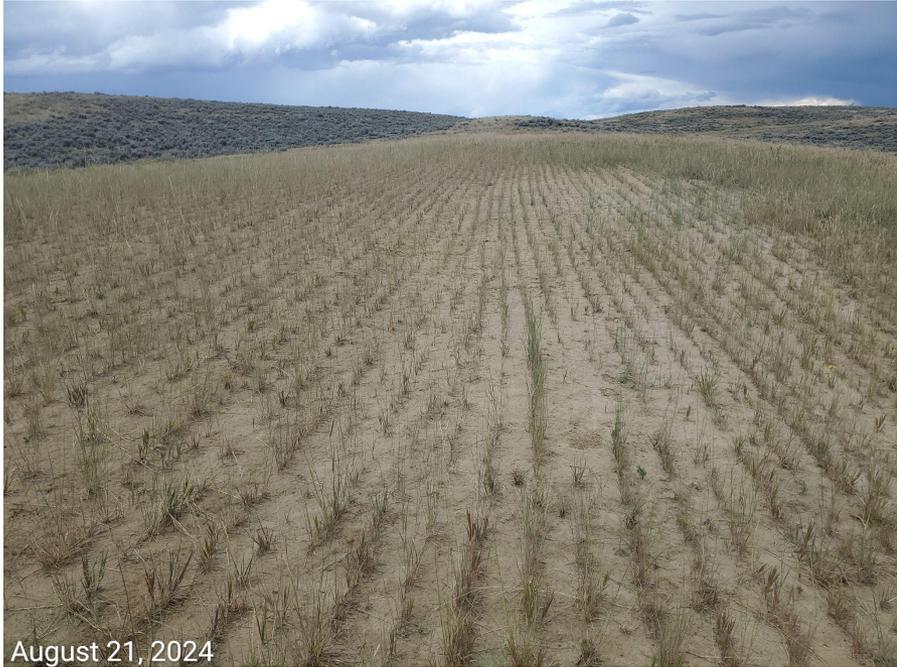
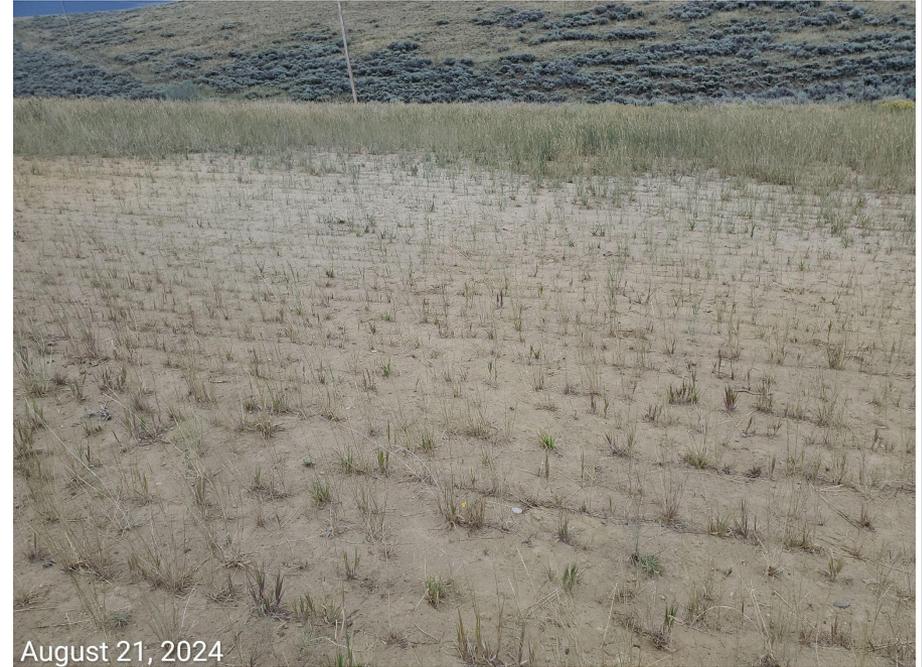
Photo 1: Photos 1-2 taken from the central areas of the Location. Photos provide an overview from north, east, south and west. Vegetative establishment, though not uniform, appears to be progressing towards 1004.c.(2) standards.

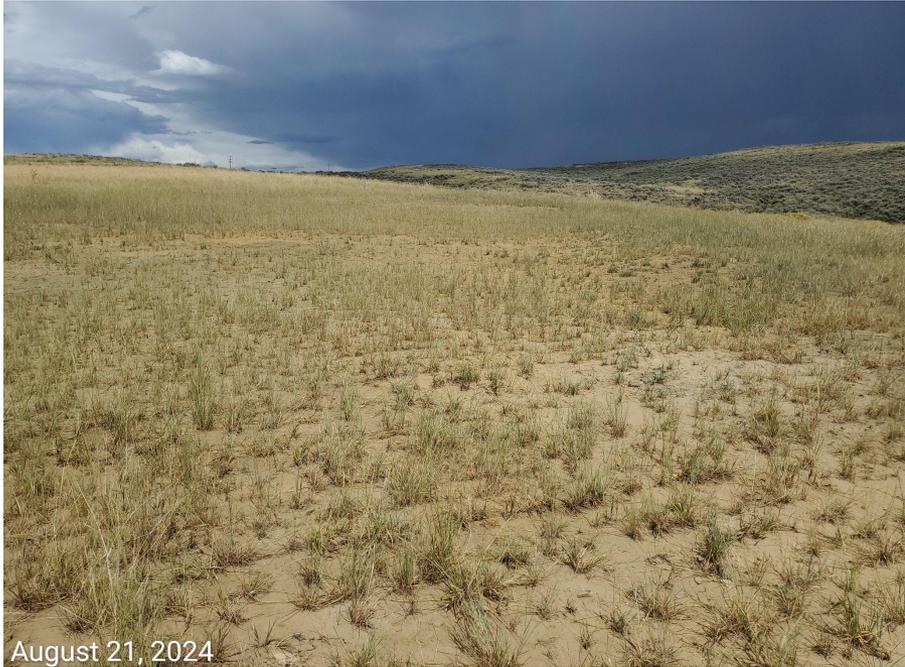
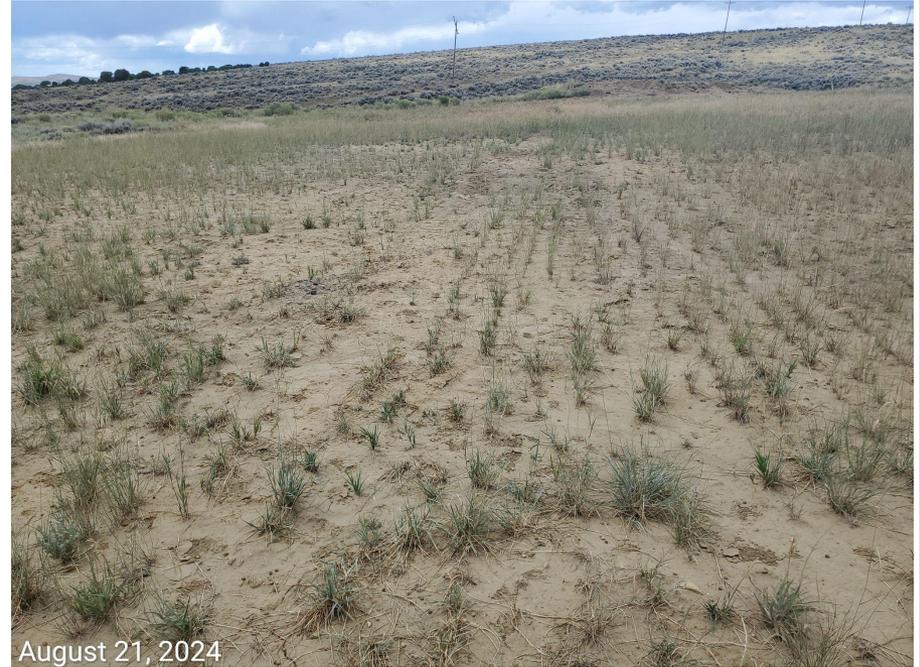
Photo 2: See comments under photo 1.

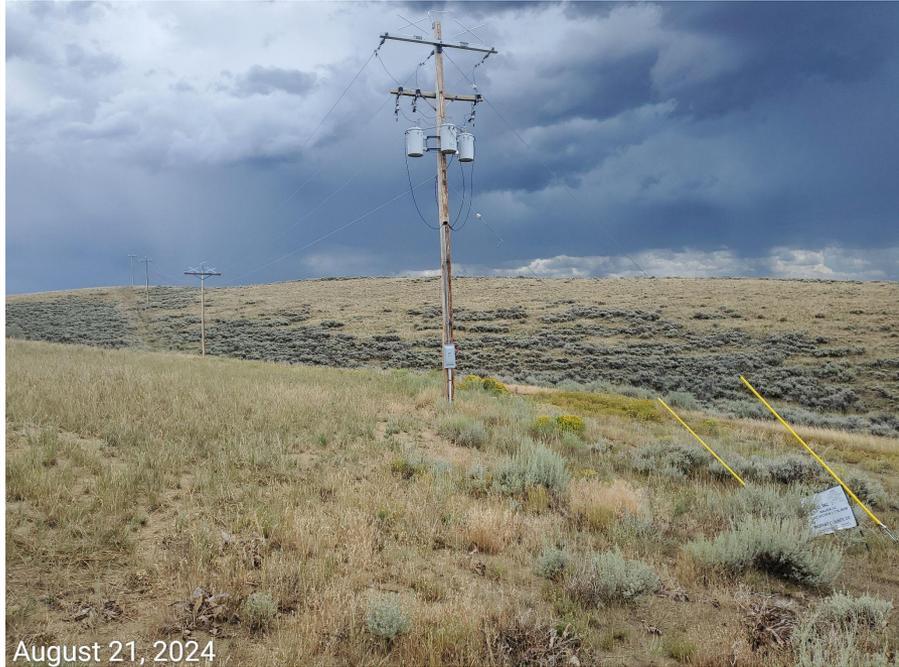
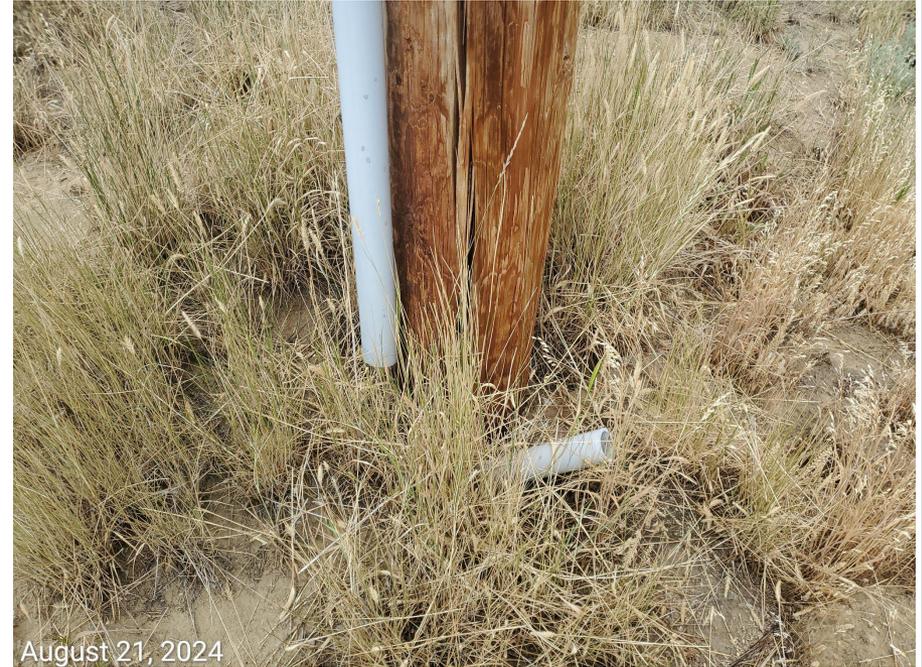
Photo 3: Photos taken from the east end of the Location, facing east. Photo shows Utility equipment on, and leading to, the Location has not been removed.

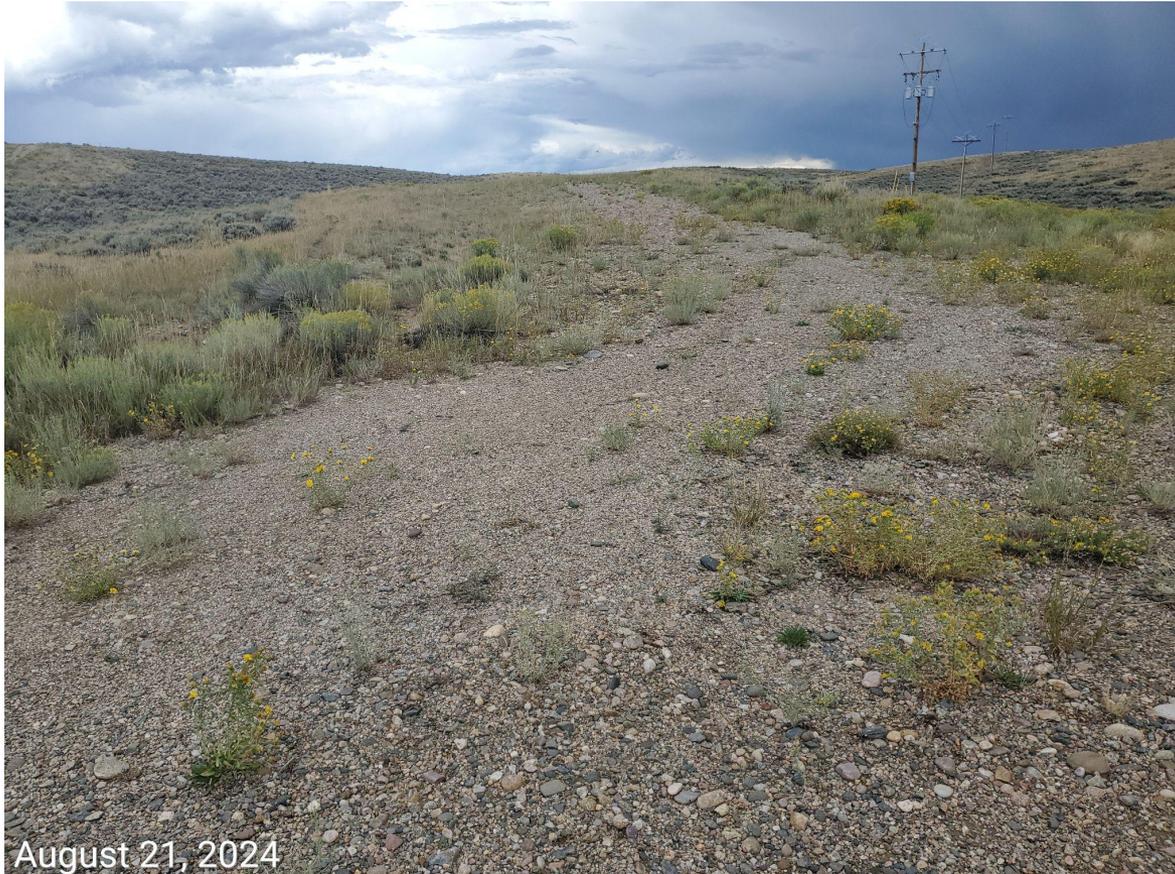
Photo 4: Photo taken from the south end of the Location, facing north. Photos shows the access road to the Location has not been reclaimed.

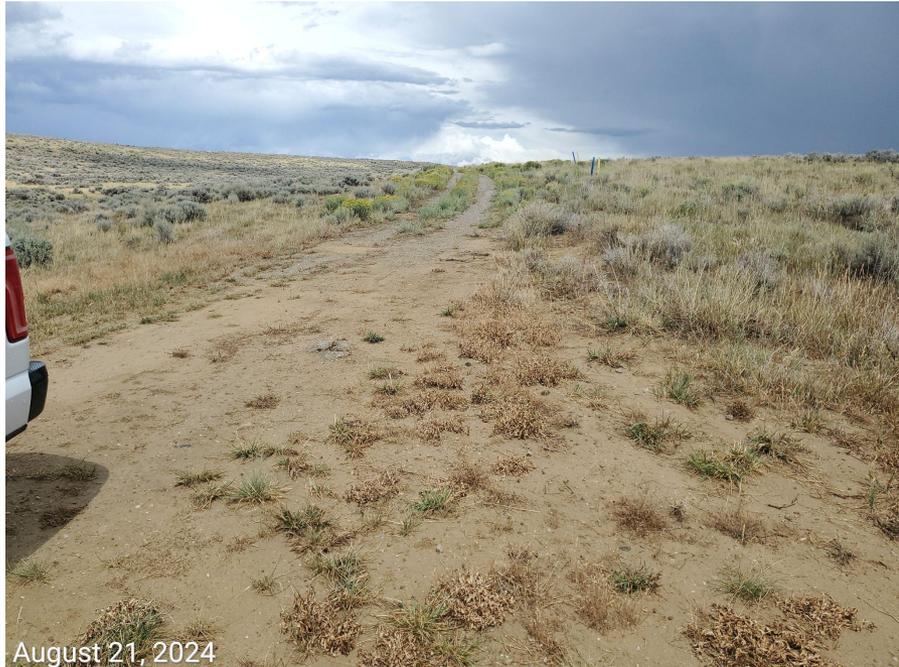
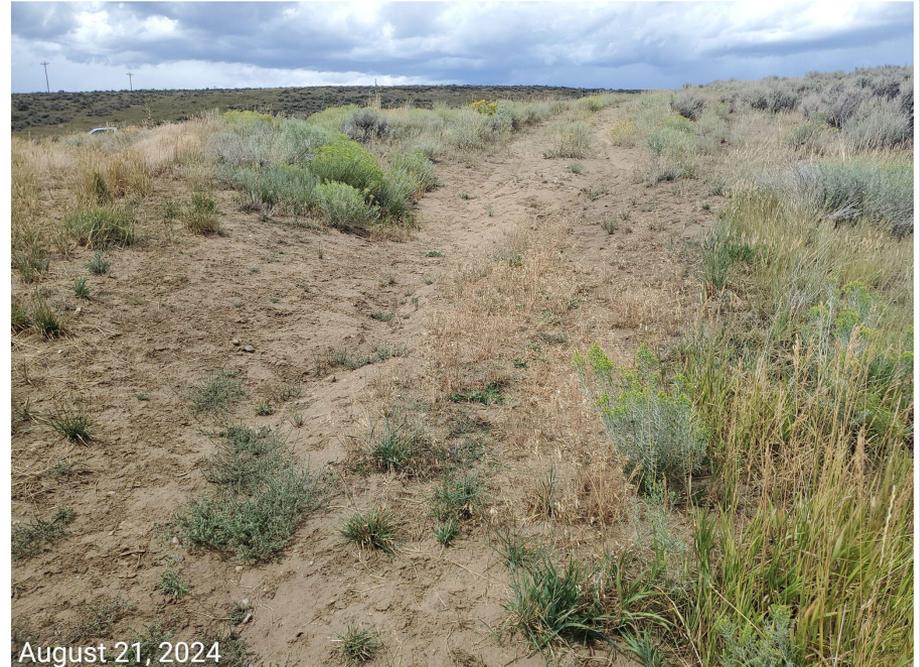
Photo 8: Photos taken from the northwest and northeast ends of the Location, facing north. Photos examples showing the access road to the Location has not been reclaimed.

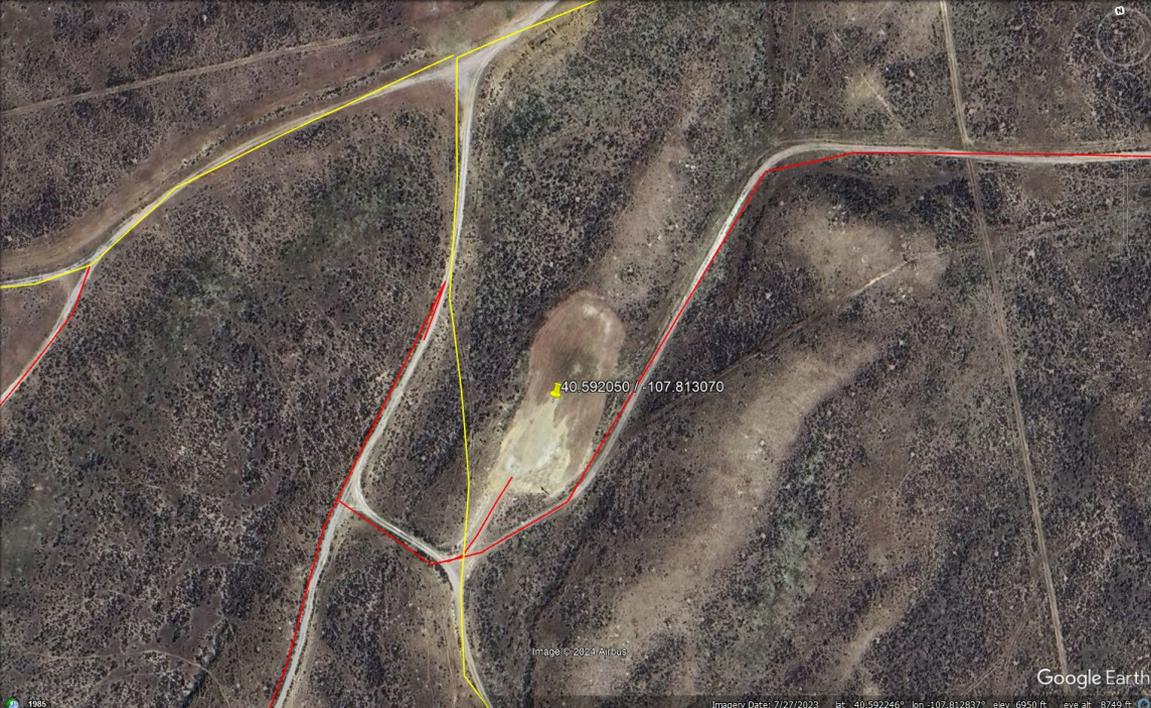
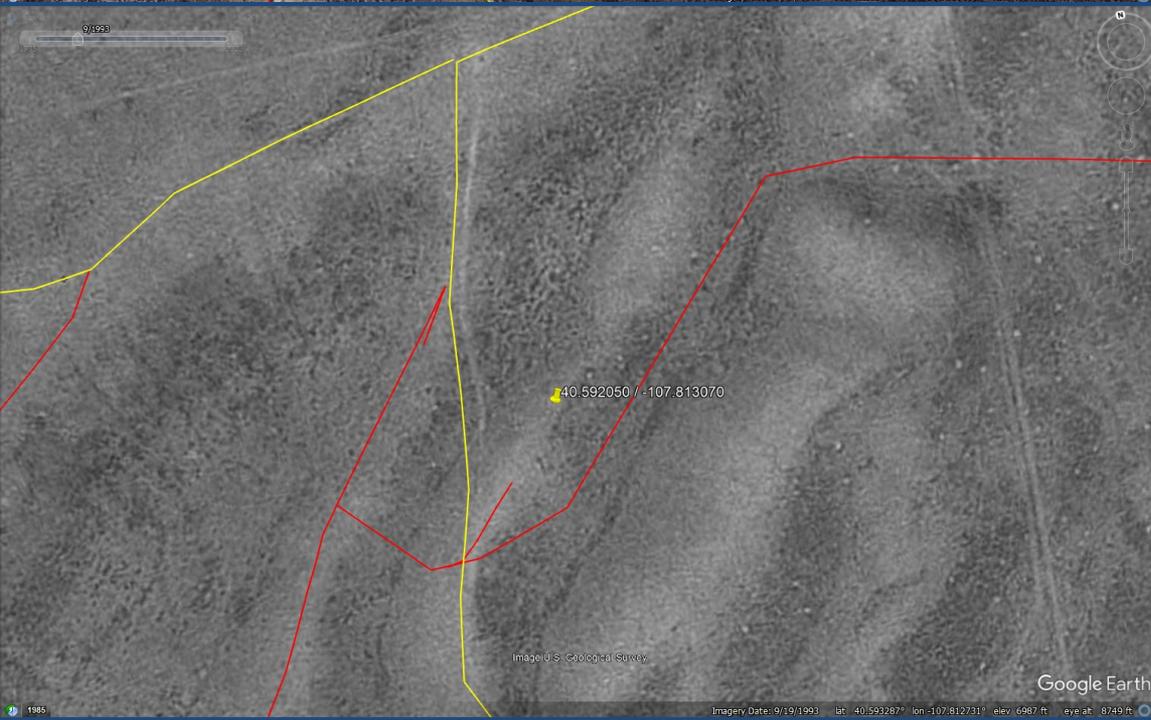
Photo 9: Google earth aerial imagery. Top photo dated 2023; bottom 1994. Yellow lines represent access roads that existed prior to Oil and Gas disturbances. Red lines represent access roads constructed to Oil and Gas Locations subject to 1004 final reclamation requirements. Access road to the Walker 3-3 did not pre-exist the Location.
