Inspection Photos

Operator: SWN PRODUCTION COMPANY LLC -
10396

Location ID: 313155

Inspection Doc: 696206192

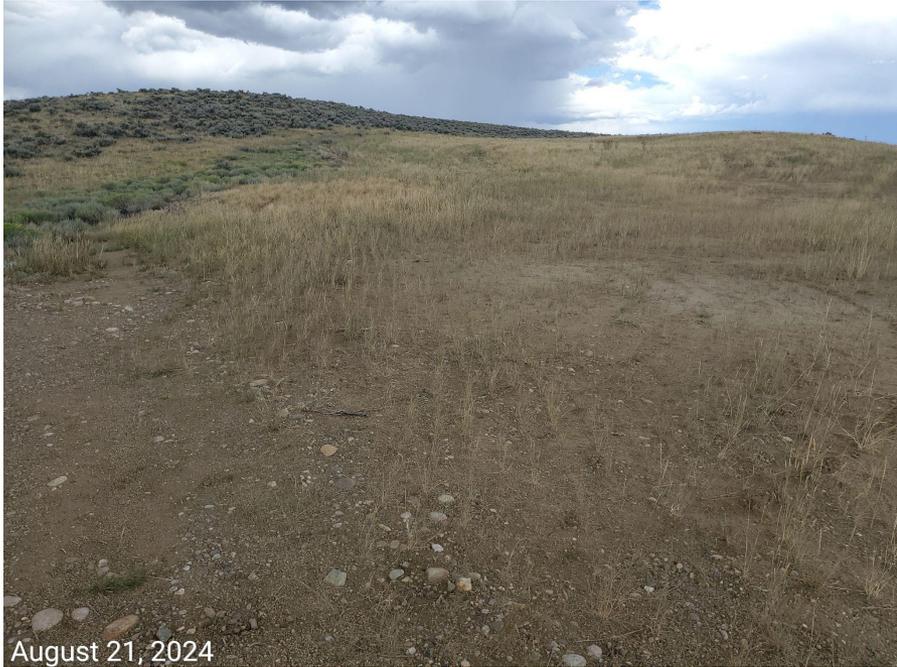
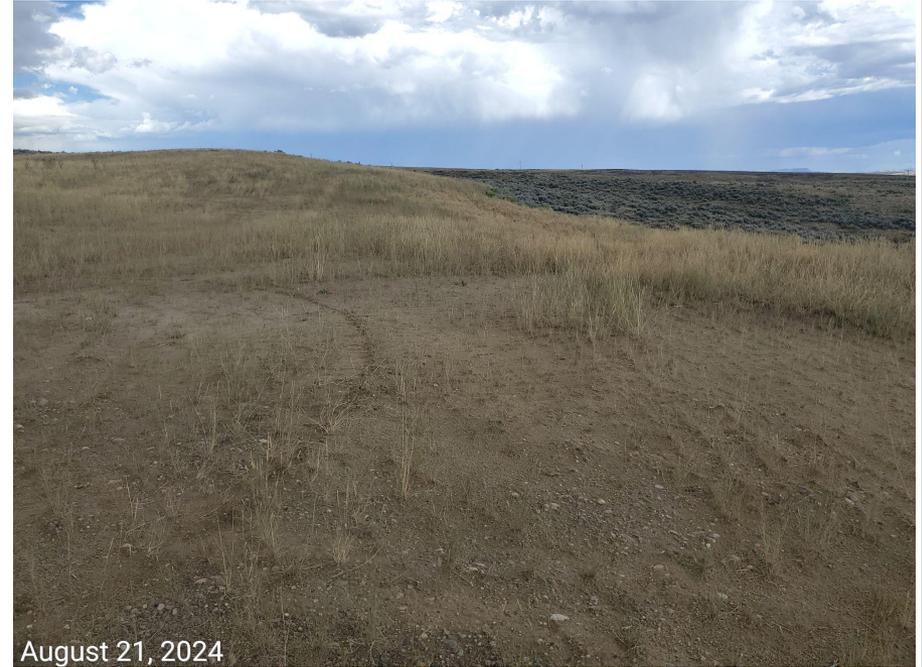
Photo 1: Photos taken from the south end of the Location, facing northwest and northeast. Location has not met 1004 revegetation requirements.

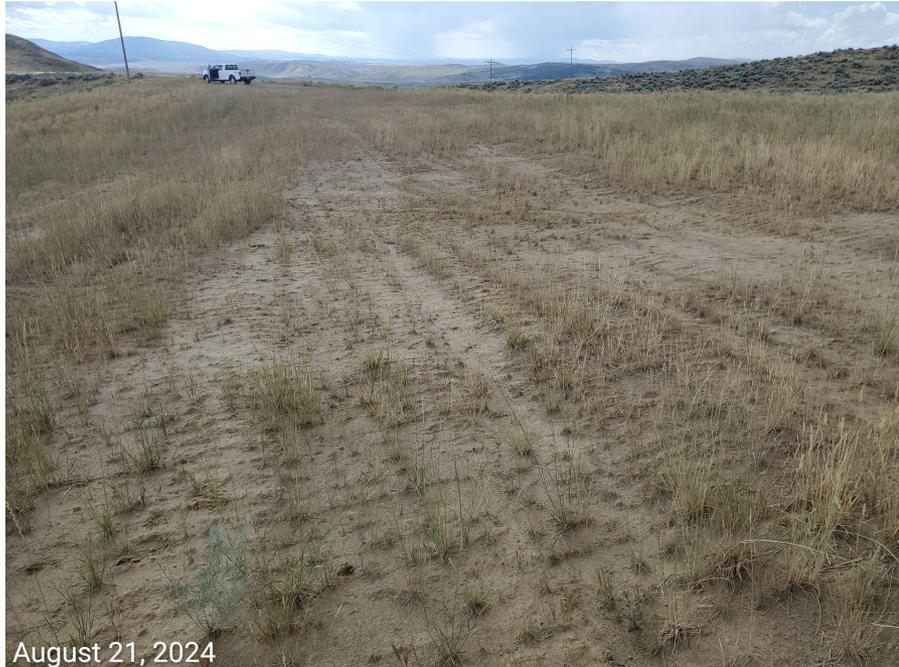
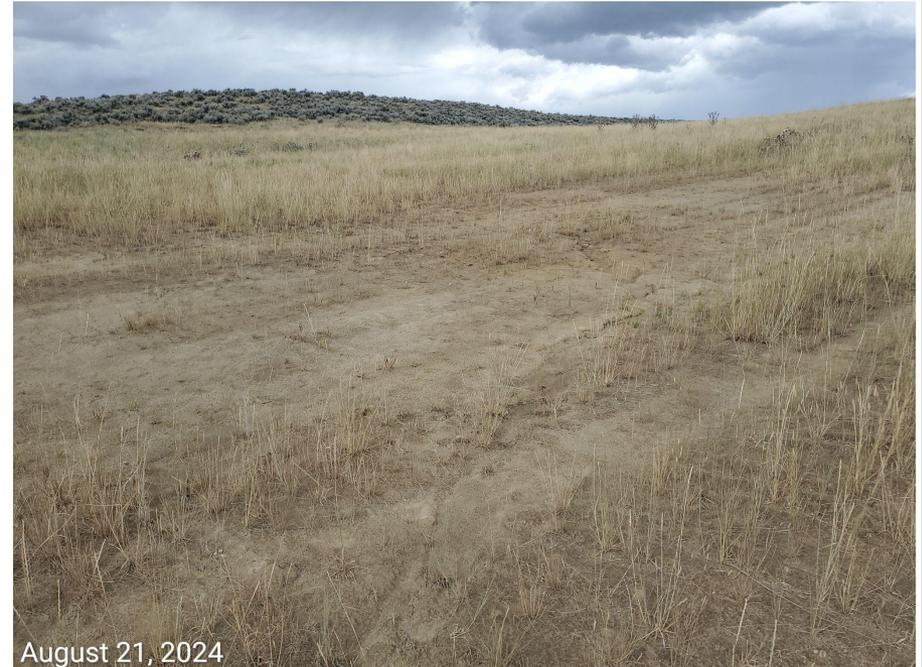
Photo 2: Photos examples showing vegetation on the Location has not achieved uniform establishment. Erosion degradation due to runoff evident.

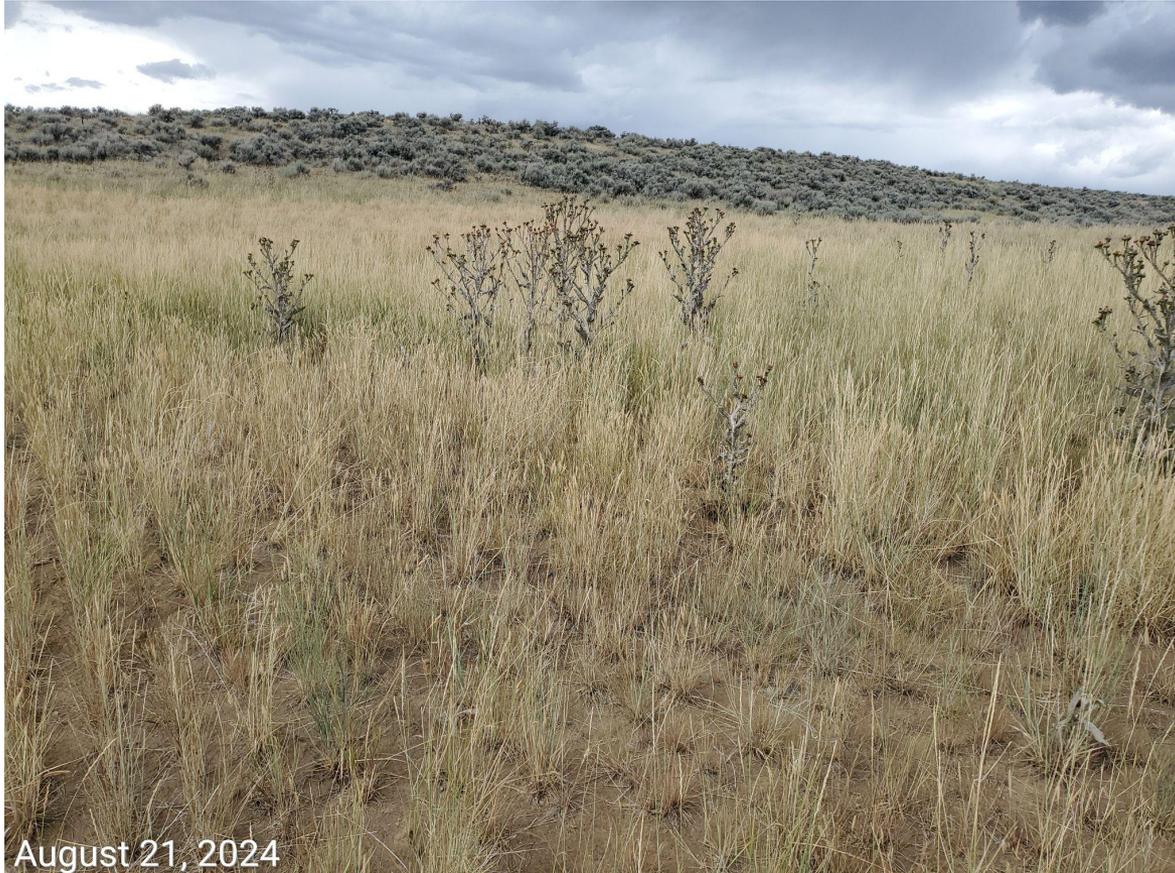
Photo 3: Photos examples of Noxious weeds (Scotch thistle) observed on the Location.

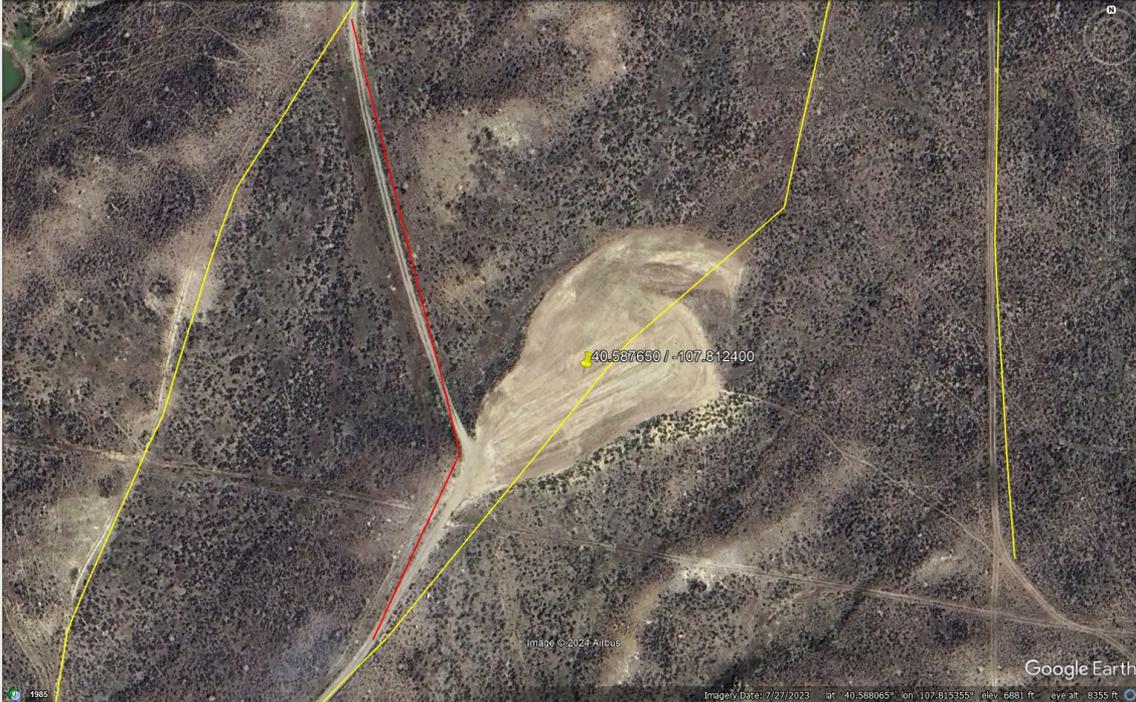
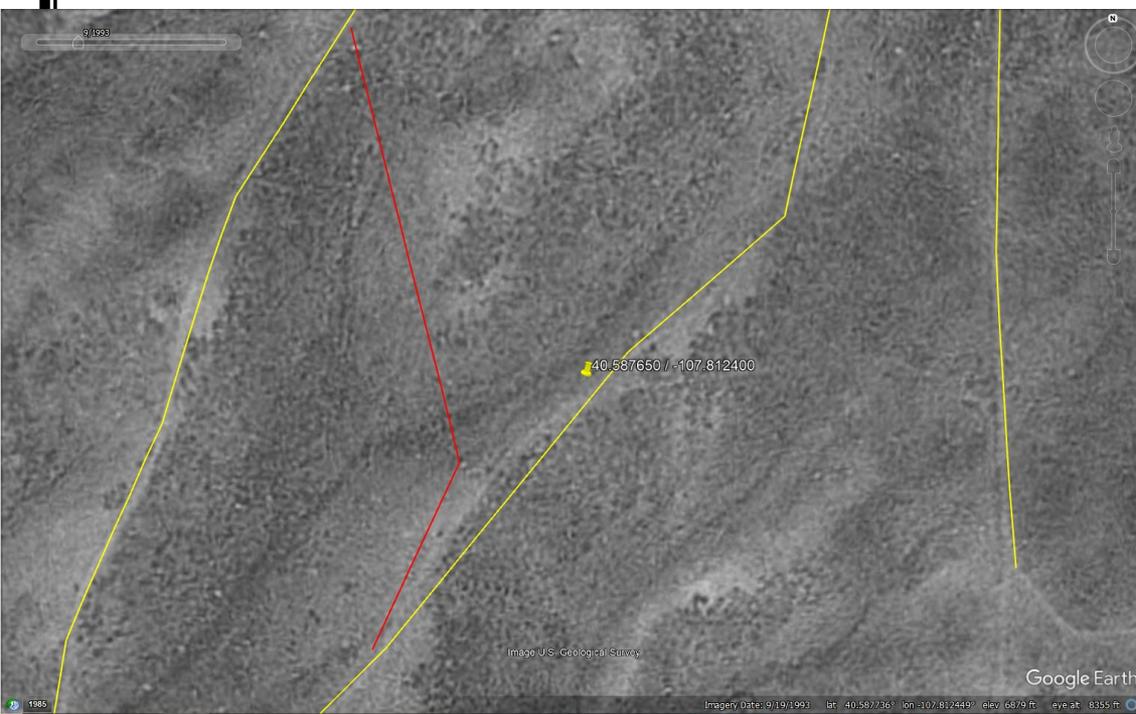
Photo 8: Google earth aerial imagery. Top photo dated 2023; bottom 1994. Yellow lines represent access roads that existed prior to Oil and Gas disturbances. Red lines represent access roads constructed to Oil and Gas Locations subject to 1004 final reclamation requirements. Access road to the Walker 3-4 did not pre-exist the Location.
