Inspection Photos

Operator: American Helium Operating LLC - 10841

Inspection Document #: 714001177

Inspection Photos
Location Name: Andy Mesa Federal 37
Location ID: 316837

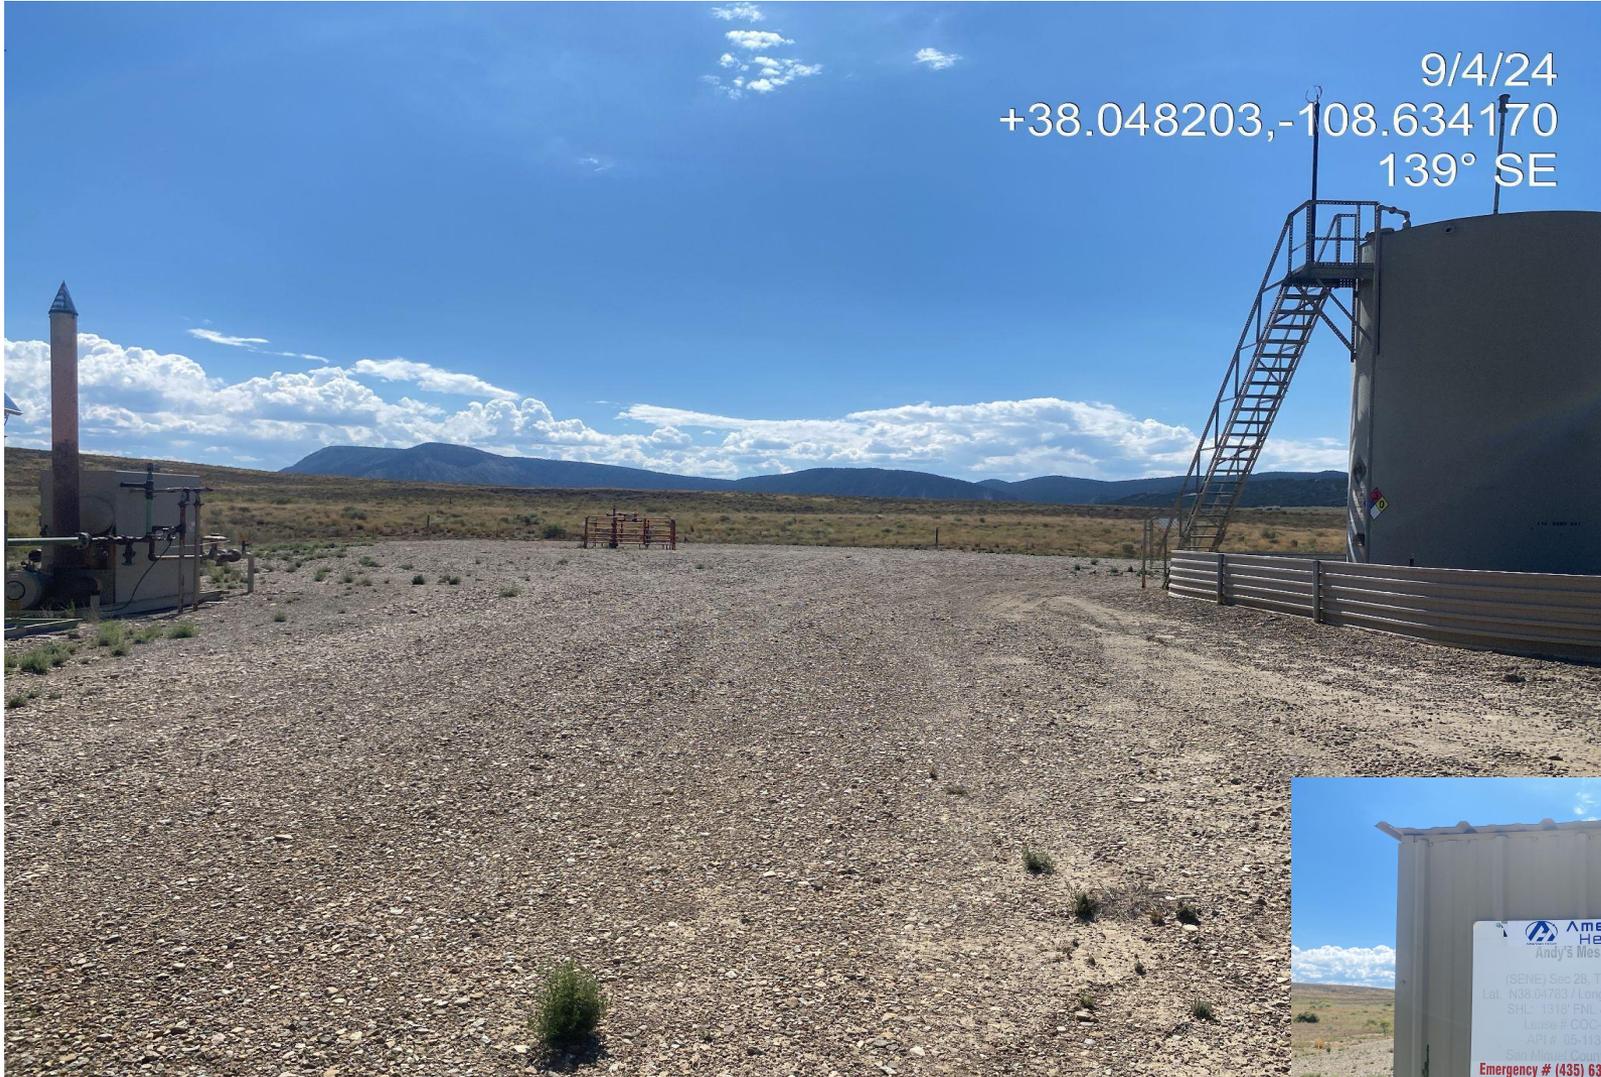
Photo 1. View of the well disturbance taken from the access point facing center.

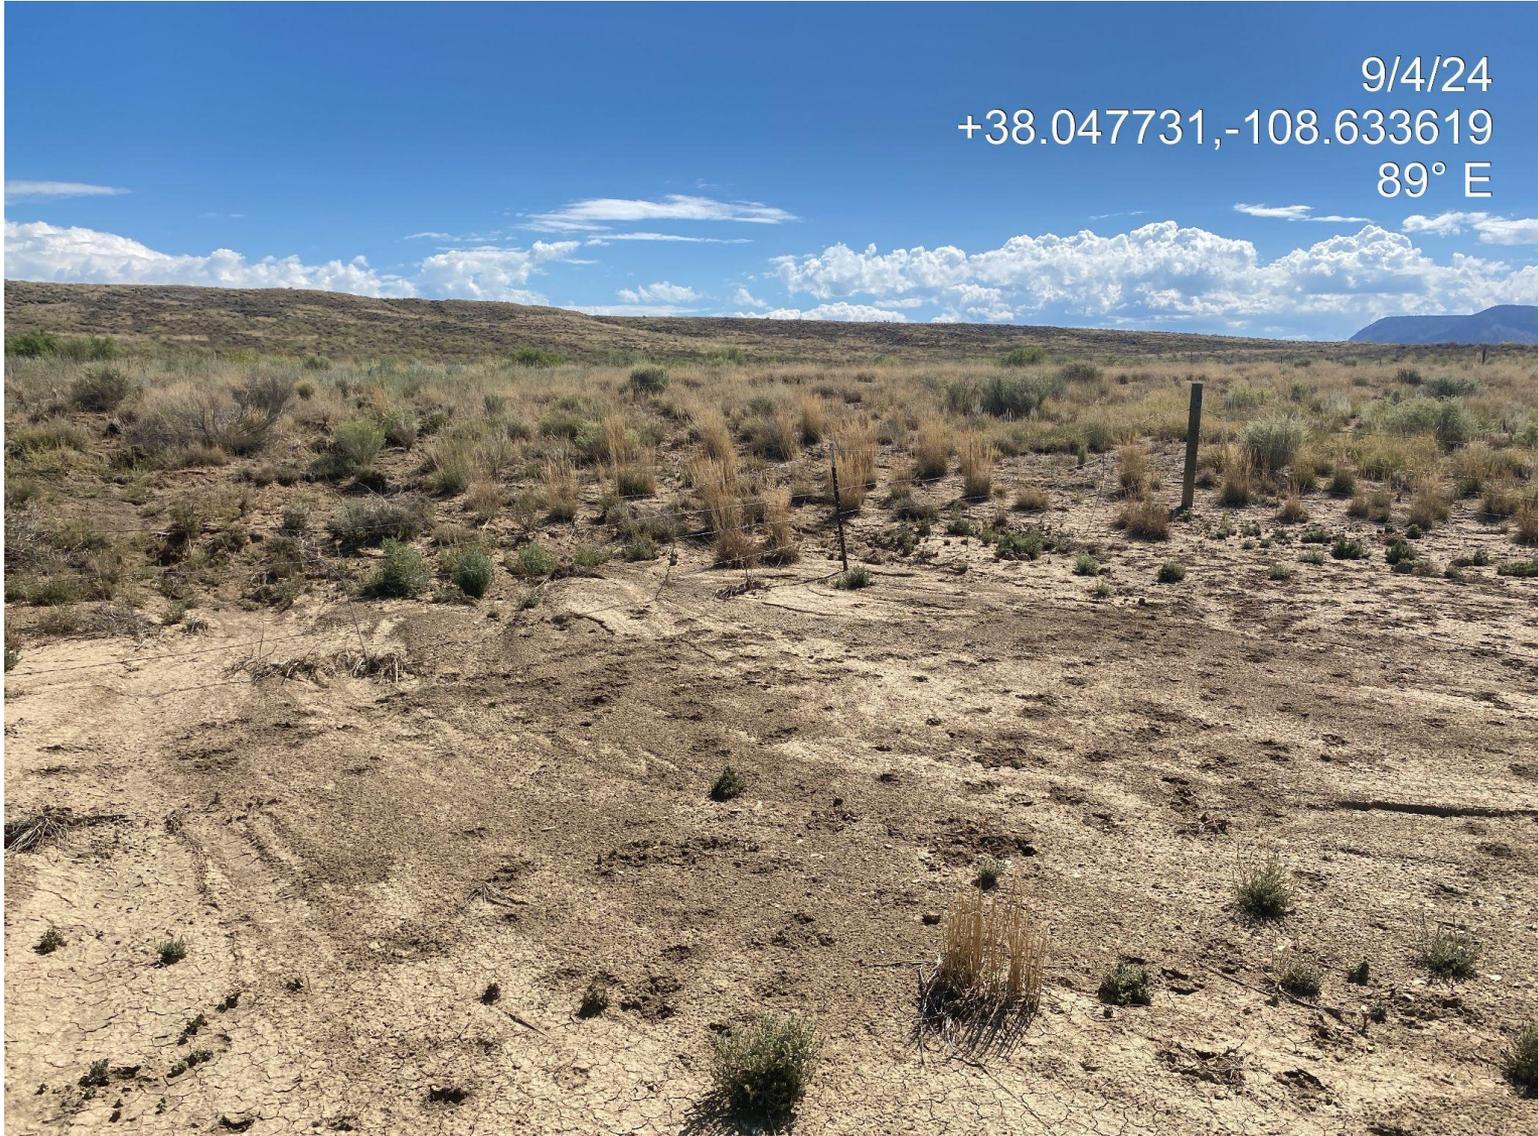
Photo 2. Erosion and sediment transport observed in the eastern portion of the disturbance. Stabilization/Stormwater BMPs needed in this area.

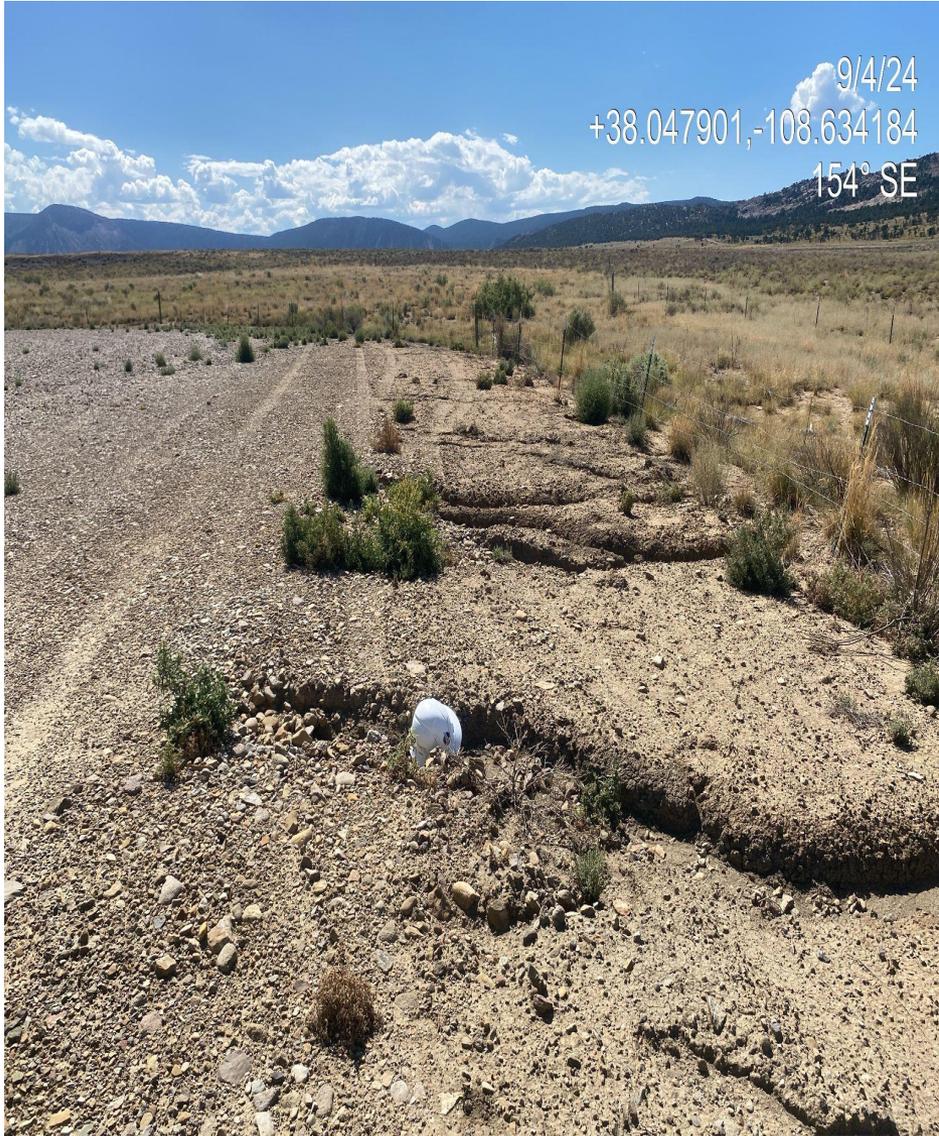
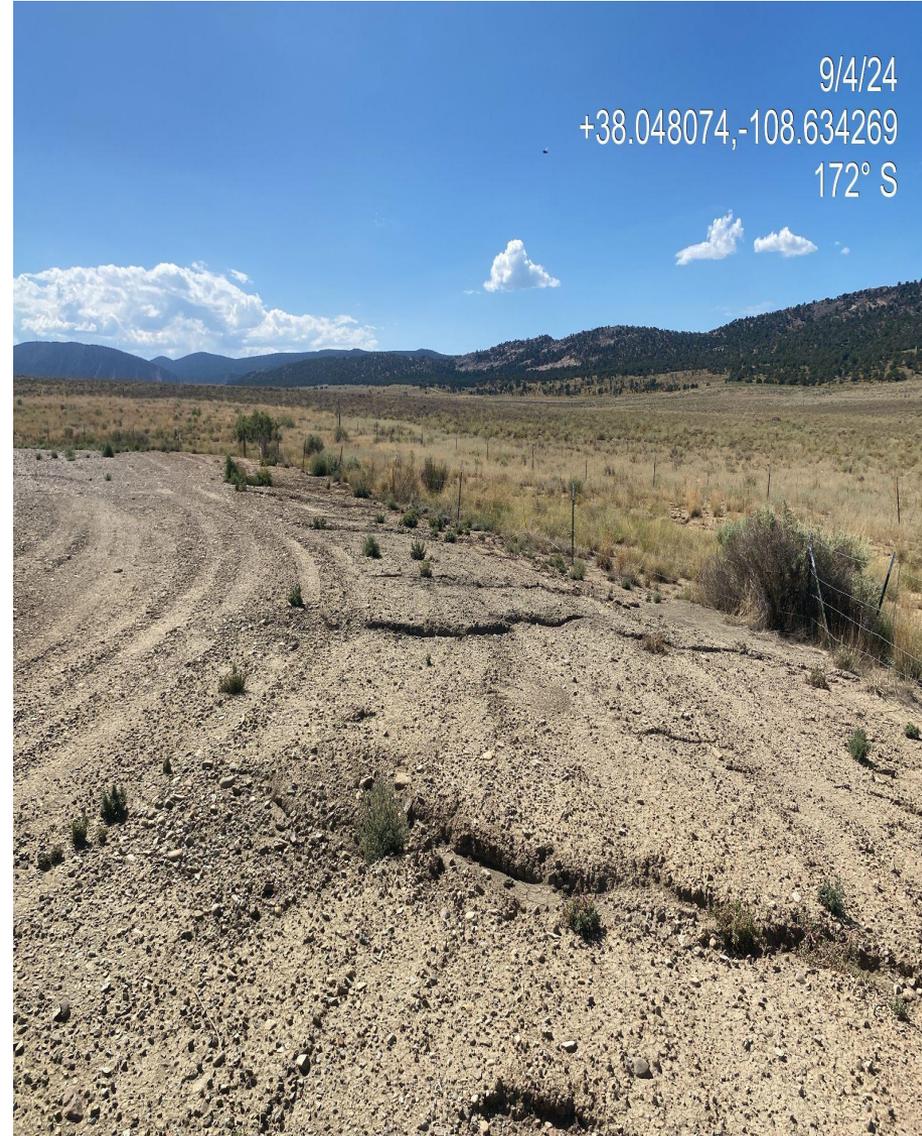
Photo 3. Several erosional channels observed in the southern portion of the disturbance. Stabilization/stormwater BMPs needed in this area.

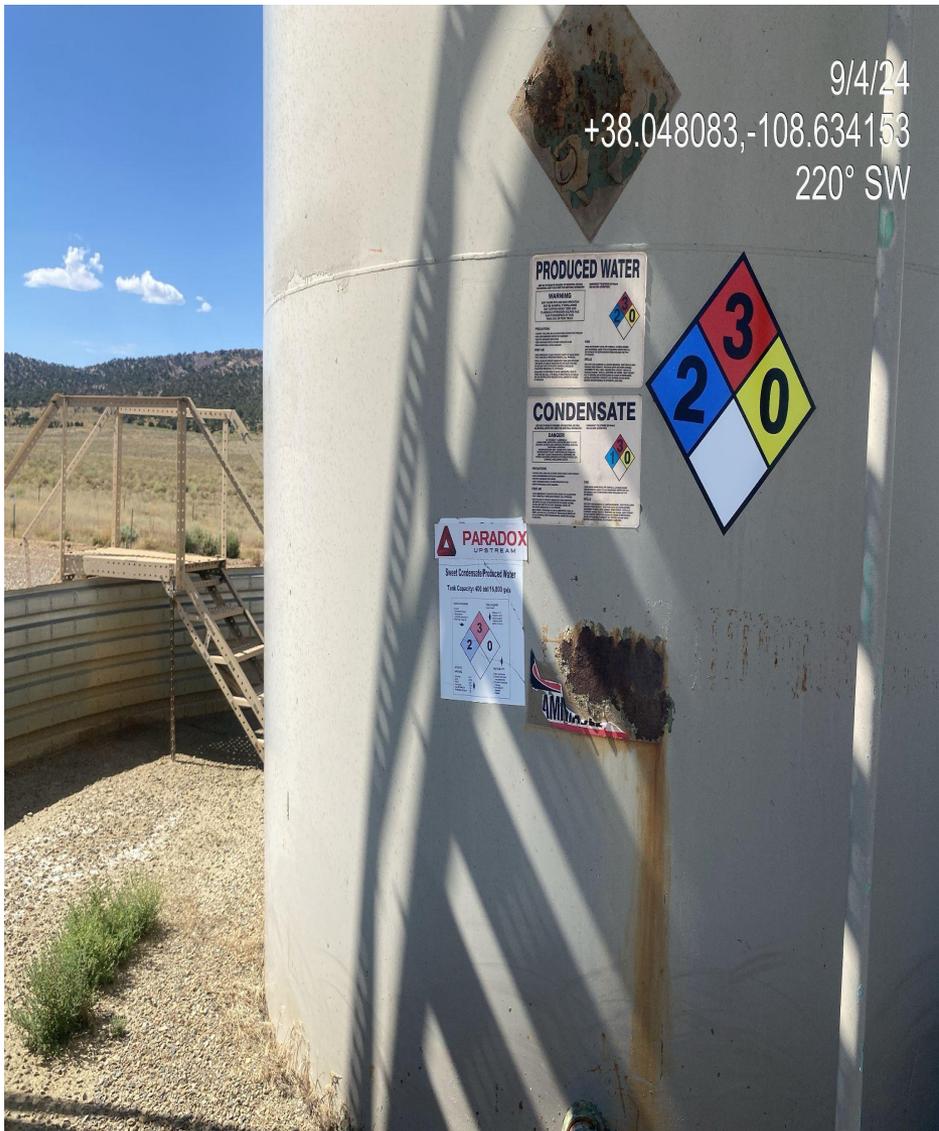
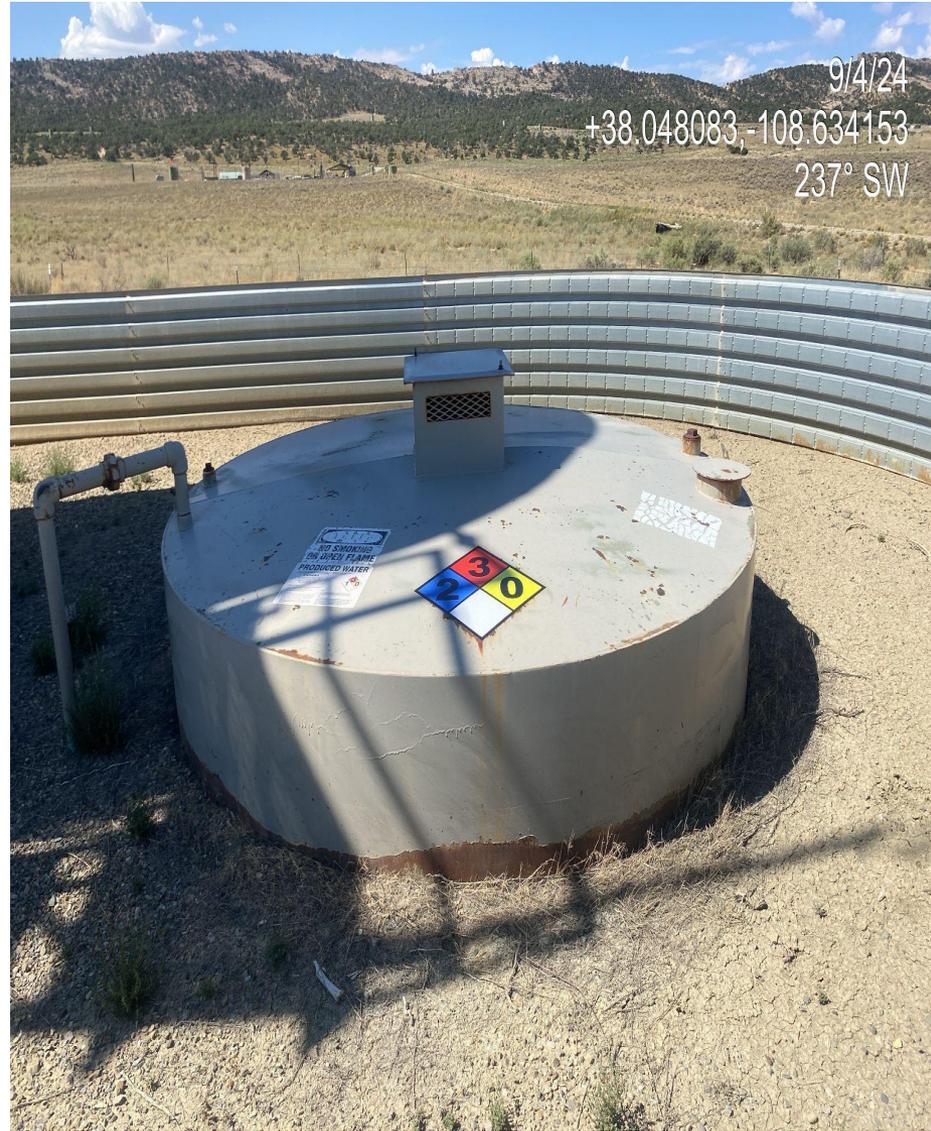
Photo 4. Signs at produced water tanks need to be updated. Per rule 605.g buying operator has 60 days from approved form 9 date to replace or update signs on location.

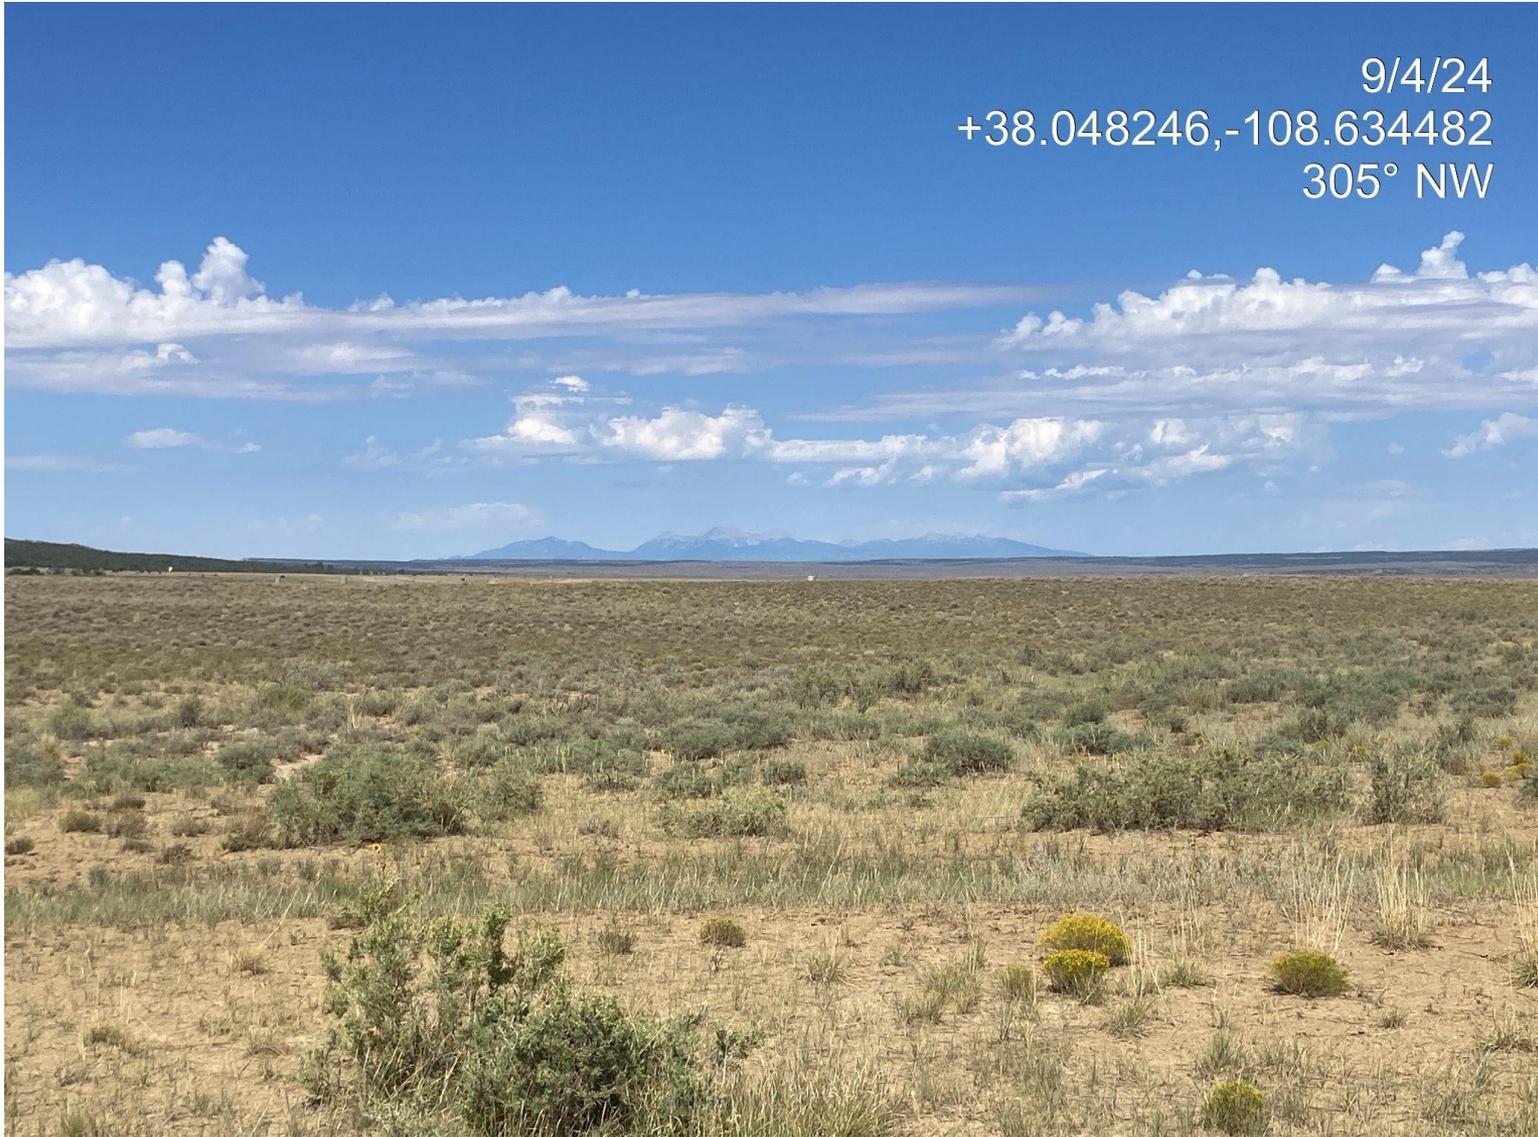
Photo 5. Reference area comprised of Black sage, Broom snakeweed, Fourwinged saltbrush and Western wheatgrass.
