# Inspection Photos

**Operator:** SWN PRODUCTION COMPANY LLC -  
10396

**Location ID:** 311776

**Inspection Doc:** 696206215

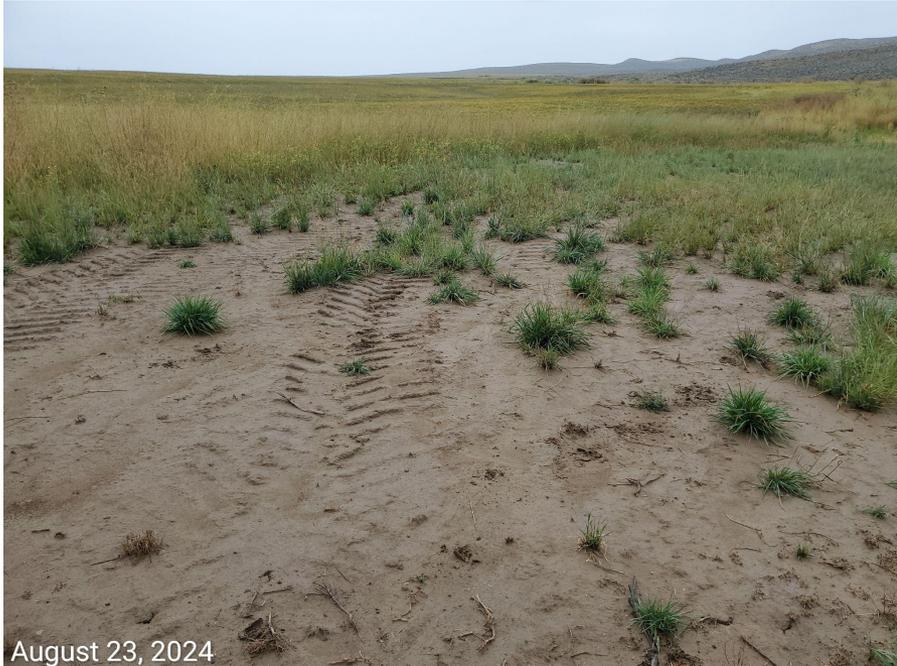
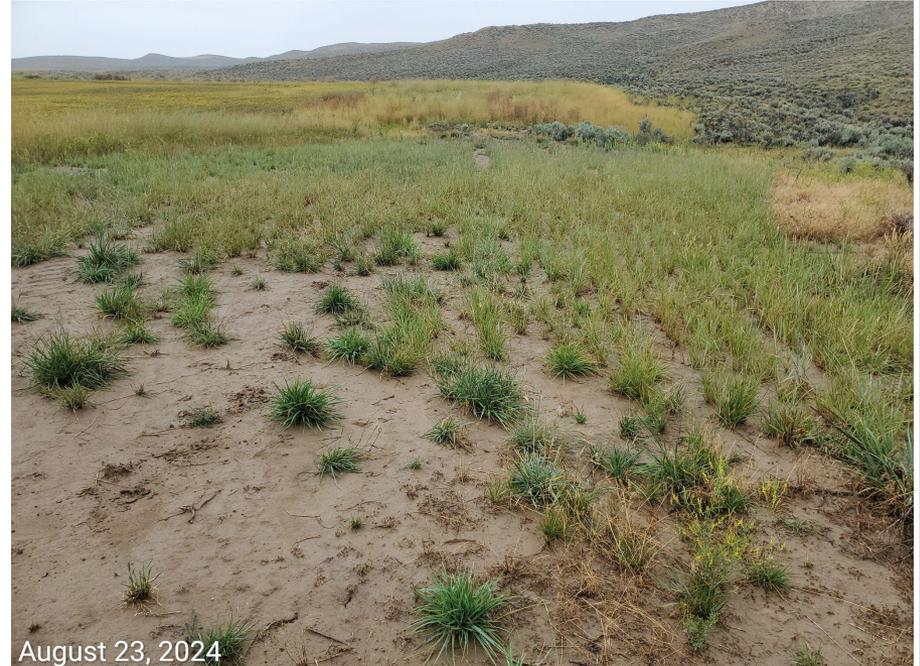
**Photo 1:** Photos taken from the southeast end of the Location, facing northwest and north. Location has been reclaimed half cropland, half noncropland. Species planted are predominantly introduced species not reflective of perennial species in the reference. Areas of the Location remain bare, and access road has not been reclaimed.

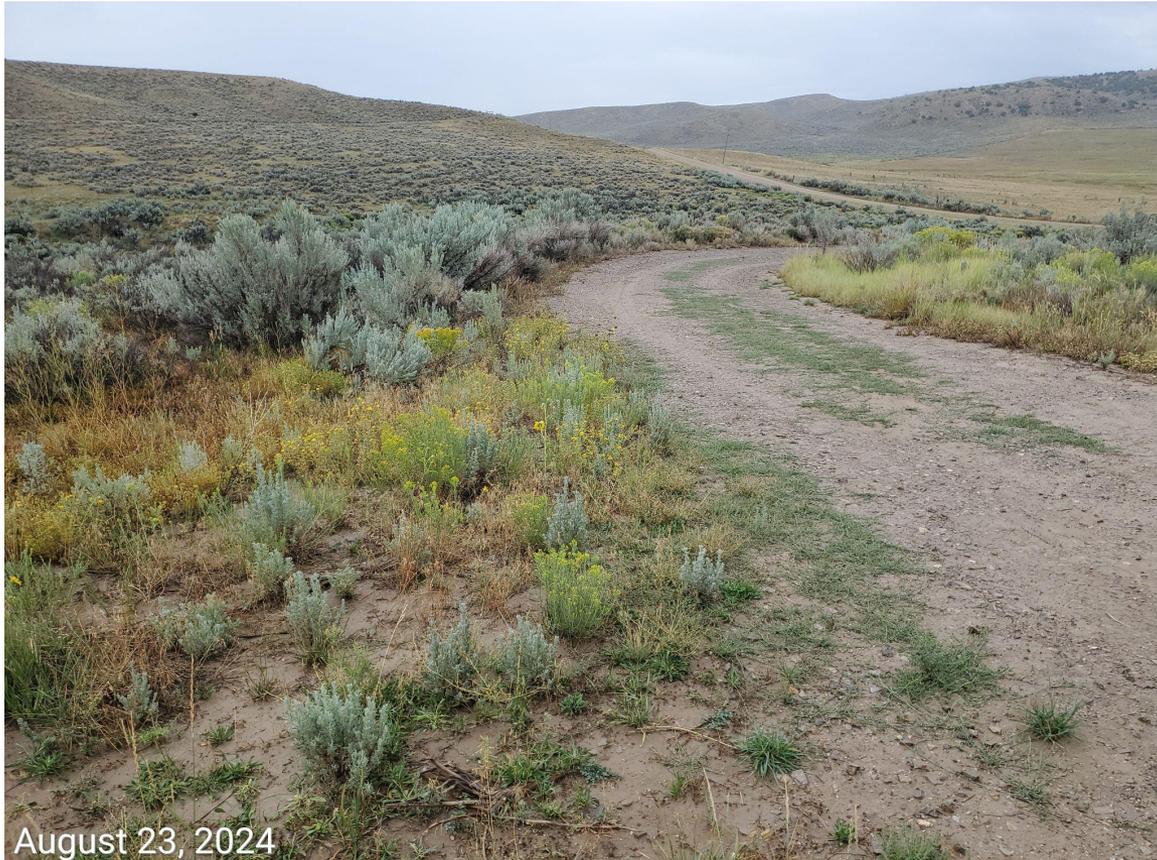
**Photo 2:** Photo example showing access road to the Location has not been reclaimed

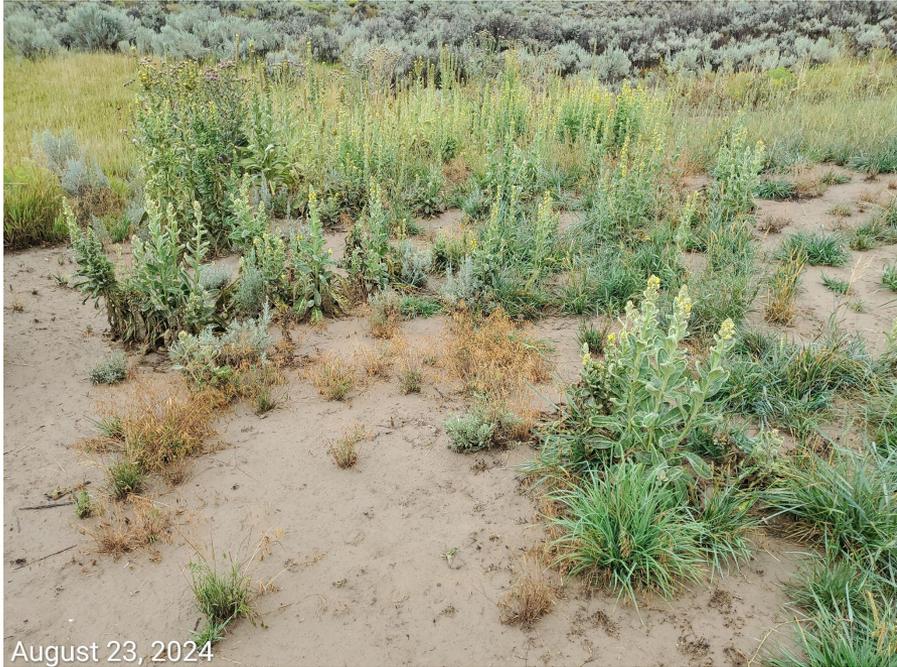
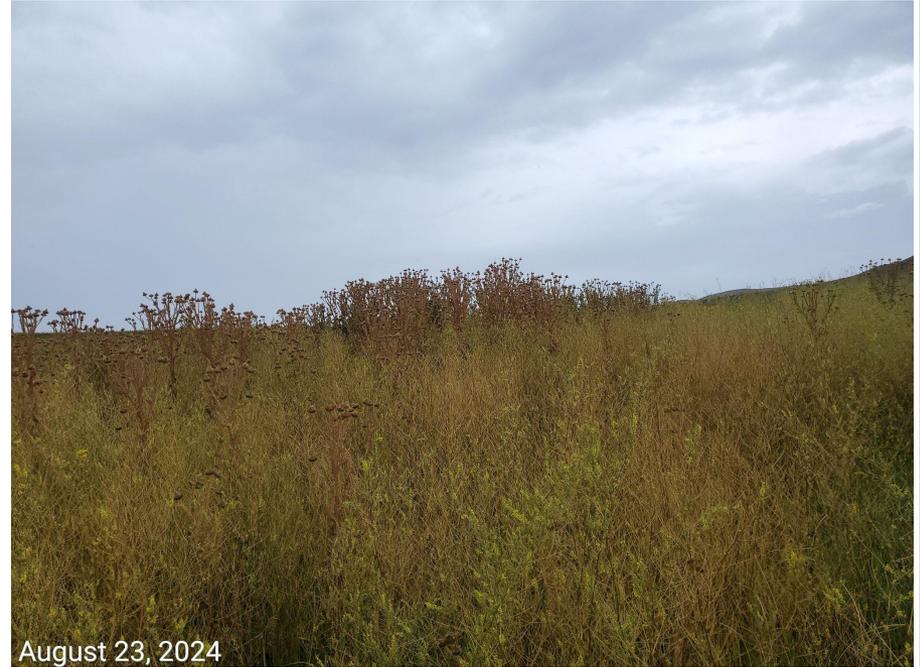
**Photo 3:** Photos 3-4 example of Undesirable and Noxious Plant species established on the Location. Weeds including Noxious species such as Common Mullein, Scotch thistle, Knapweed, Canada thistle. Areas of the Location also have not achieved uniform desirable vegetative establishment. Biennial species such as Sweet clover is dominant within northern areas of the reclamation (Photo right).

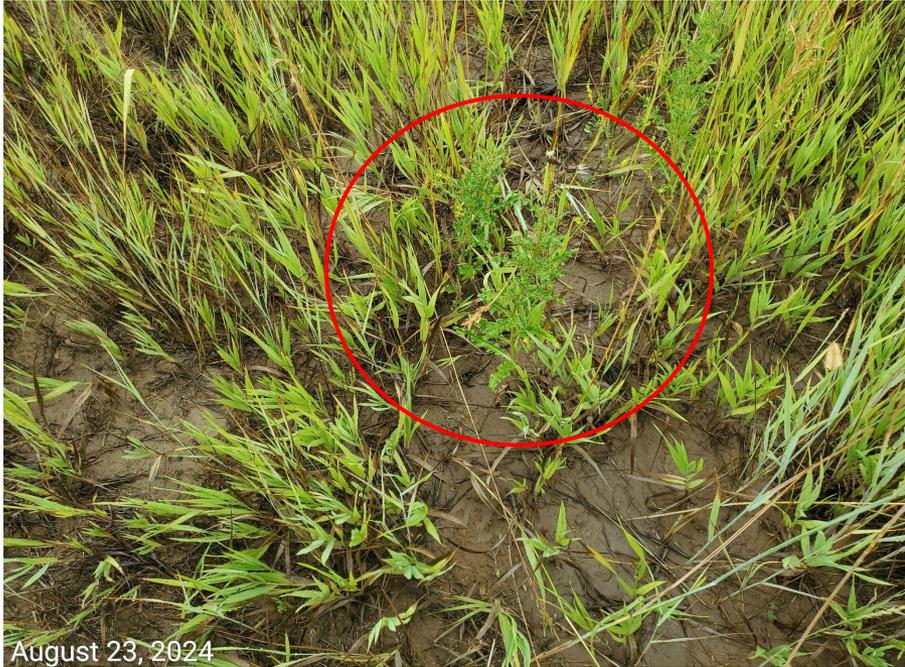
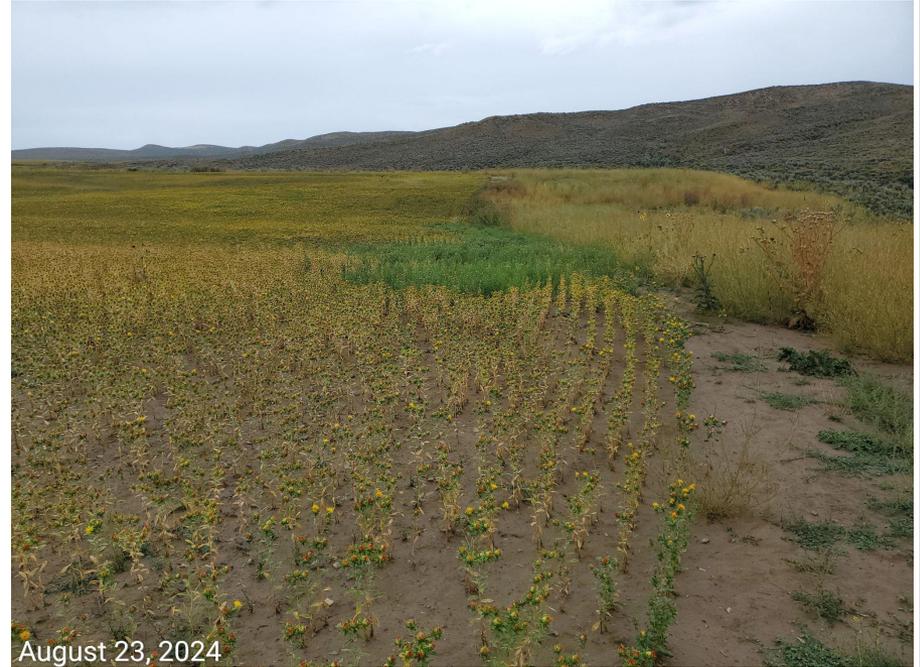
**Photo 4:** See comments under photo 3. Photo left Canada thistle. Photo right also shows Location has been reclaimed half cropland, half noncropland

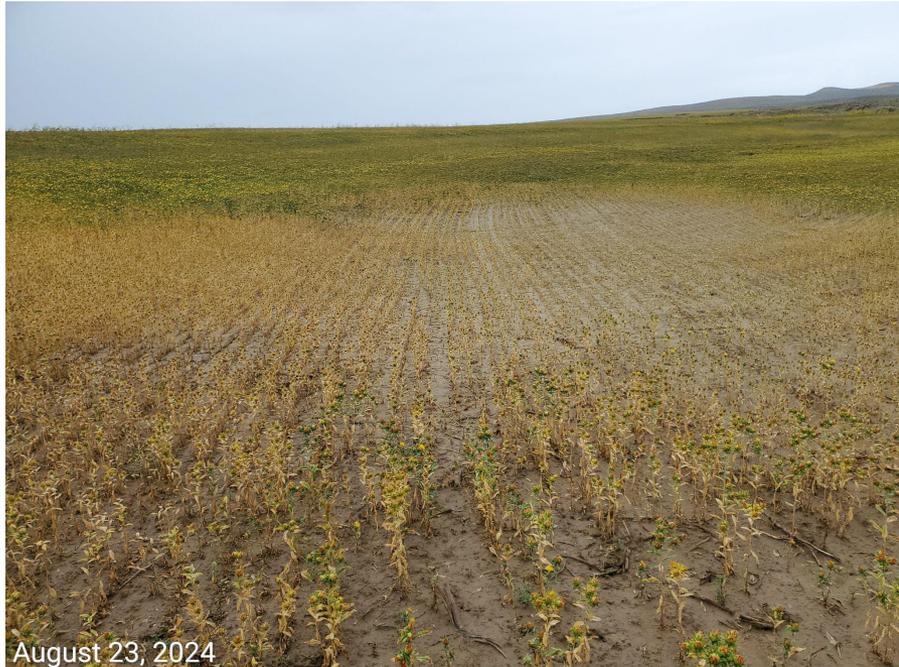
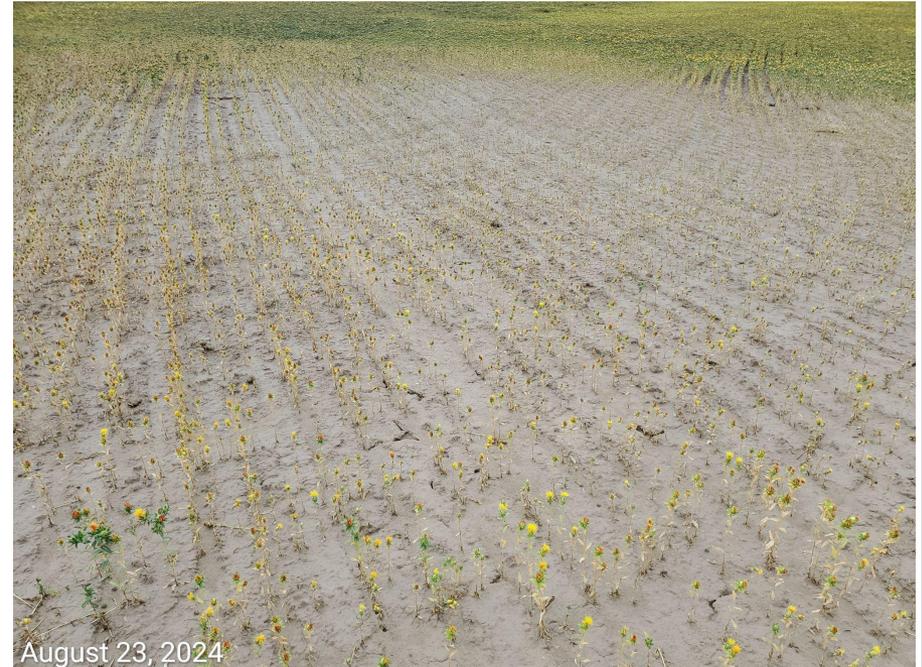
**Photo 5:** Photos taken from the western half of the Location. Crop at time of inspection Safflower. Crop vegetative establishment on the well location/disturbance area is not reflective of the reference area. There are areas within the cropland areas of the Location where issues appear to exist that are hindering the reclamation of the location; crop establishment is thin, growth is stunted, and not reflective of crop established within adjacent undisturbed areas; compaction, remediation, or other issues may still exist within these areas.

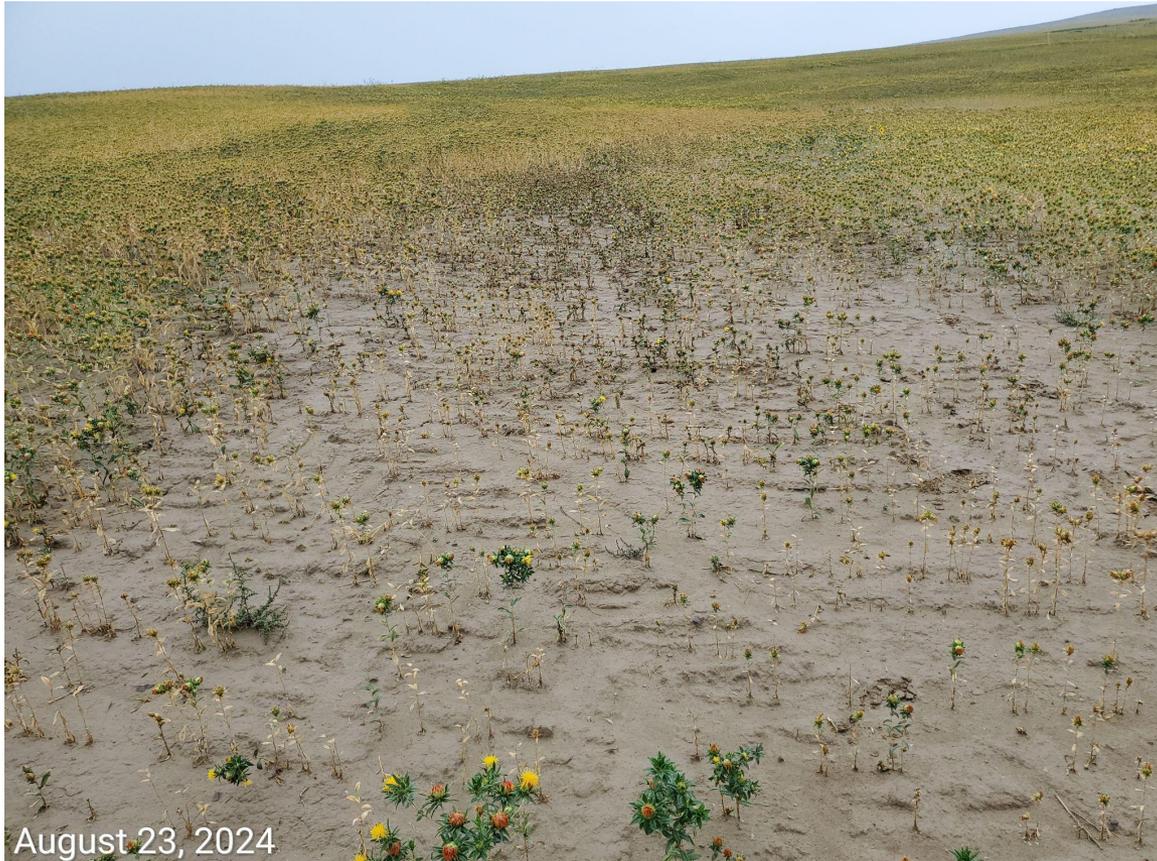
**Photo 6:** See comments under photo 5.

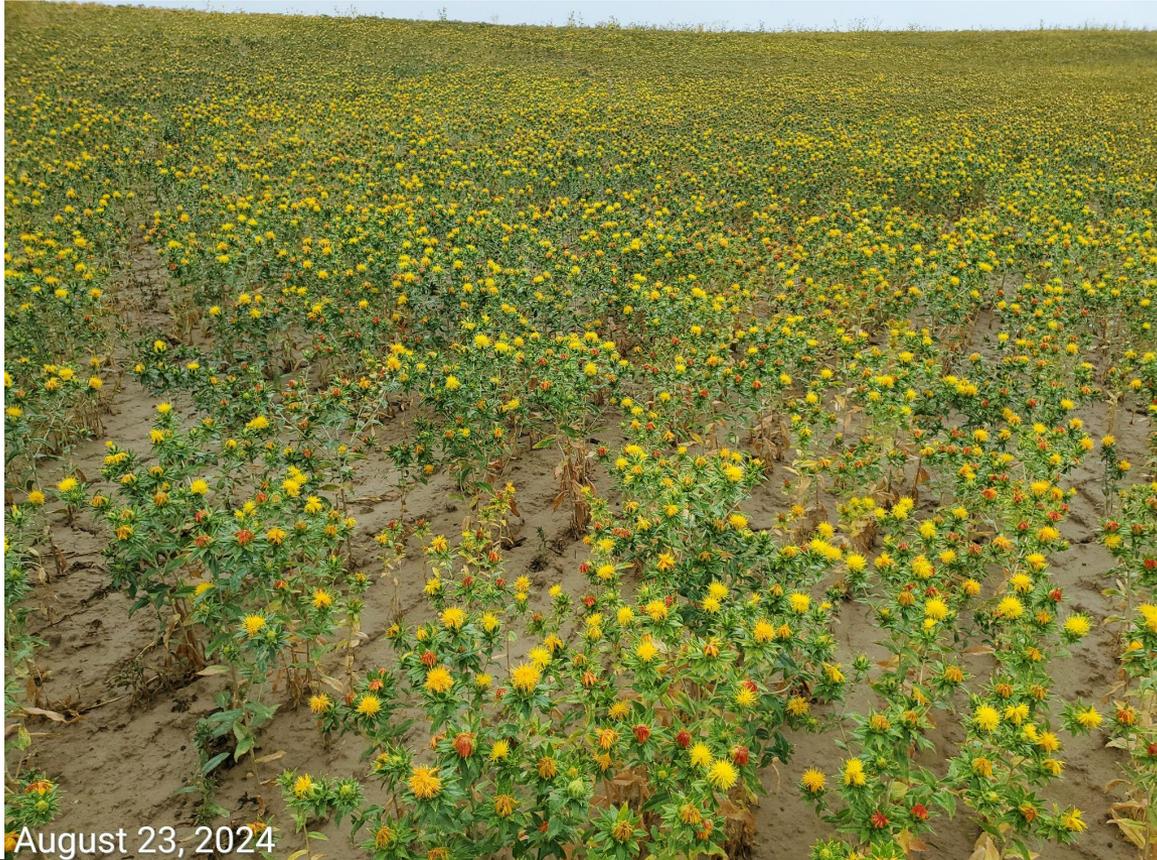
**Photo 7:** Photo taken from the reference cropland areas west of the Location. Photo to compare crop establishment between reference and disturbance areas
