Inspection Photos

ID: 478058

Operator: OGRIS OPERATING LLC

Inspection Date: 9/16/2024

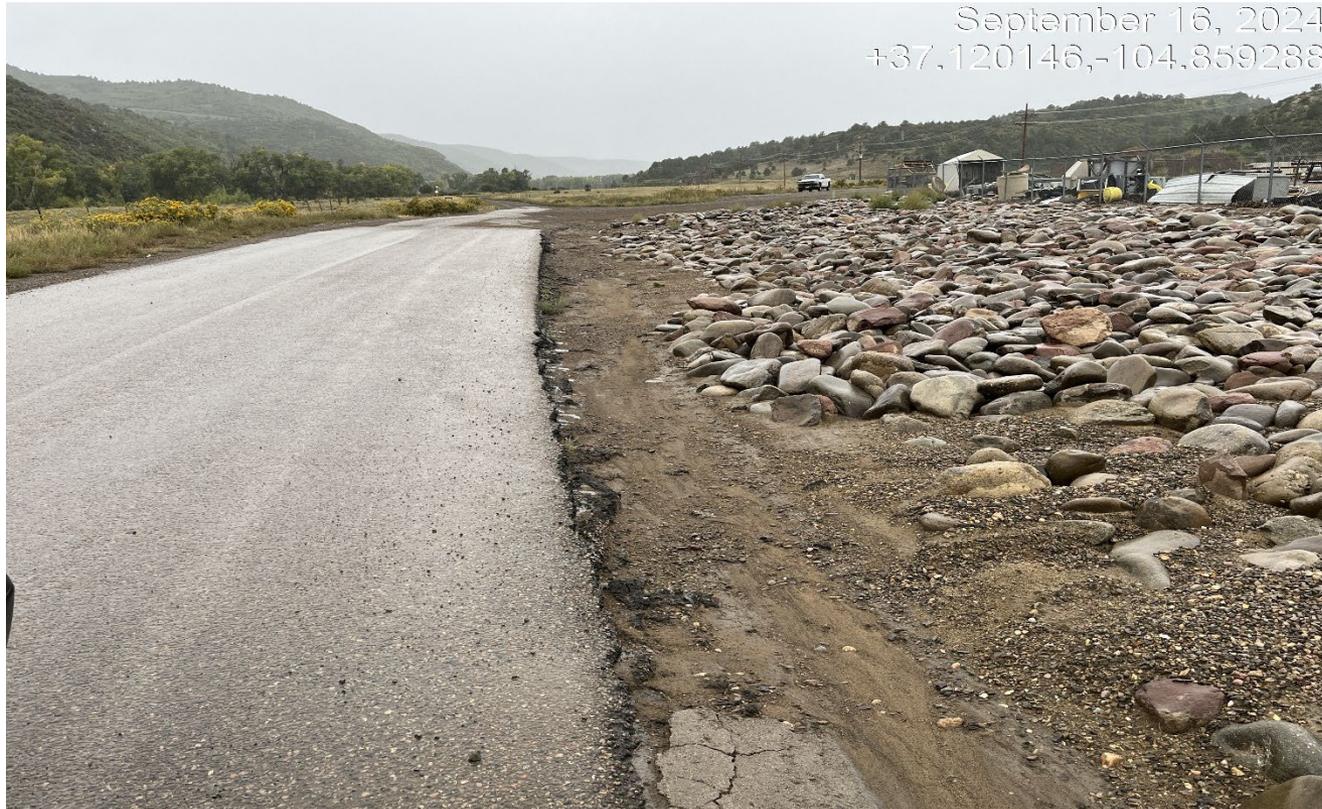
Photo 1. Facing southwest along the main road to the production facility. The sediment along the roadside has been cleaned out to allow storwater drainage to the culvert.

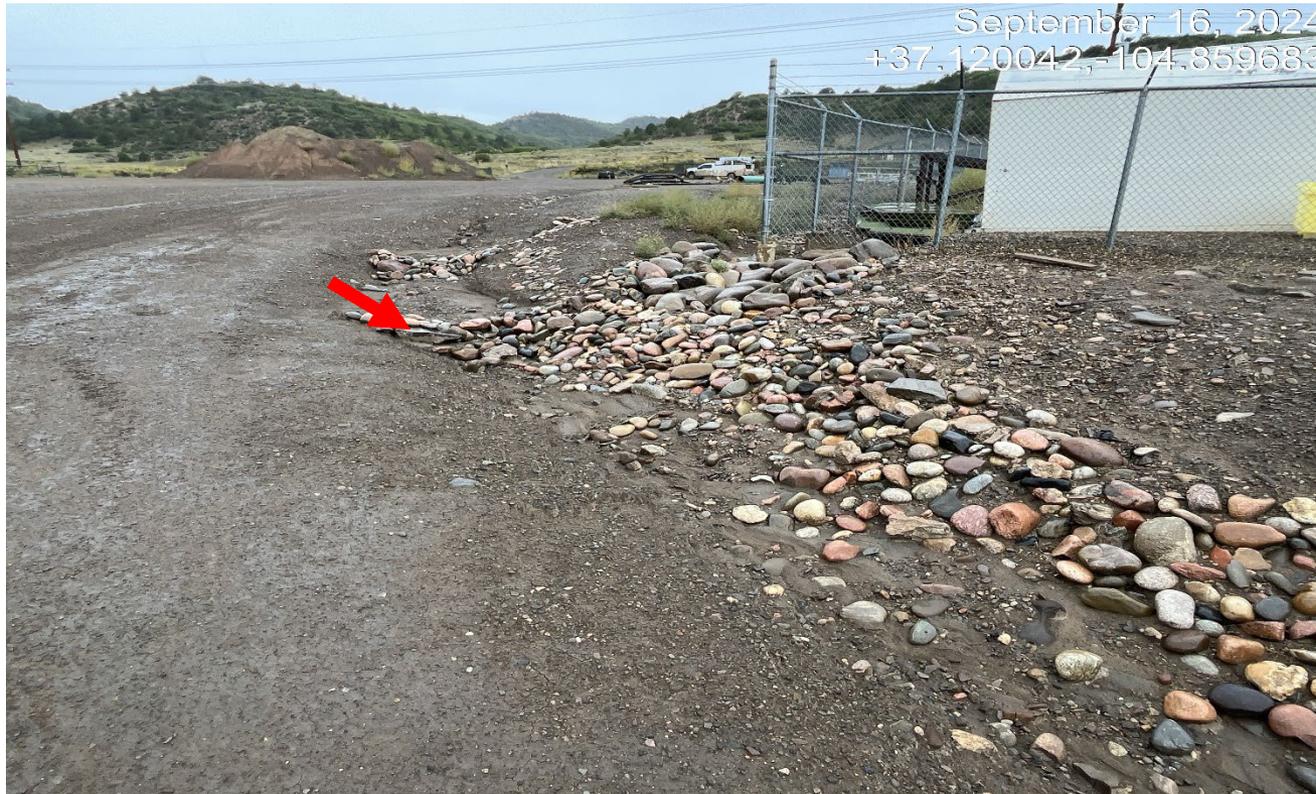
Photo 2. Facing west at the road to the production facility. There are rock check dams that have already filled in with sediment and need to be cleaned out. A larger sediment catch may be better to prevent sediment transport onto the road. Also, round rock does not lock together and can easily be displaced.

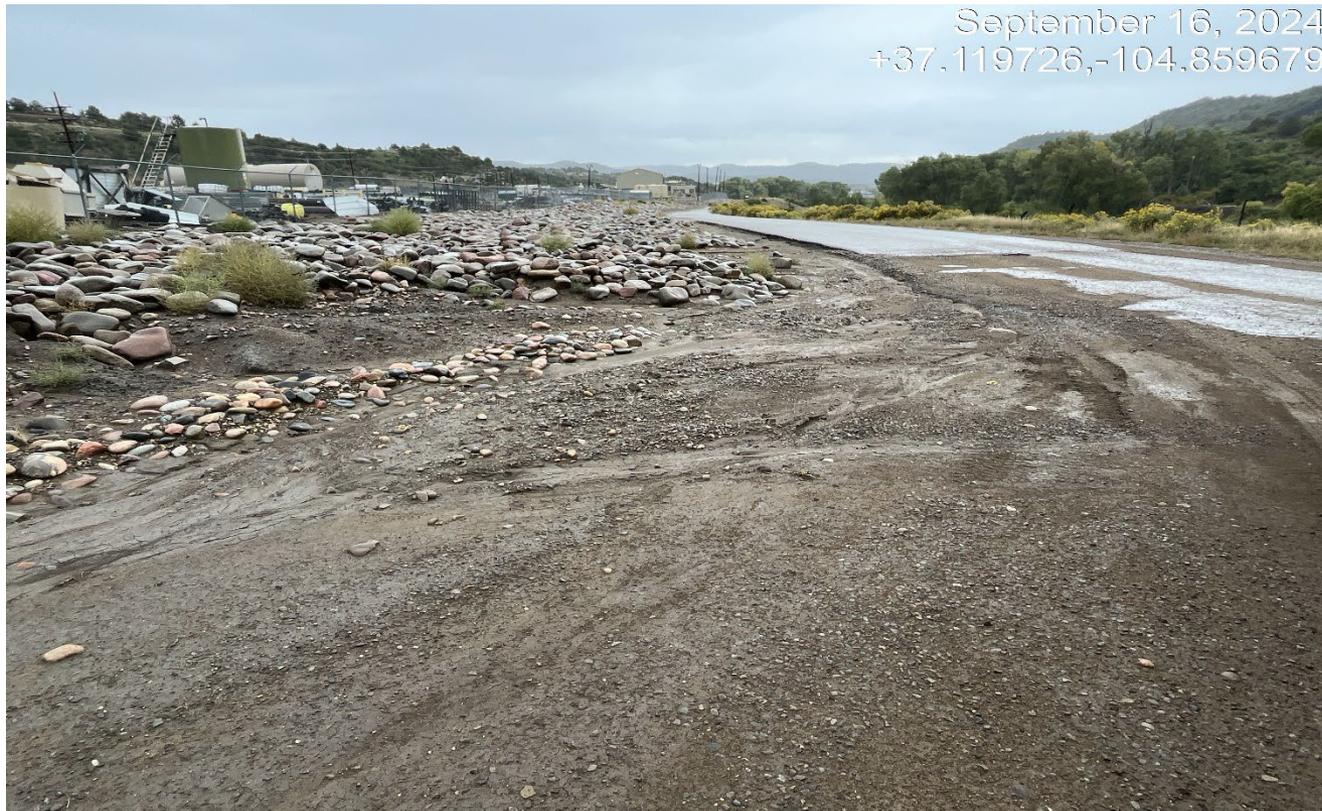
Photo 3. Facing back toward the main public road. Sediment needs to be cleaned off the road and vehicle tracking controls need to be implemented.

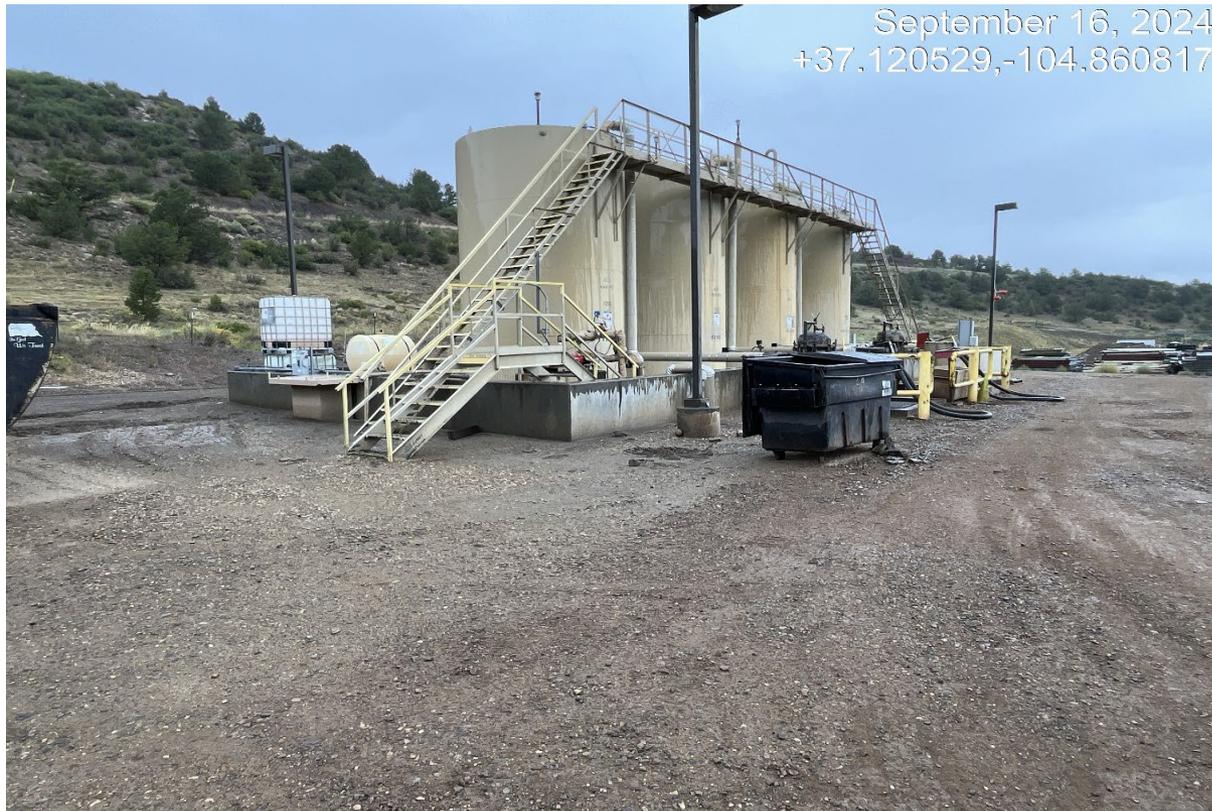
Photo 4. Facing northwest toward the tank battery.

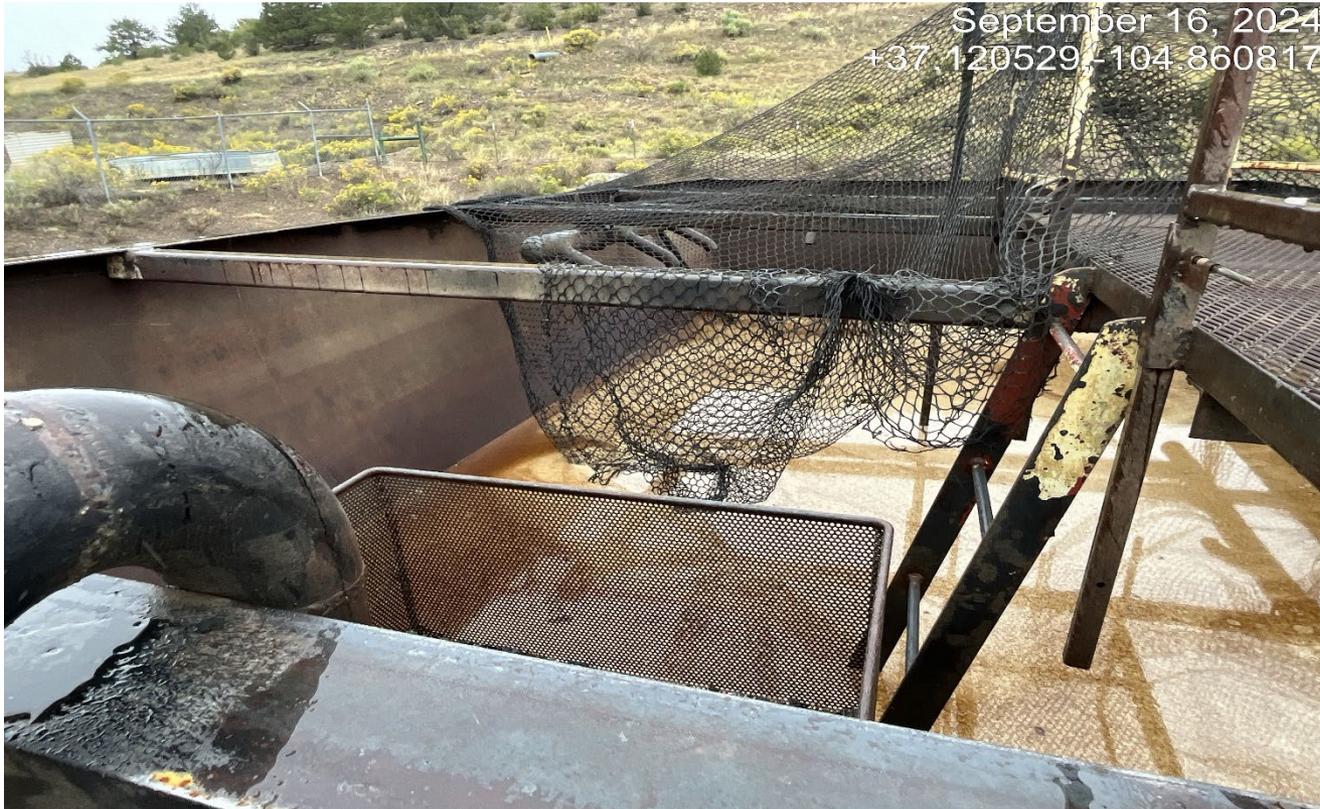
Photo 5. The netting on the open top tank does not cover the entire open top tank. Previous CA was not completed.

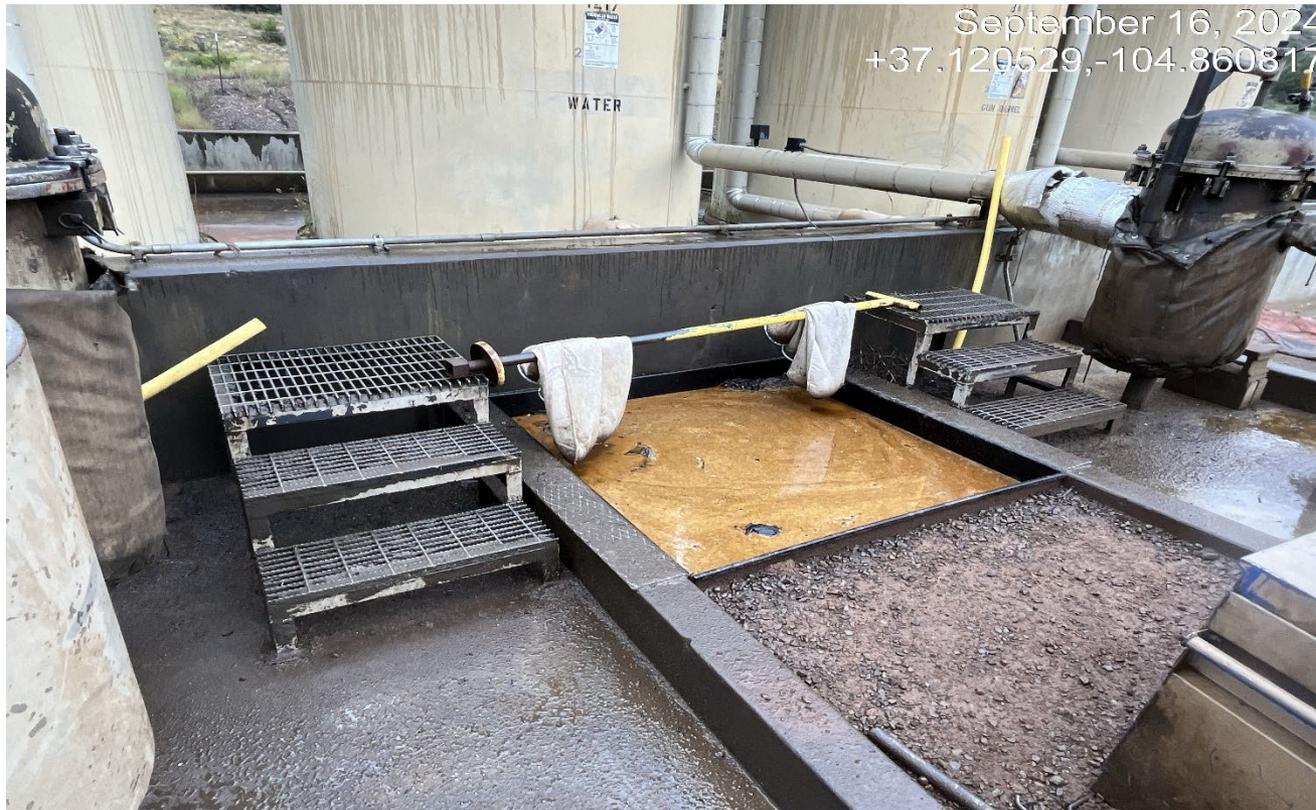
Photo 6. There is oily fluids in the secondary containment. Additionally netting must be installed to prevent wildlife entry. Previous CA was not completed.

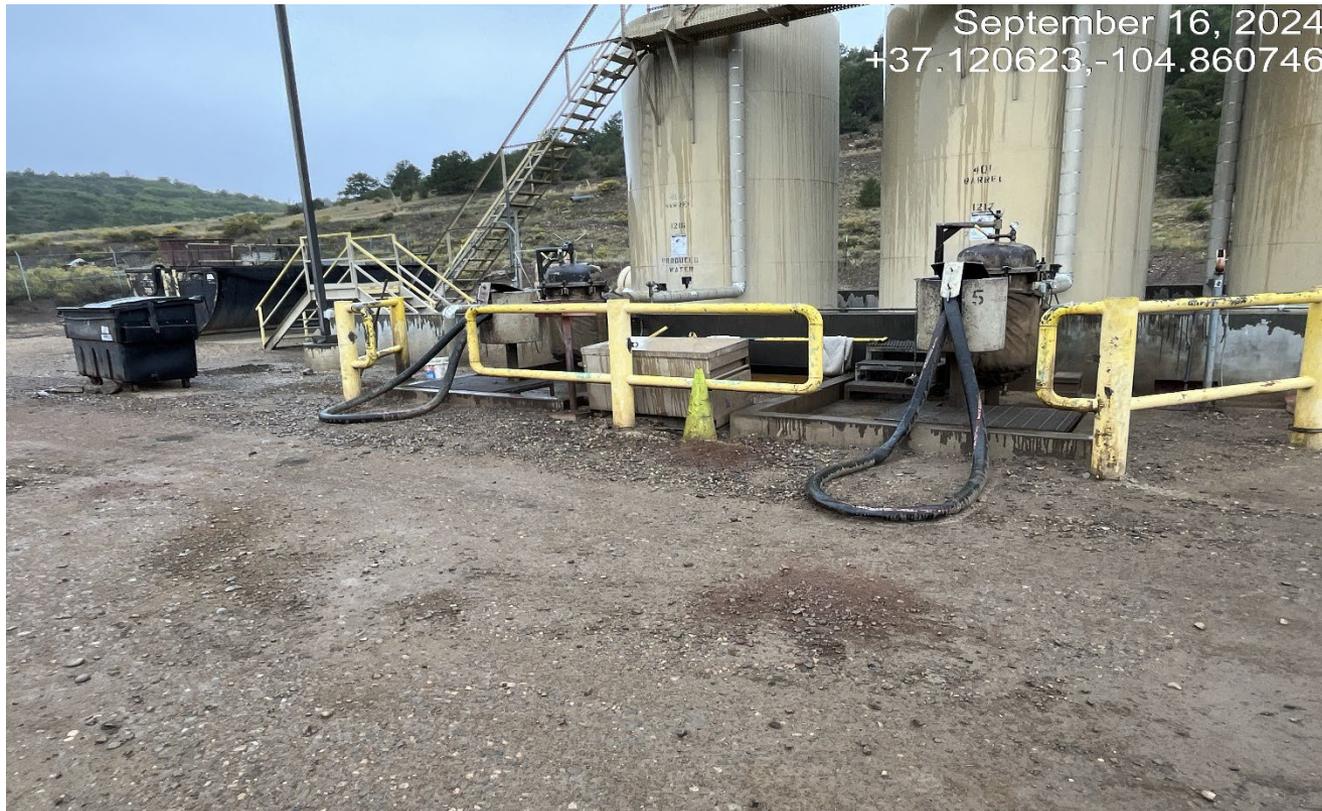
Photo 7. Facing toward the tank battery. There still appears to be stained soils where trucks connect to the hoses.
