Operator: XOG

Location Name: Island Grove Directional 1

Loc ID: 423393

Inspection: 708201294

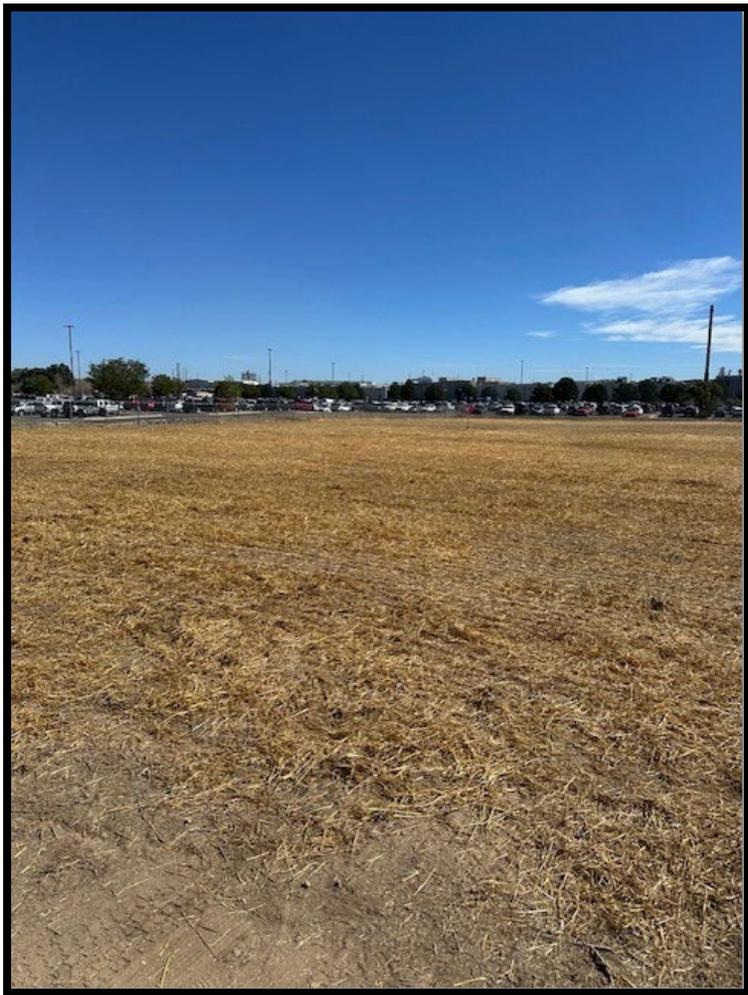
Exhibit A

CA: This location does not comply with Rule 1004. During this inspection, it was observed that the former access road does not appear to have been reclaimed with the presence of road base material and the reclaimed location is not progressing towards vegetative standards. Colorado List C Noxious Weeds (Cheatgrass and field bindweed), and undesirable vegetation (kochia) predominate the reclaimed areas. Additional reclamation activities are required. Refer to attached inspection photos. Comply with Rule 1004. Reseed disturbance areas using a seed mixture requested by the surface owner, or a mixture prescribed by the local county NRCS. Establish vegetation with total perennial, non-invasive uniform plant cover of at least eighty (80) percent of reference area levels. Ensure erosion controls are implemented to stabilize the seeded soil. Operator shall continue to monitor and manage this site until the location meets Rule 1004 standards, including stormwater and weed management.

CA Resolution: Operator has reported that the Fall seeding has now been completed, and location is in compliance with Rule 1004.
