Inspection Photos

Operator: CHEVRON USA INC #16700

Location ID: 323800

Inspection Doc: 696206238

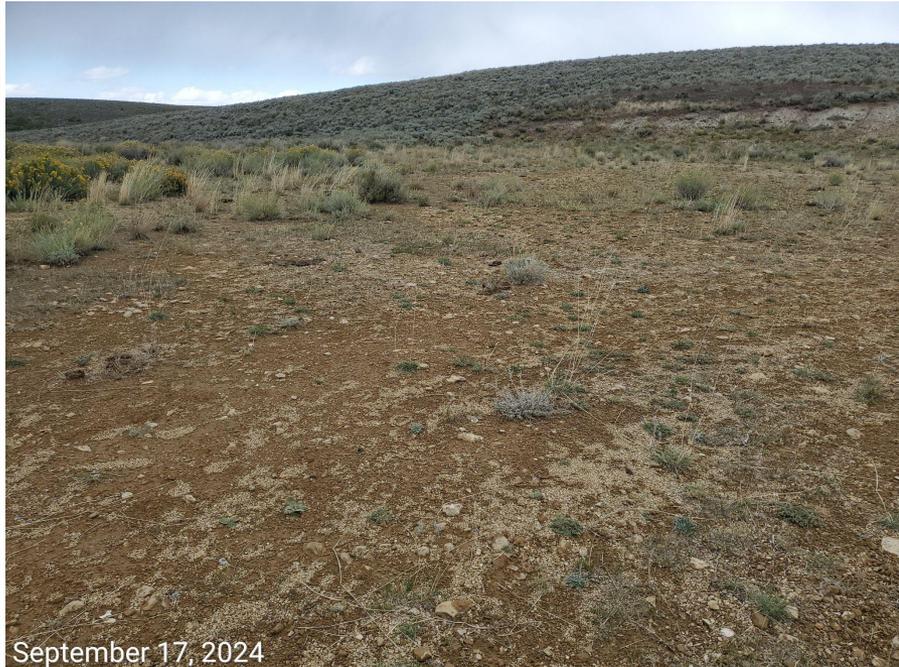
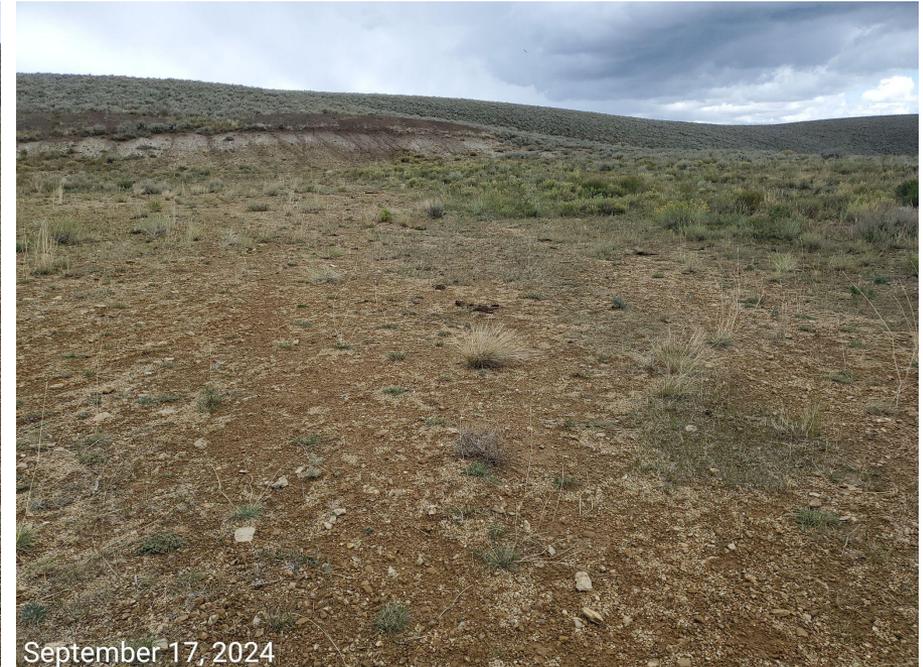
Photo 1: Photos taken from the south end of the Location, facing northwest and north east. Final reclamation including, but not limited to, compaction alleviation, recontouring/regrading, replacement of topsoil, and revegetation activities have not been performed in accordance with 1004 Requirements.

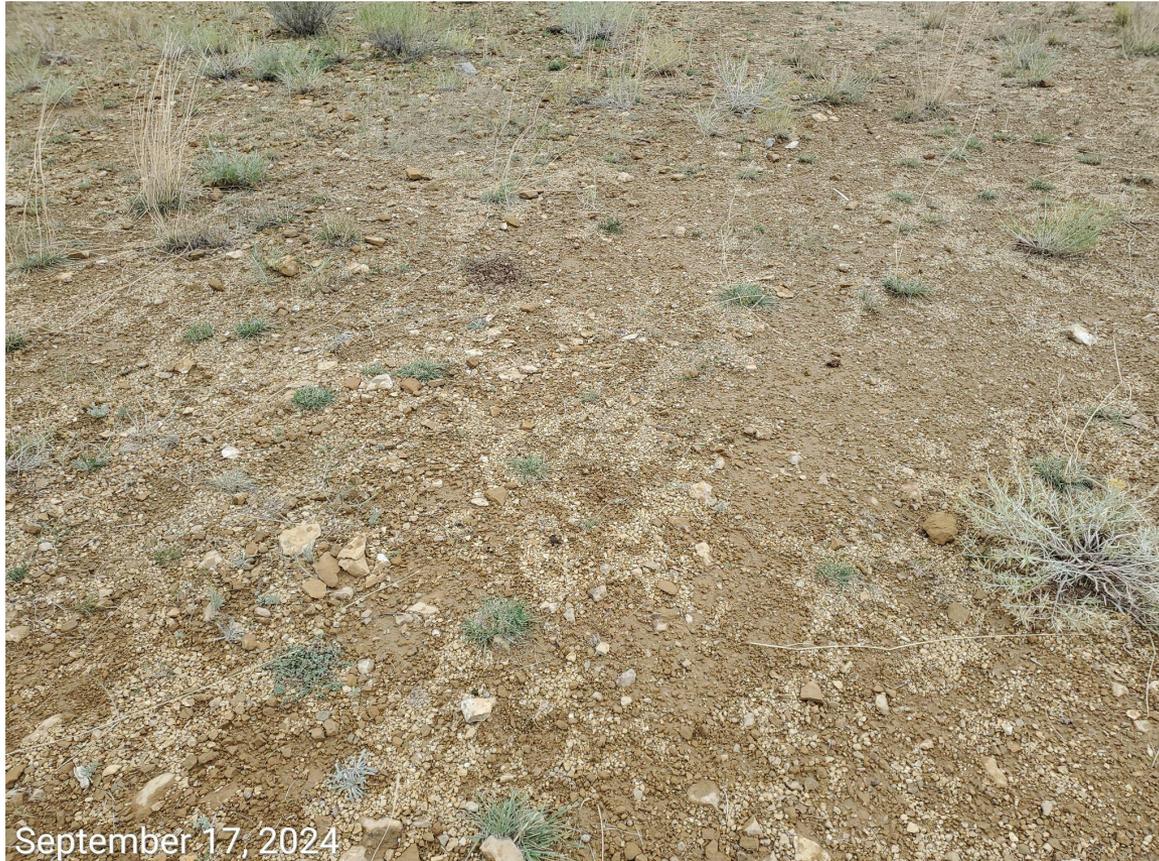
Photo 2: Pad surface. See comments under photo 1.

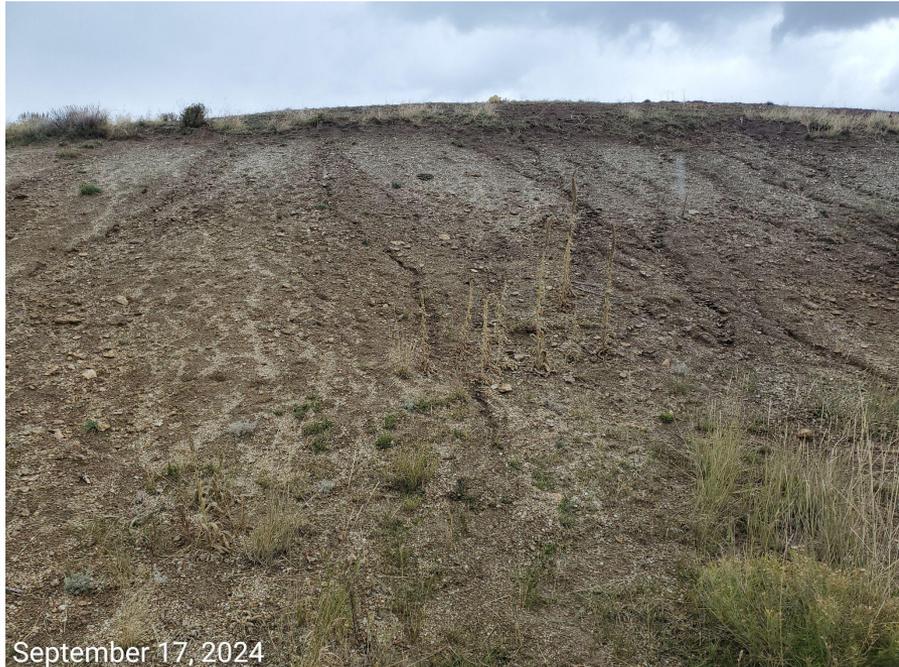
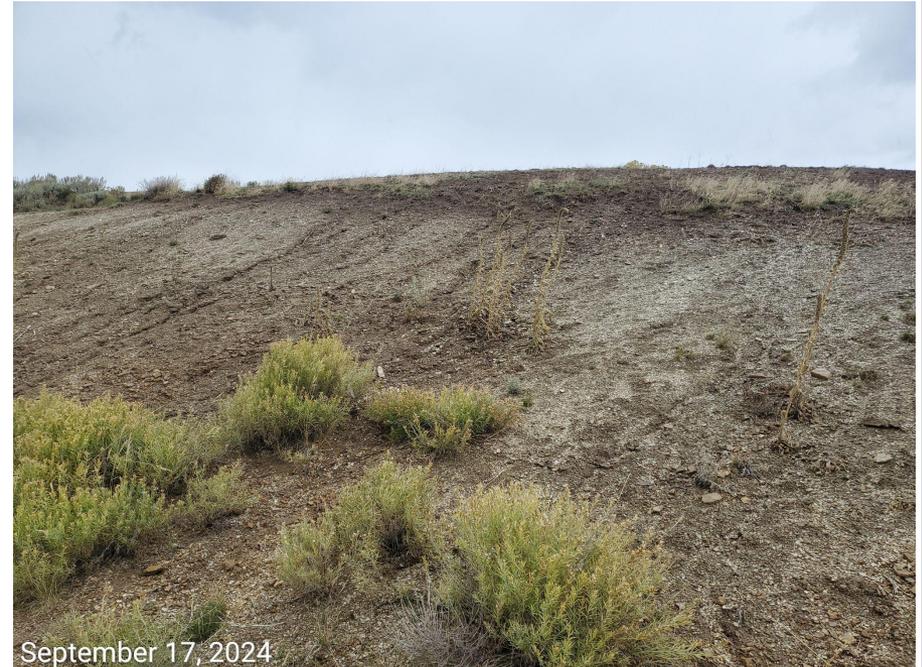
Photo 3: Photos taken from the cut slopes of the Location. Weeds have continued to establish on the Location. Erosion degradation also evident.

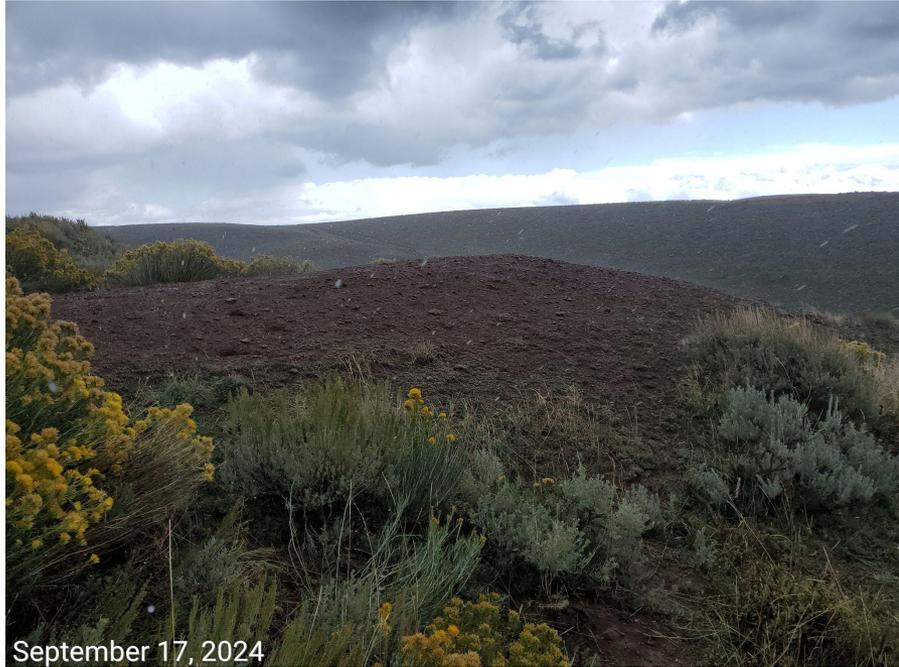
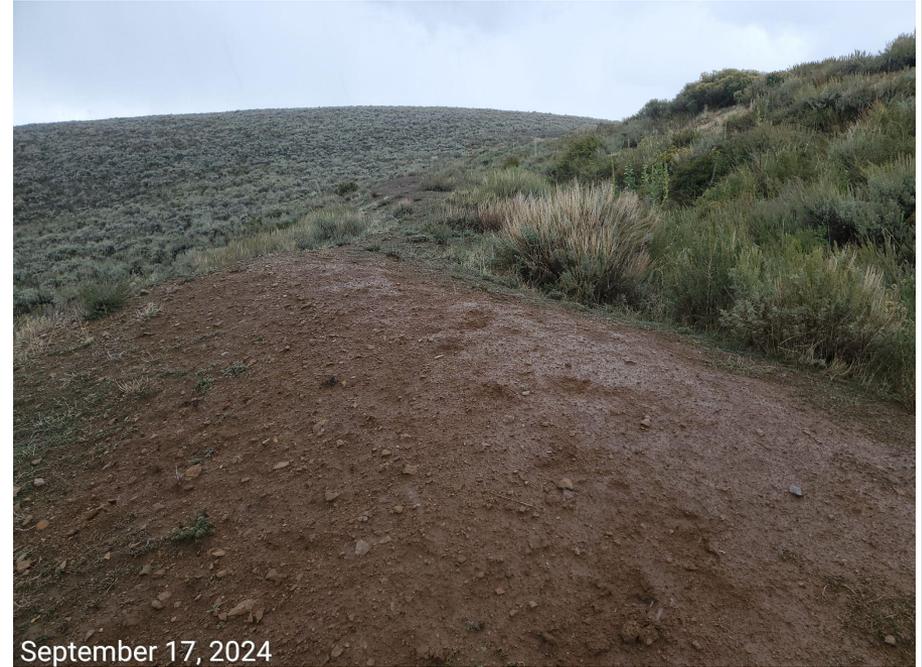
Photo 4: Photos taken from the southeast, and west ends of the Location. Photos show topsoil remains stockpiled, and has not been replaced; topsoil also remains predominantly bare.

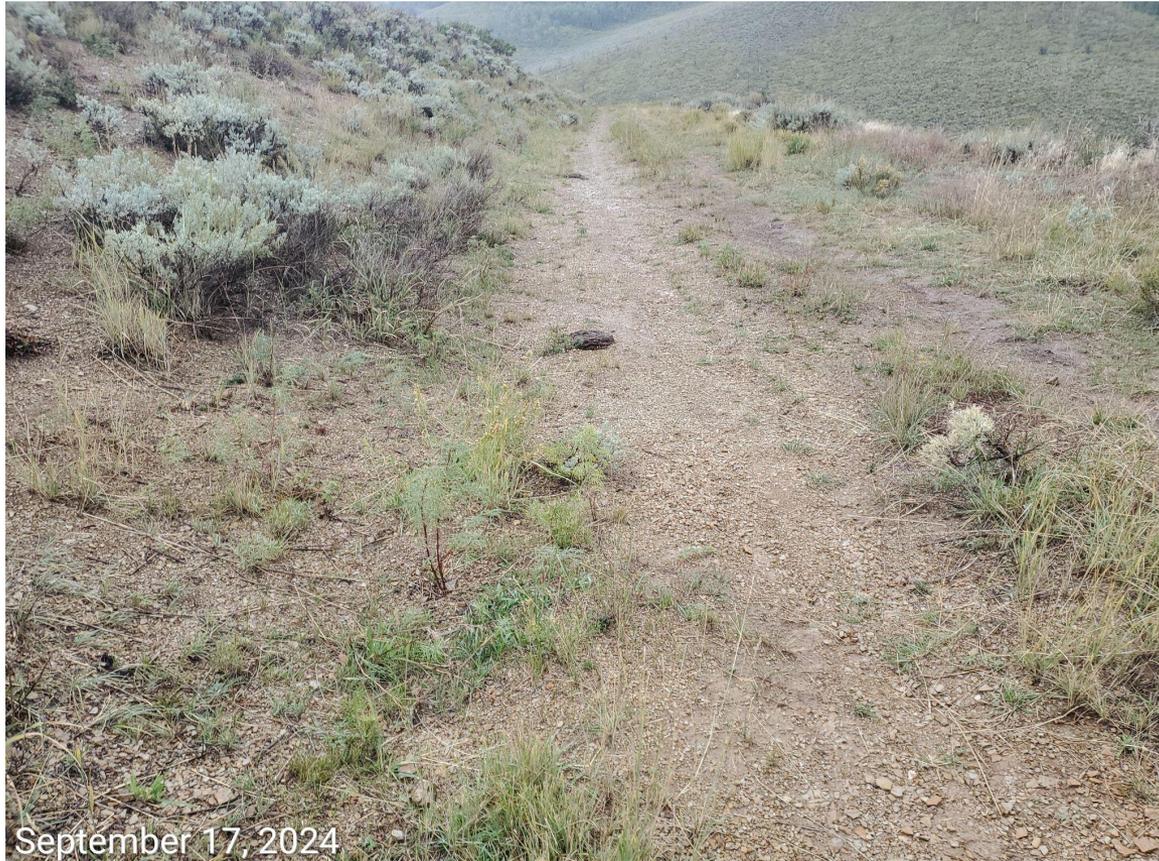
Photo 5: Photo examples showing access road has not been reclaimed.
