Inspection Photos

Operator: Simcoe LLC - 10749

Location ID: 325839

Inspection Photos
Location Name: Burkett A1
Location ID: 325839

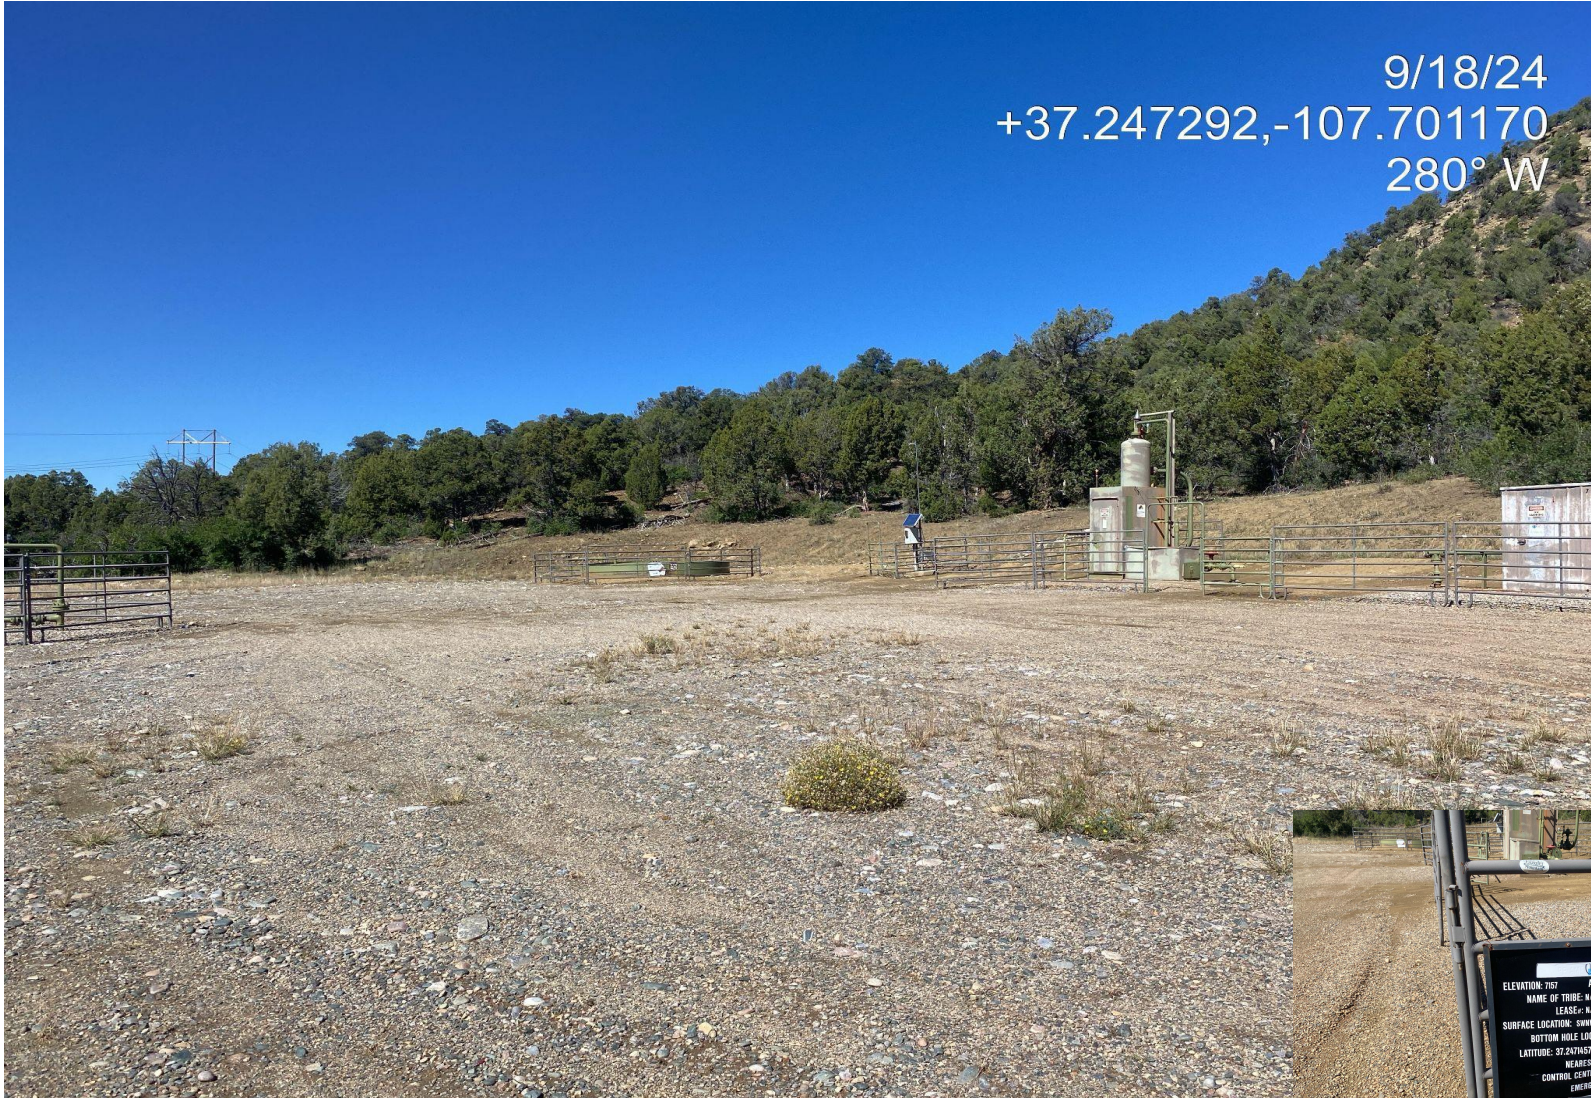
Photo 1. View of the well pad taken from the access point facing center.

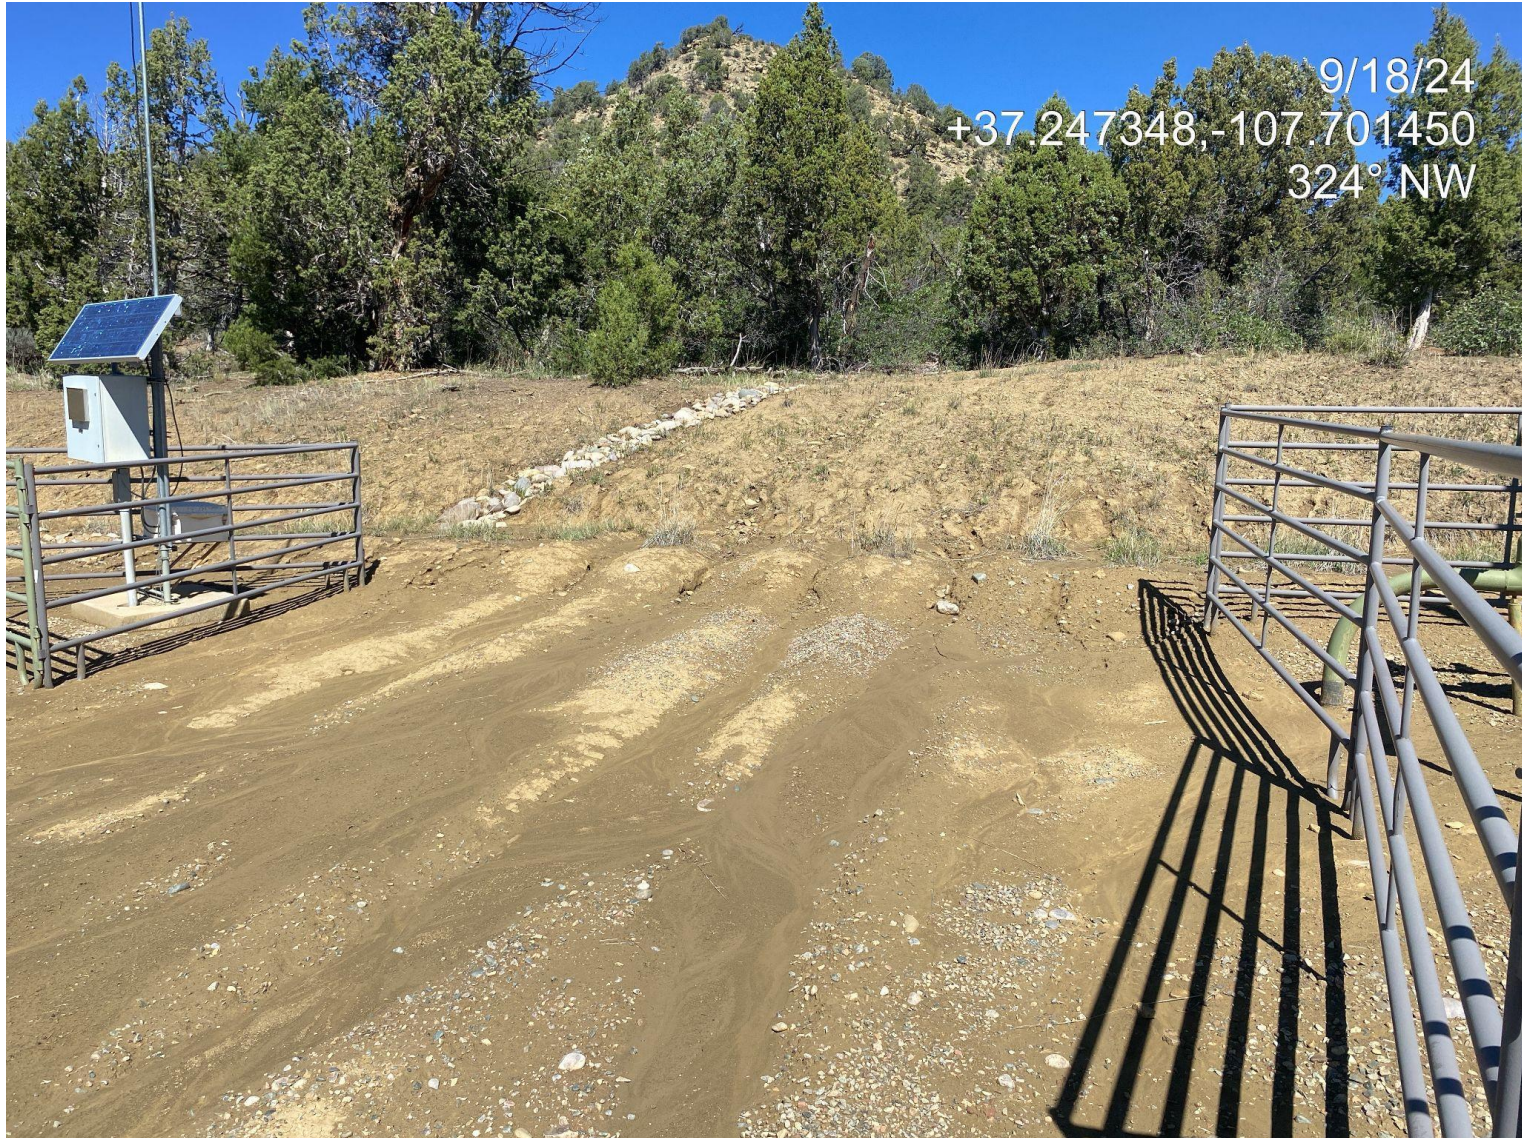
Photo 2. View of active erosion and sediment transport occurring on the northern edge of the active pad. Stormwater BMPs are needed in this area.

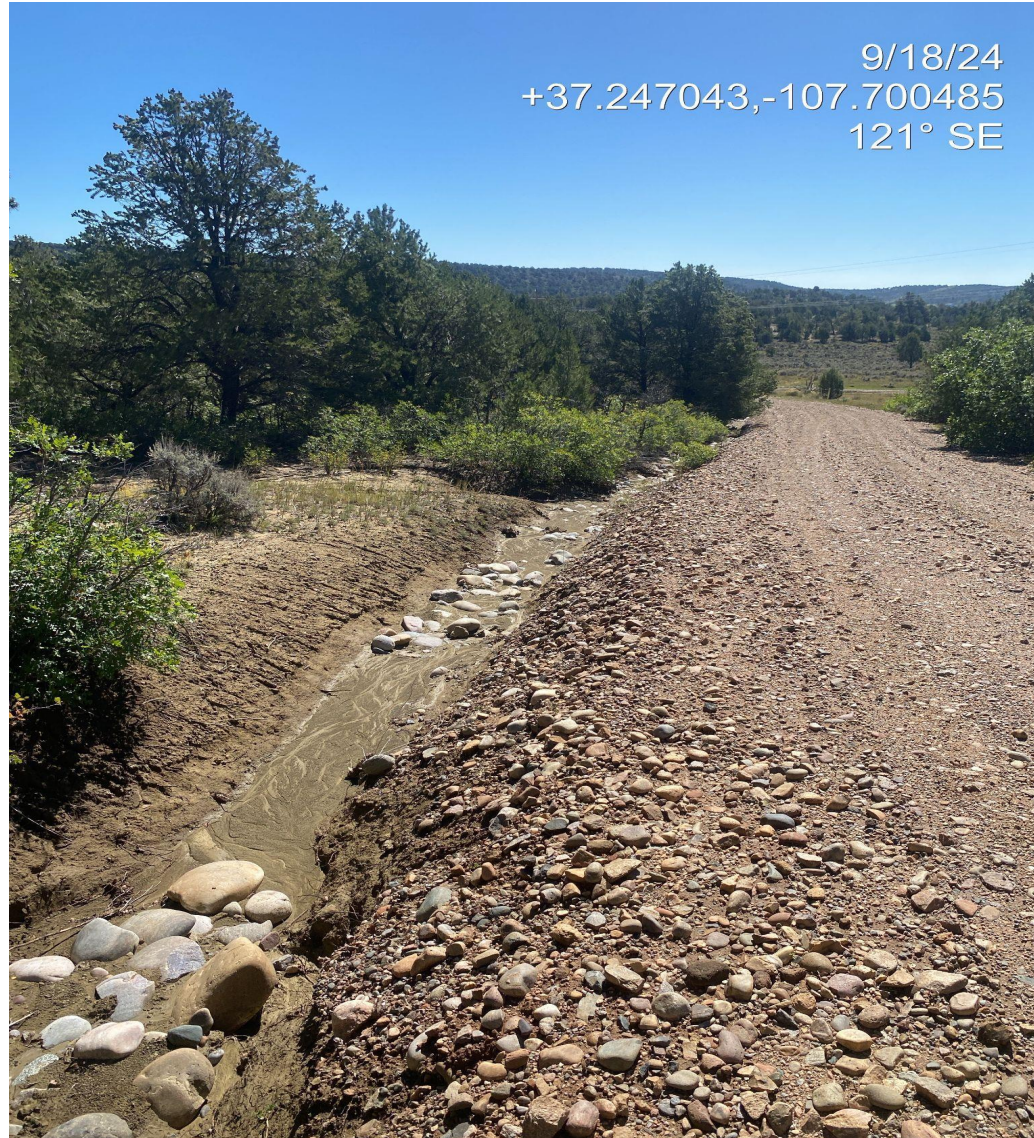
Photo 3. View of check dams along access road that are filled with sediment and no longer functioning.

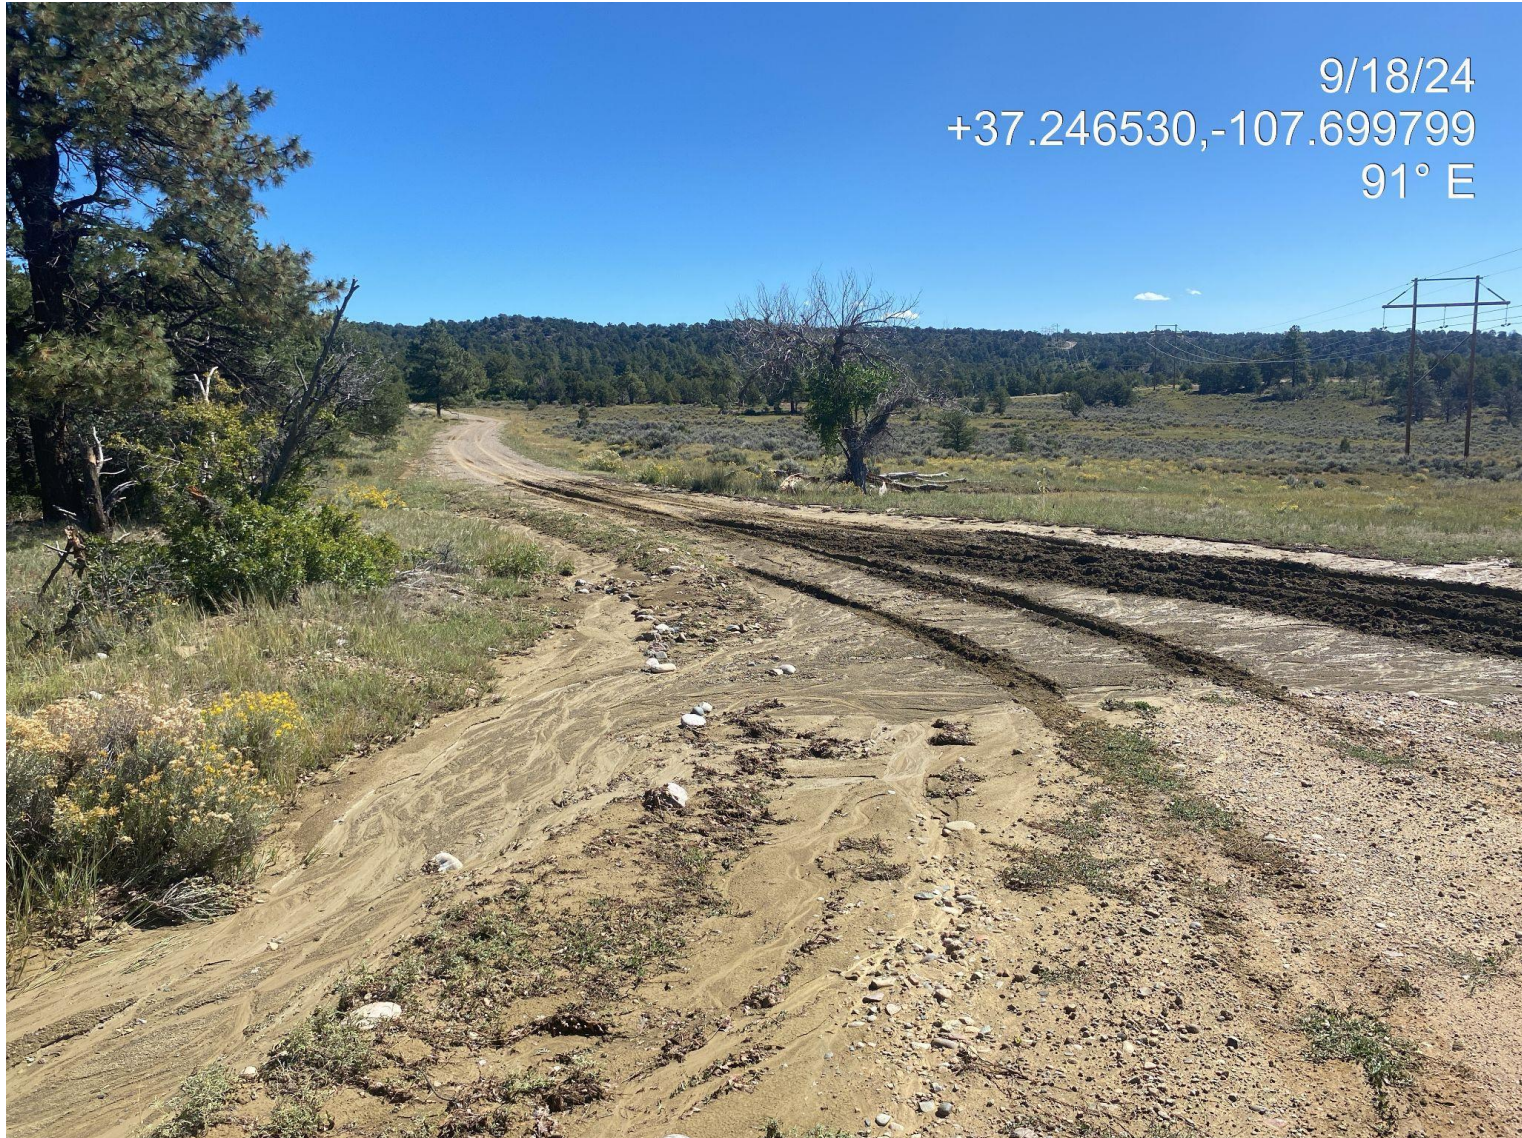
Photo 4. View of severe sediment deposition occurring at the location access point, as deep as a 10 inches in some areas.
