Interim Reclamation and Stormwater Inspection

Operator: K.P. KAUFFMAN COMPANY INC. #46290

Location ID: 324591

Inspection Photos
Location Name: Dwinell 1 Pad
Location ID: 324591

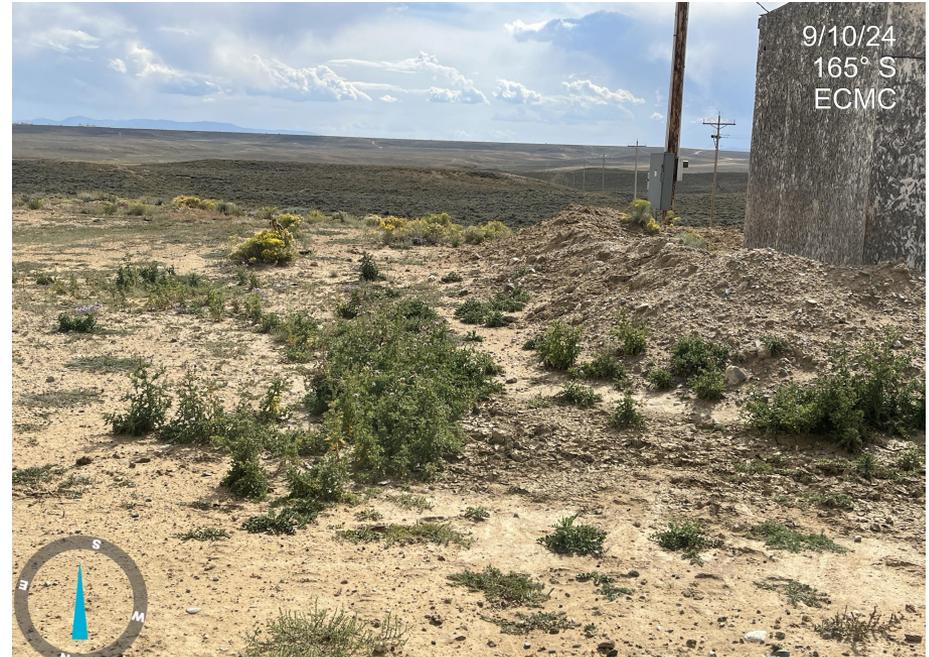
Photo 2. Photo taken the entrance of the Location, facing south. Weeds observed growing along the perimeter. Photo illustrates failure of stormwater BMPs. Operator shall repair stormwater BMPs per Rule 1002 and control weeds per Rule 606.

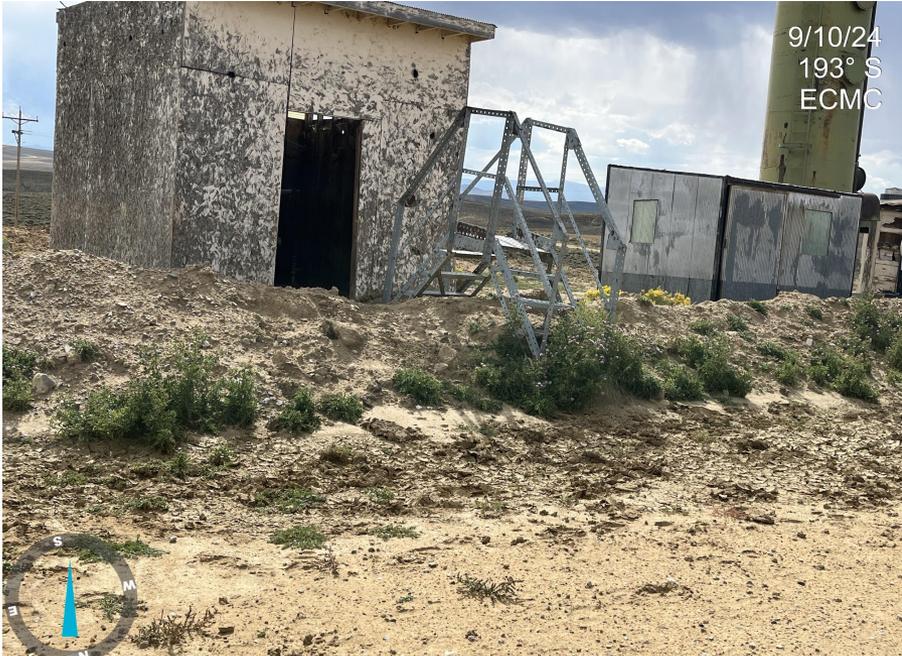
Photo 3. Photo taken from the pad center, facing south. Photo illustrates weeds growing in secondary containment berms. Secondary containment does not appear to be adequate. Comply with Rule 1002.f.(2). and 606.c.

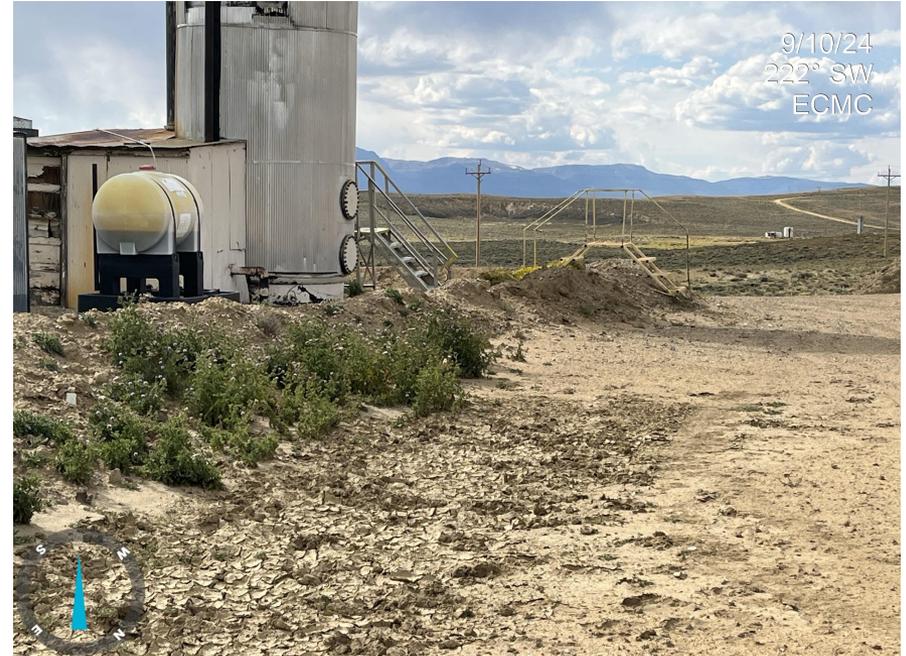
Photo 4. Photo taken from the pad center, facing southwest. Photo illustrates failing BMPs and weeds. Comply with Rule 1002.f.(2). and 606.c.

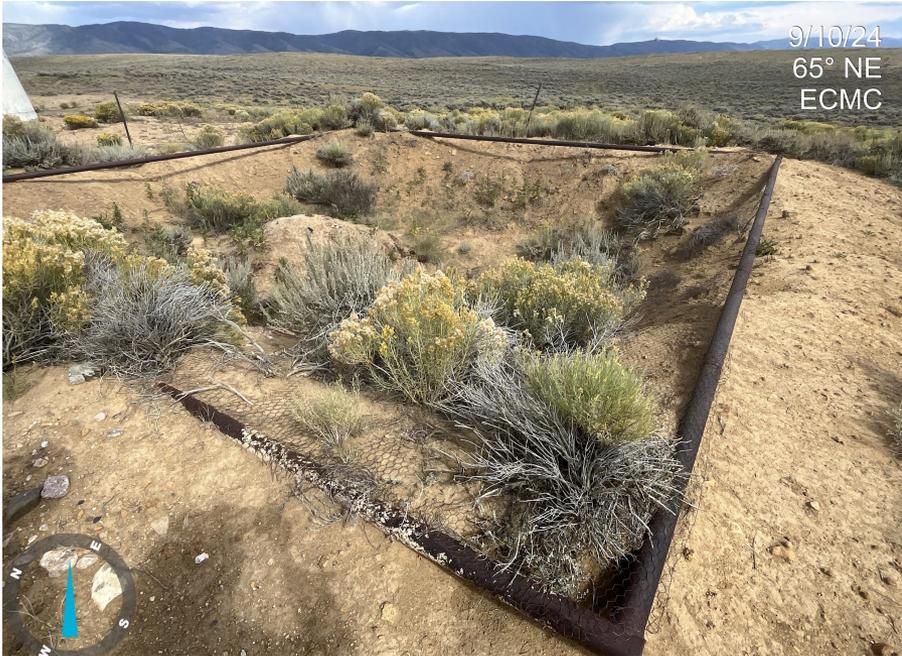
Photo 5. Photo taken from the southeastern pad surface, facing northeast. Photo illustrates insufficient or missing BMPs on pit. Operator shall install/maintain stormwater BMPs per Rule 1002.f.(2)

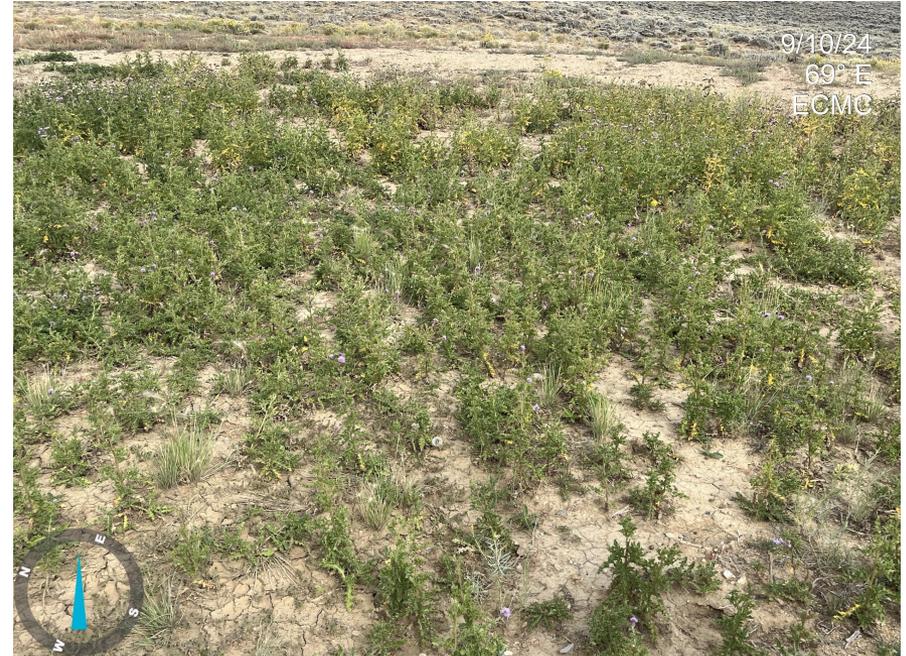
Photo 6. Photo taken from the northeastern pad surface, facing east. Photo illustrates weeds and areas no longer used for production shall be reclaimed per Rule 1003..

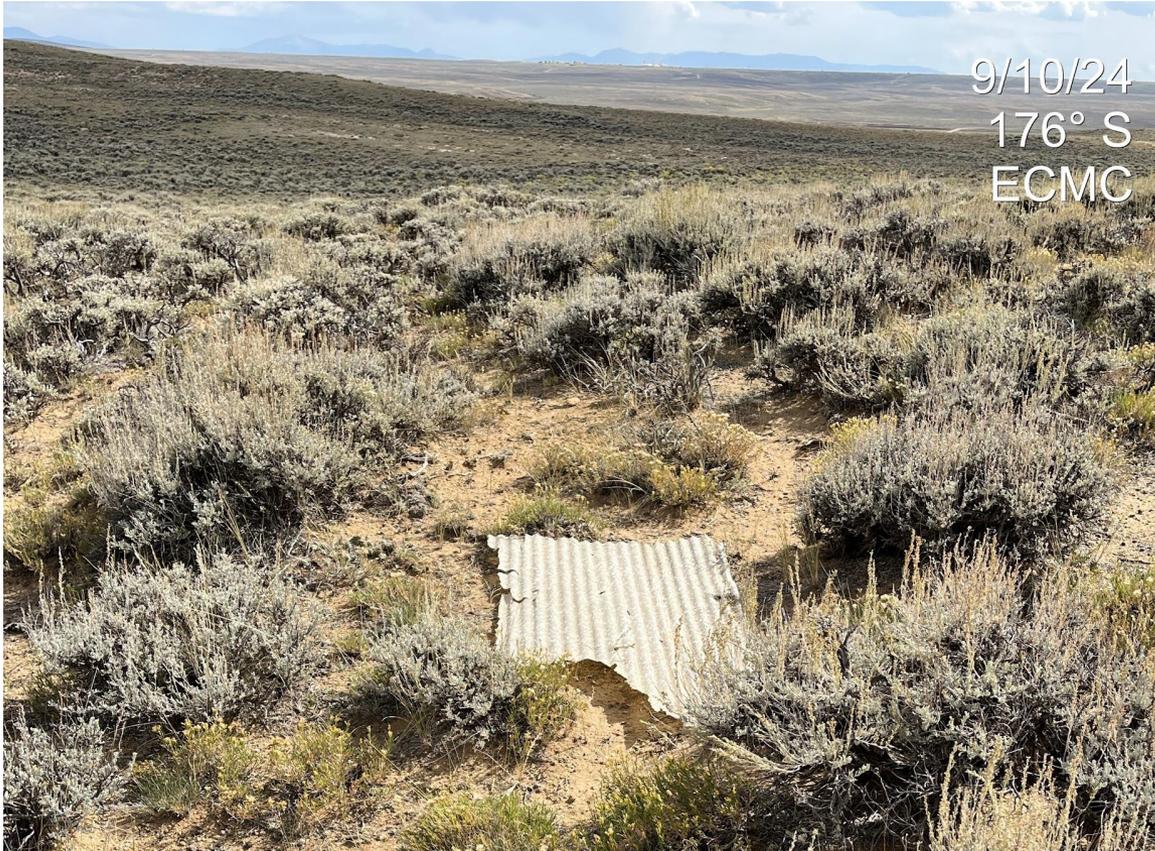
Photo 7. Photo taken from off-site north of pad, facing south. Photo illustrates trash is evident off-site.

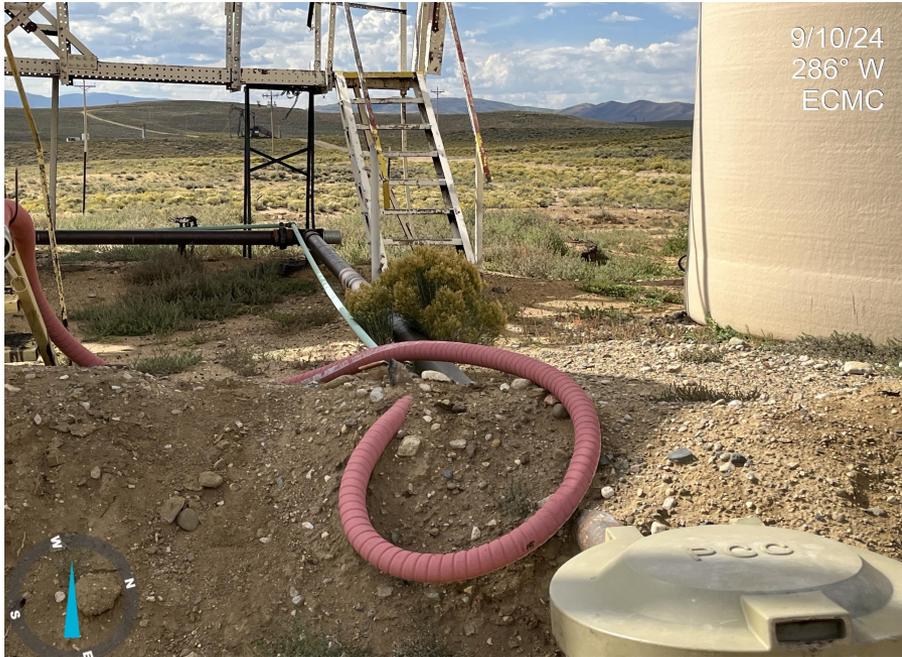
Photo 8. Photo taken from the western pad surface, facing west. Photo illustrates a hose which could contribute to a potential spill if not connected, capped, and stored in secondary containment.
