Final Reclamation and Stormwater Inspection

Operator: KERR MCGEE OIL & GAS ONSHORE LP - #47120

Location ID: 329141

Inspection Document #: 697505514

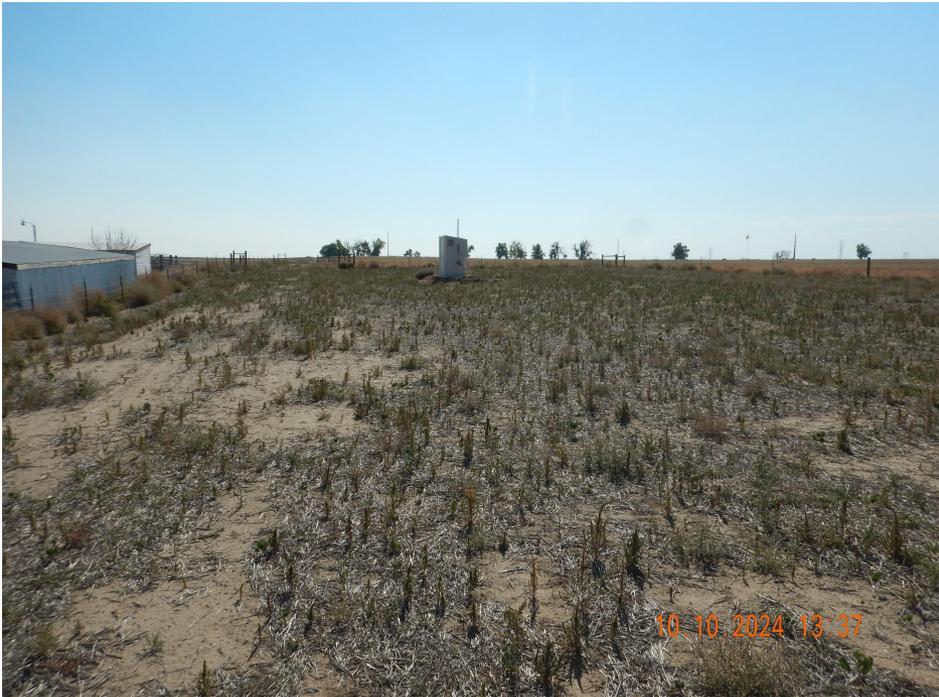
Photo 1. Photo taken from the entrance of the off-location tank battery, facing South. Photo illustrates final reclamation activities have been performed; however, a midstream meter house remains.

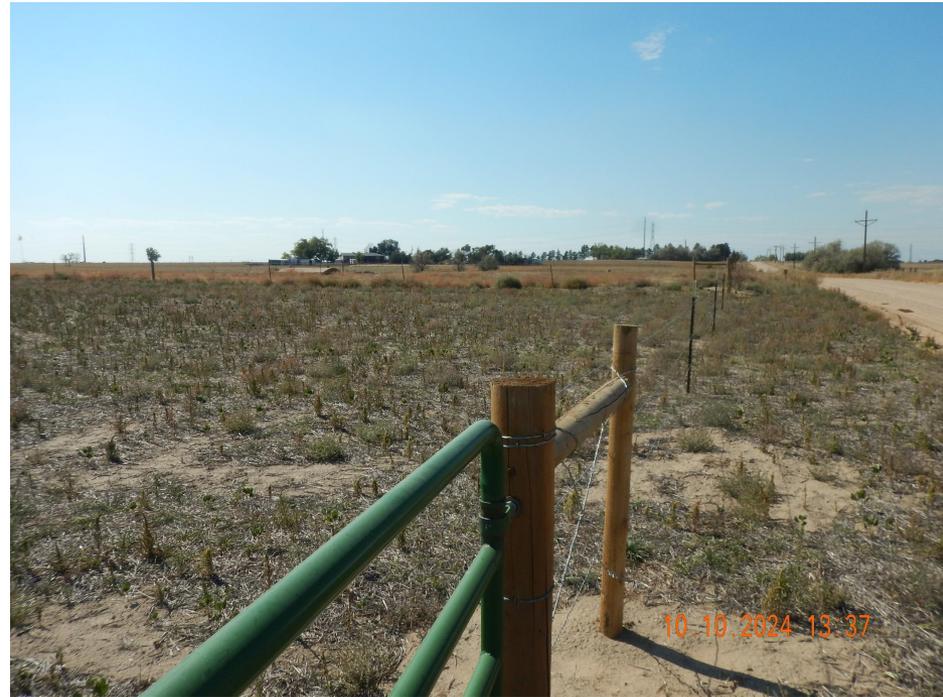
Photo 2. Photo taken from the entrance of the off-location tank battery, facing West. See comments under Photo 1.

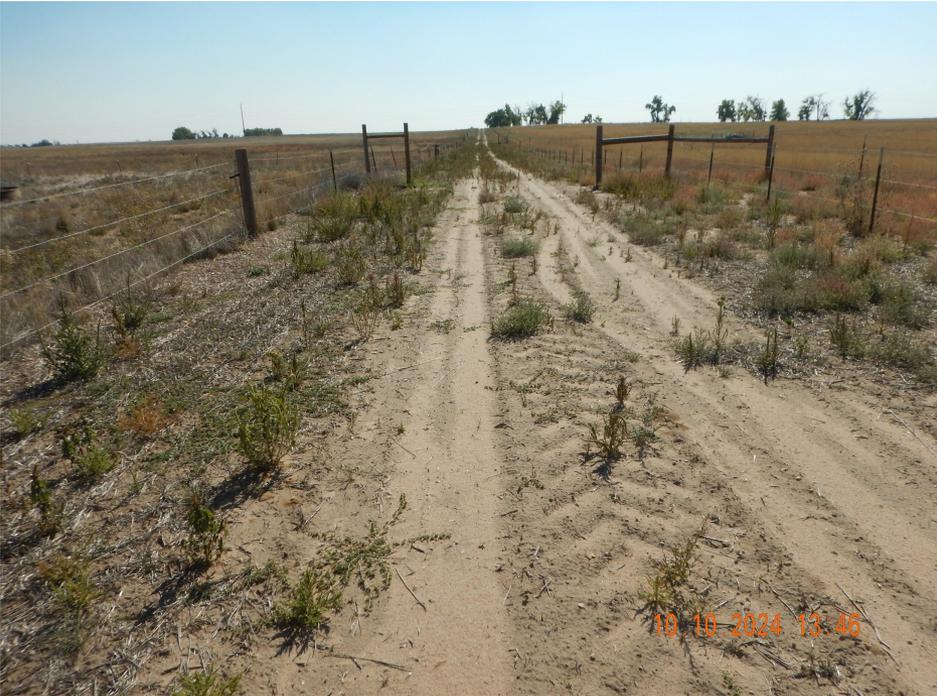
Photo 3. Photo taken along a portion of the access road, facing South. Photo illustrates much of the access road within the tire track portions did not have any germination or straw mulch.

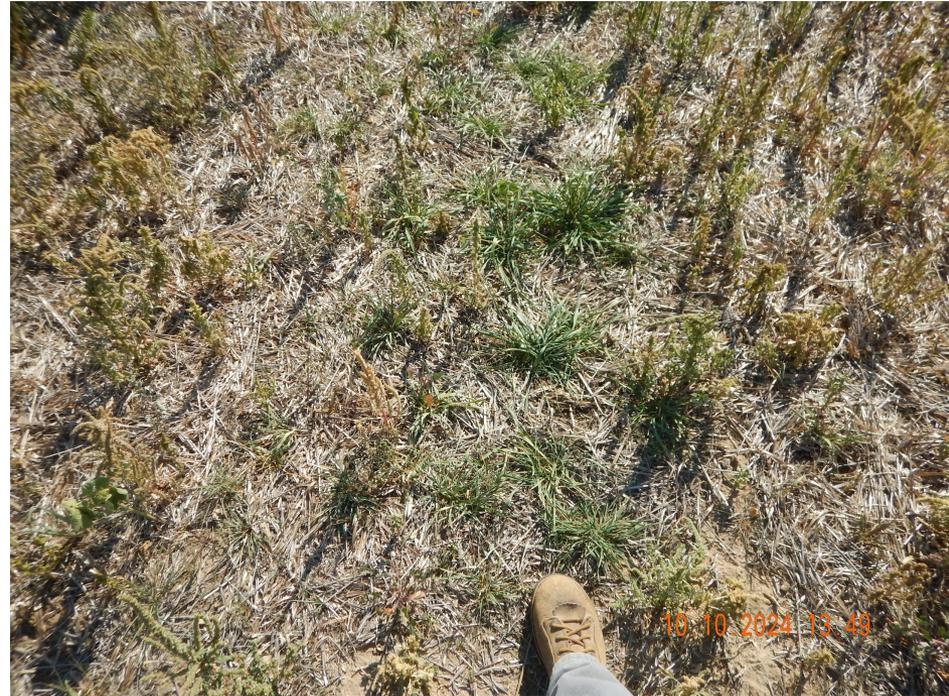
Photo 4. Photo taken along a portion of the access road along the eastern side. Photo illustrates germination of plant species within the straw mulch.

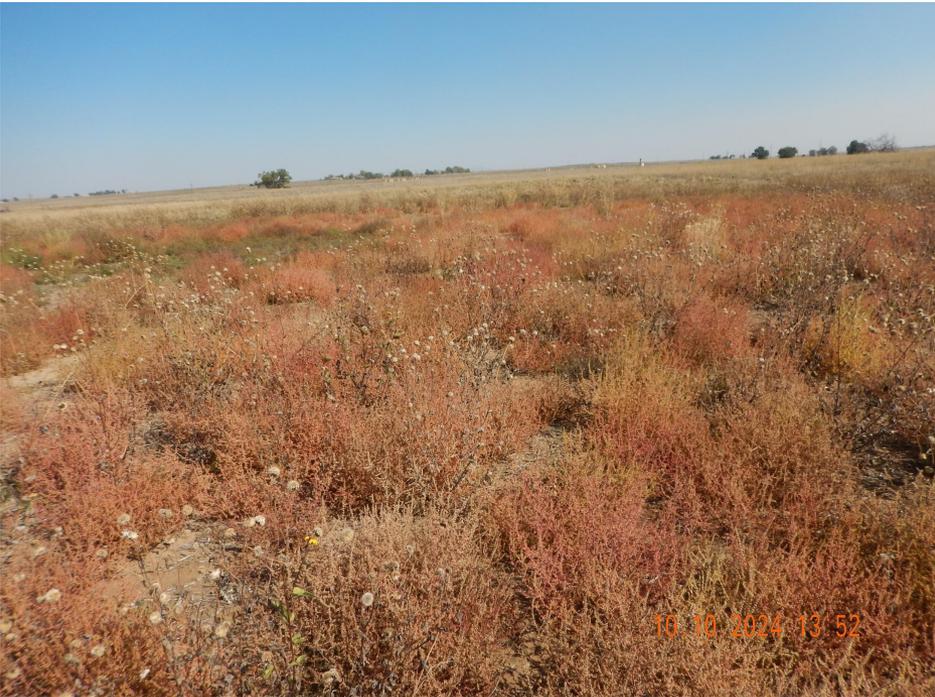
Photo 5. Photo taken from the well location, facing East. Photo illustrates the well location is predominately weedy, annual vegetation.

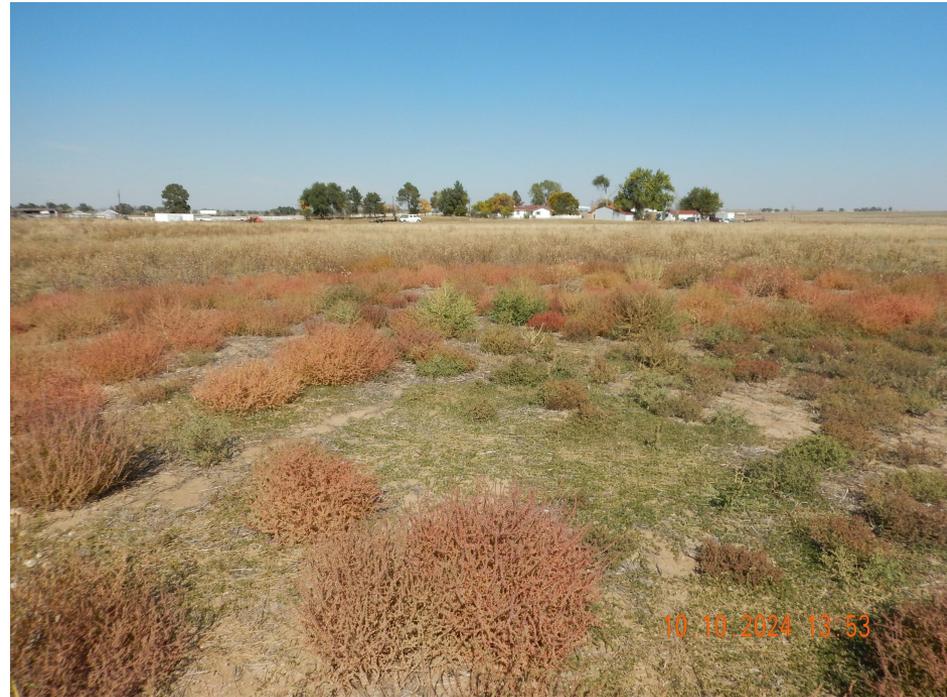
Photo 6. Photo taken from the well location, facing North. See comments under Photo 5.

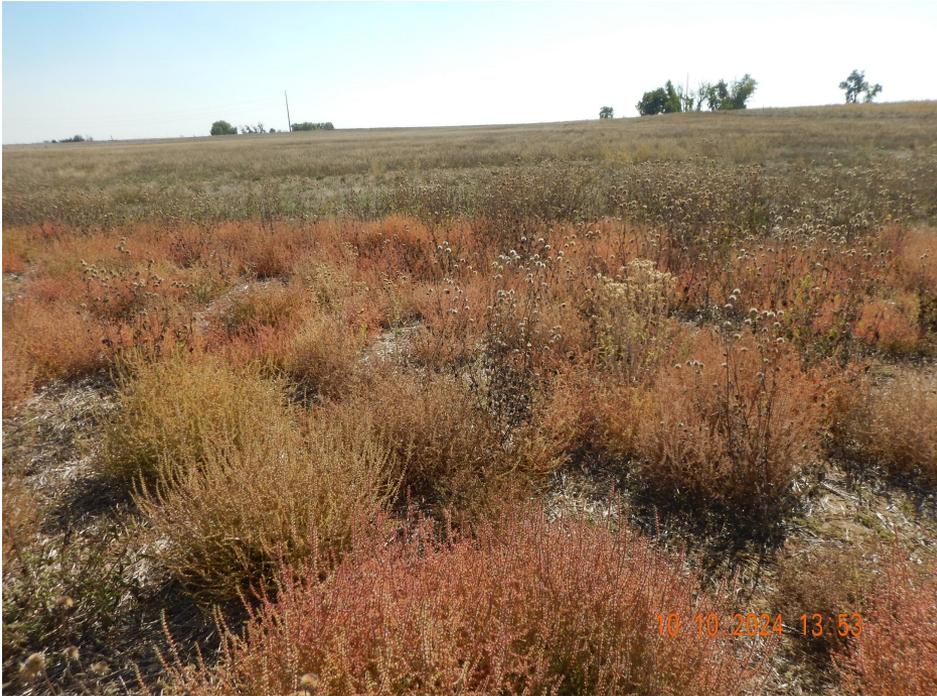
Photo 7. Photo taken from the well location, facing South. See comments under Photo 5.

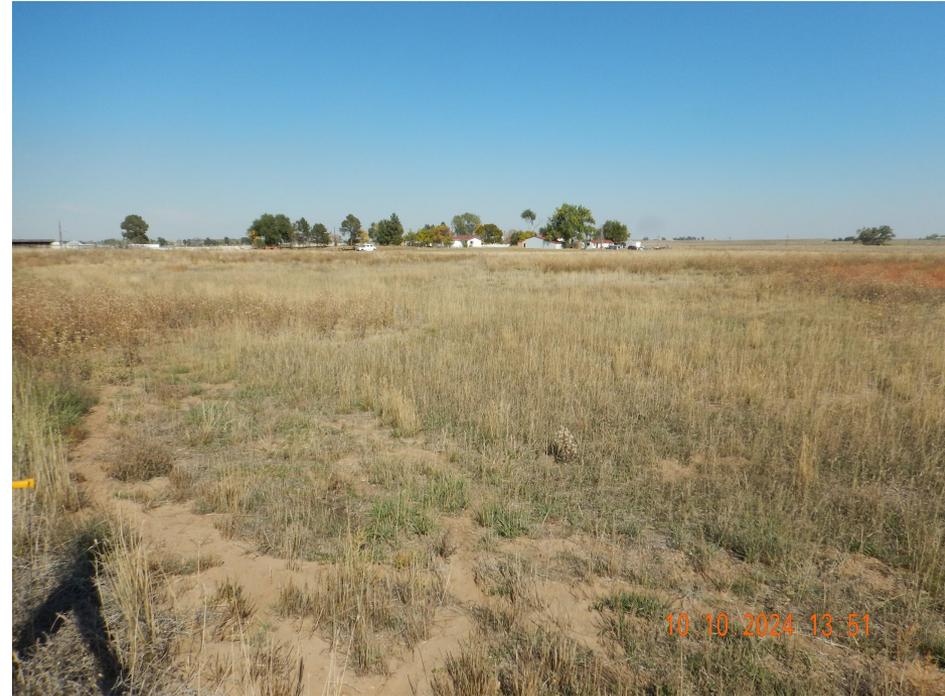
Photo 8. Reference photo taken west of the well location, facing North.
