Final Reclamation and Stormwater Inspection

Operator: BONANZA CREEK ENERGY OPERATING
COMPANY - 8960

Location ID: 305849

Inspection Photos
Location Name: Pronghorn 14- 8
Location ID: 305849

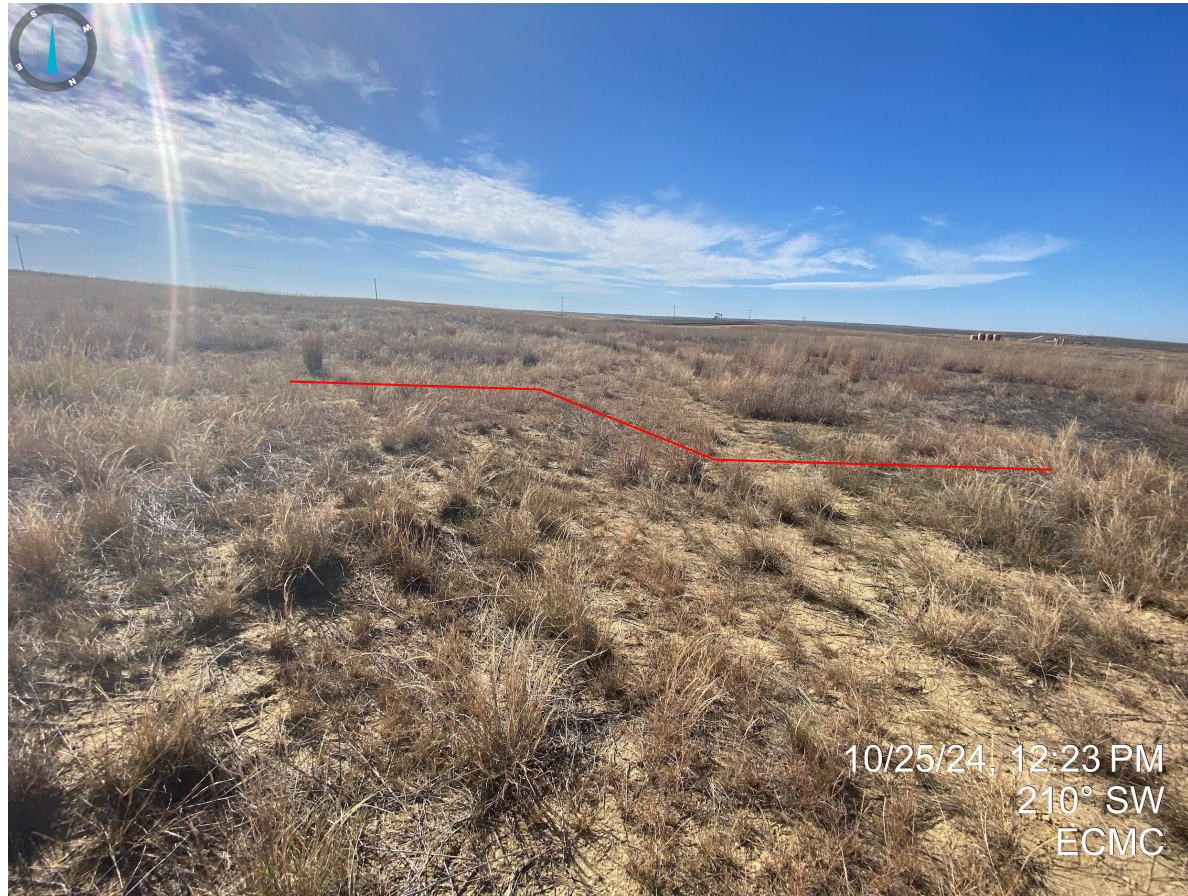
Photo 1. Taken from the production areas facing southwest along the access road. Red line illustrates that portions of the former access road do not appear to have been recontoured.

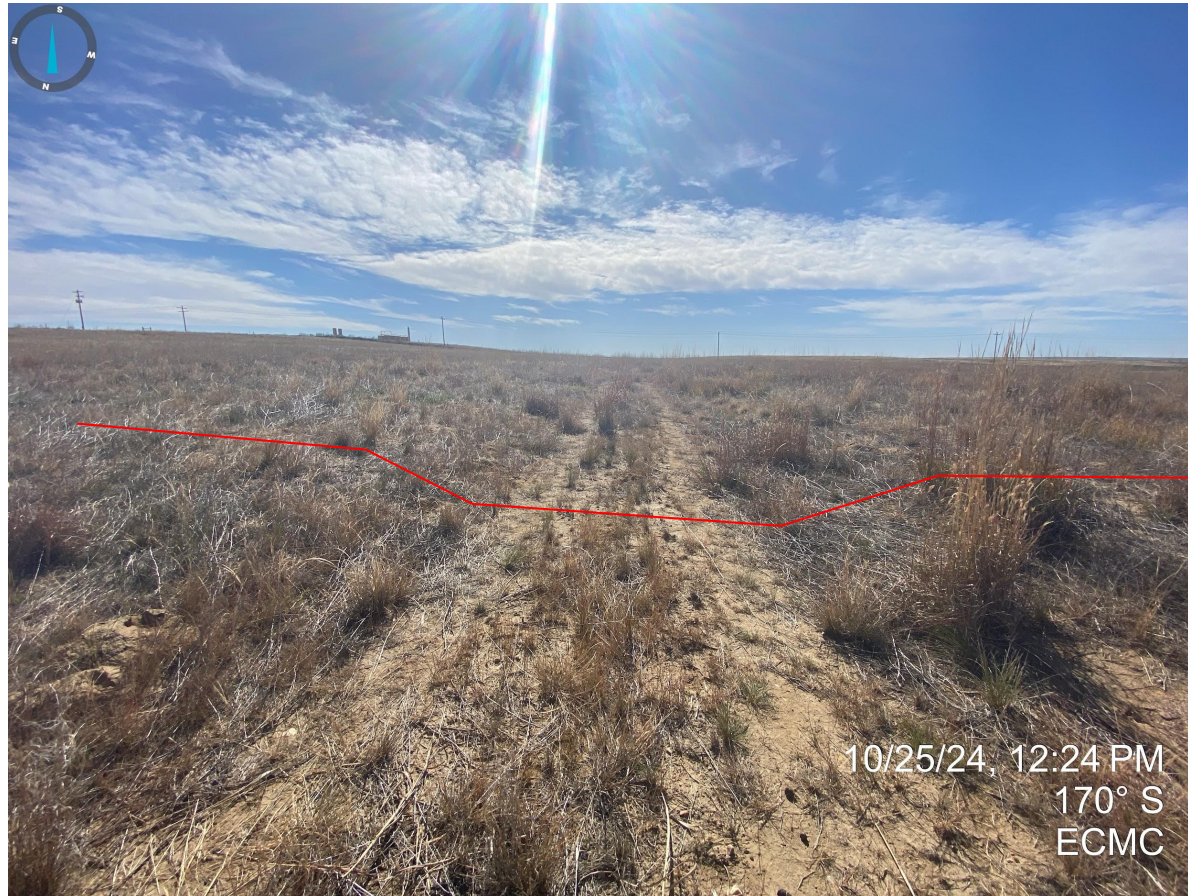
Photo 2. Facing south along the access road. Red line illustrates that portions of the former access road do not appear to have been recontoured.

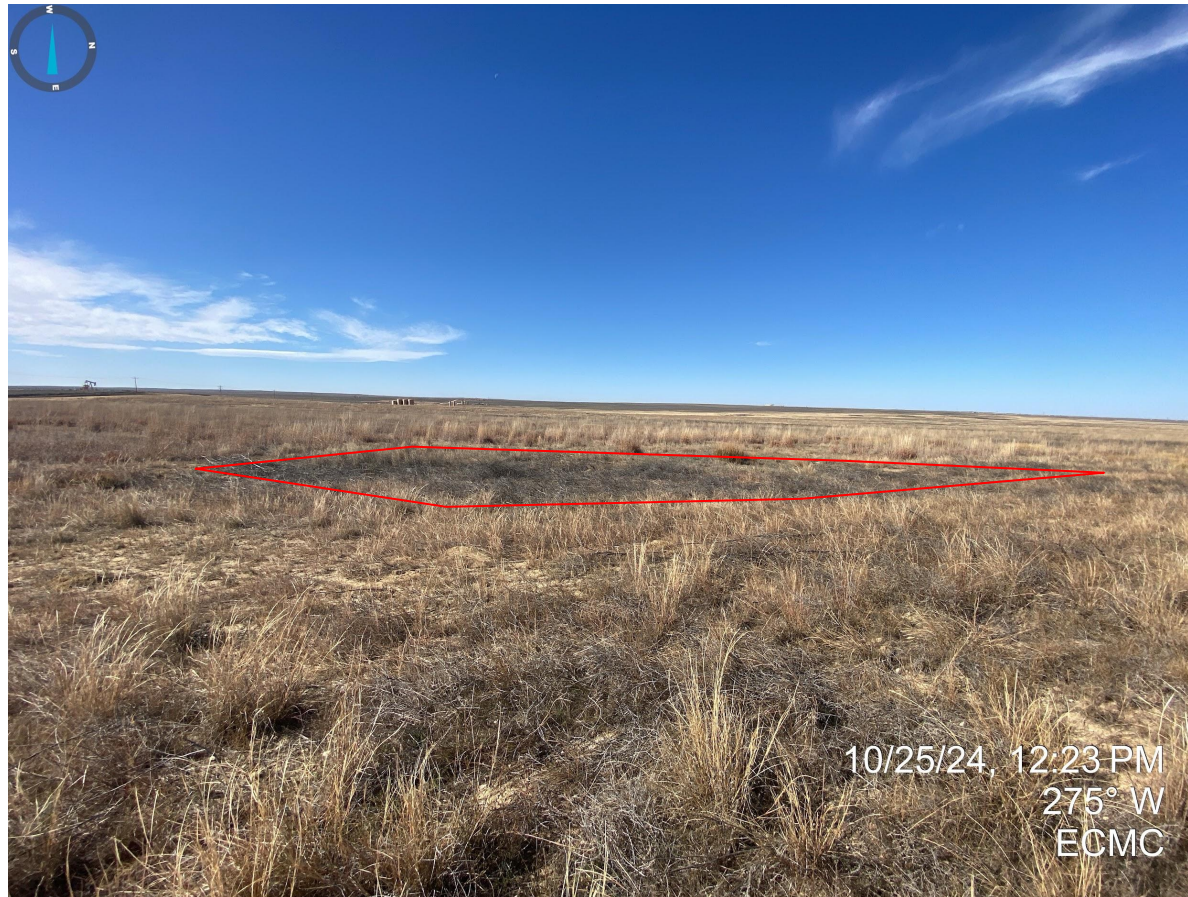
Photo 3. Taken near the center of the location, facing west. Red outlined portion does not appear to have been recontoured.

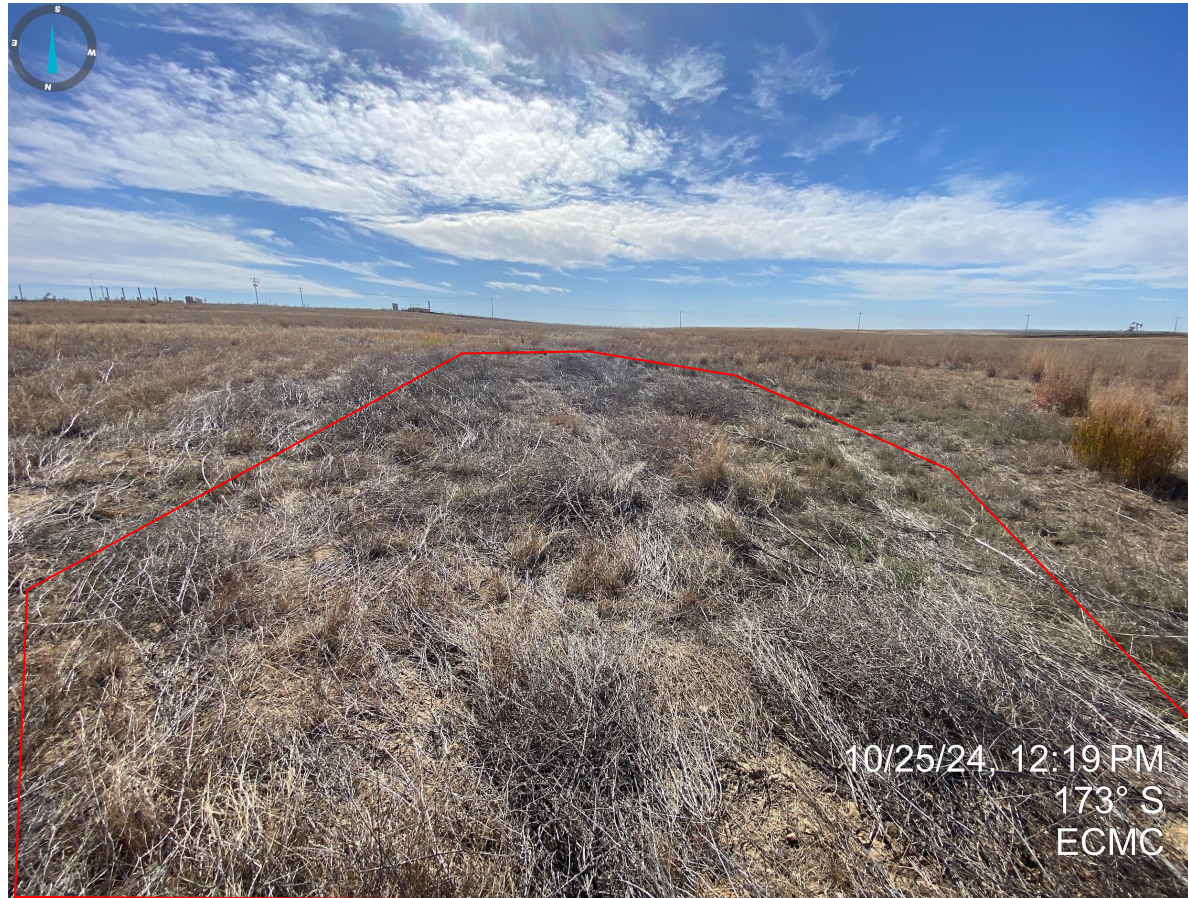
Photo 4. Continue from Photo 3, facing south. See comments in Photo 3.

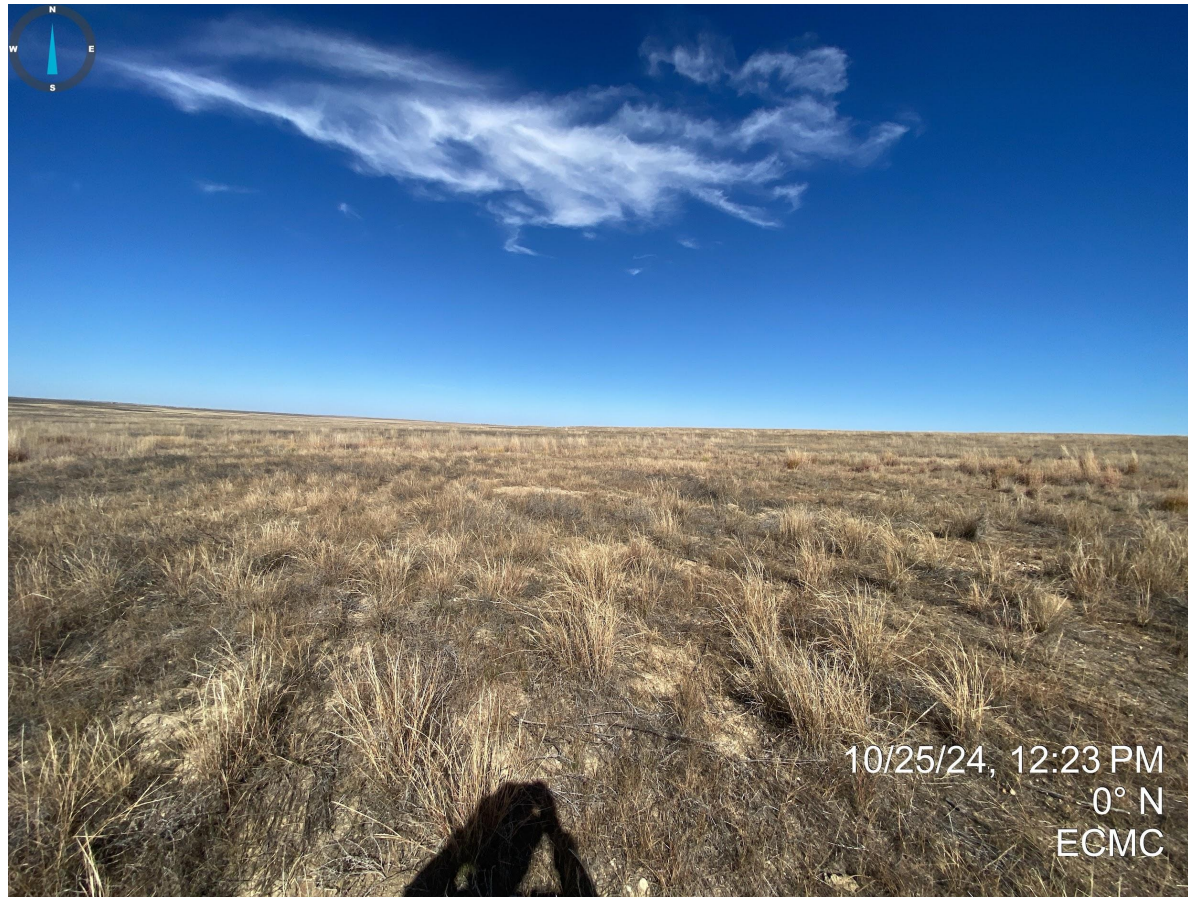
Photo 5. Taken near the center of the location, facing north. The former location appears to be graded flat and has not been contoured to match the surrounding topography.

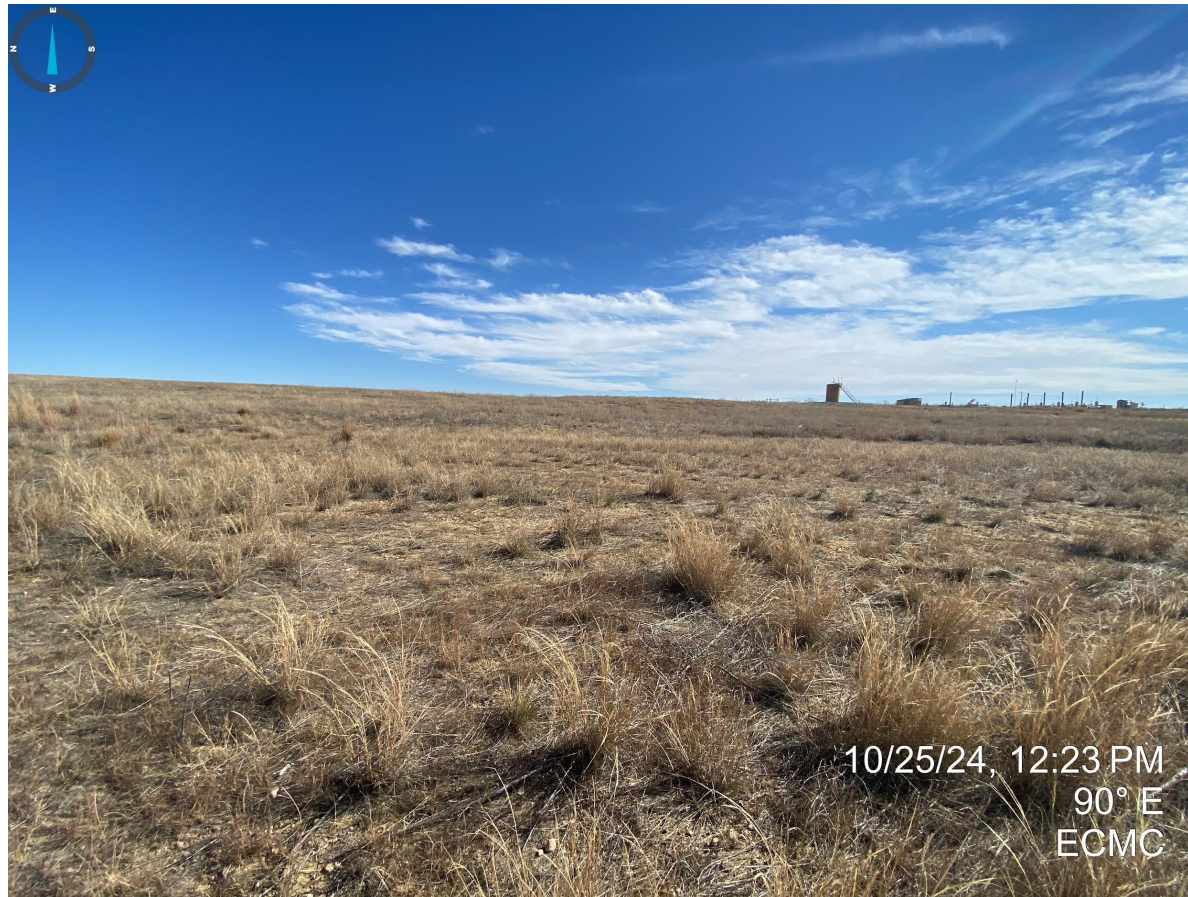
Photo 6. Taken near the former separator location, facing east. The former location is appears to be graded flat and has not been contoured to match the surrounding topography.

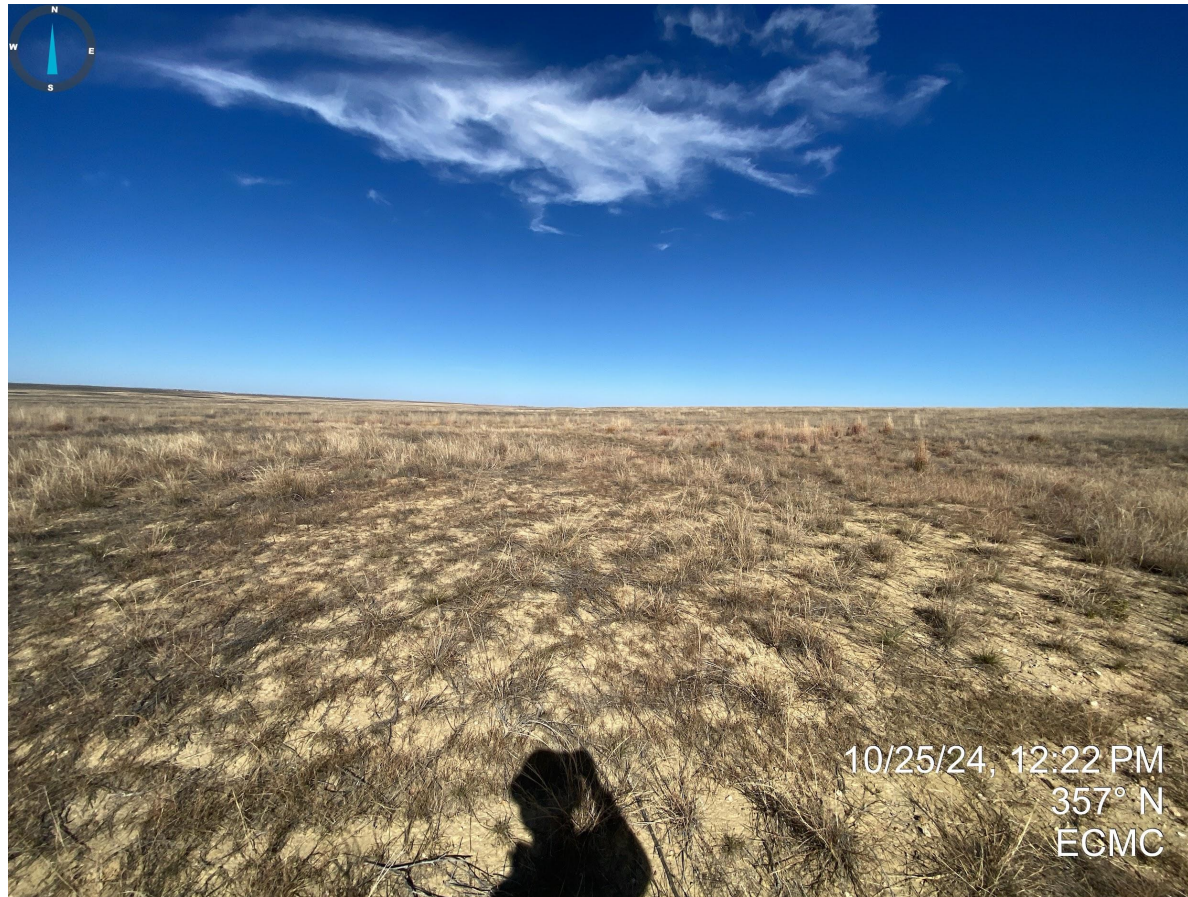
Photo 7. Non-uniform vegetation cover near the former separator.

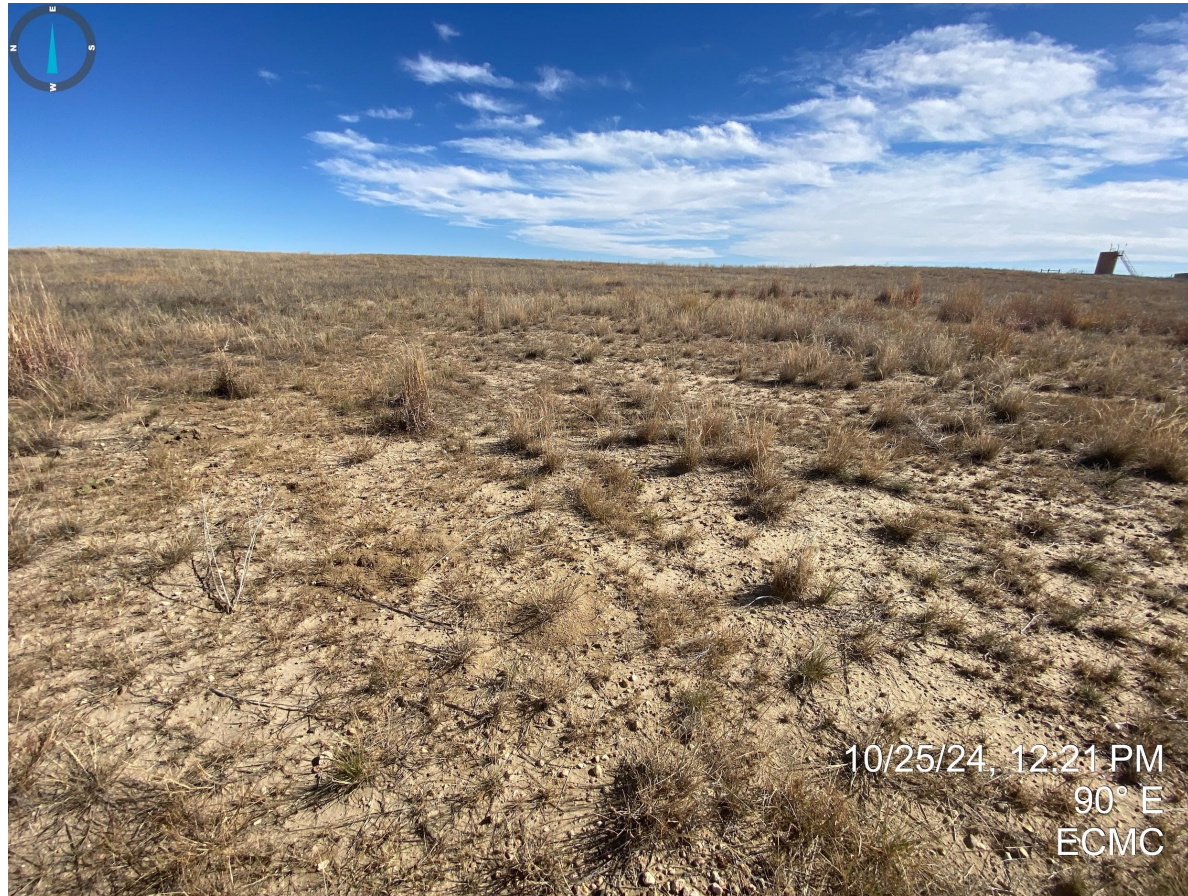
Photo 8. Non-uniform vegetation near the former tank battery.
