Inspection Photos

Operator: GUNNISON ENERGY LLC #10515

Location ID: 334446

Inspection Doc: 696206391

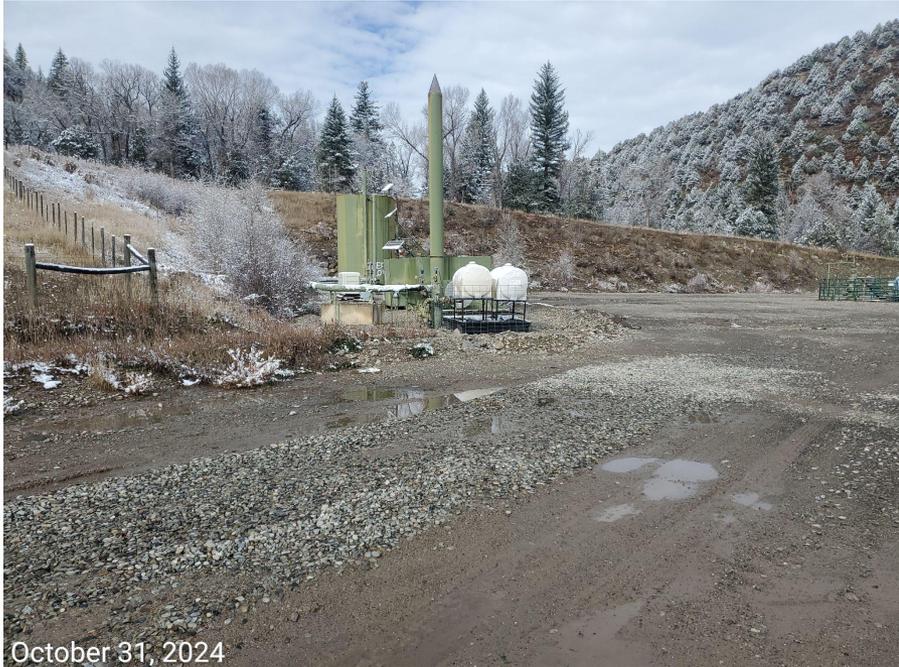
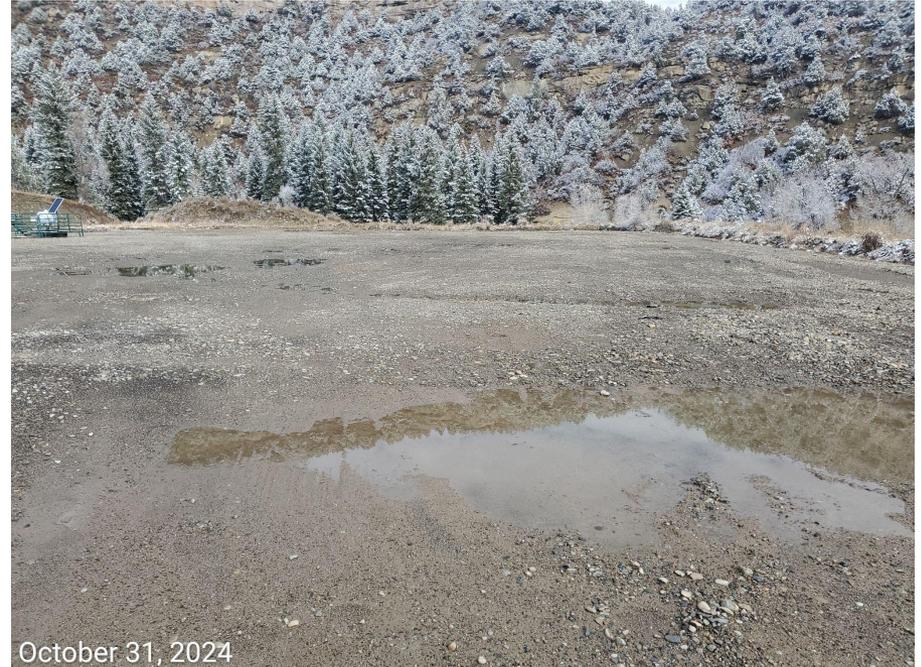
Photo 1: Photos taken from the Location entrance, on the south east end of the Location. Photos provide an overview of the Location facing northwest and north. Photos show interim reclamation including, but not limited to, compaction alleviation, recontouring/regrading, replacement of soils/topsoil, and revegetation activities have not been performed pursuant to 1003 requirements.

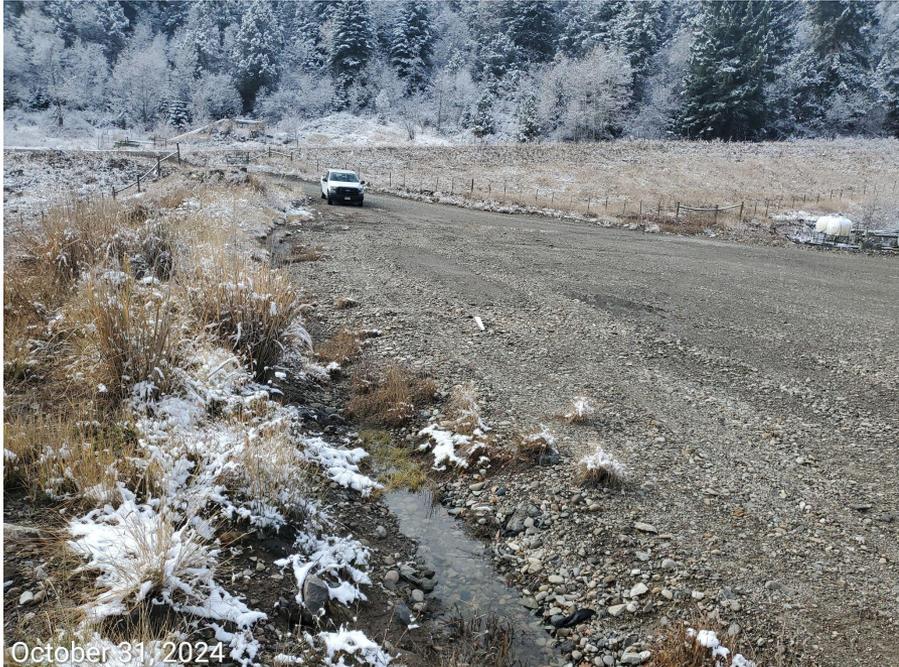
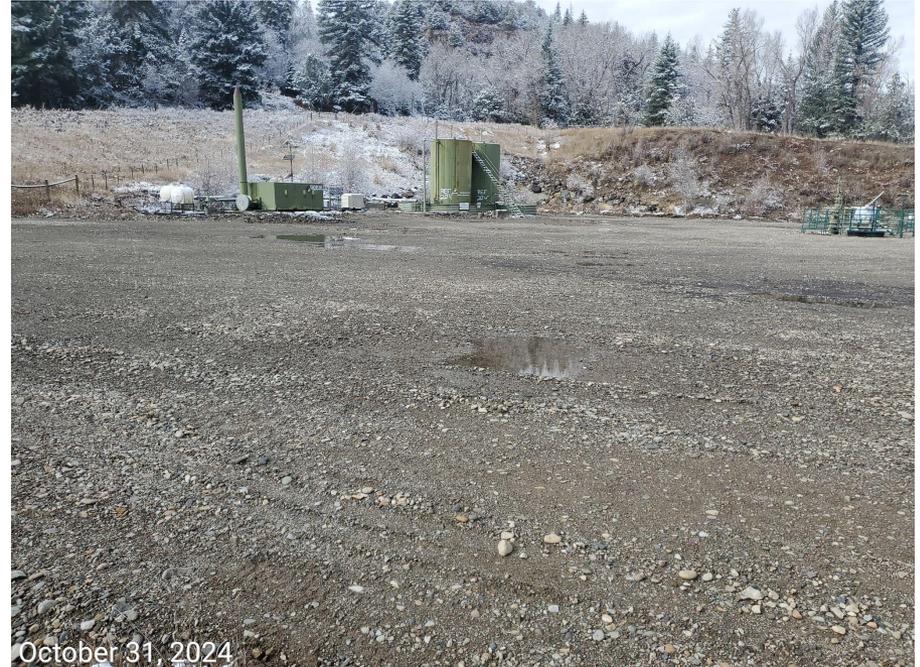
Photo 2: Photos 2-3 taken from the east end of the Location. Photos provide an overview of the Location from south, southwest, northwest to north. Photos show interim reclamation including, but not limited to, compaction alleviation, recontouring/regrading, replacement of soils/topsoil, and revegetation activities have not been performed pursuant to 1003 requirements.

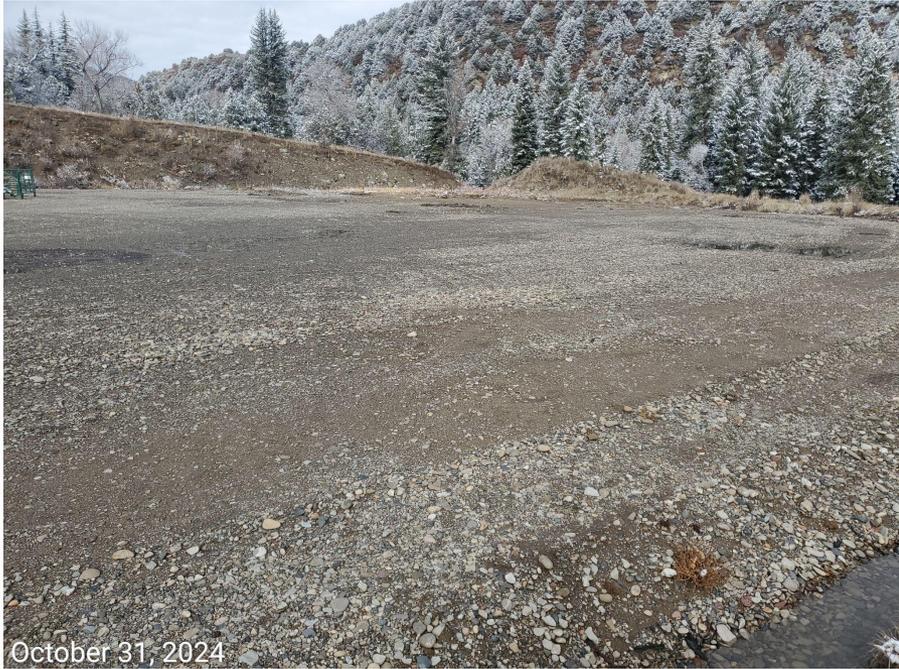
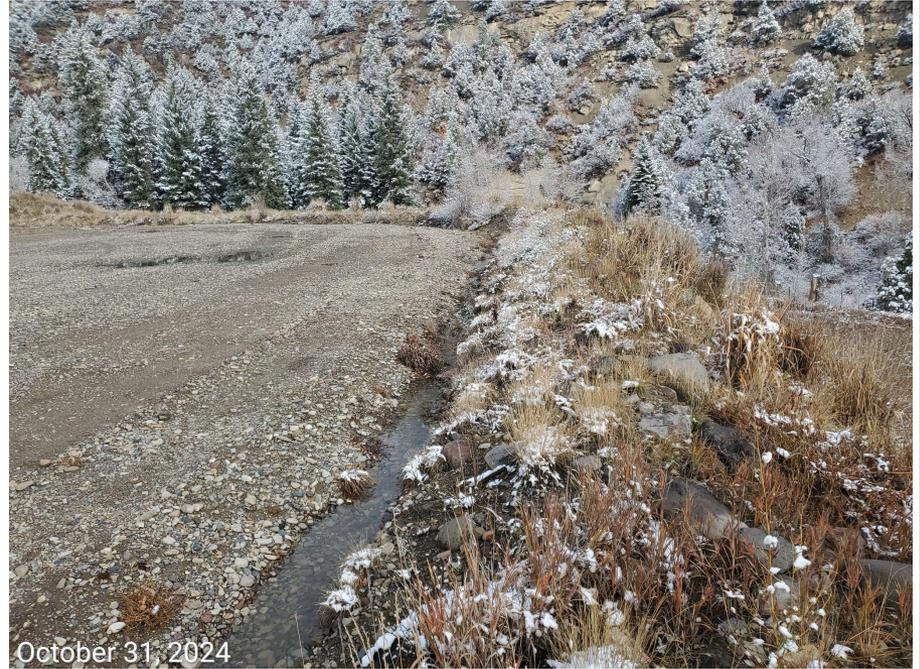
Photo 3: See comments under photo 2.

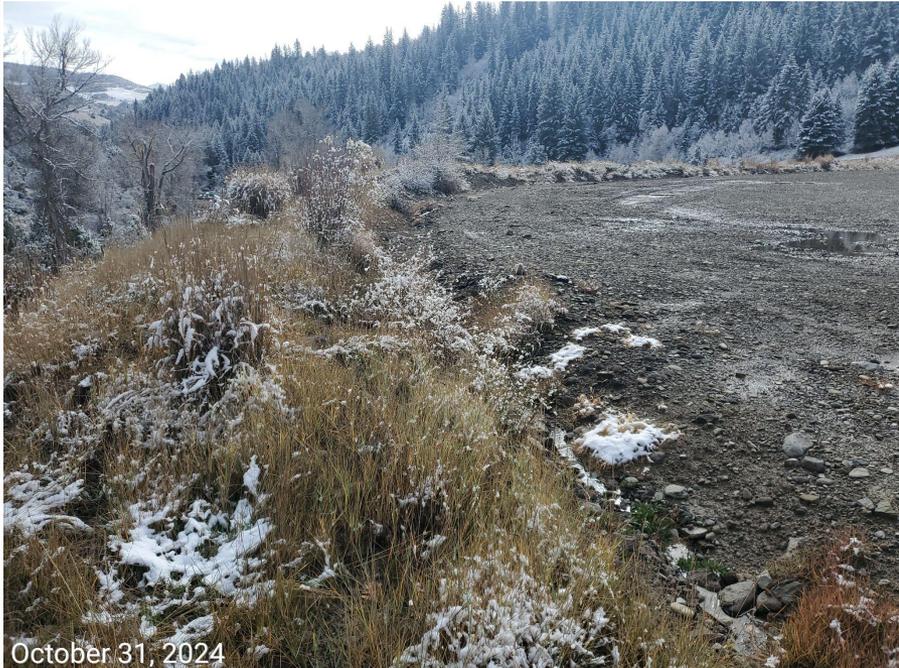
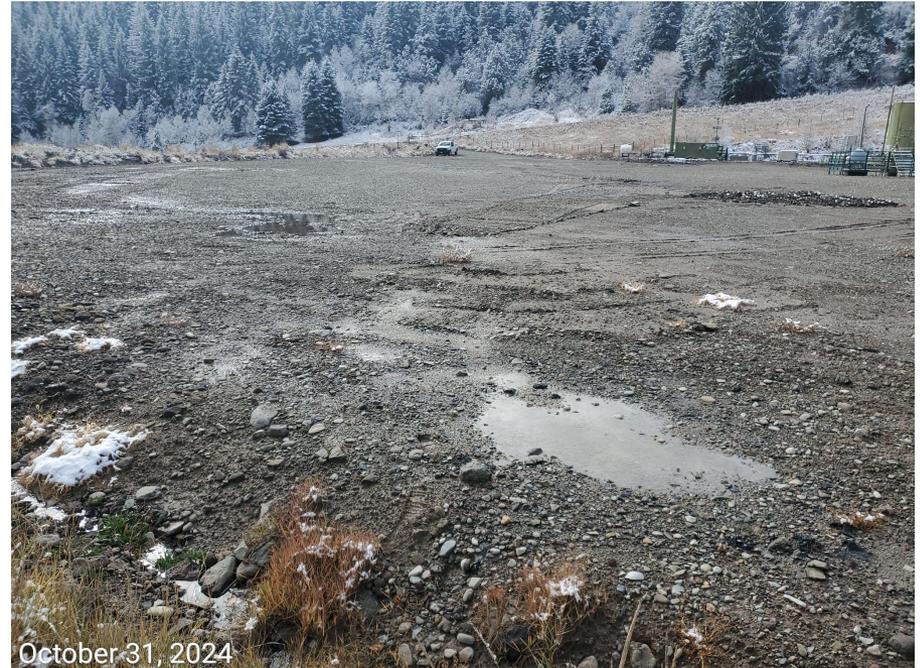
Photo 4: Photos 4-5 taken from the north end of the Location. Photos provide an overview of the Location from east, southeast, southwest to west. Photos show interim reclamation including, but not limited to, compaction alleviation, recontouring/regrading, replacement of soils/topsoil, and revegetation activities have not been performed pursuant to 1003 requirements.

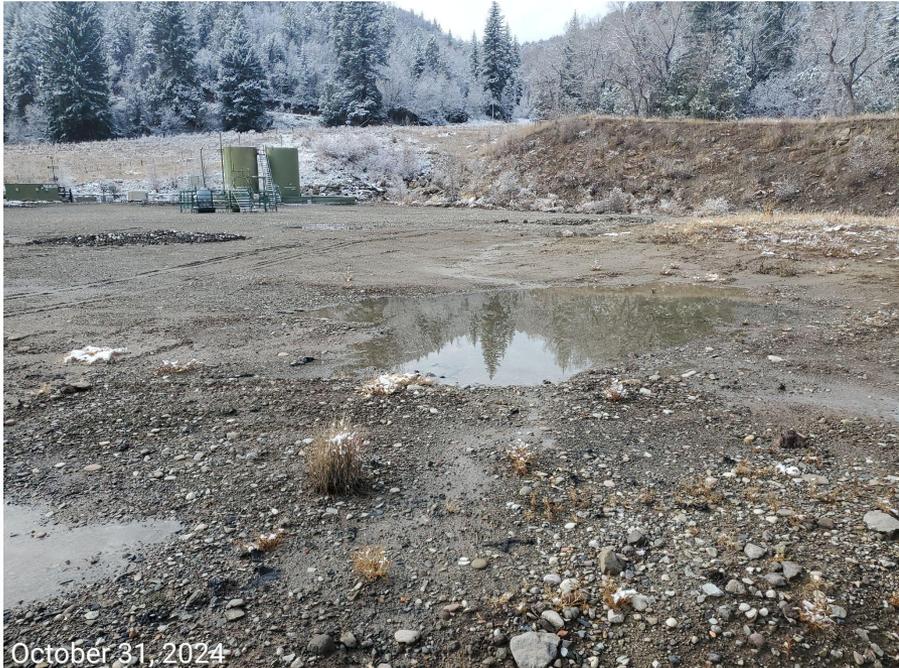
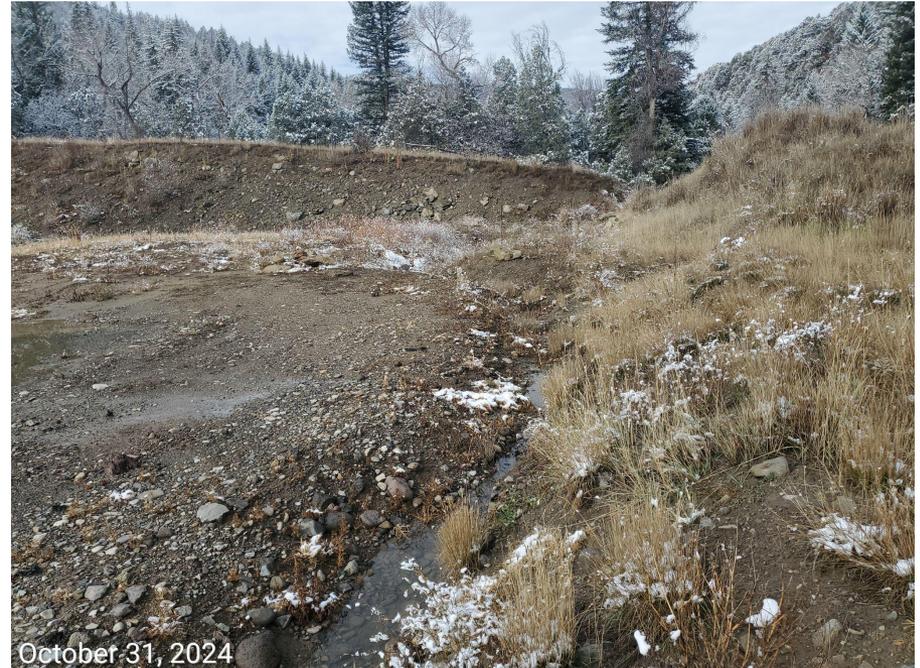
Photo 5: See comments under photo 4.
