Inspection Photos

Operator: GUNNISON ENERGY LLC #10515

Location ID: 427218

Inspection Doc: 696206393

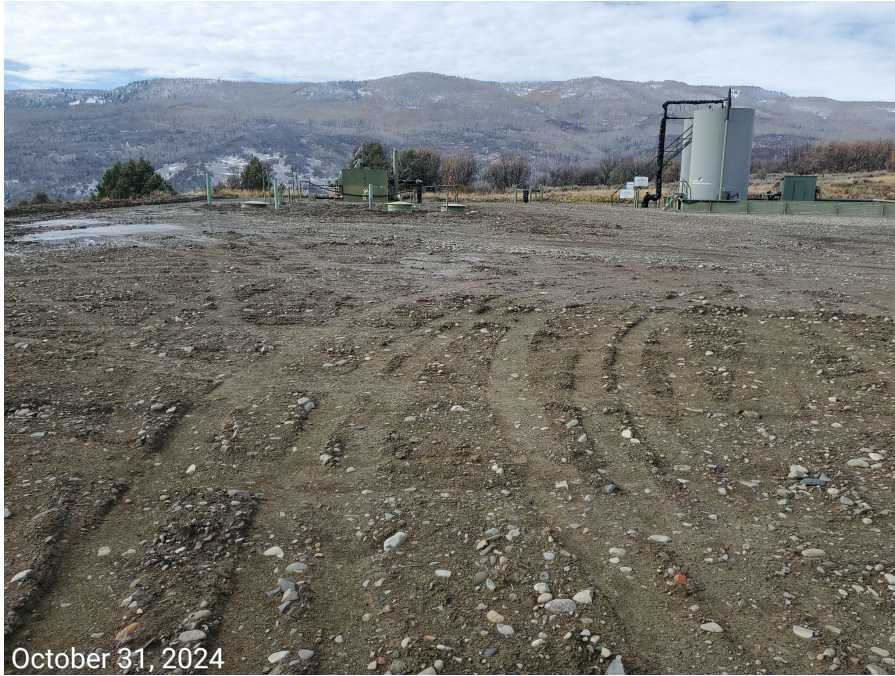
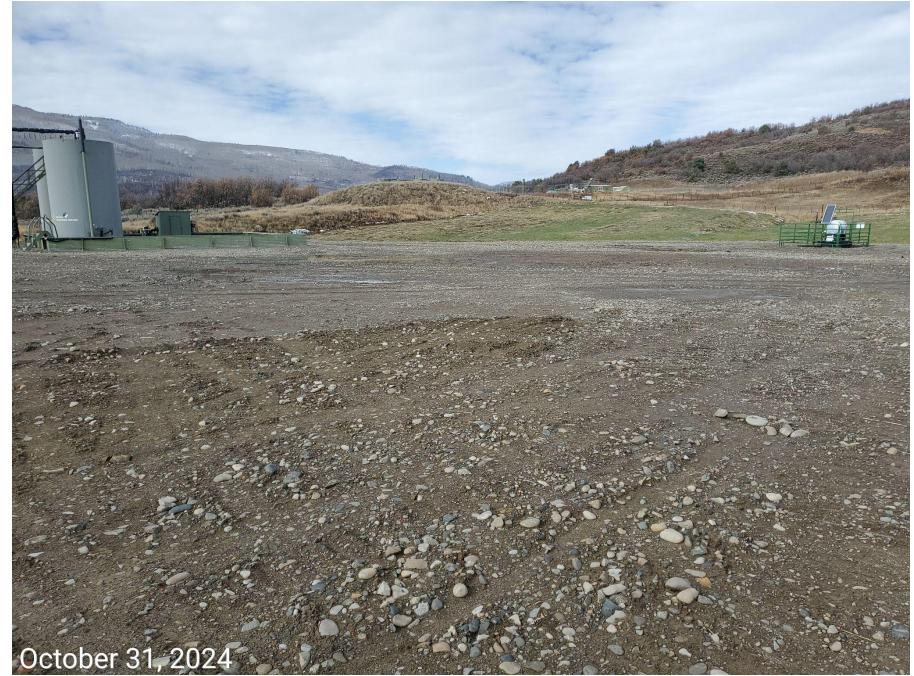
Photo 1: Photos 1-2 taken from the south end of the Location. Photos provide an overview of the Location facing west, northwest, northeast to east. Photos show interim reclamation of areas not necessary for production has been performed.

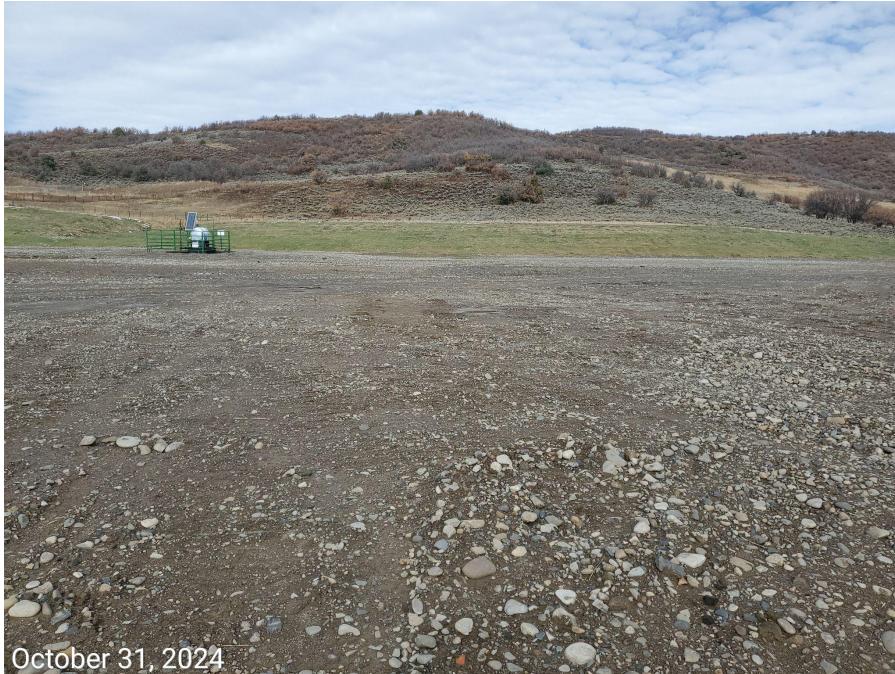
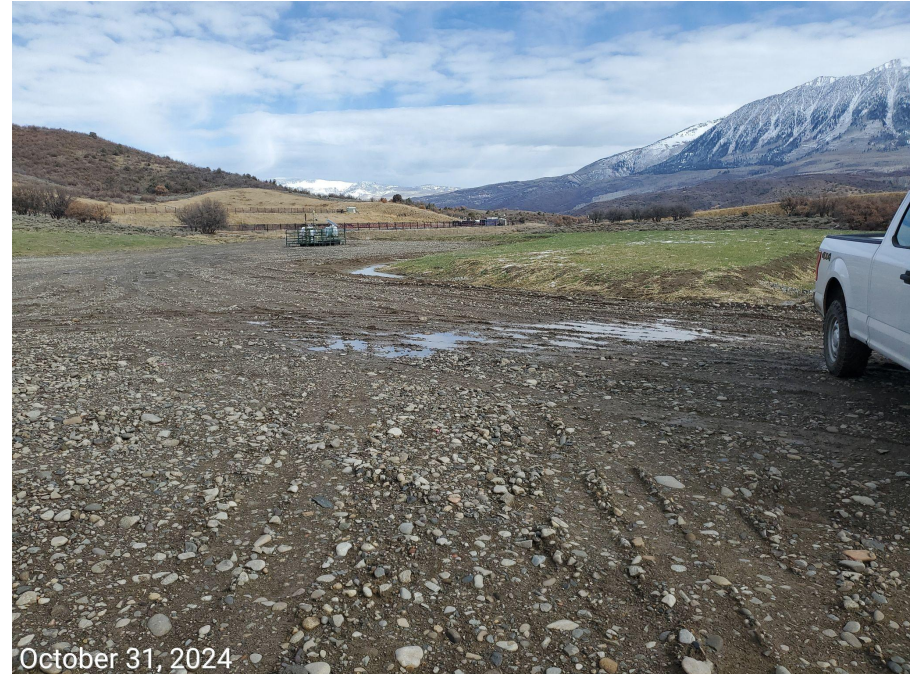
Photo 2: See comments under photo 1.

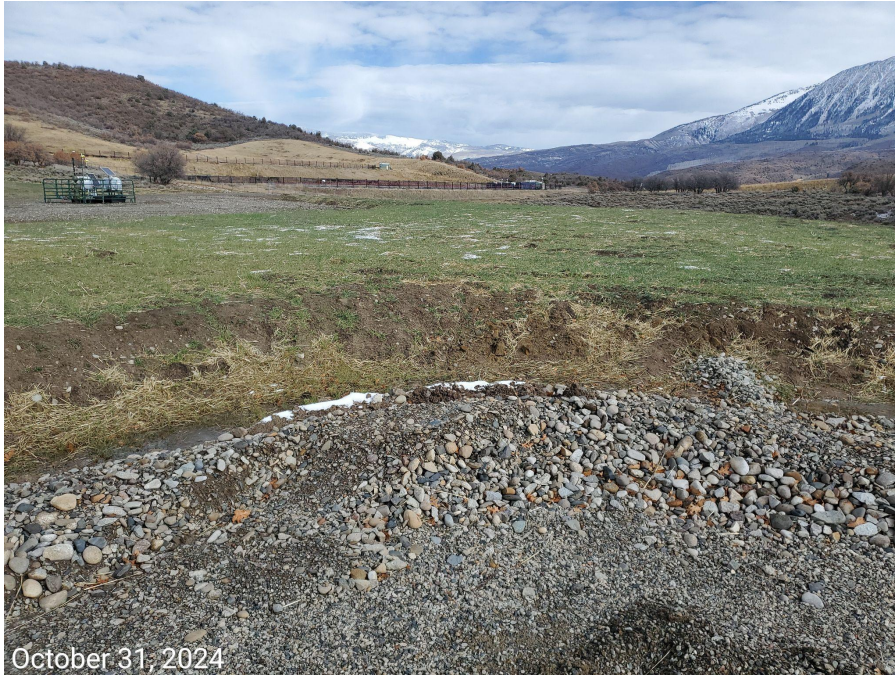
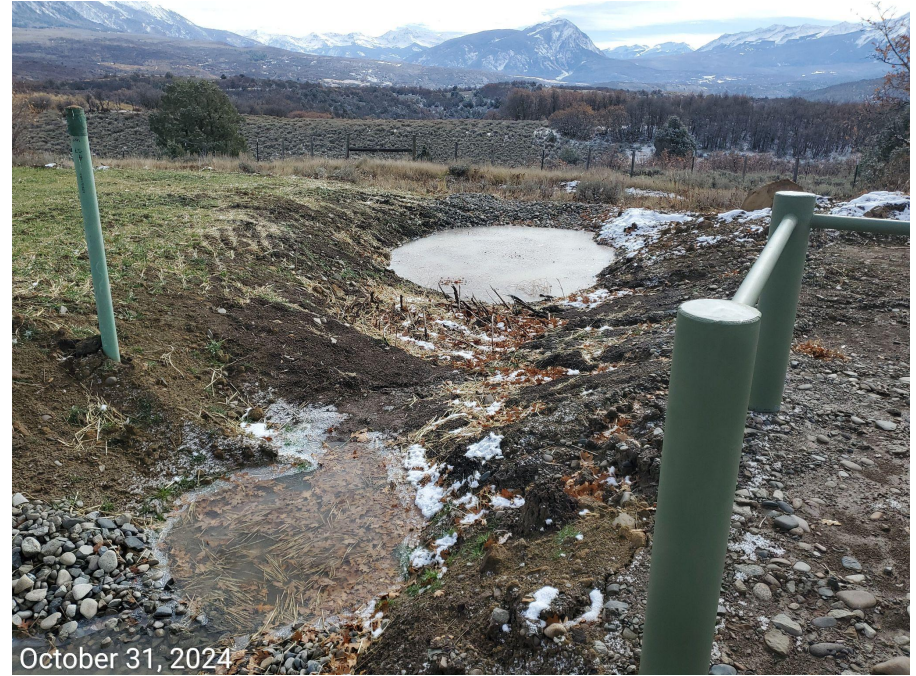
Photo 3: Photos taken from the south end of the Location, facing northeast and south. Photos show interim reclamation has been performed. Photos right also shows sediment trap.

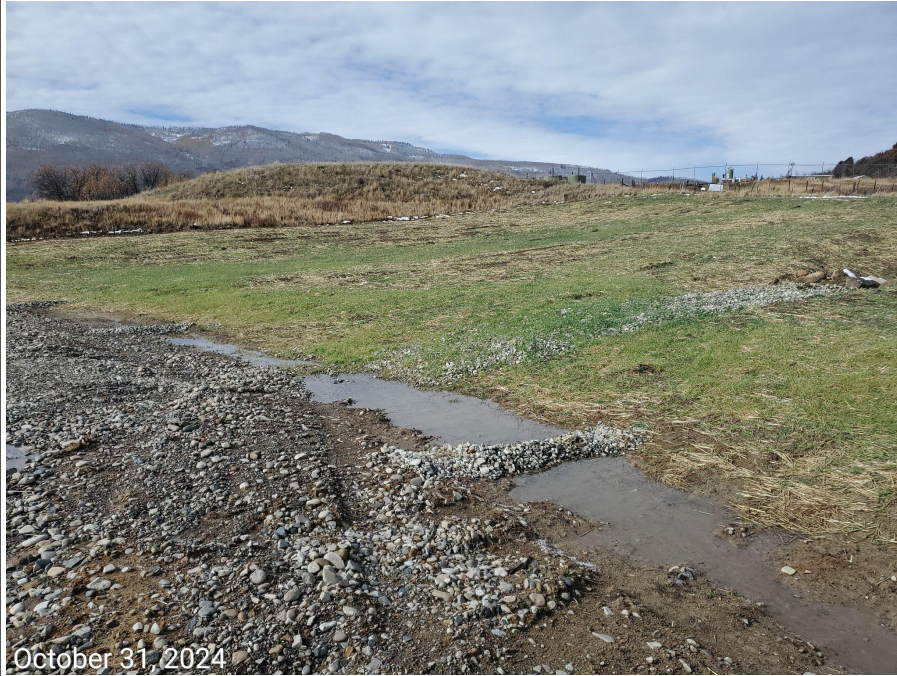
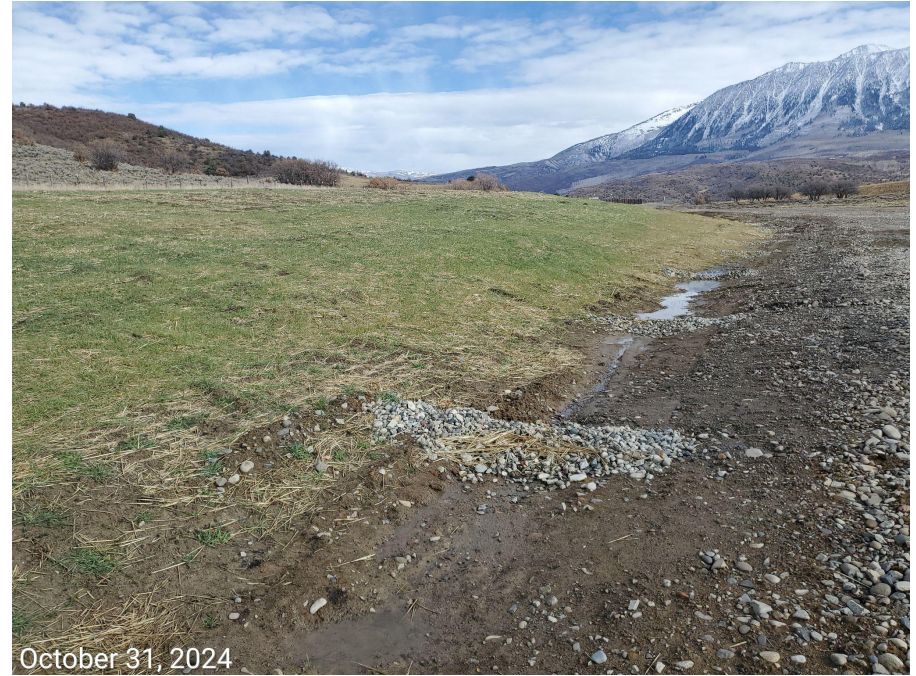
Photo 4: Photos taken from the north end of the Location, facing northwest and northeast. Photo shows interim reclamation has been performed. Photos also examples showing the stormwater diversion ditch along the perimeter of the pad.

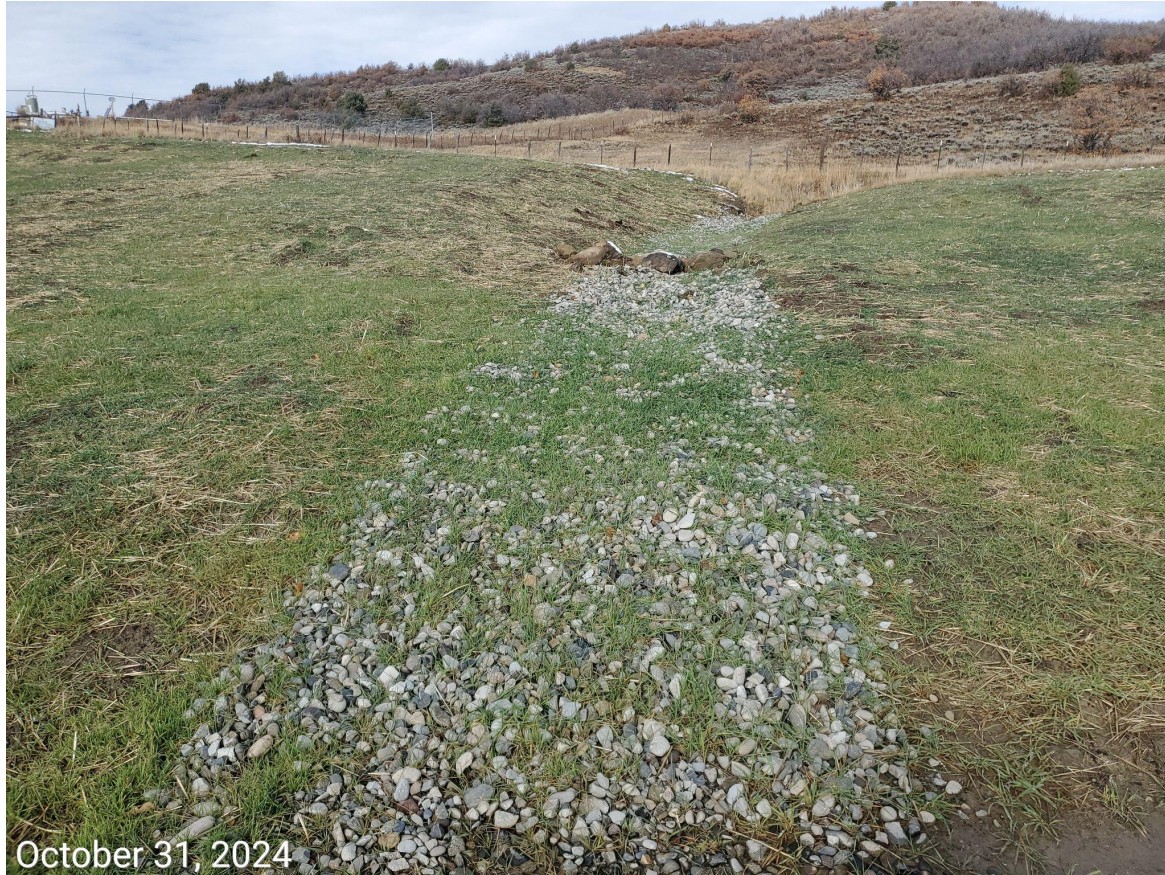
Photo 5: Photo taken from the north end of the Location, facing north. Photo shows erosion degradation at the culvert outlet has been repaired.

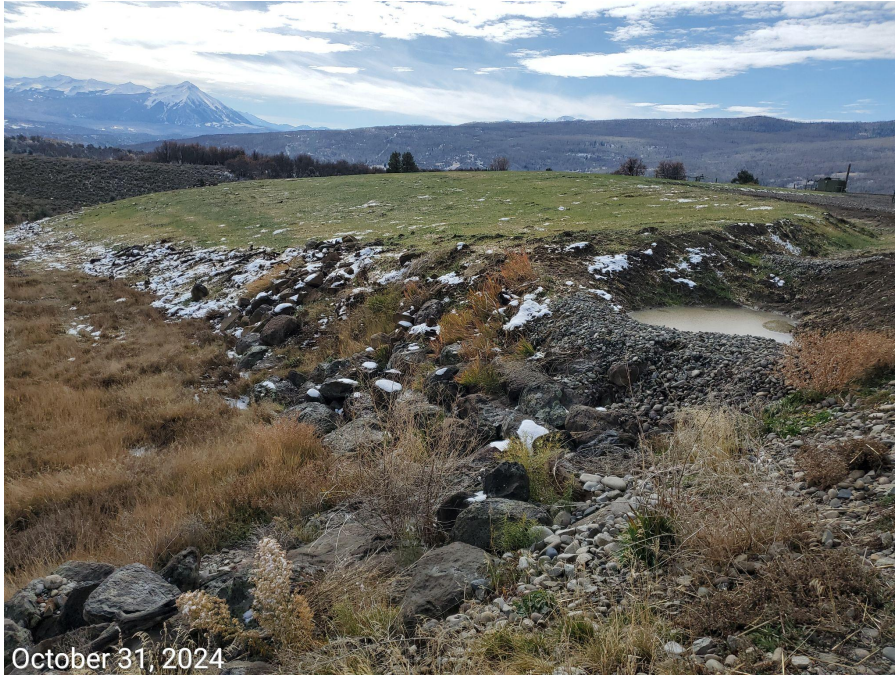
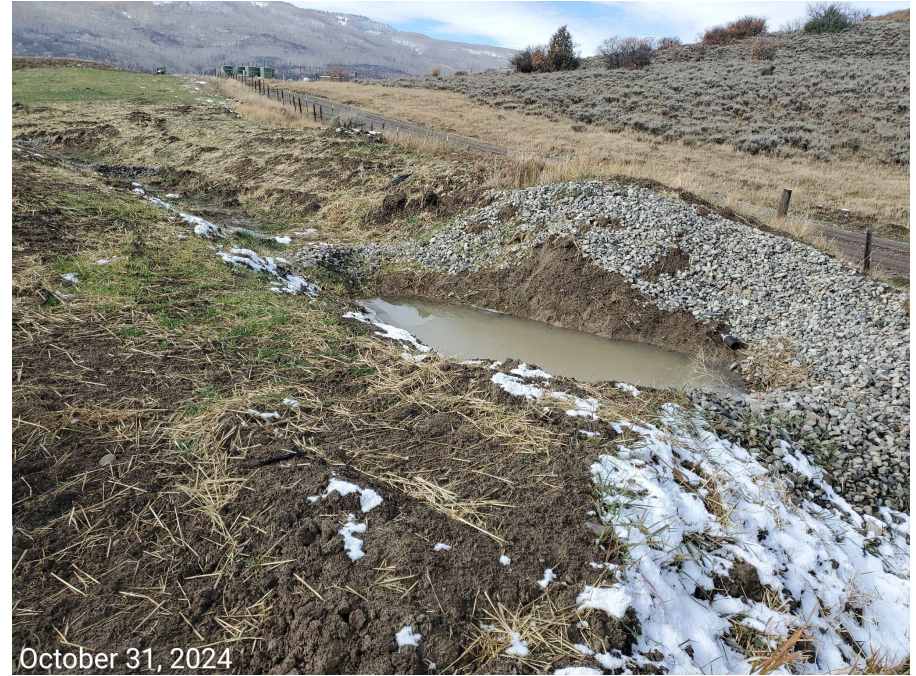
Photo 6: Photos taken from the east end of the Location, facing southwest and northwest. Photos show interim reclamation has been performed. Photo right also shows sediment trap.

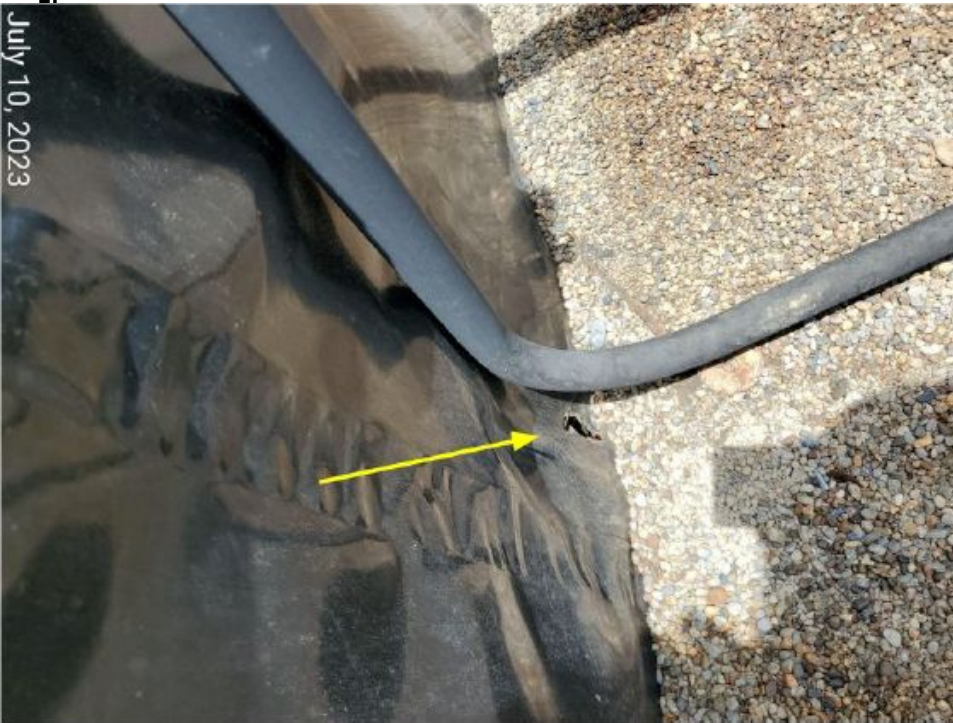
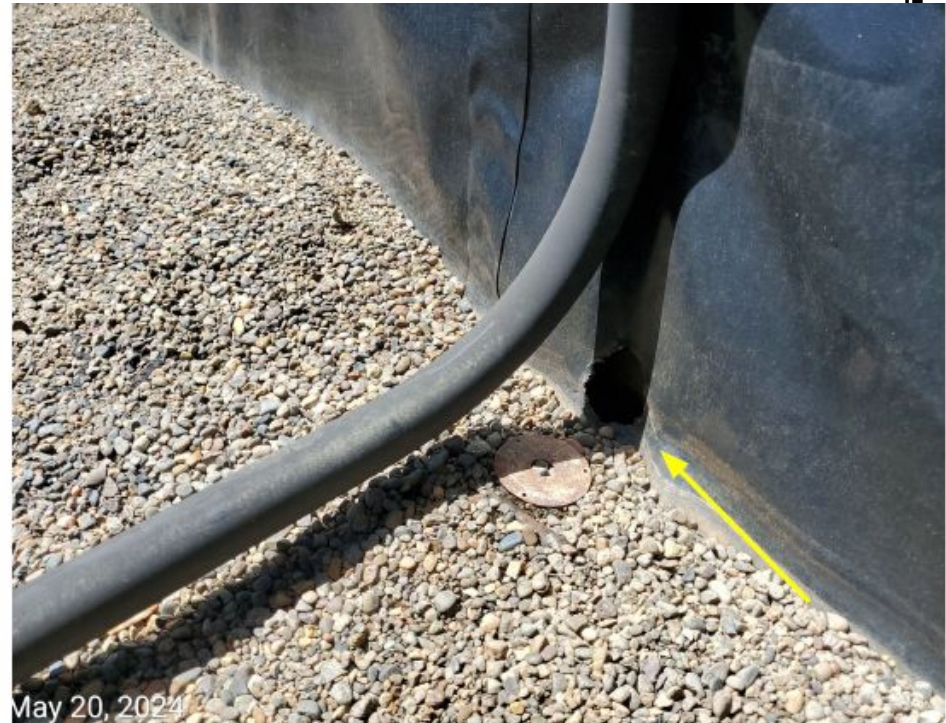
Photo 7: Photos taken from the tank battery facility on the west end of the Location. Photo left taken during the 7/10/2023 inspection; photo right taken during the 5/20/2024. Photos show hole within liner at the tank battery facility documented over multiple inspections.

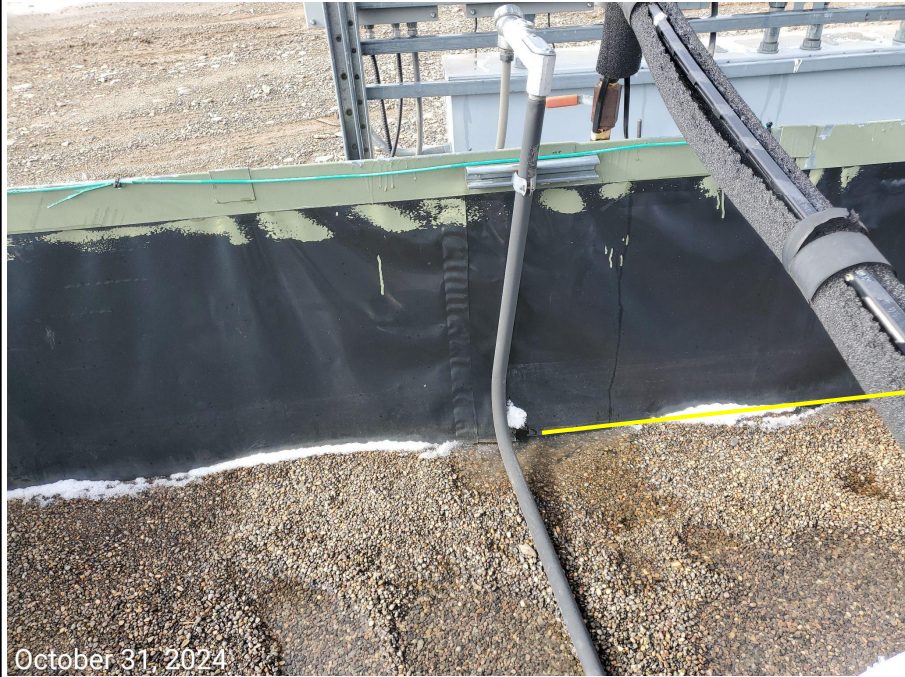
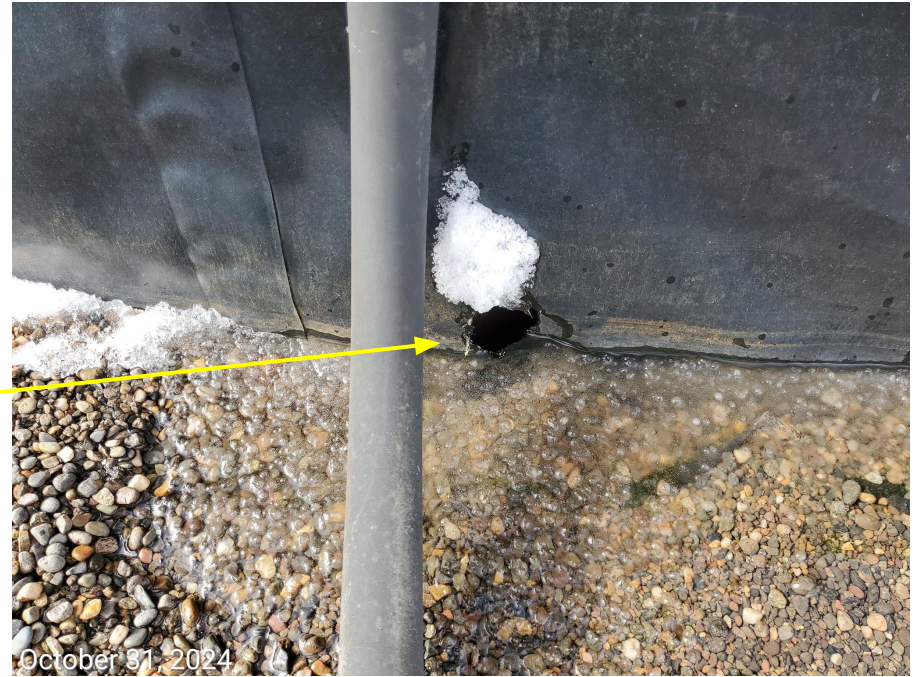
Photo 8: Continued from photo 7. Photos show hole within liner at the tank battery facility has not been repaired; work to ensure that secondary containment remains impervious to contain a spill or release has not been performed, or has been insufficient.
