Inspection Photos

Operator: GUNNISON ENERGY LLC #10515

Location ID: 324475

Inspection Doc: 696206398

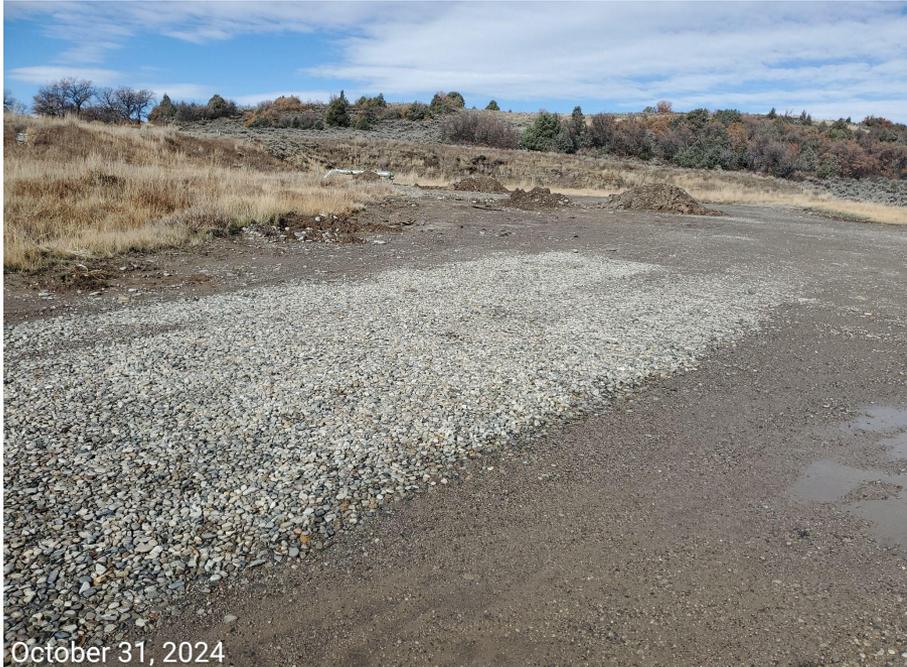
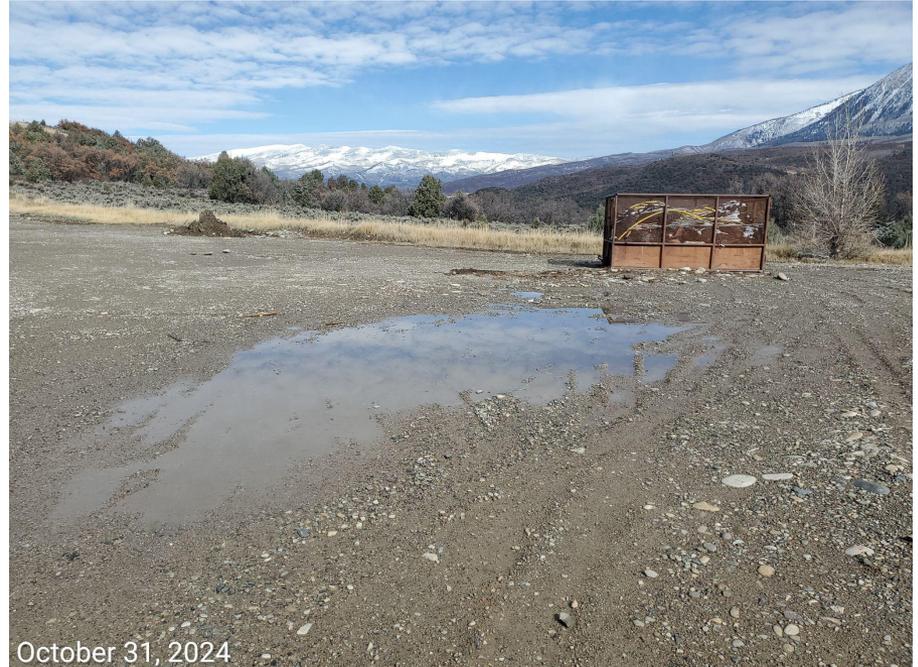
Photo 1: Photos taken from the south end of the Location. Photos provide an overview of the Location north to northeast.

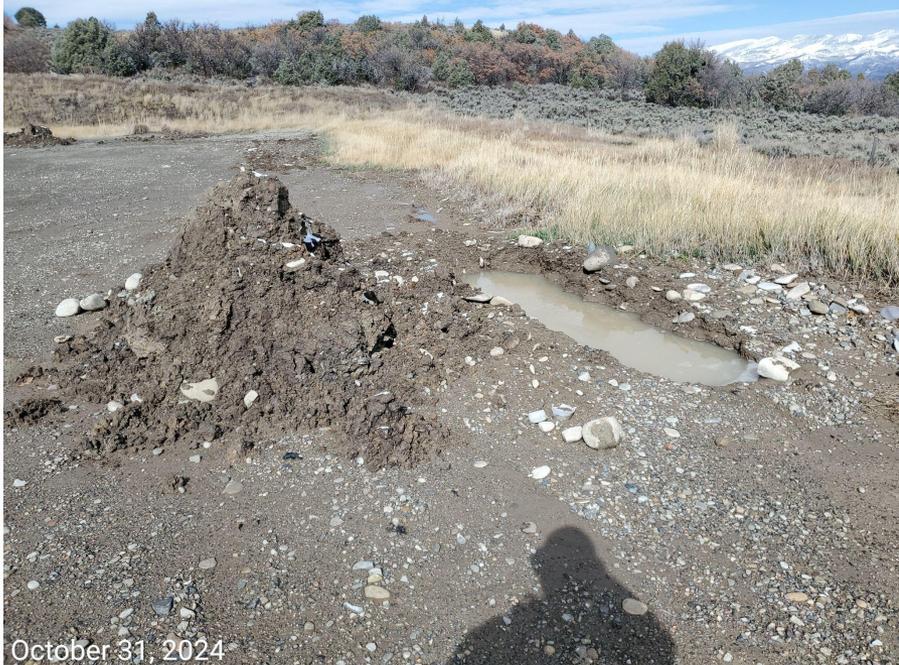
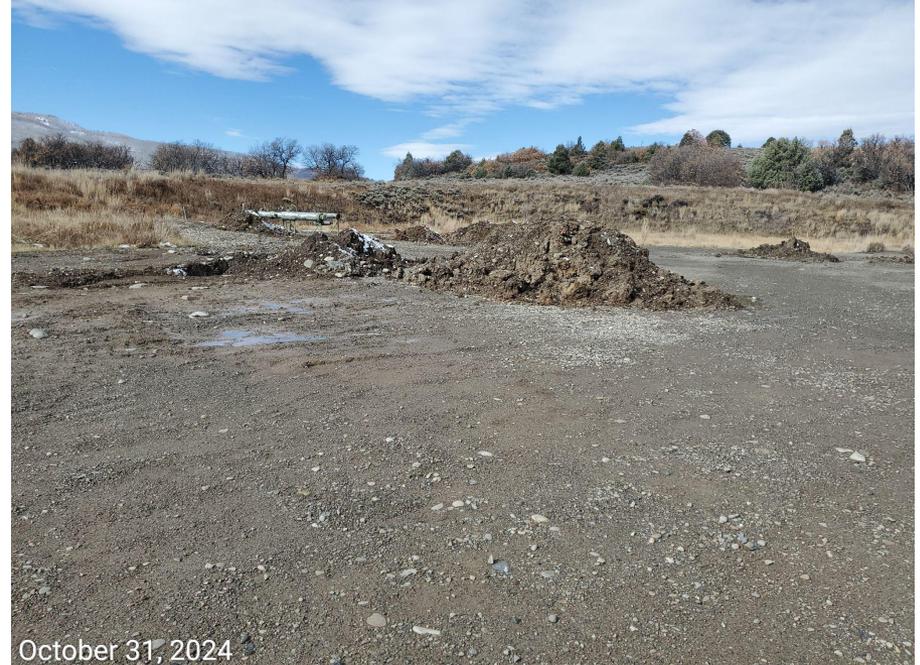
Photo 2: Photos 2-3 examples showing excavations missing required fencing, and stockpiled soils missing BMPs pursuant to Rules 1002.c and 1002.f.

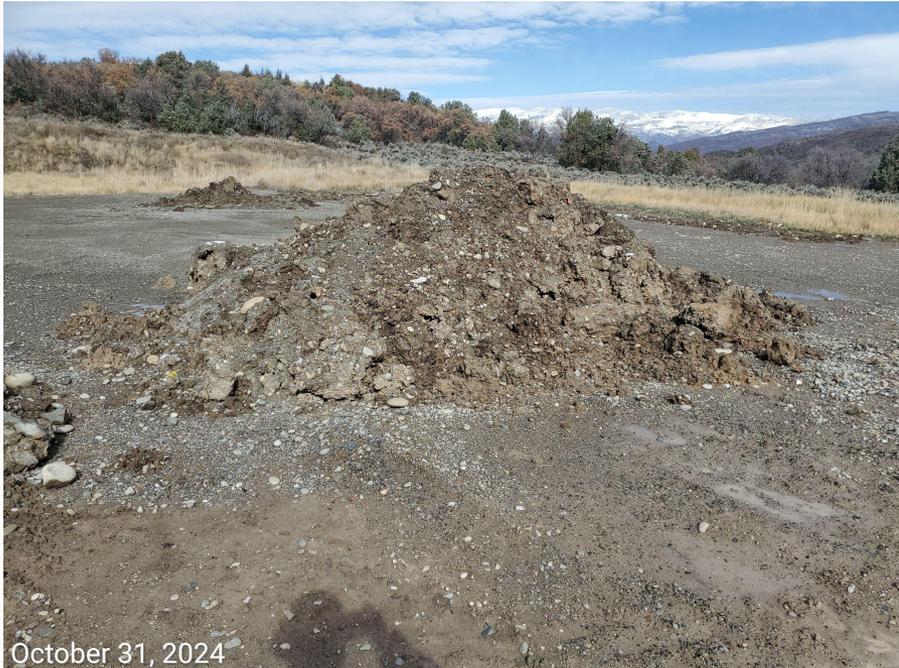
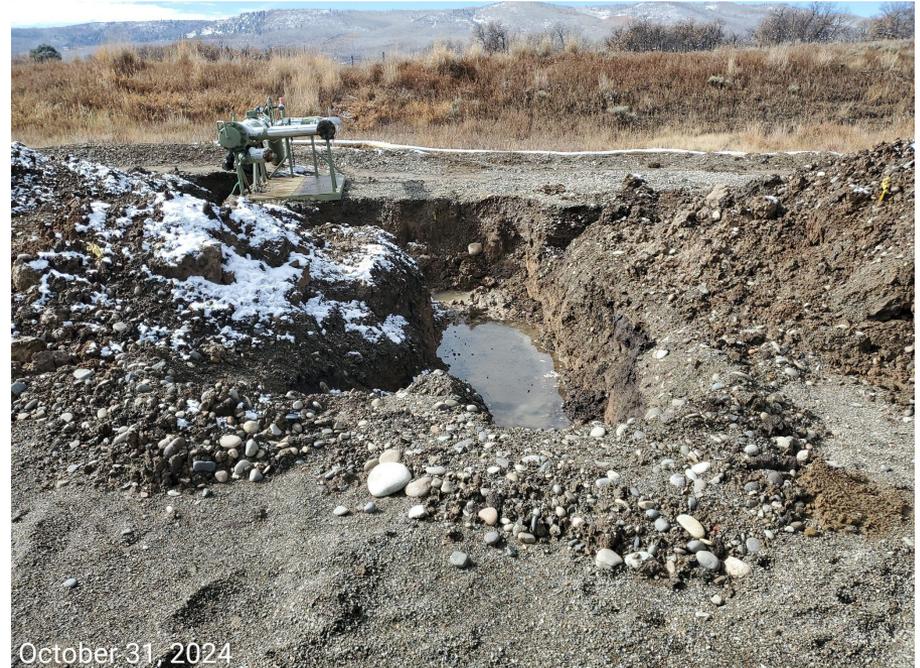
Photo 3: See comments under photo 2. Pipe/Equipment in photo right requires removal pursuant to 1004 requirements.

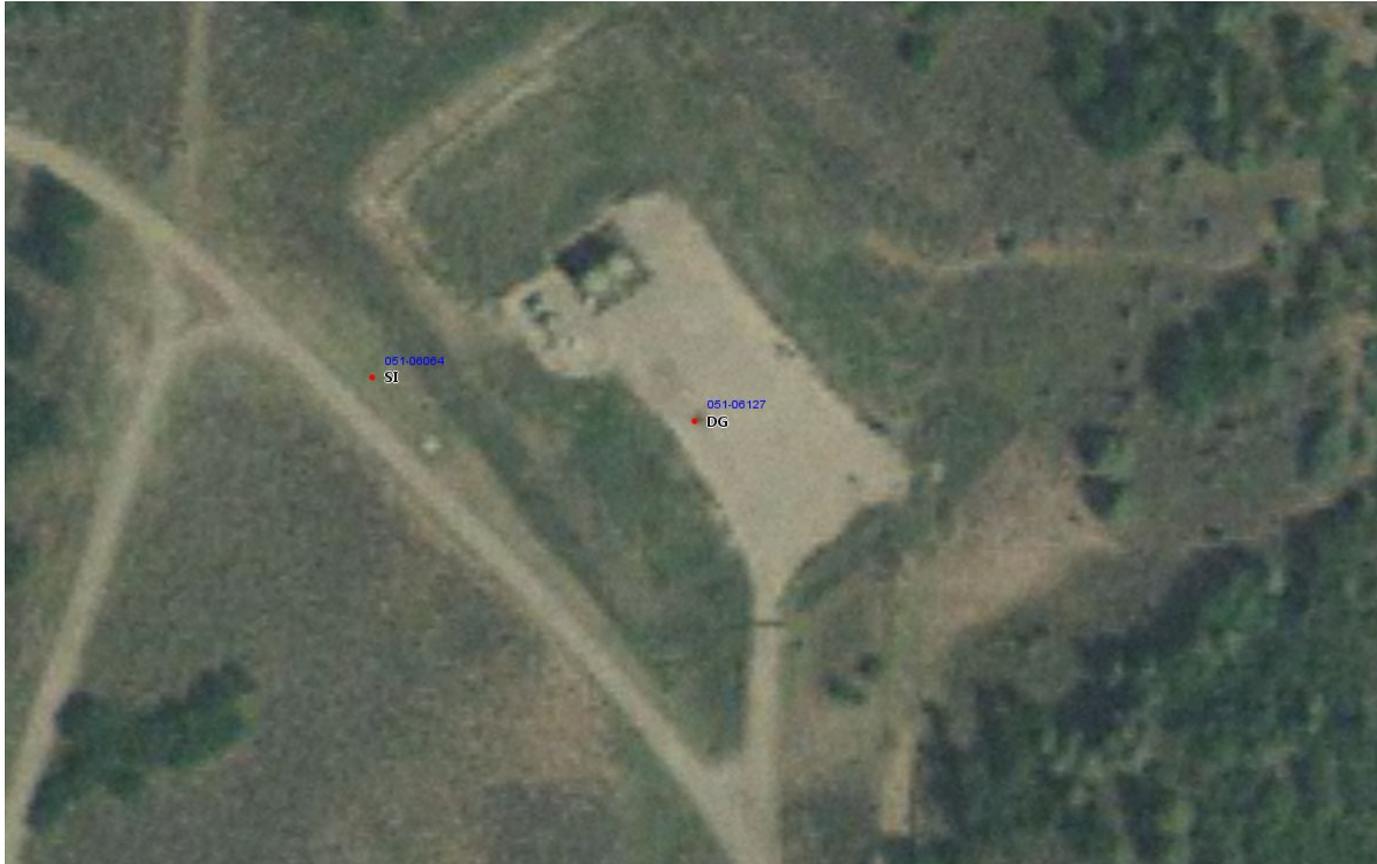
Photo 4: COGIS Imagery showing wells- Photo shows “as drilled” coordinates for well API 05-051-06064 are incorrect.
