# SITE-SPECIFIC QUALITY ASSURANCE & QUALITY CONTROL AUDIT

## Final Reclamation Complete Notice – Cropland Drone Imagery

### PERMIT CLOSURE REPORT – CROPLAND

**Location Name** REGNIER FARMS-62N68W/19NWNE

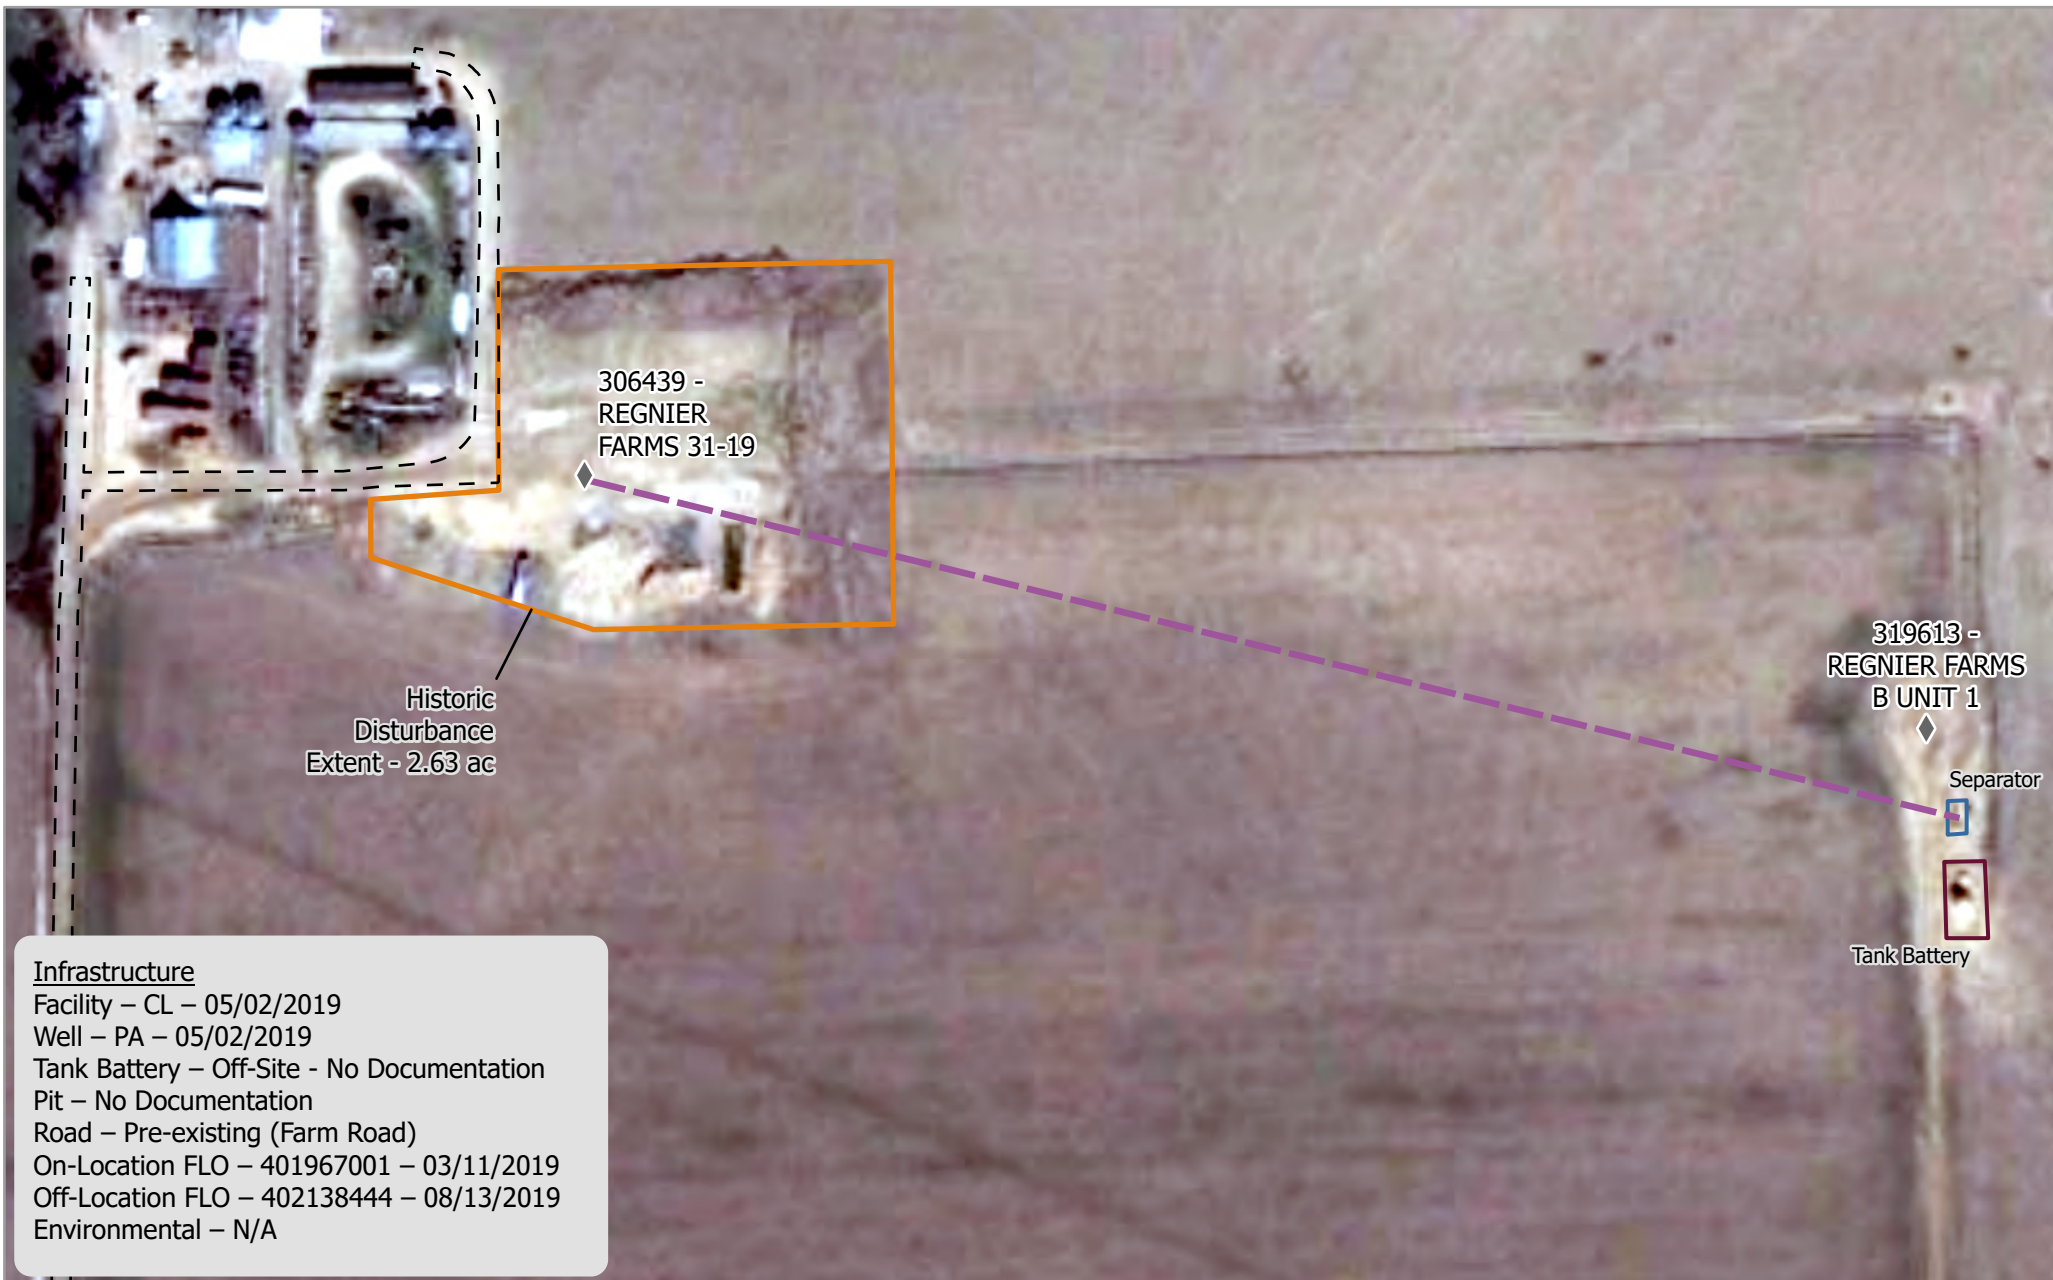
**CIV - 306439- REGNIER FARMS 31-19**  
**Map Extent - Pre-Plugging Overview**

Imagery: Maxar  
Imagery Date: 2 Apr 2007  
Map Date: 09 Oct 2024  
Datum: WGS 1984 UTM Zone 13N  
POC: Soil Sage

Total Disturbance:  
2.63 Acres  
Scale: 1:2,000

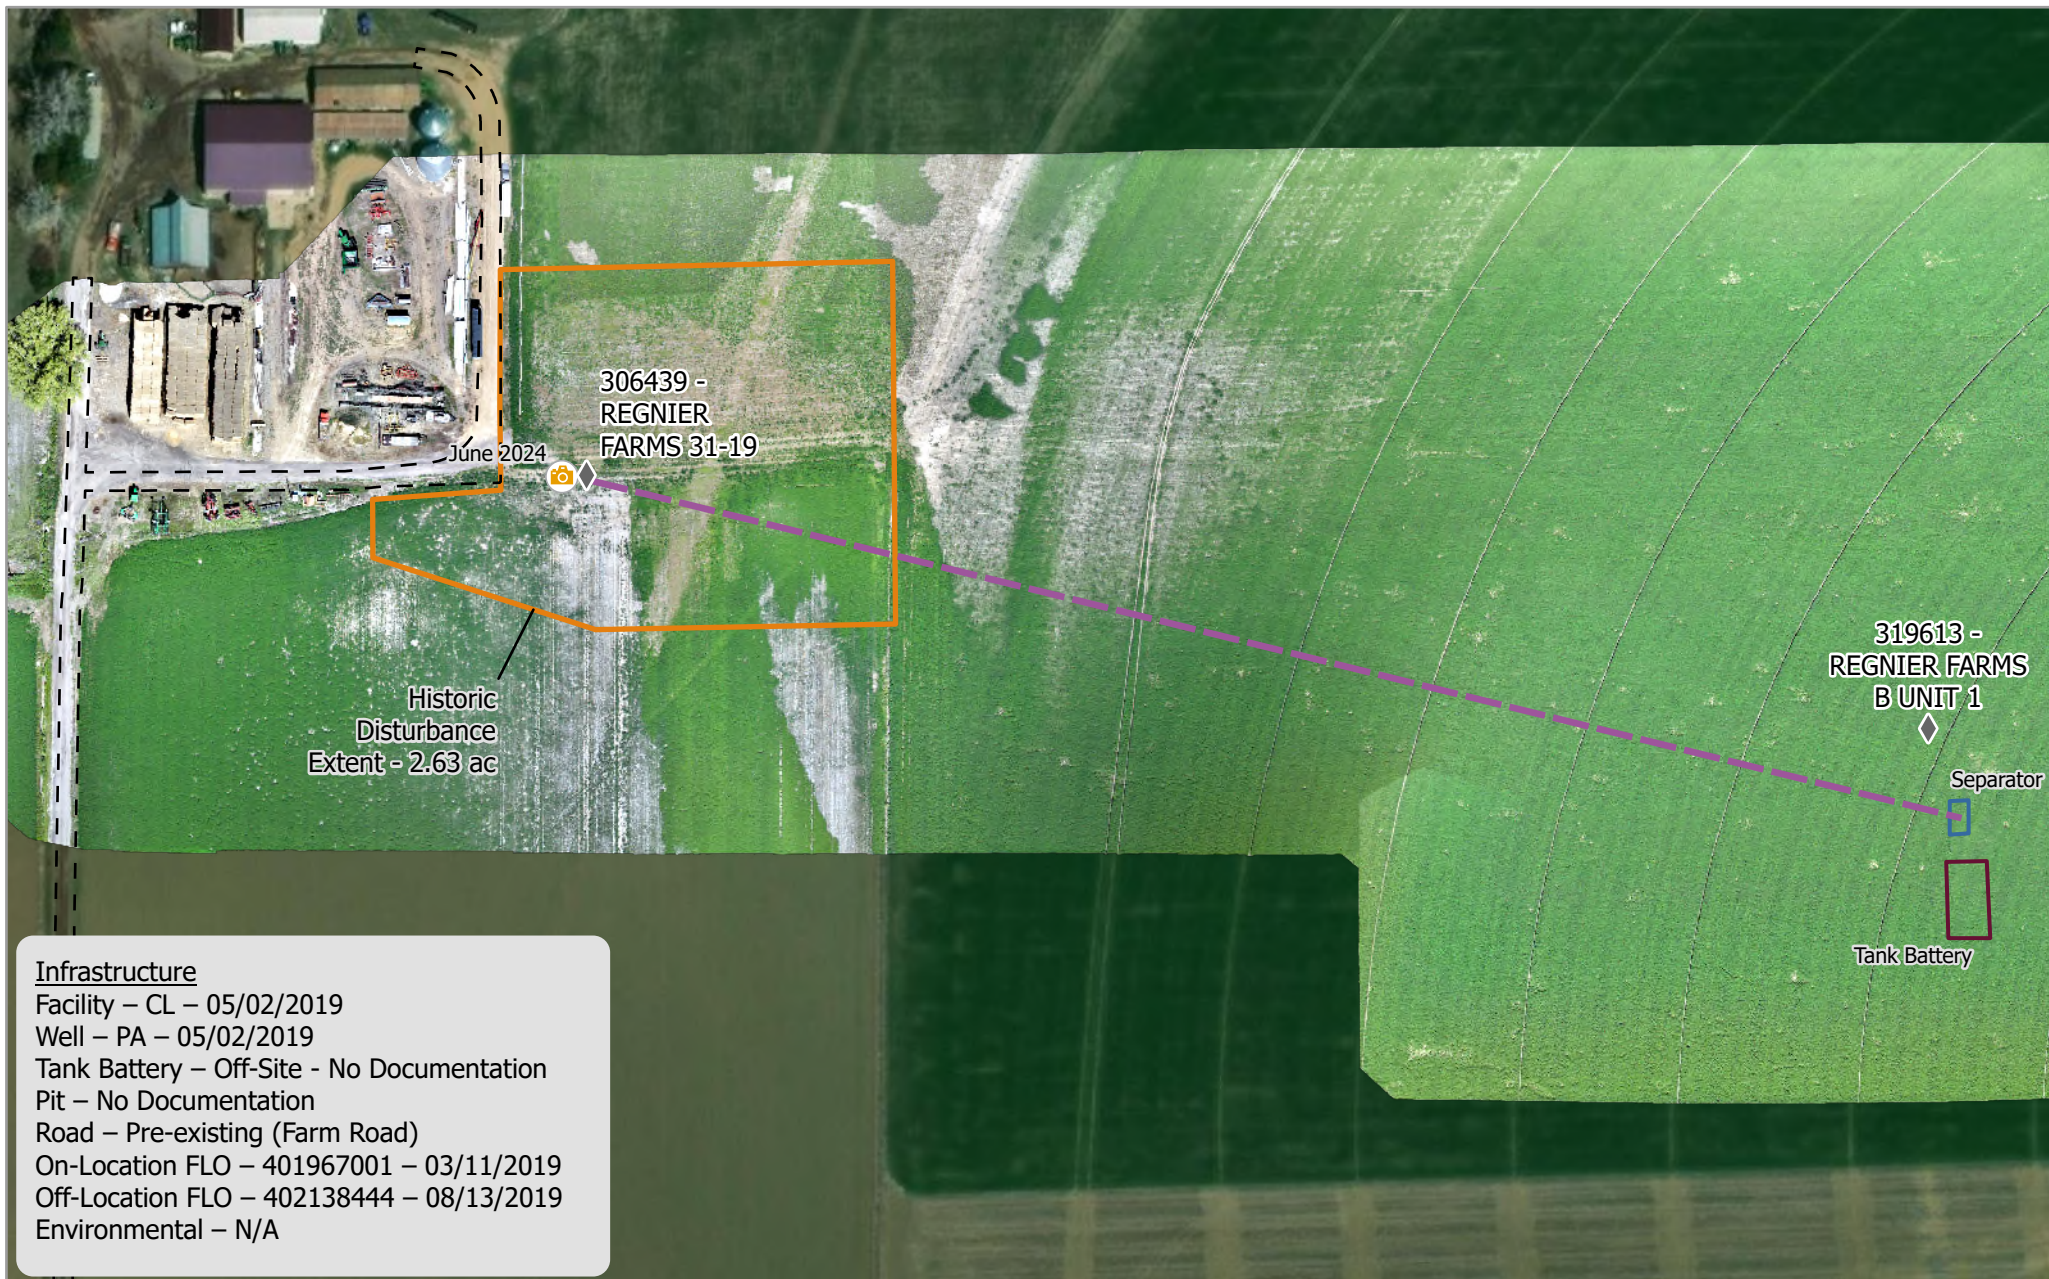
## CIV - 306439- REGNIER FARMS 31-19 Map Extent - Post-Plugging Overview

Soil Sage drone imagery confirms that no equipment was left on site at this location after reclamation activities occurred.

Imagery: RS Orthomosaic  
 Imagery Date: 23 September 2024  
 Map Date: 09 Oct 2024  
 Datum: WGS 1984 UTM Zone 13N  
 POC: Soil Sage

Total Disturbance:  
 2.63 Acres  
 Scale: 1:2,000

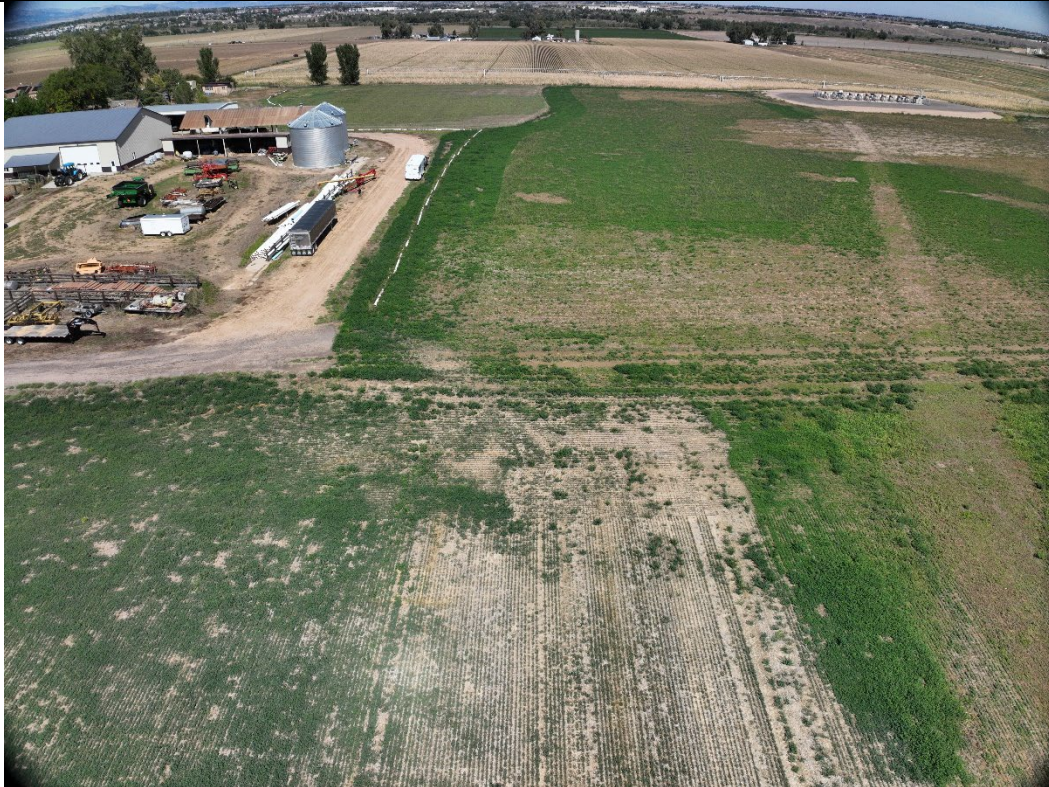
**NORTH** – 40.128798 / -105.044509

**In View** – Well, Access Road, Flowline

\*Active Location ID [451044](#) in background not associated with Location ID [306439](#)

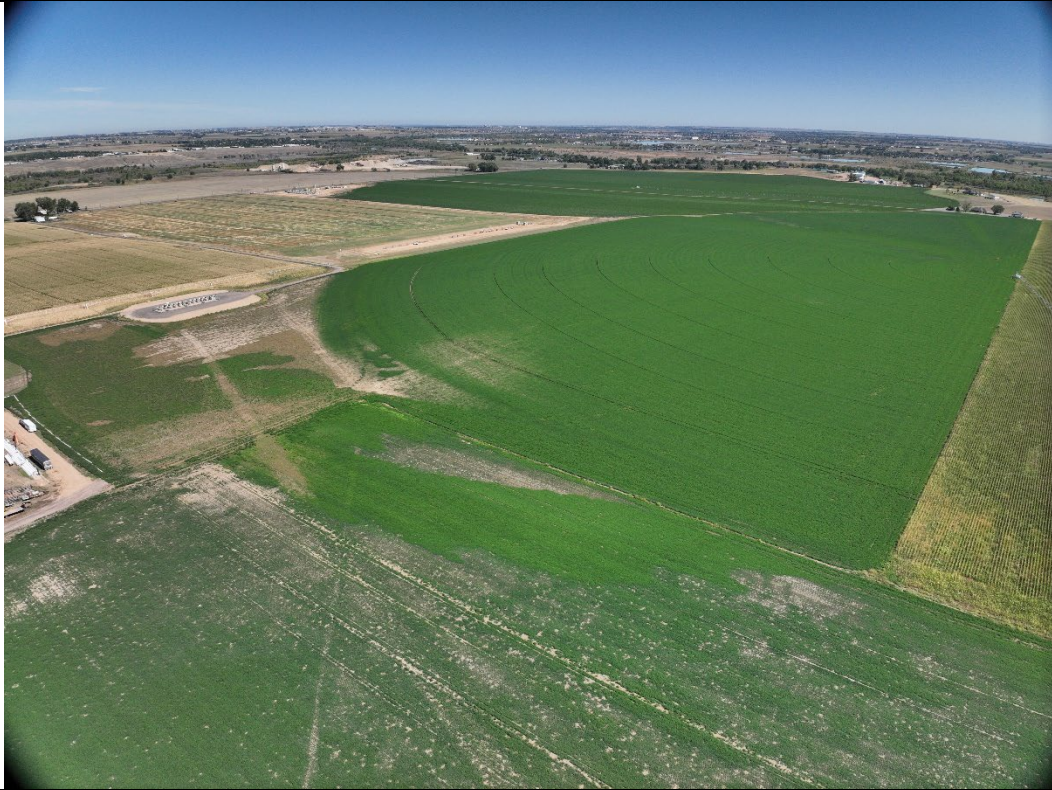
**NORTHEAST – 40.127309 / -105.045568**

**In View – Well, Tank Battery, Access Road, Flowline**

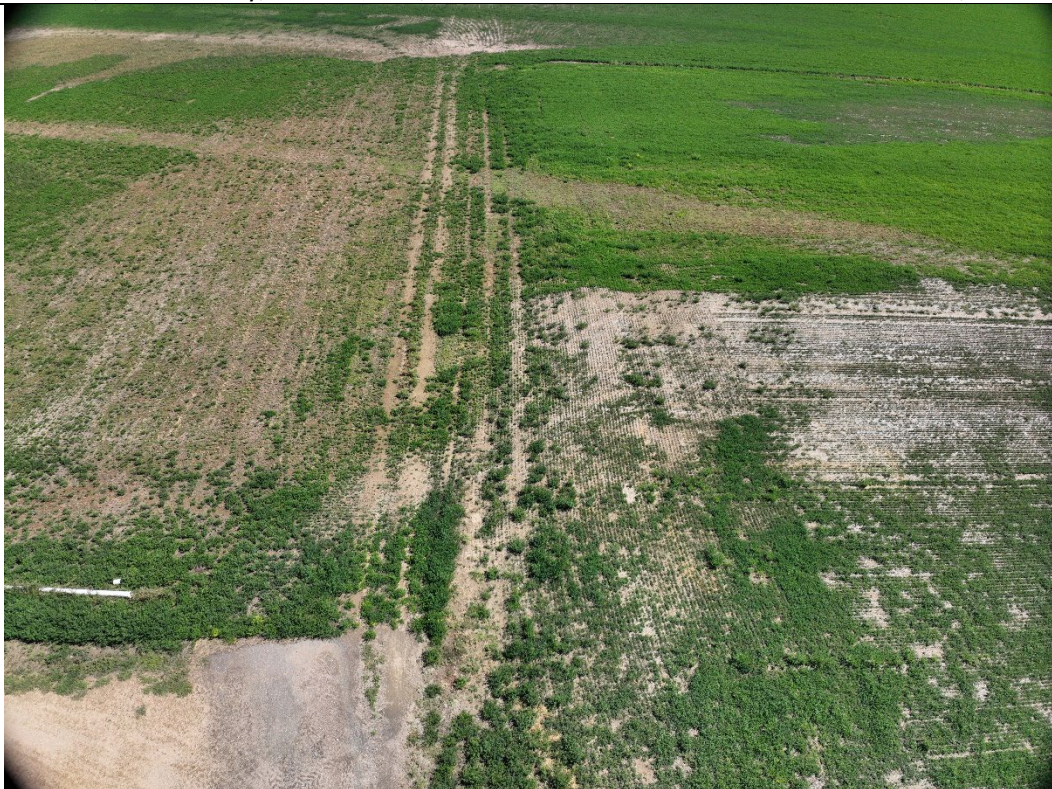
**EAST – 40.129372 / -105.044920**

**In View – Well, Access Road, Flowline**

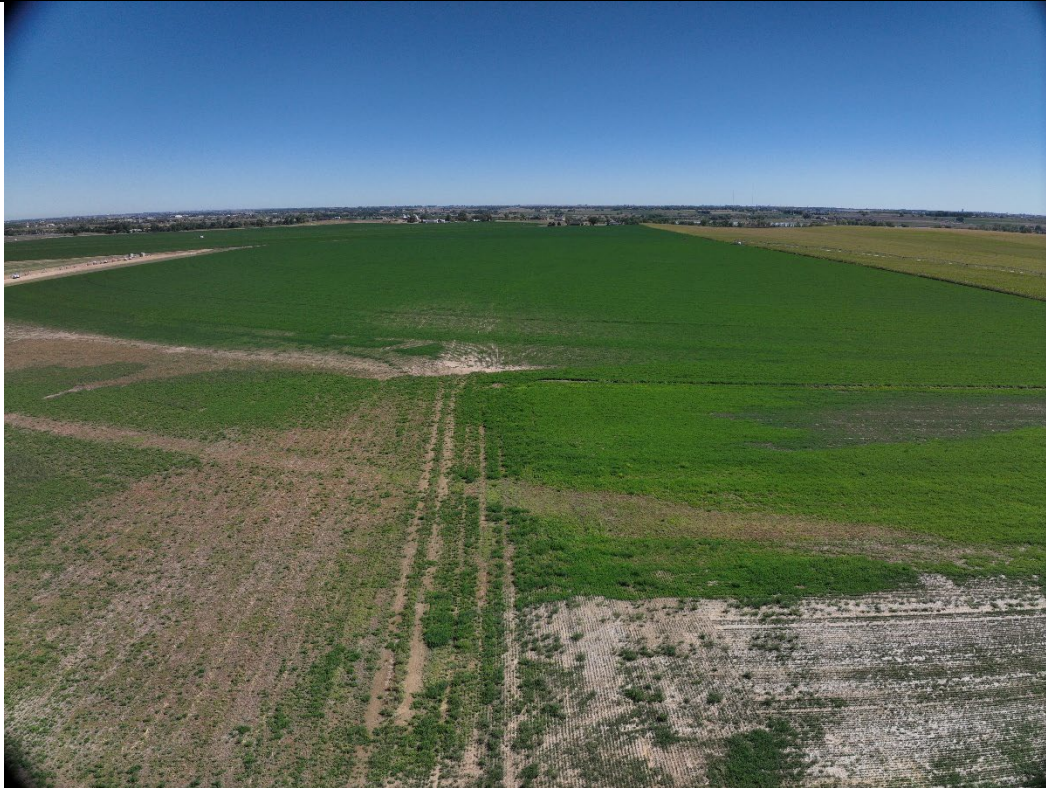
**EAST** – 40.129238 / -105.044921

**In View** – Well, Tank Battery, Access Road, Flowline

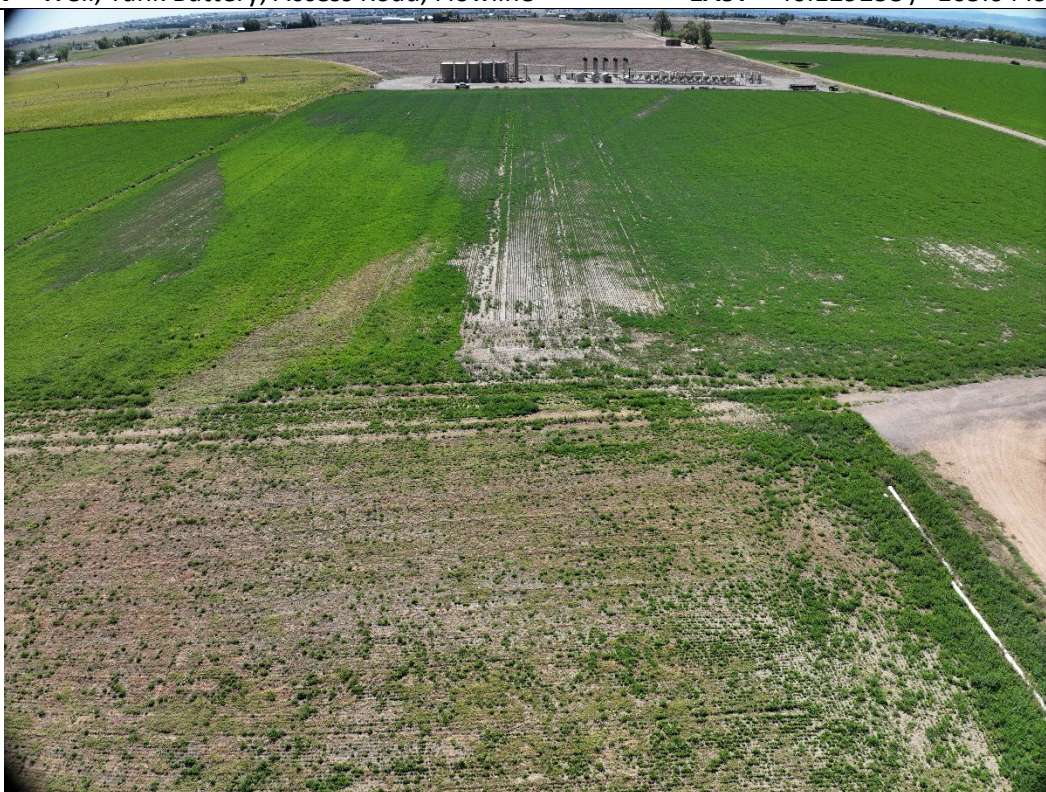
**SOUTH** – 40.129738 / -105.044412

**In View** – Well, Access Road, Flowline

\*Active Location ID [451039](#) in background not associated with Location ID [306439](#)

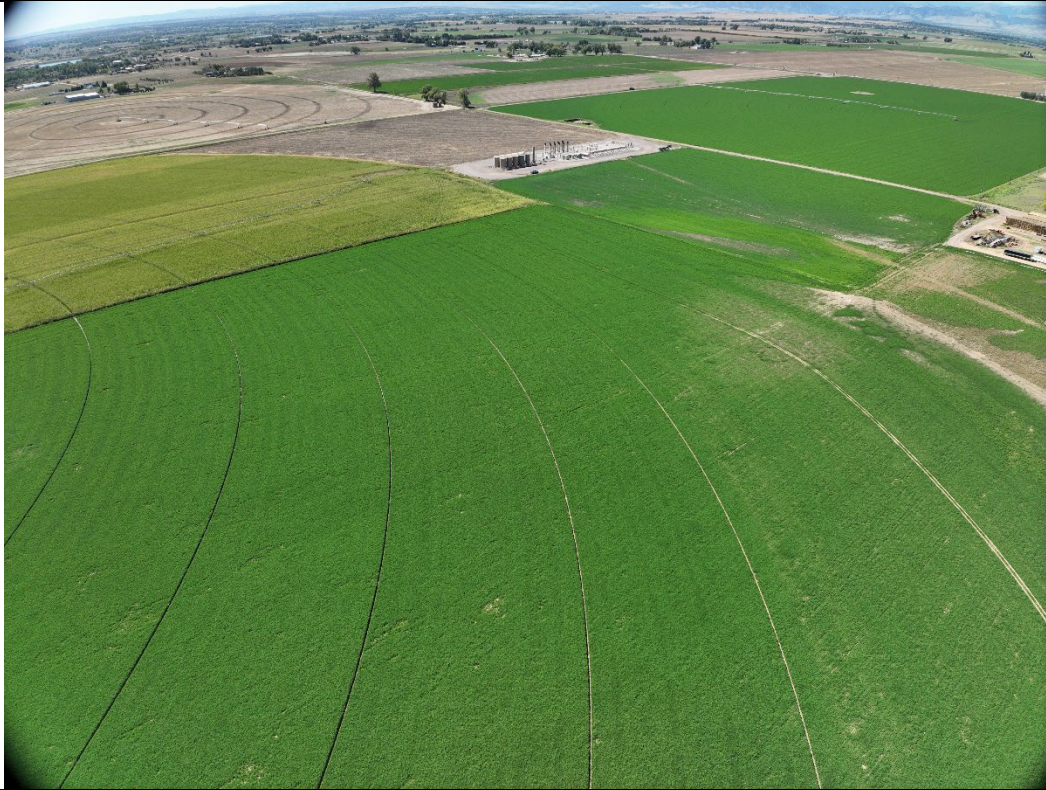
**SOUTHWEST** – 40.130520 / -105.040206

**In View** – Well, Tank Battery, Access Road, Flowline

\*Active Location ID [451039](#) in background not associated with Location ID [306439](#)

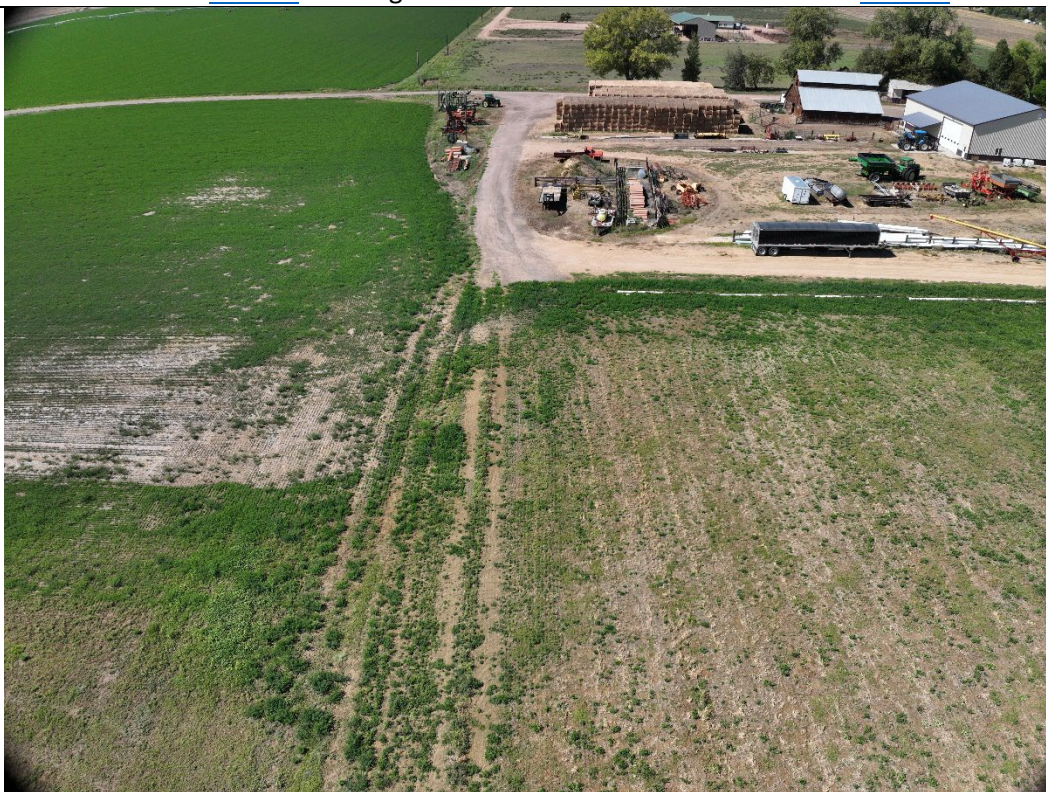
**WEST** – 40.129357 / -105.043935

**In View** – Well, Access Road, Flowline

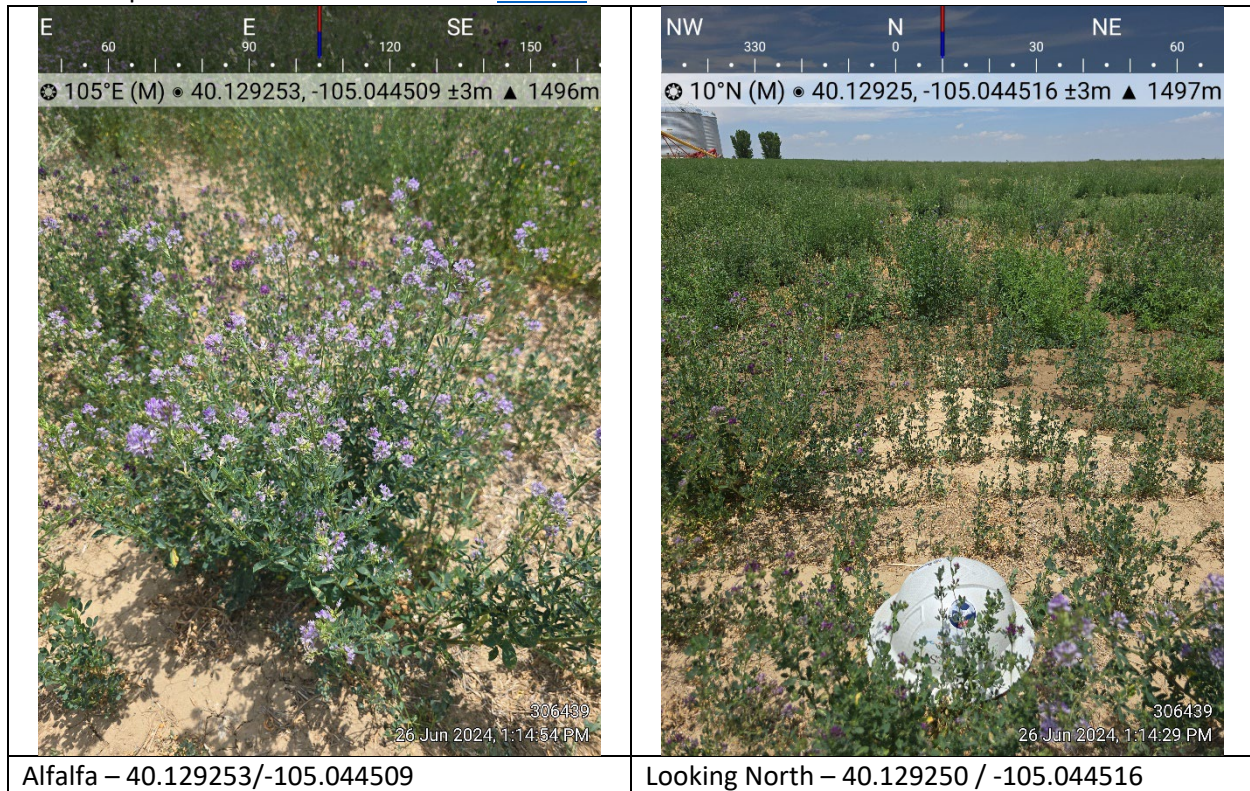
Looking Southwest – 40.129246/-105.044522

Handheld photos taken from Location ID [306439](#) wellhead.

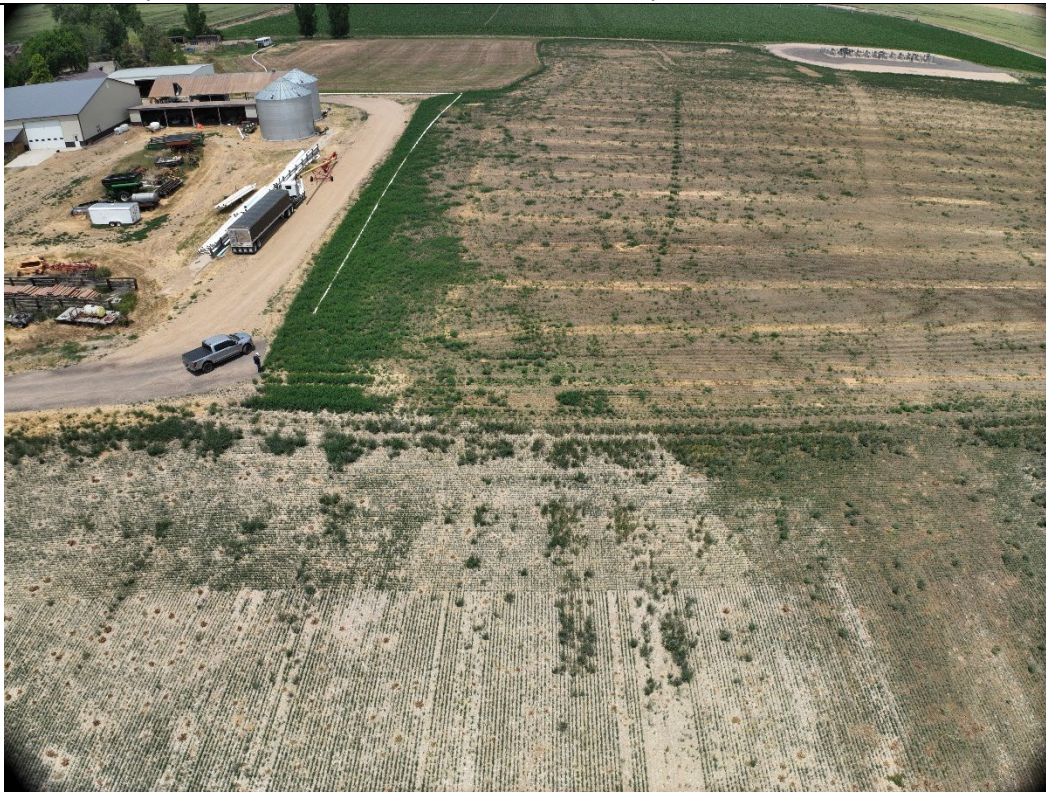
**NORTH** – 40.128859 / -105.044438

**In View** – Well, Access Road, Flowline

\*Active Location ID [451044](#) in background not associated with Location ID [306439](#)

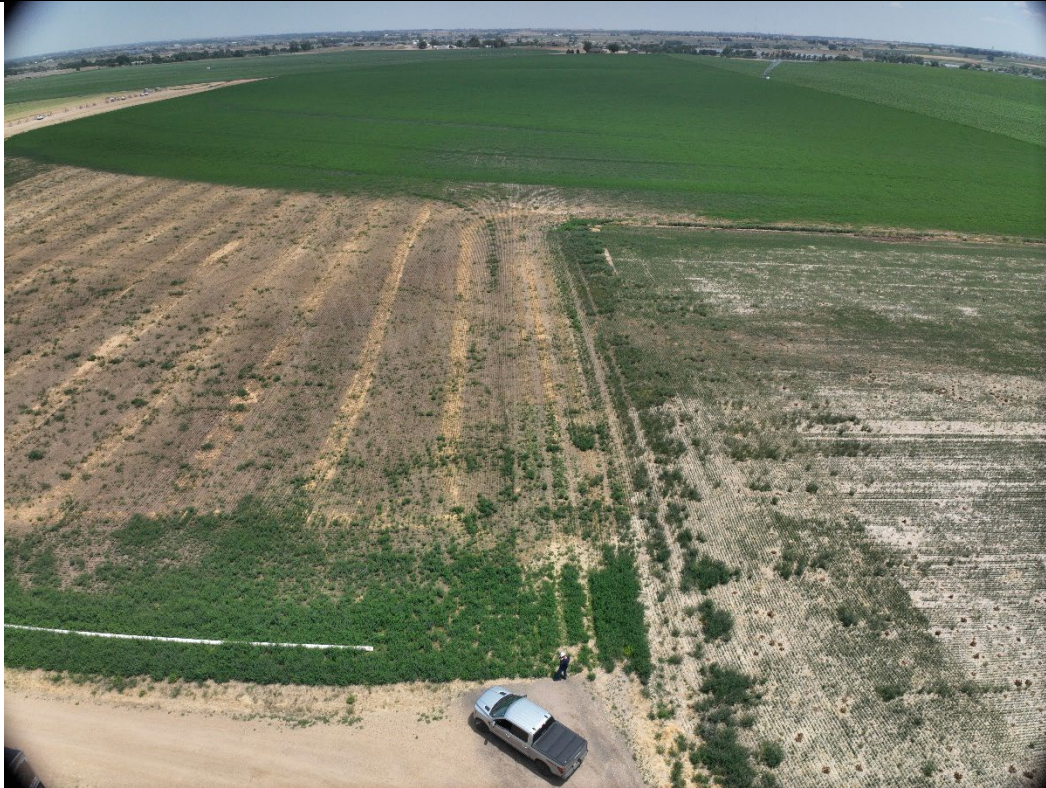
**EAST** – 40.129323 / -105.045022

**In View** – Well, Tank Battery, Access Road, Flowline

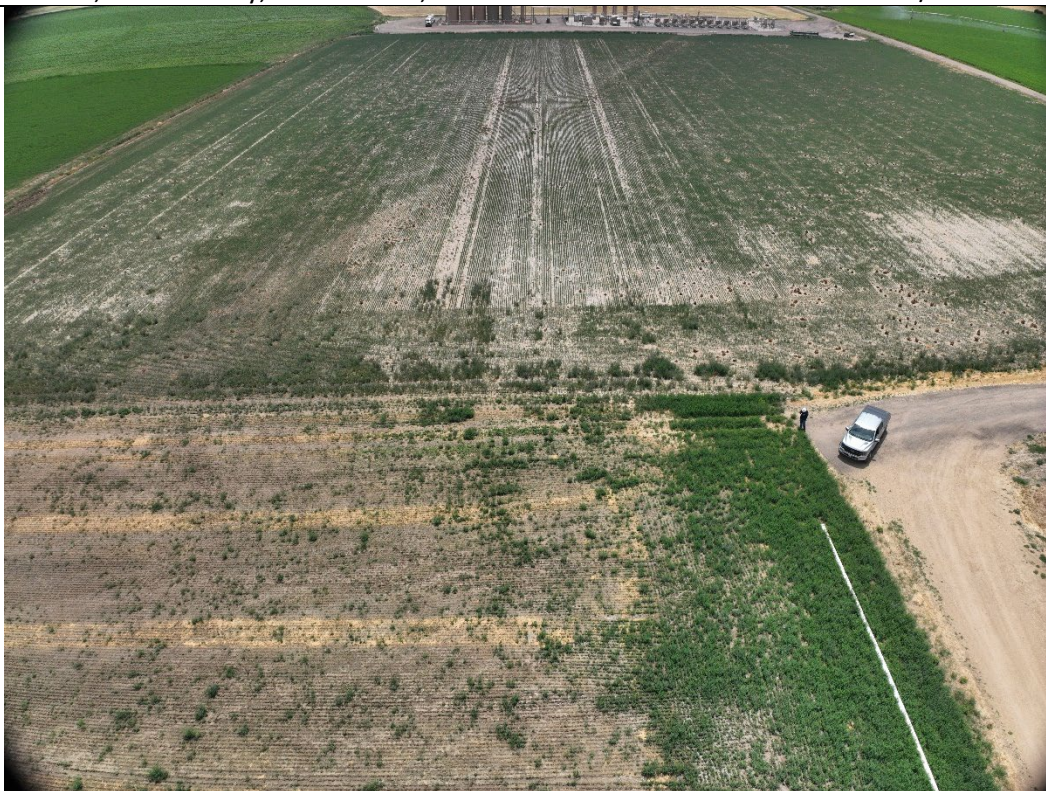
**SOUTH** – 40.129693 / -105.044481

**In View** – Well, Access Road, Flowline

\*Active Location ID [451039](#) in background not associated with Location ID [306439](#)

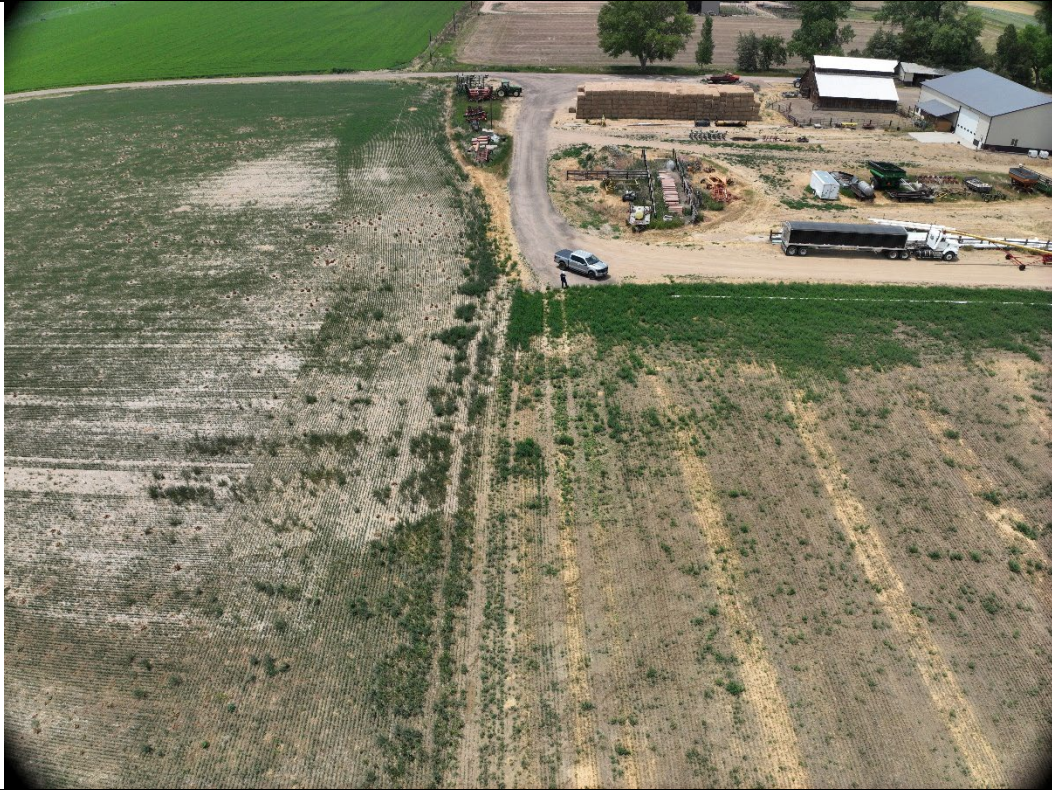
**WEST** – 40.129297 / -105.043940

**In View** – Well, Access Road, Flowline

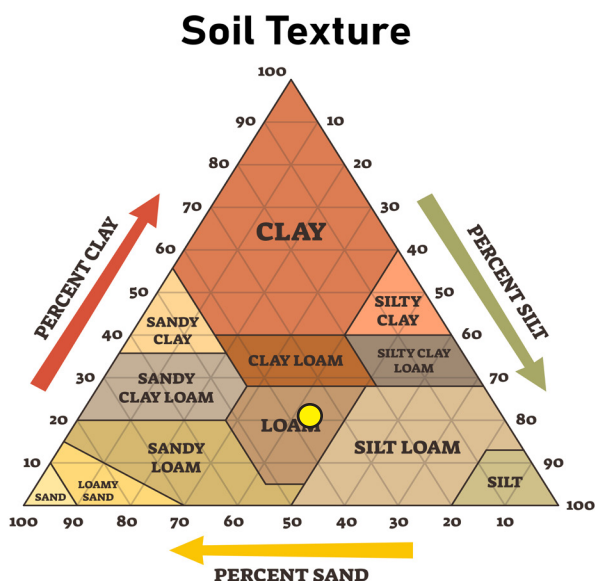
### Soil Texture Triangle reflect the 0-10 in depth

Depth (in)	Physical			Chemical			
	Texture	Bulk Density	Particle Size Percent sand, silt, clay	pH	EC	SAR	OM%
0-7	Loam	1.33	37-42-21	7.9	0.0	0.0	1.25
7-60	Silt Loam	1.23	10-68-23	7.9	0.0	0.0	0.75
