Final Reclamation Inspection

Operator: RENEGADE OIL & GAS COMPANY LLC - 74165

Location ID: 418097

Inspection Photos
Location Name: STATE OF COLORADO #2-33
Location ID: 418097

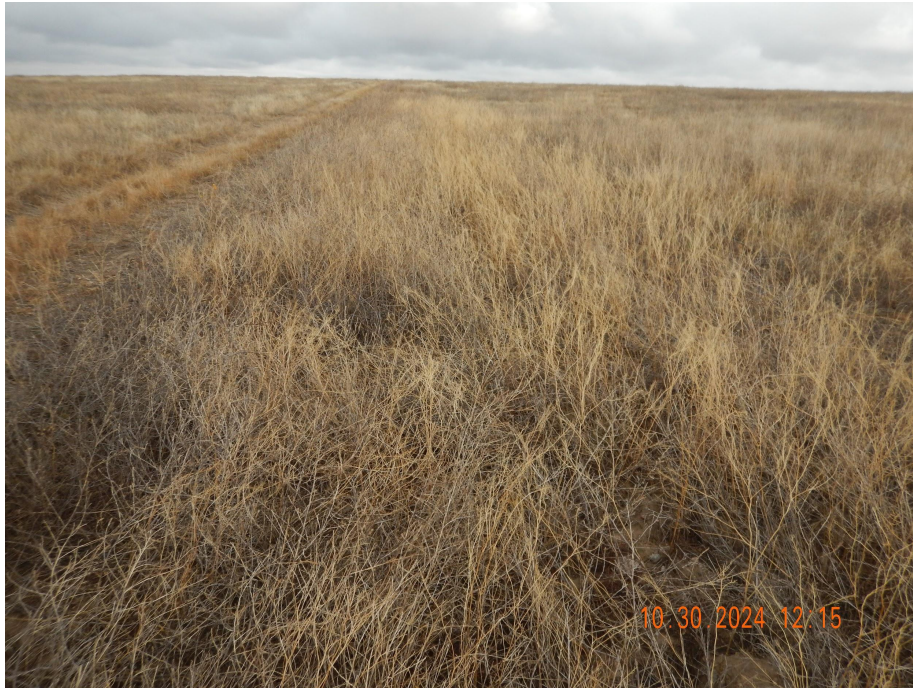
Photo 1. Photo taken from the western portion of the access road, facing East. Photo illustrates this section is dominated by annual, weedy vegetation.

Note- this section of road may get re-disturbed by another Operator on a new, proposed oil and gas location.

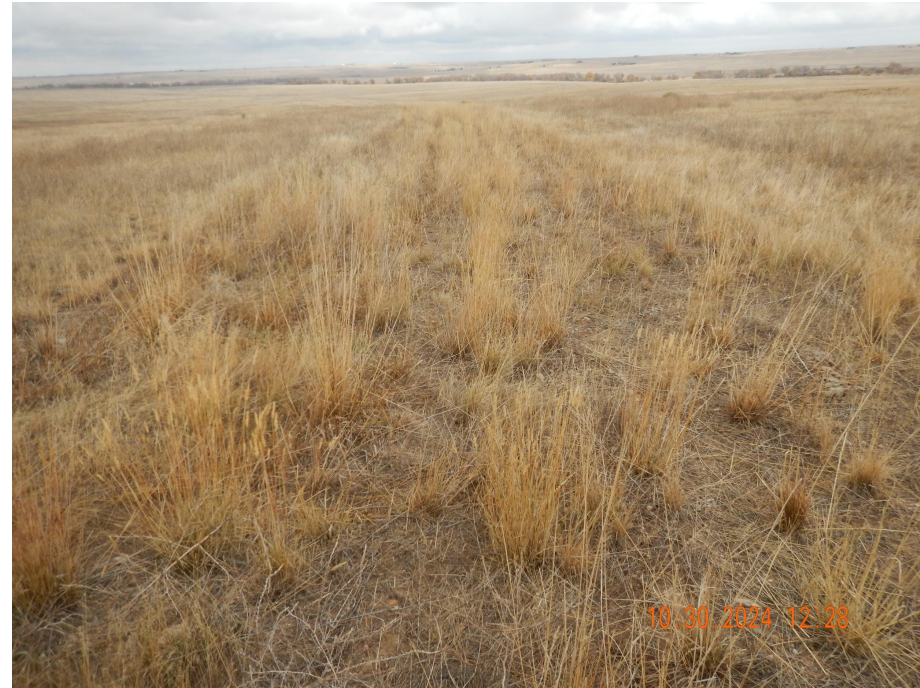
Photo 2. Photo taken from the approximate halfway point of the access road, facing East. Photo illustrates the establishment of introduced, perennial grasses (Crested wheatgrass), which was not part of the SLB seed mixture.

See Photo 3 for a close up of Crested wheatgrass.

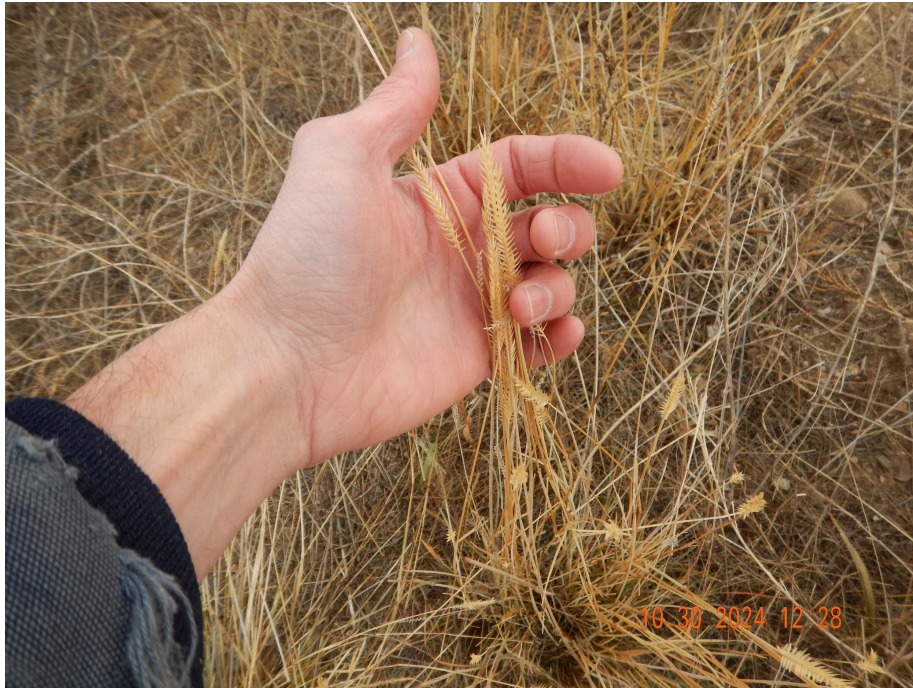
Photo 3. Photo illustrates the introduced, perennial Crested wheatgrass.

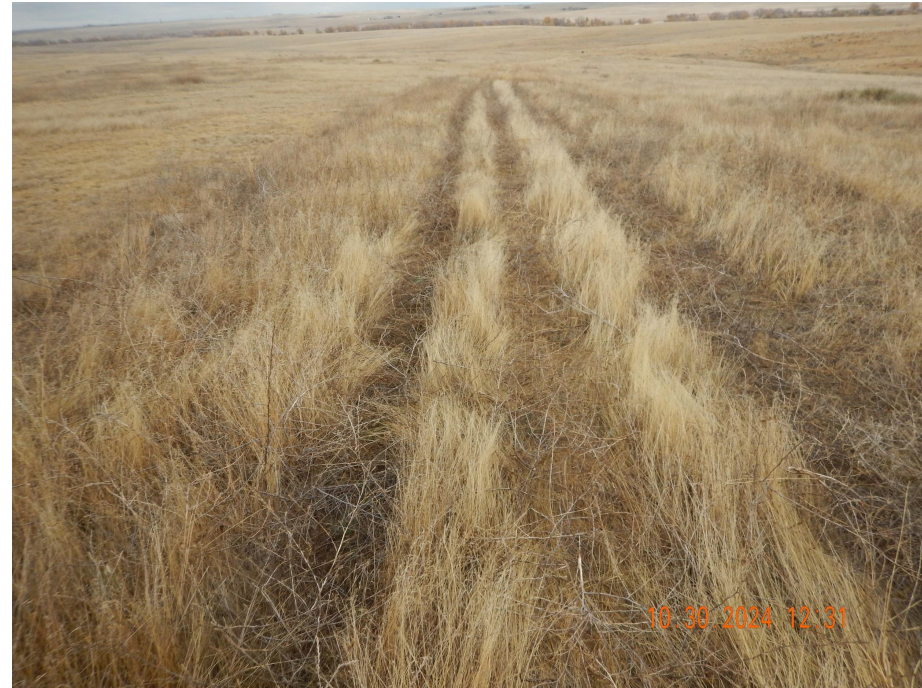
Photo 4. Photo taken from a portion of eastern access road, facing East. Photo illustrates the establishment of Cheatgrass, a List C noxious weed species.

See Photo 5 for a close up of Cheatgrass.

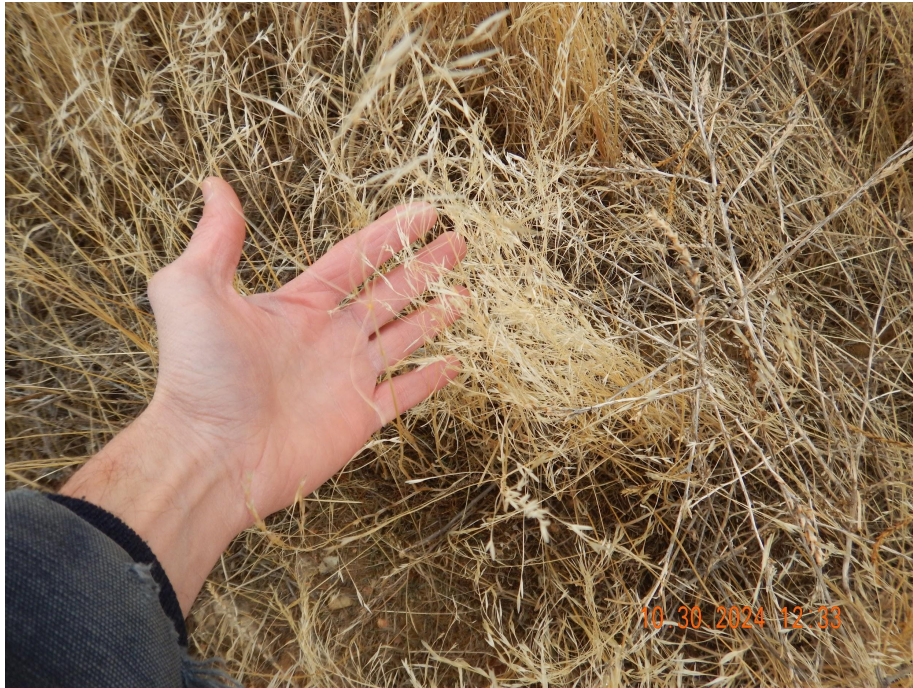
Photo 5. Photo illustrates Cheatgrass.

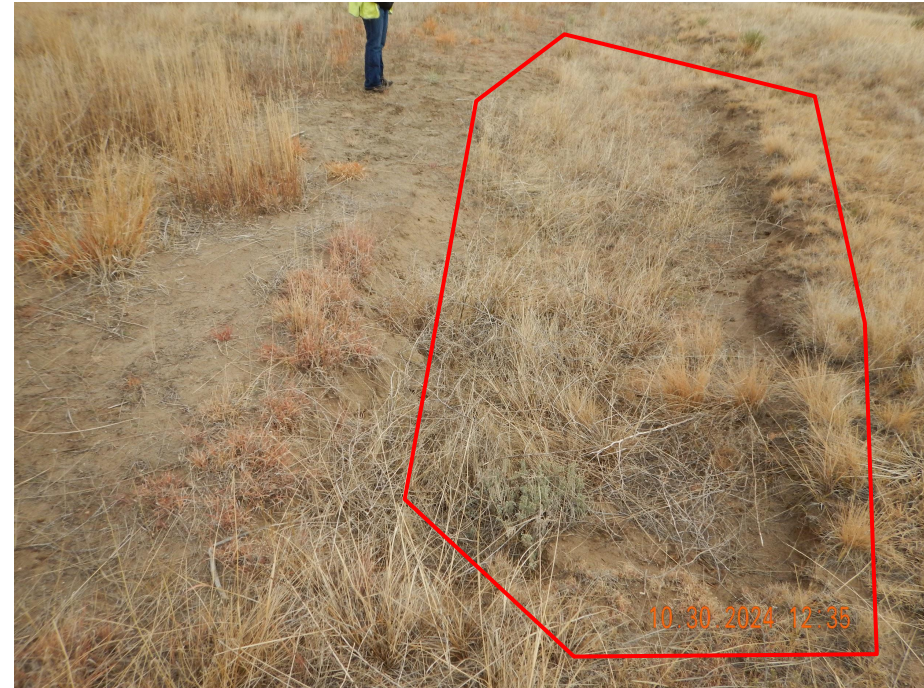
Photo 6. Photo taken from a portion of eastern access road just west of the location, facing East. Photo illustrates a portion of the access road that was not properly recontoured with evidence of historic erosion. Given the proximity to surface water (creek drainage), this shall be recontoured and long-term stabilization through revegetation.

Also, refer to Photo 11.

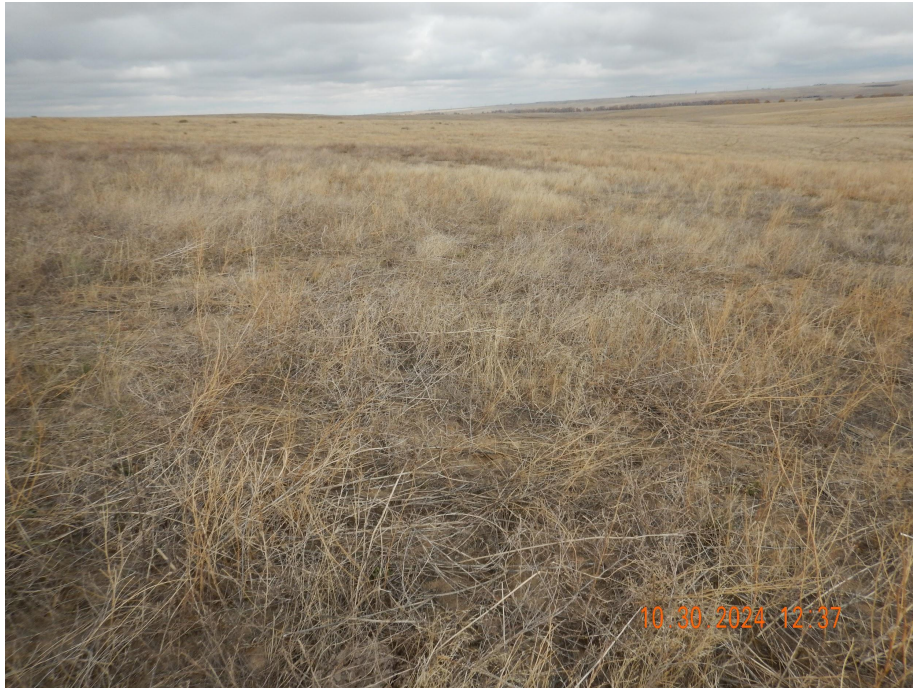
Photo 7. Photo taken from the central location, facing North. Photo illustrates much of the location is weedy, annual vegetation with some germination of perennial grasses. It does not appear that weed management has been performed. Again, perennial grasses are mostly introduced species not reflective of reference areas and not approved by the SLB.

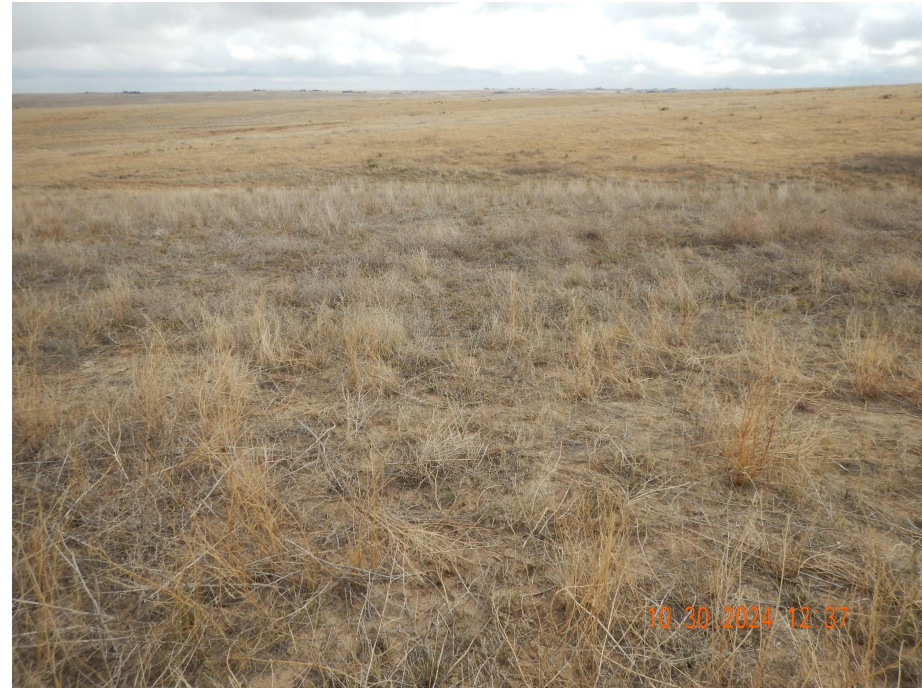
Photo 8. Photo taken from the central location, facing East. See comments under Photo 7.

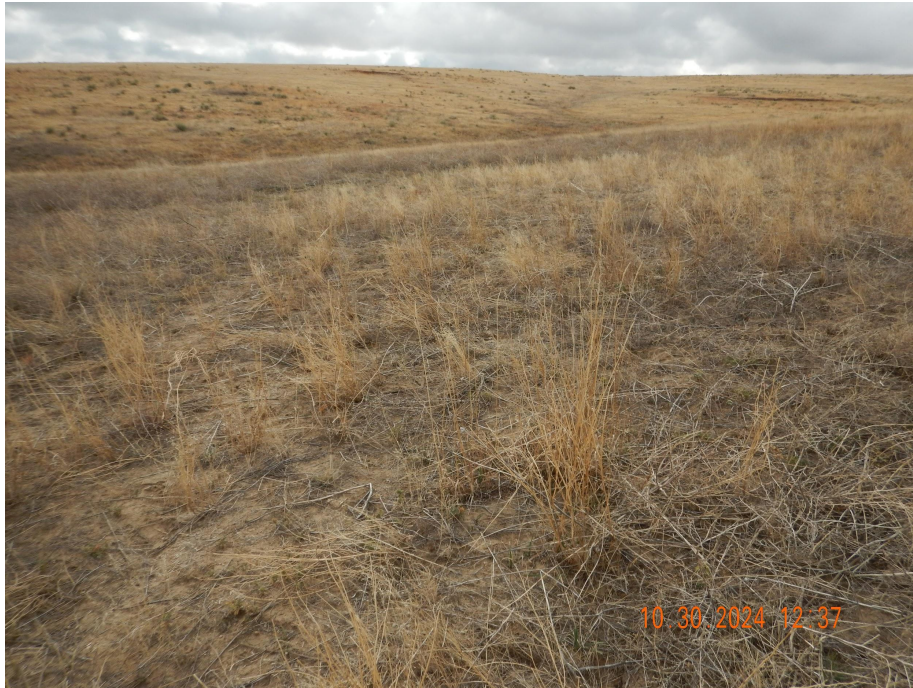
Photo 9. Photo taken from the central location, facing South.
See comments under Photo 7.

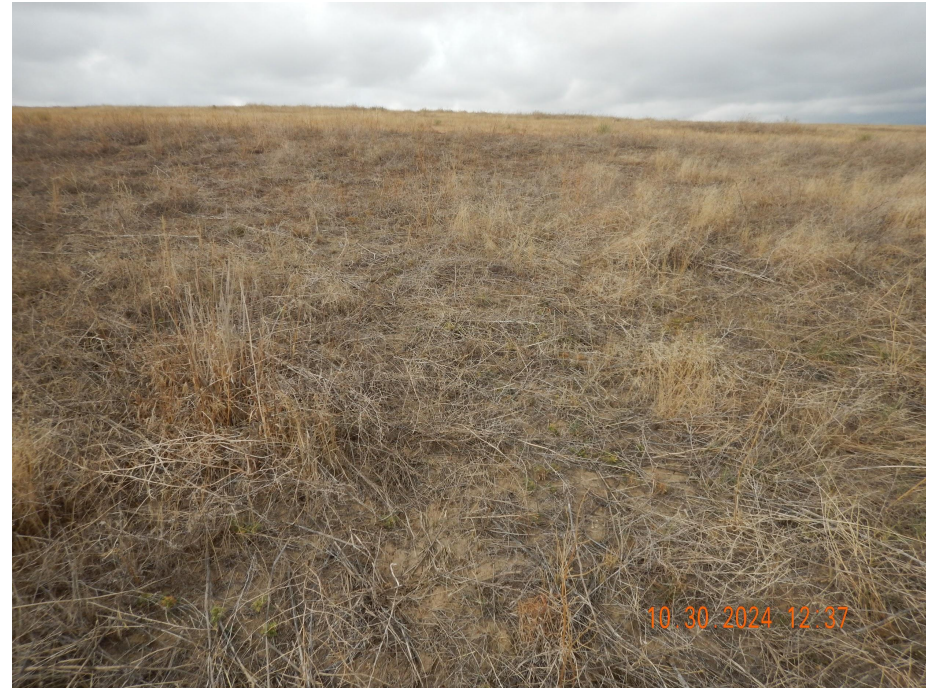
Photo 10. Photo taken from the central location, facing West.
See comments under Photo 7.

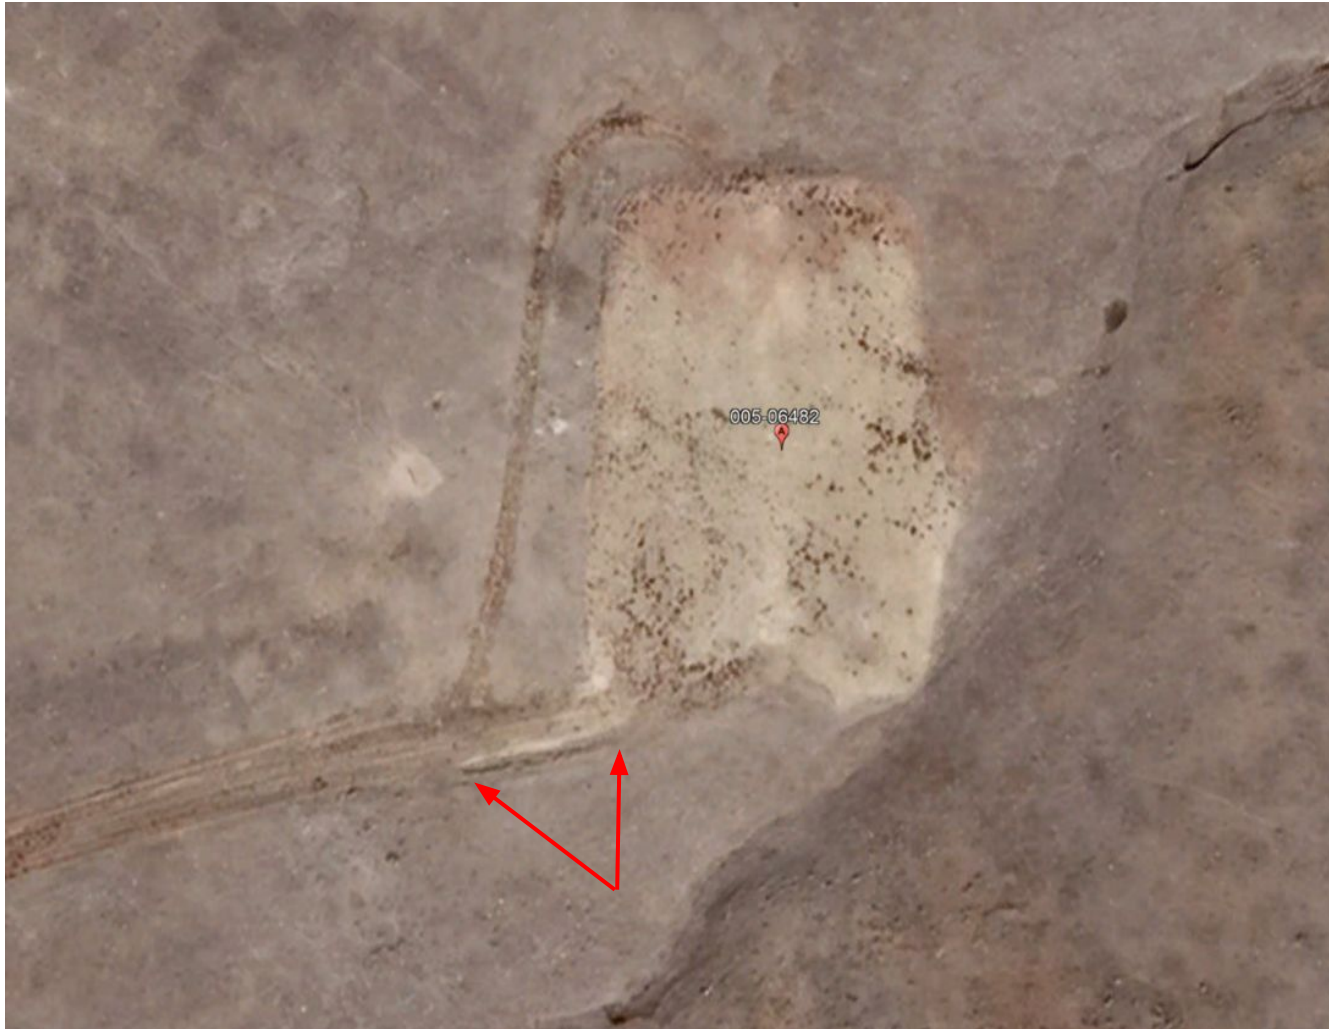
Photo 11. Google Earth aerial image from March 14, 2022 illustrating the eastern portion of the access road and location. Photo is highlighting an area that needs to be recontoured.

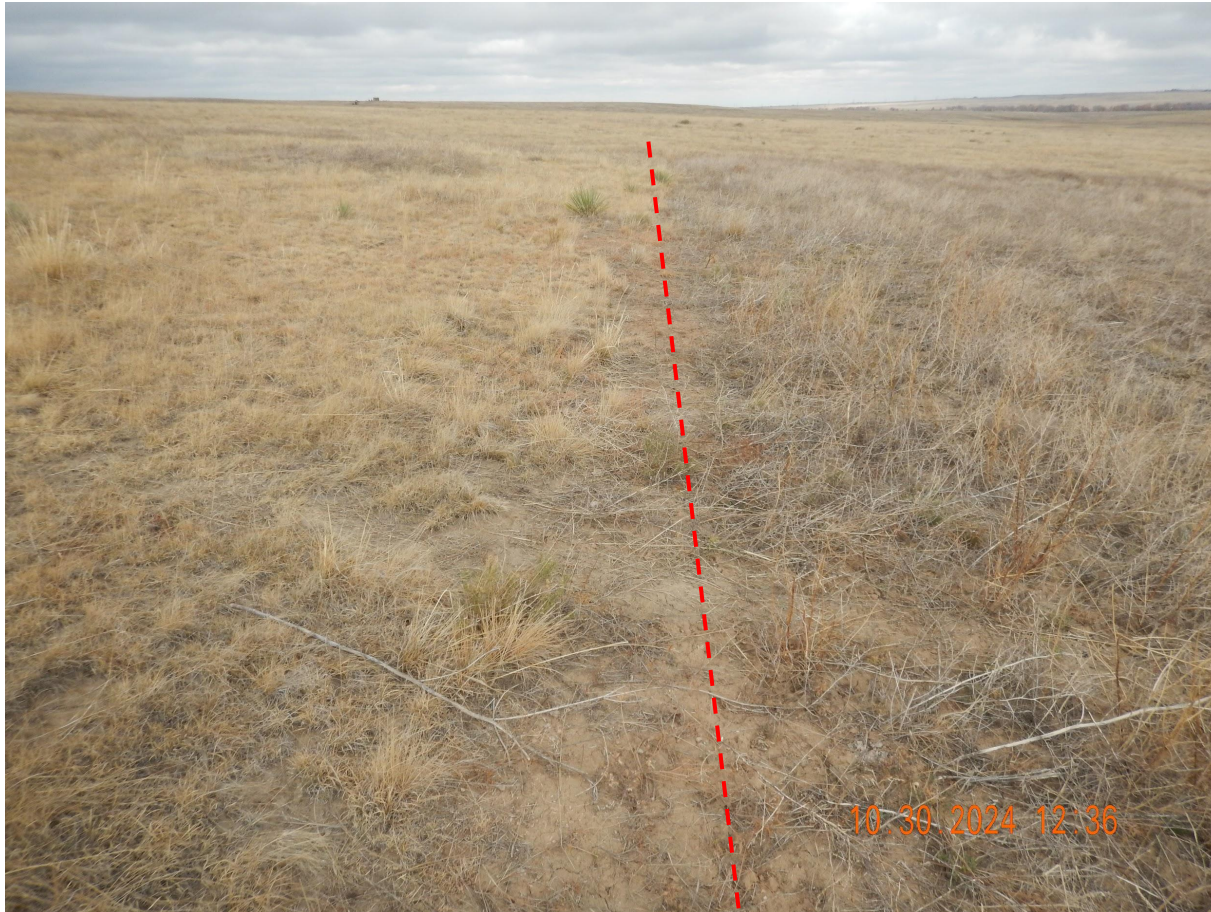
Photo 12. Reference photo taken along the western boundary of location, facing North. Reference area vegetation to the left of the red-dashed line; reclamation area to the right, which illustrates weedy, annual vegetation.
