REPORT OF WORK COMPLETION (ROWC)

**ELU A18 495 Cuttings
QB Energy Operating, LLC
Garfield County, Colorado
Remediation Project Number : TBD**

November 12, 2024
Ensolum Project No. 09D2436023

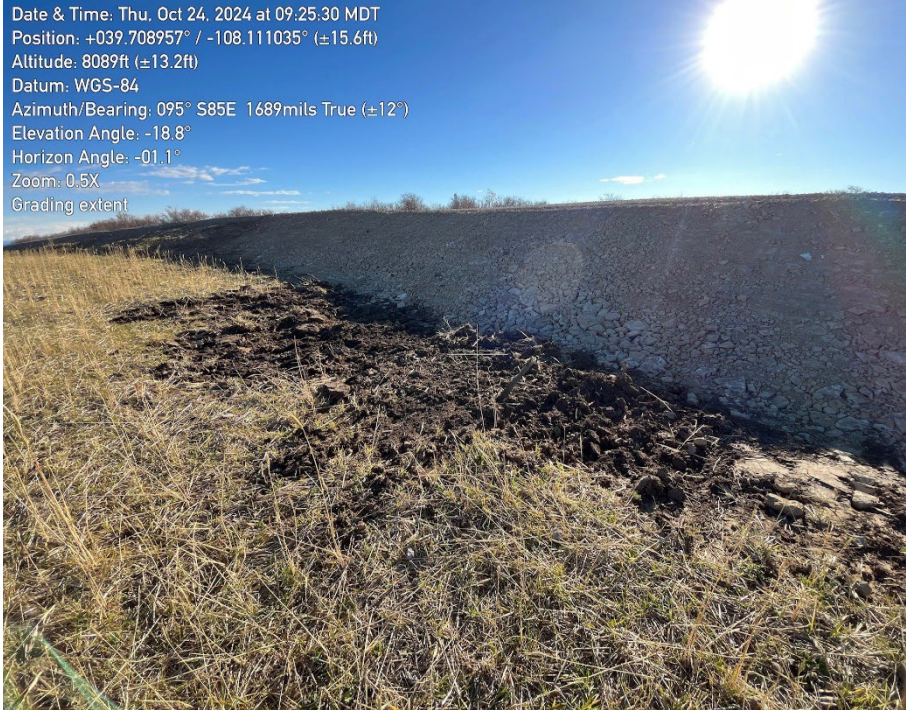
View facing east of the excavation/grading extent.

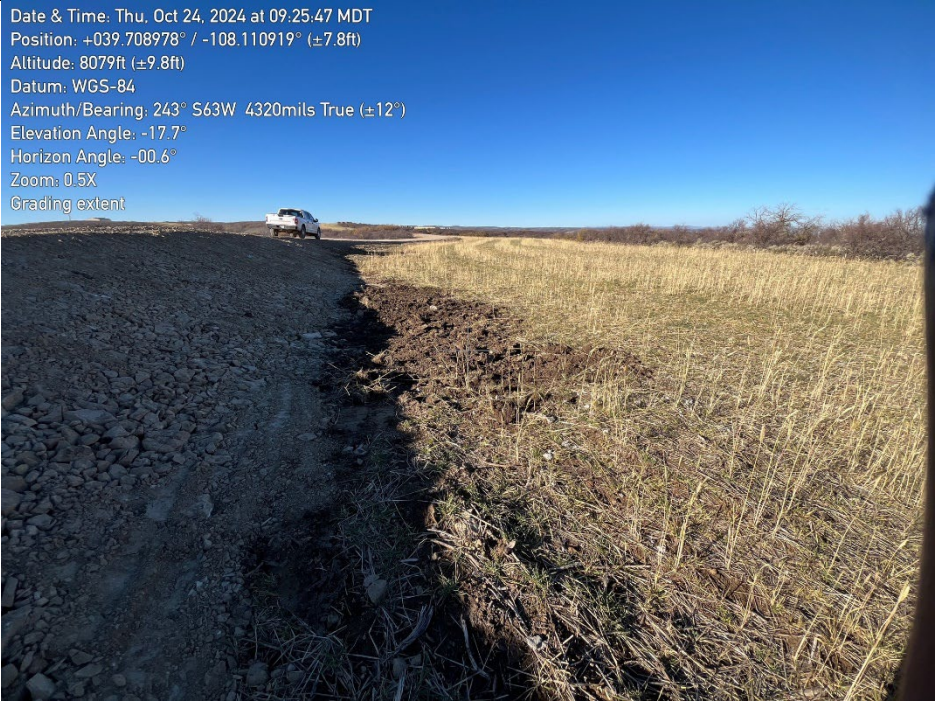
View facing southwest of the excavation/grading extent.

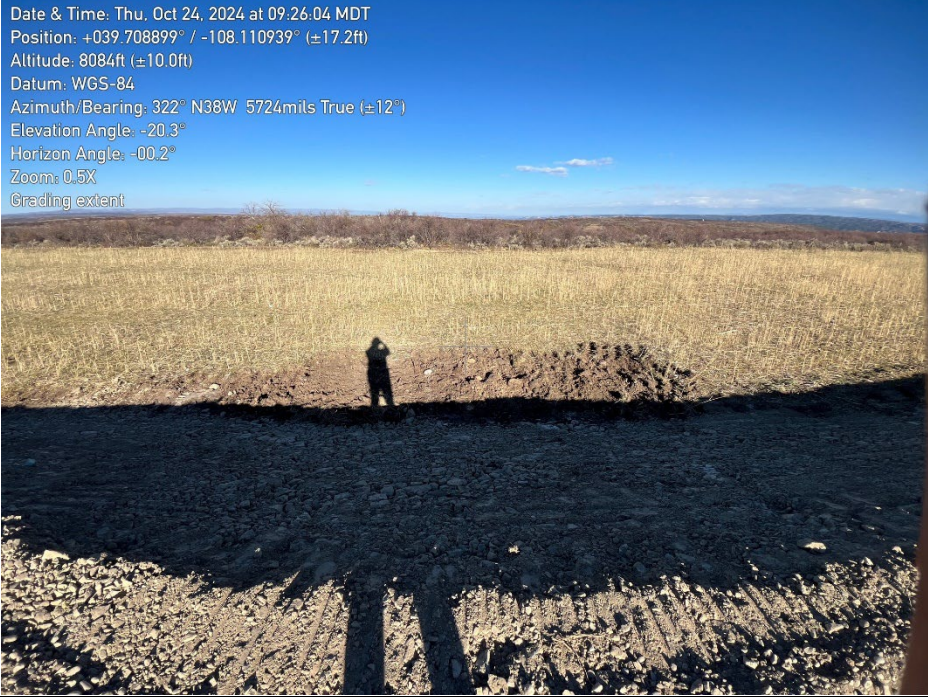
View facing west of the excavation/grading extent.

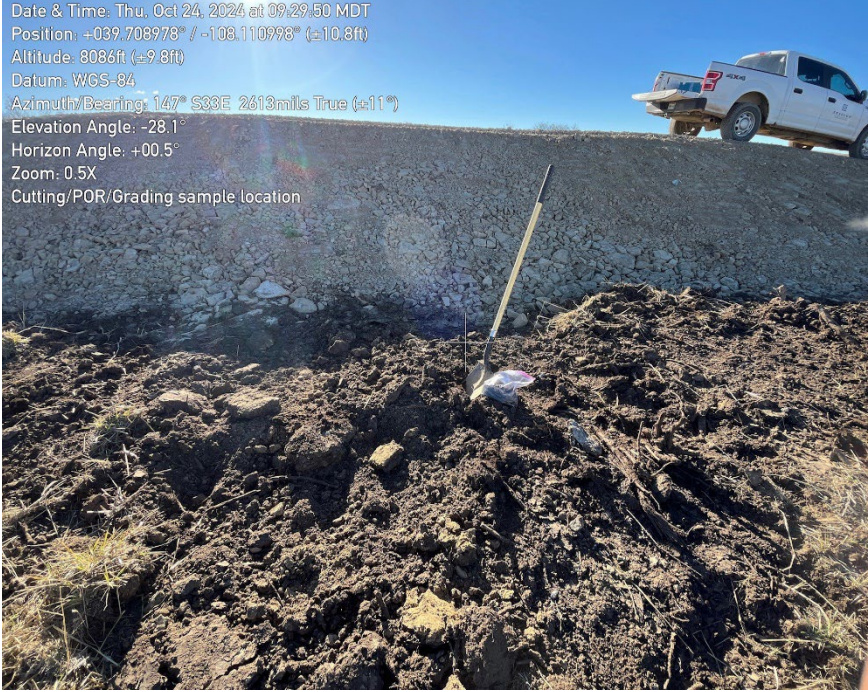
View facing southeast of BASE01 sample location.

Based on the October 24, 2024, analytical results sample A18 495-(BASE01)@0.5 exceeded ECMC Table 915-1 protection of groundwater standards for selenium and barium.
