Inspection Photos

Operator: Simcoe LLC - 10749

Location ID: 325888

Inspection Photos
Location Name: Dry Creek Federal 1
Location ID: 325888

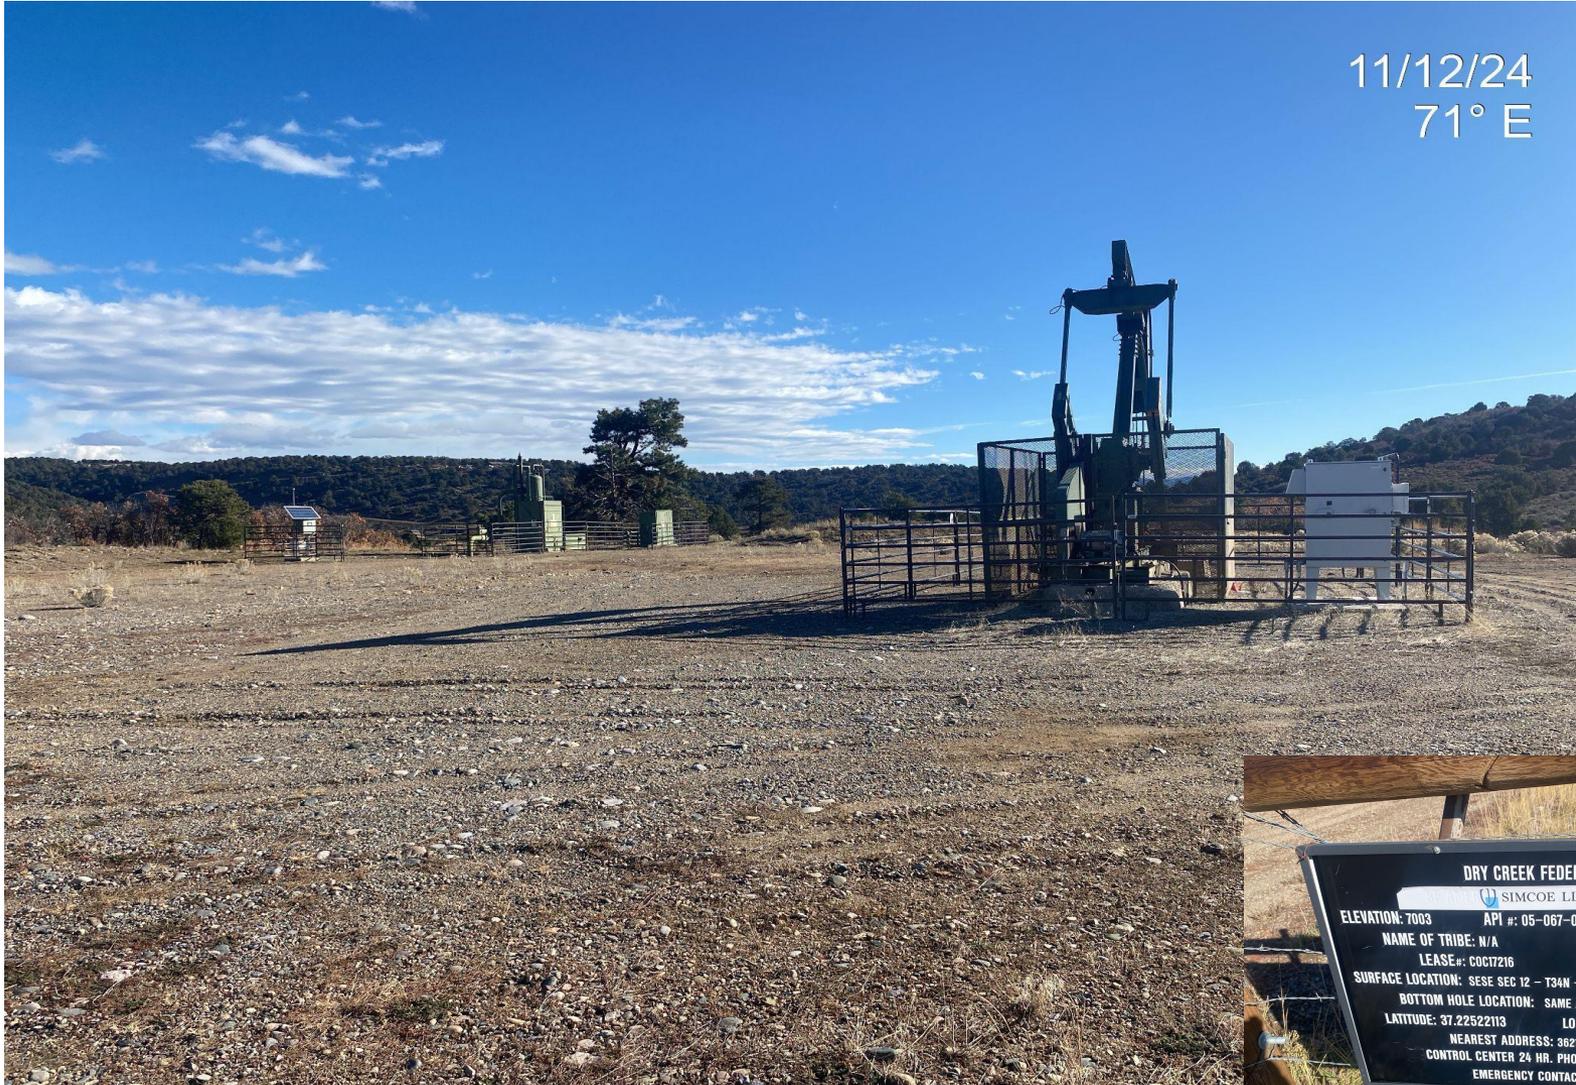
Photo 1. View of well disturbance taken from the access point facing center.

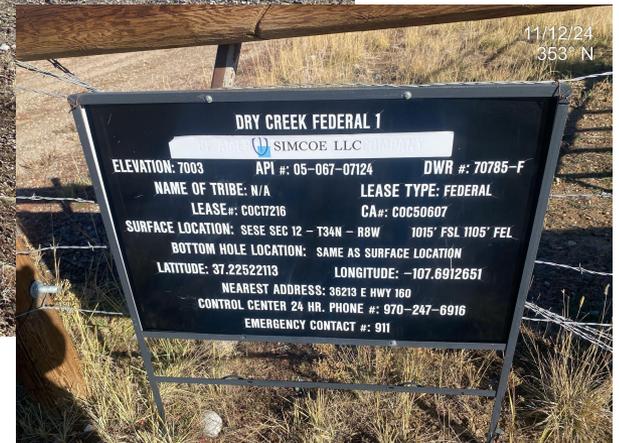
DRY CREEK FEDERAL 1
SIMCOE LLC
ELEVATION: 7003 API #: 06-067-07124 DWR #: 70785-F
NAME OF TRIBE: N/A LEASE TYPE: FEDERAL
LEASE#: COC17216 CA#: COC50607
SURFACE LOCATION: SESE SEC 12 - T34N - R8W 1015' FSL 1105' FEL
BOTTOM HOLE LOCATION: SAME AS SURFACE LOCATION
LATITUDE: 37.22522113 LONGITUDE: -107.6912651
NEAREST ADDRESS: 36213 E HWY 160
CONTROL CENTER 24 HR. PHONE #: 970-247-6916
EMERGENCY CONTACT #: 911

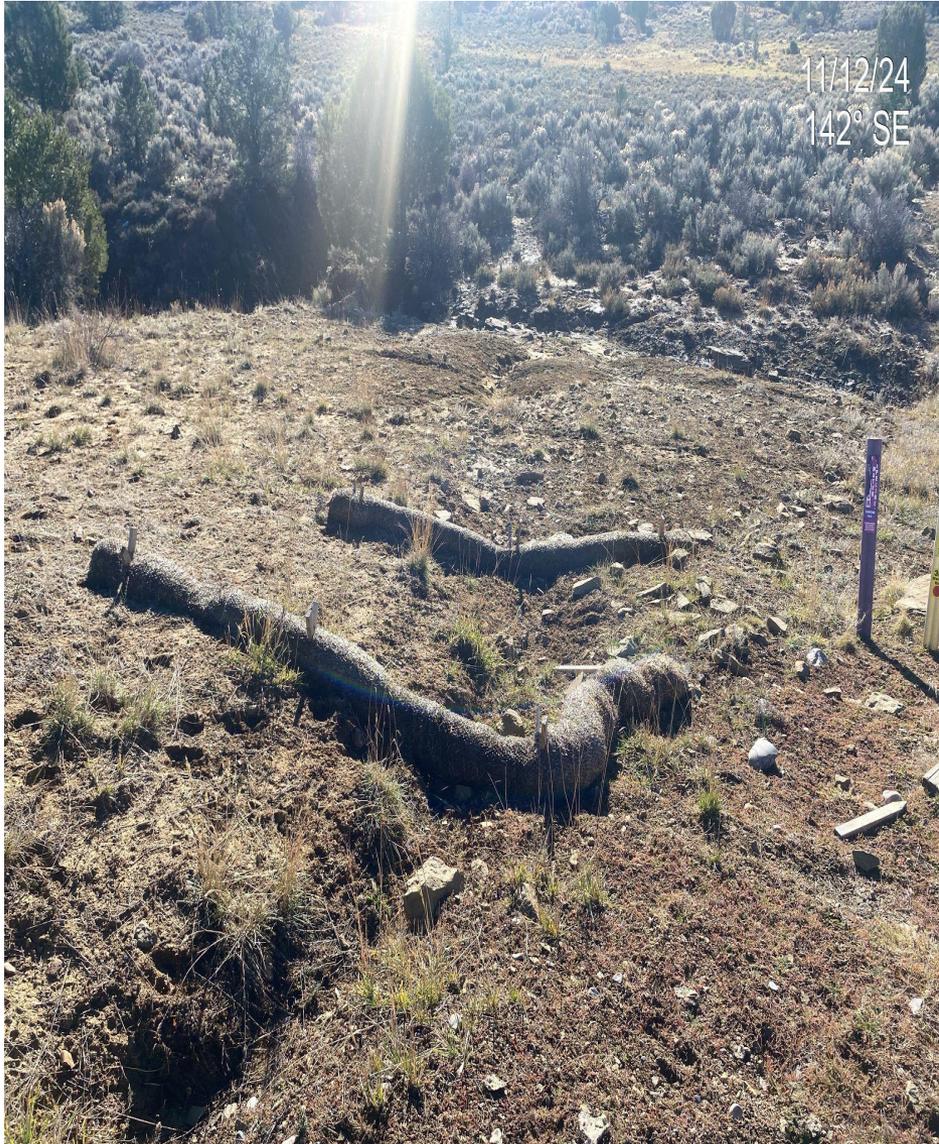
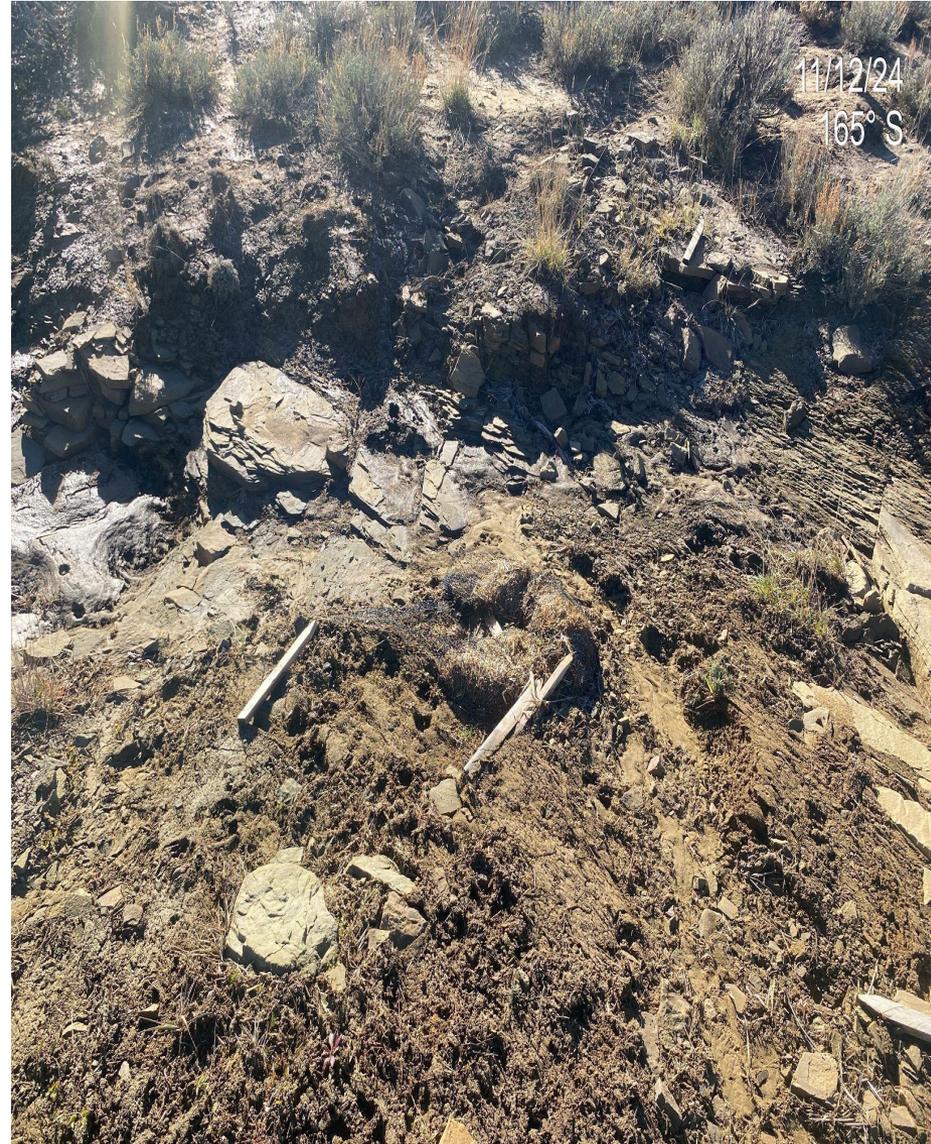
Photo 2. Wattles installed in the southeast corner to address erosion issues have not been installed per good engineering practice. Stormwater persists and water is running under the wattles.

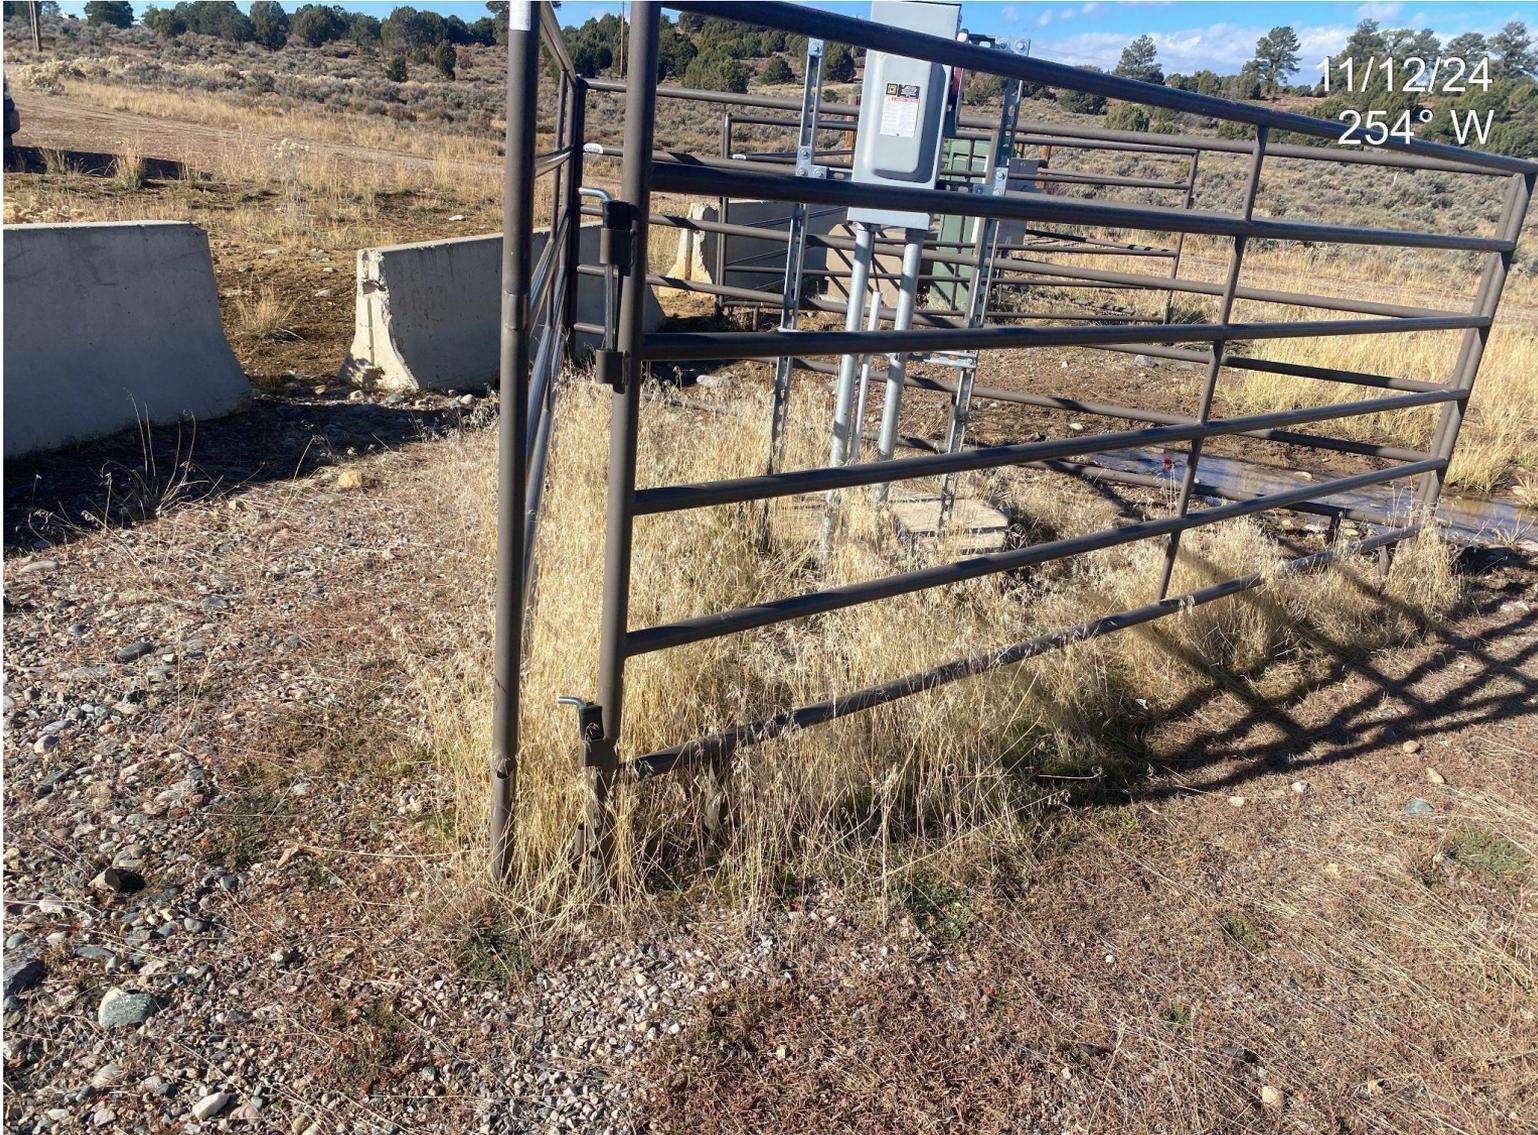
Photo 3. Patch of Cheatgrass observed at electrical equipment in the western corner of the disturbance.

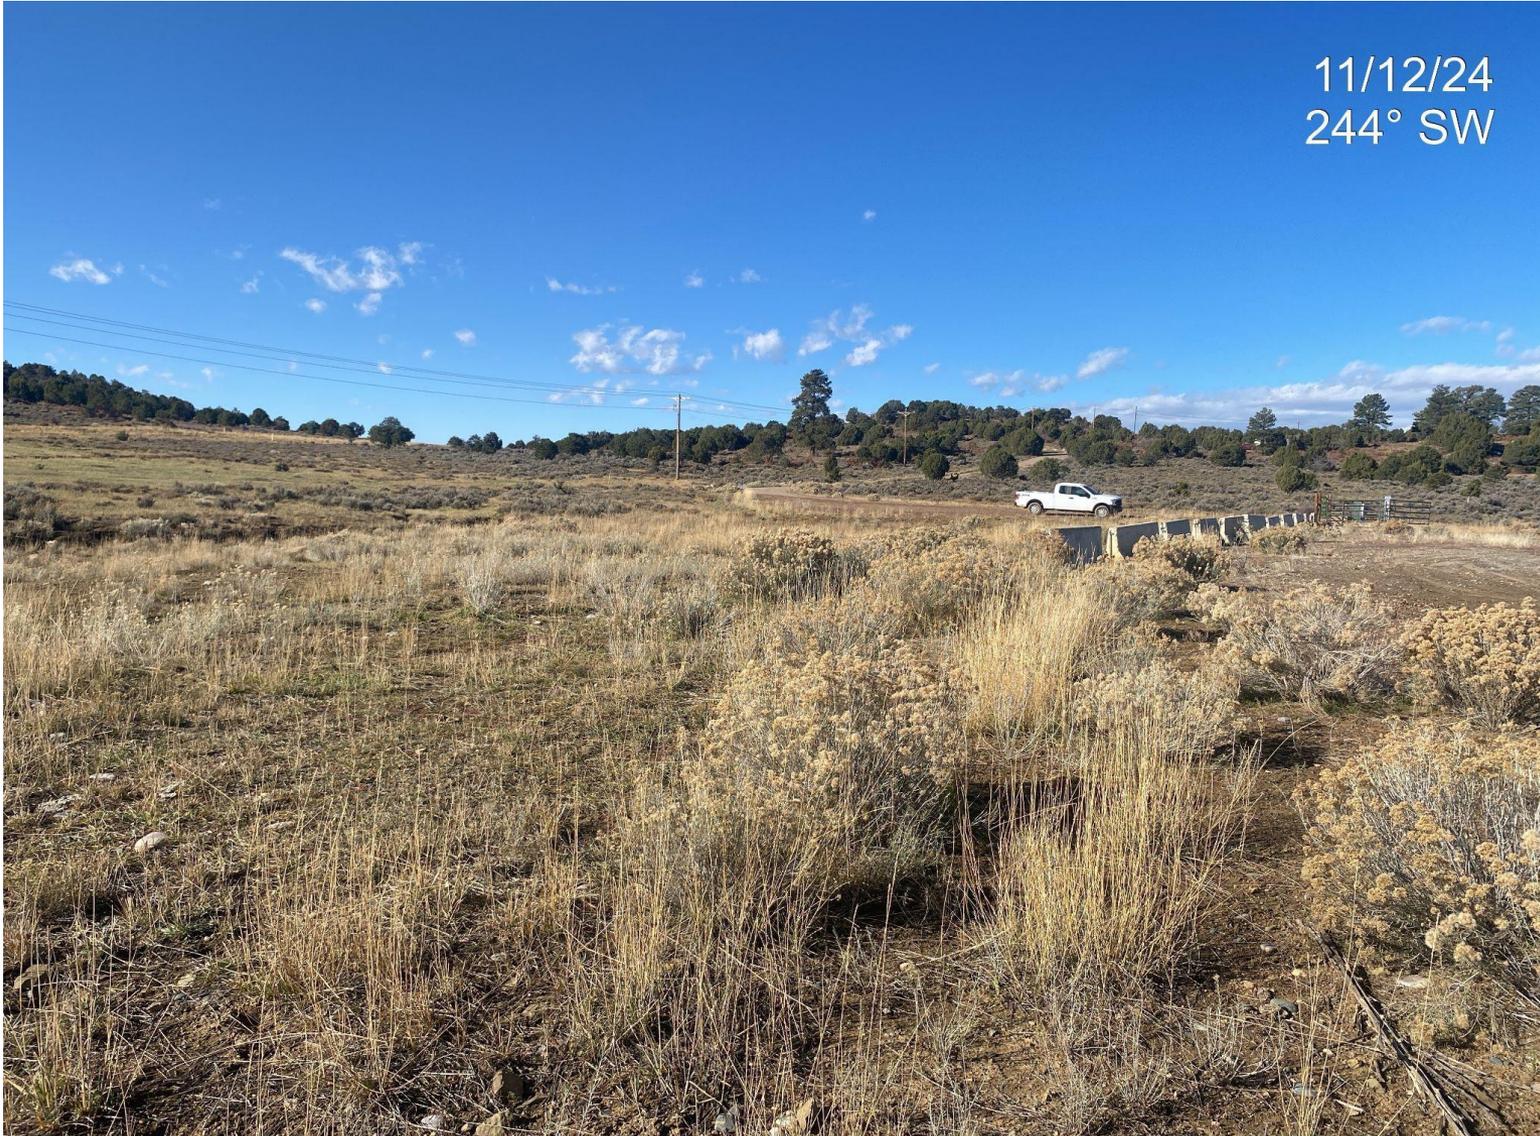
11/12/24
244° SW

Photo 4. View of southern interim reclamation composed predominantly of Western Wheatgrass and Rabbitbrush.

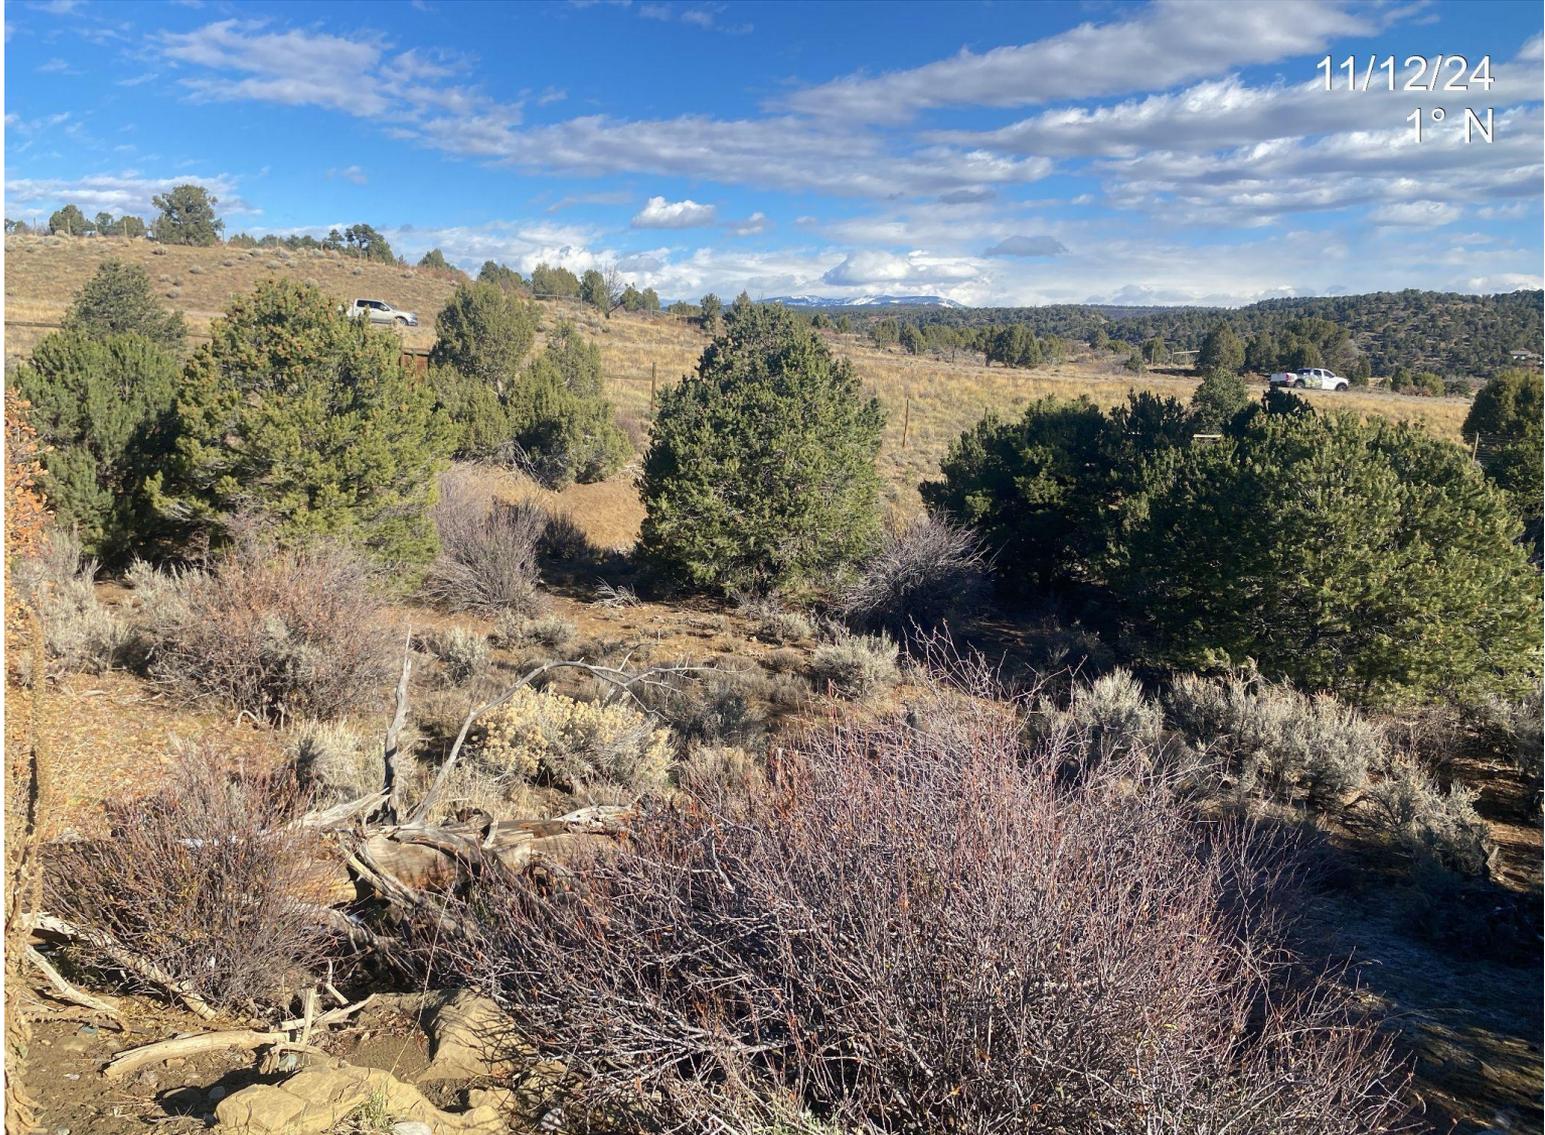
Photo 5. Reference area composed of Juniper, Sagebrush and Rabbitbrush.
