Inspection Photos

Operator: Simcoe LLC - 10749

Location ID: 306769

Inspection Photos
Location Name: Neleigh 01-07 2
Location ID: 306769

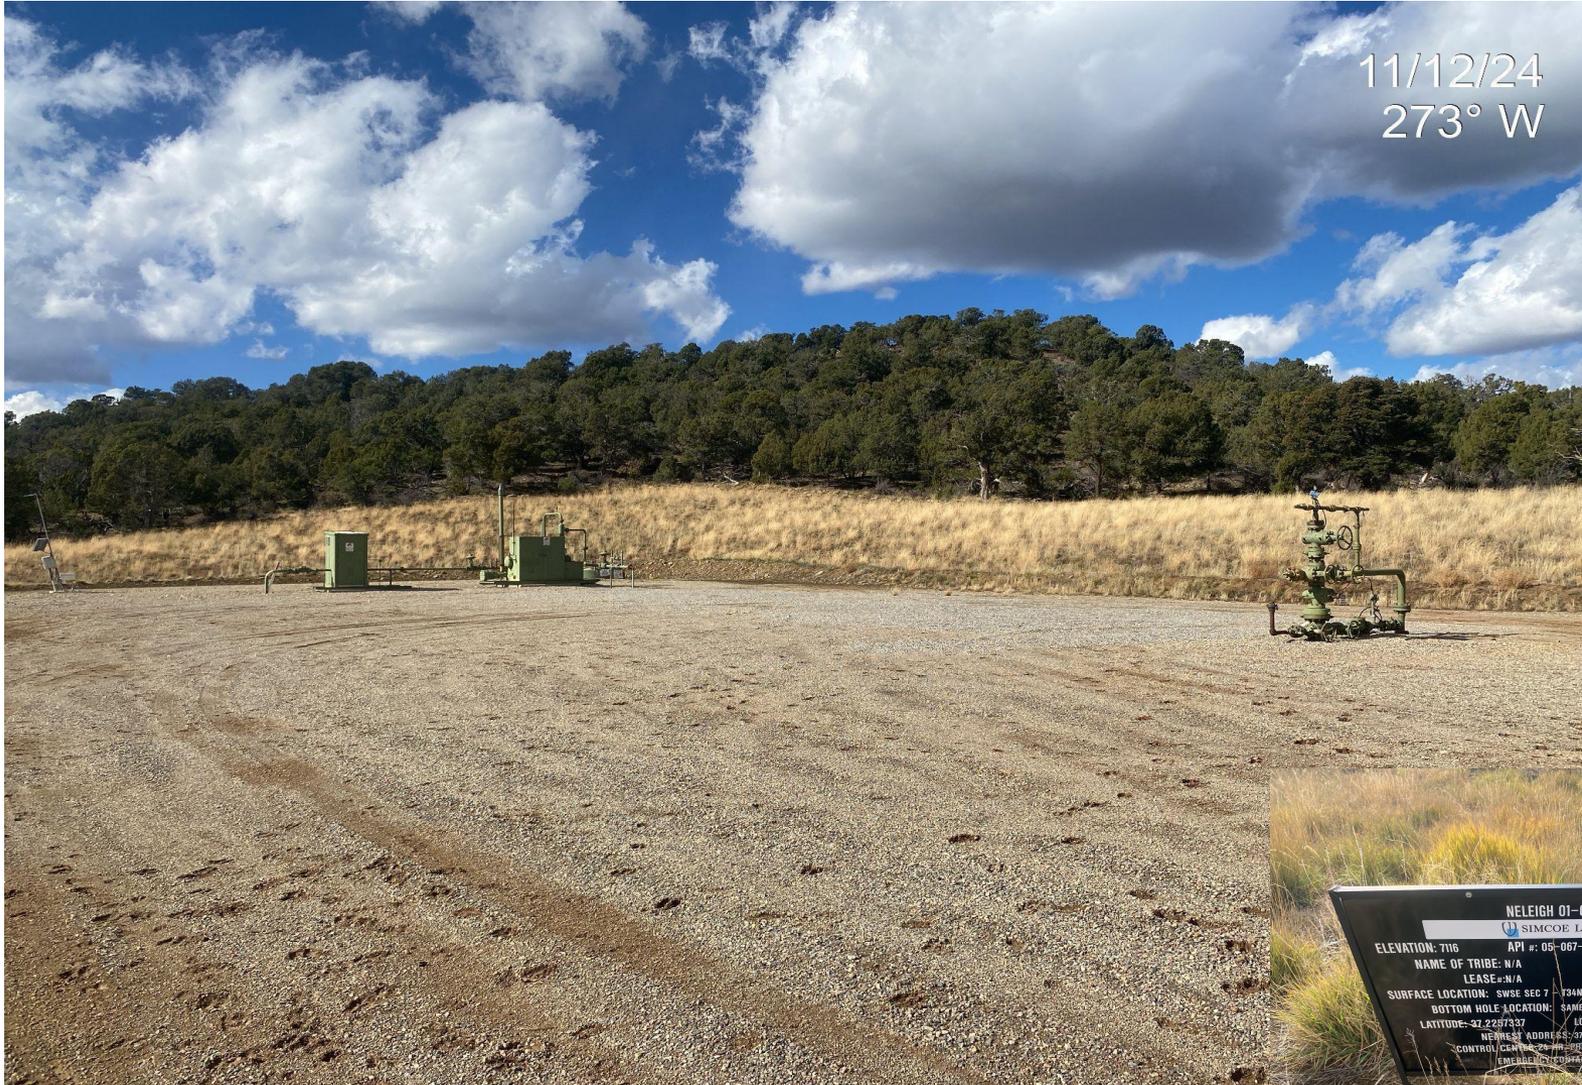
Photo 1. View of well disturbance taken from the access point facing center.

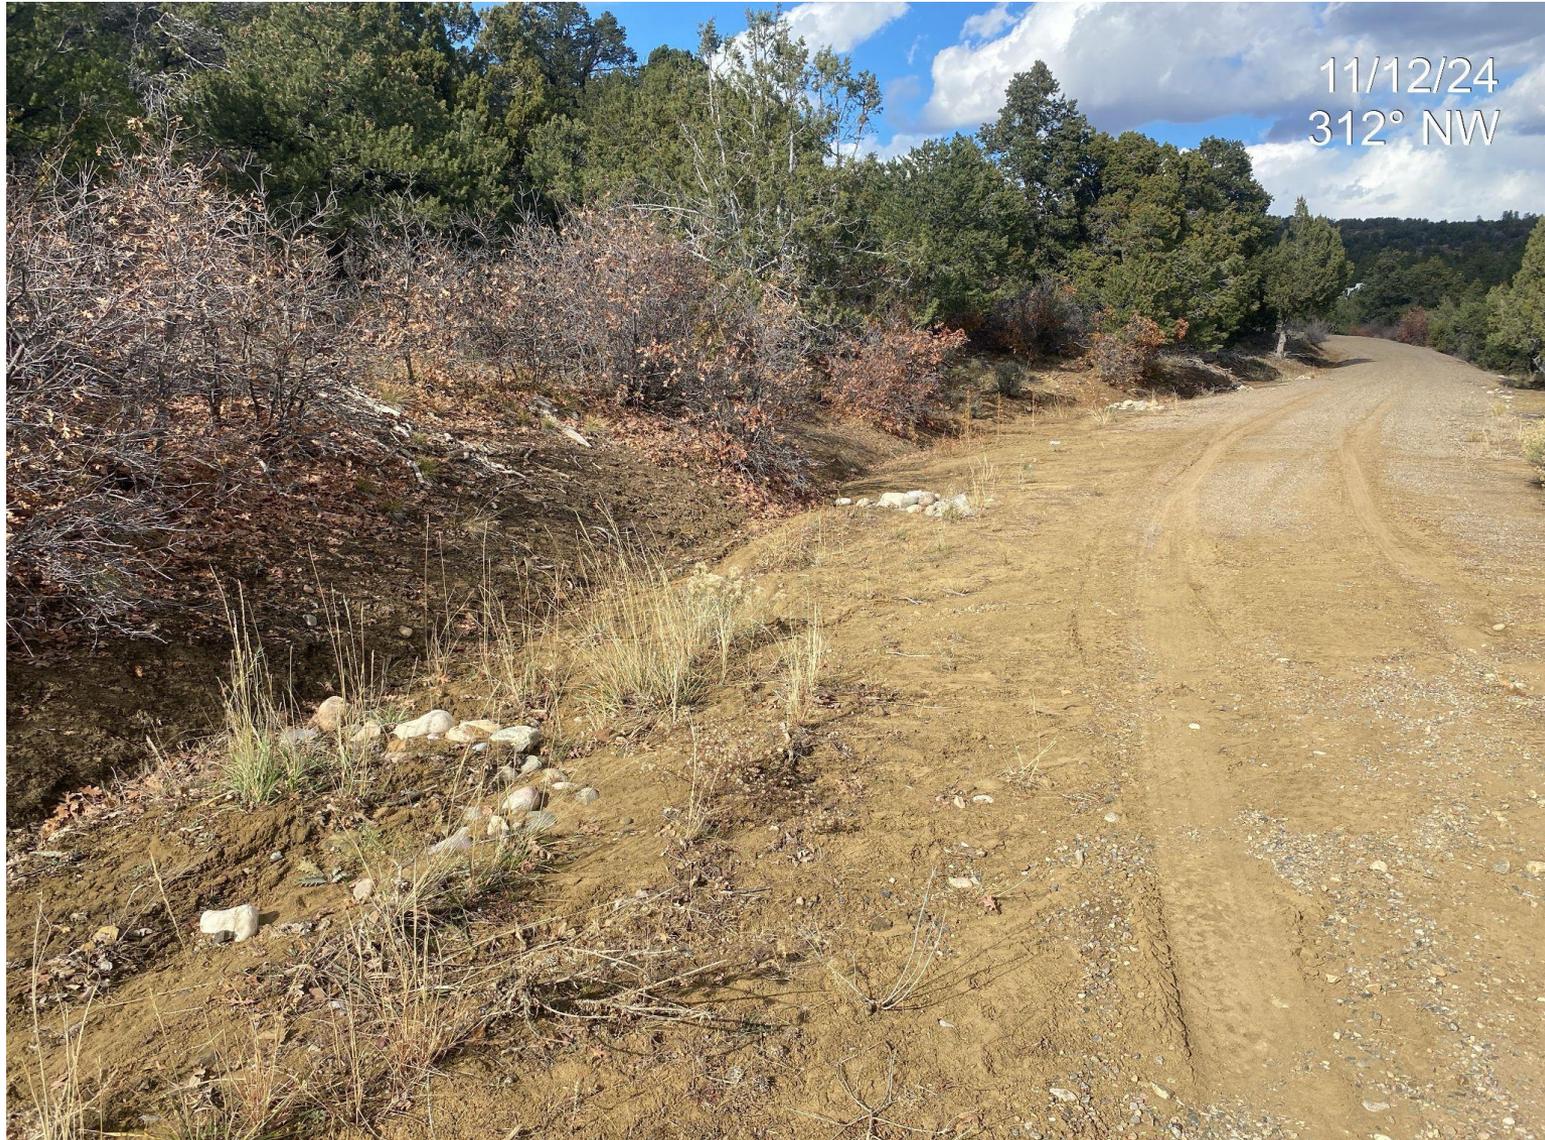
Photo 3. Stormwater BMPs installed along the access road have filled with sediment and are no longer functioning, maintenance is needed. Sediment has started to migrate and settle on the access road.
