Inspection Photos

Operator: Simcoe LLC - 10749

Inspection Document #: 714001487

Inspection Photos
Location Name: Gearhart C 1
Location ID: 326071

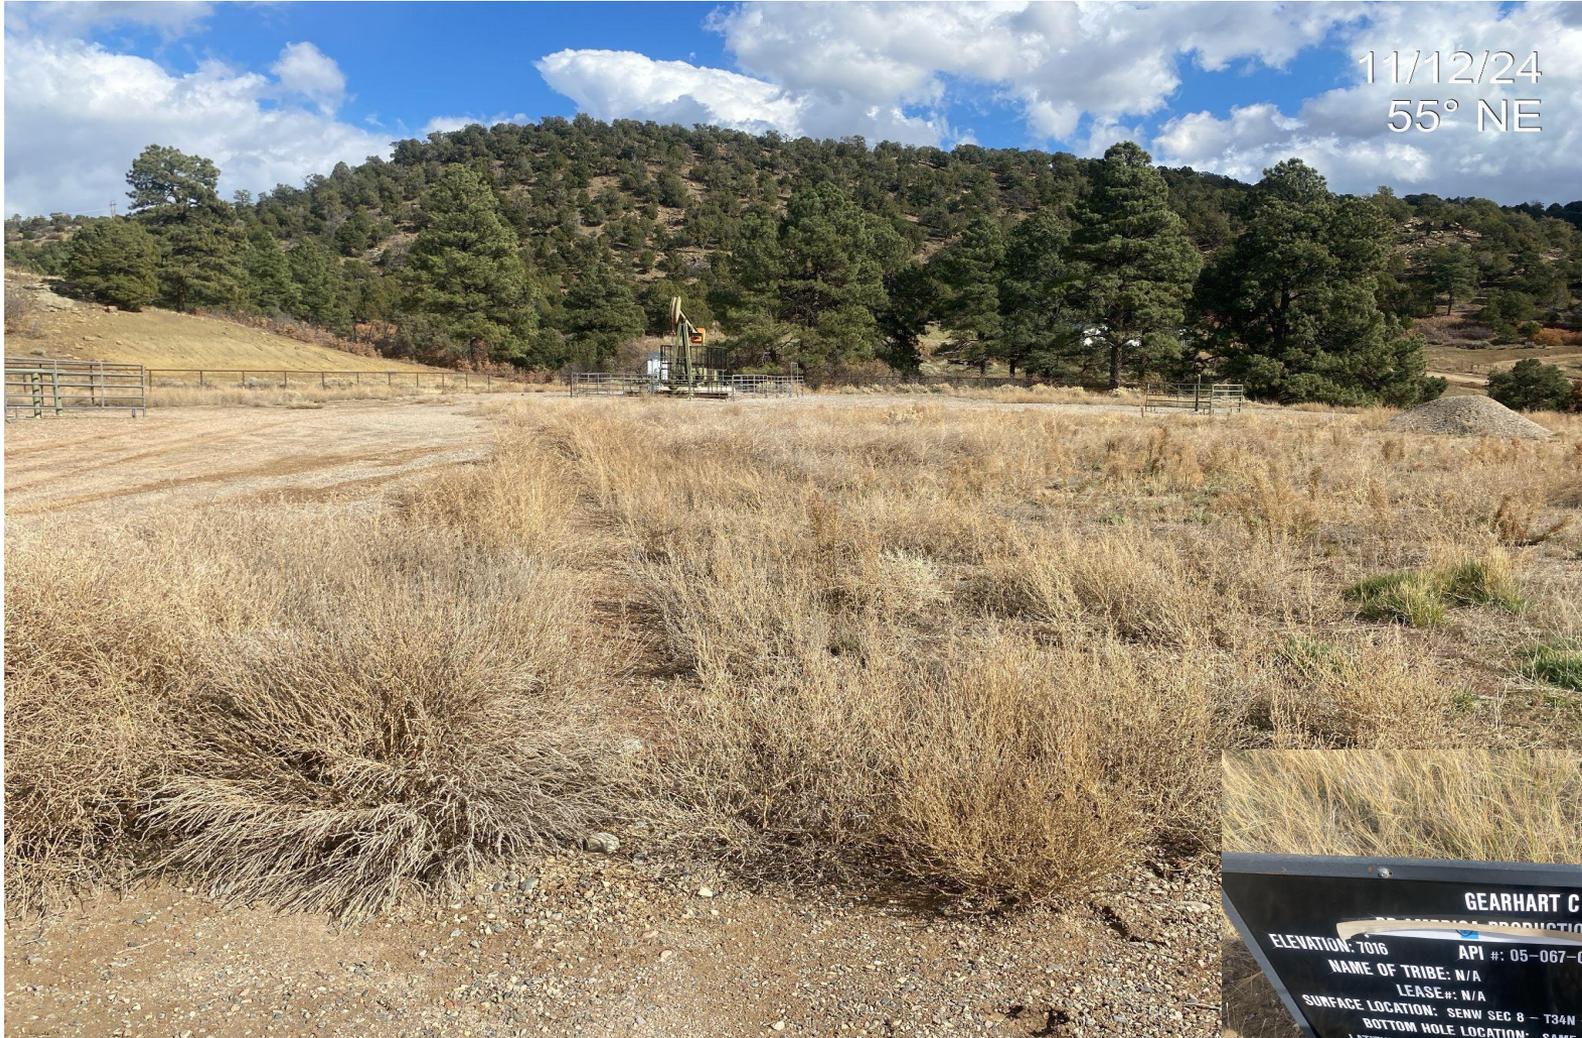
Photo 1. View of well disturbance taken from the access point facing center.
Note: Weedy debris dominating active pad and interim reclamation areas.

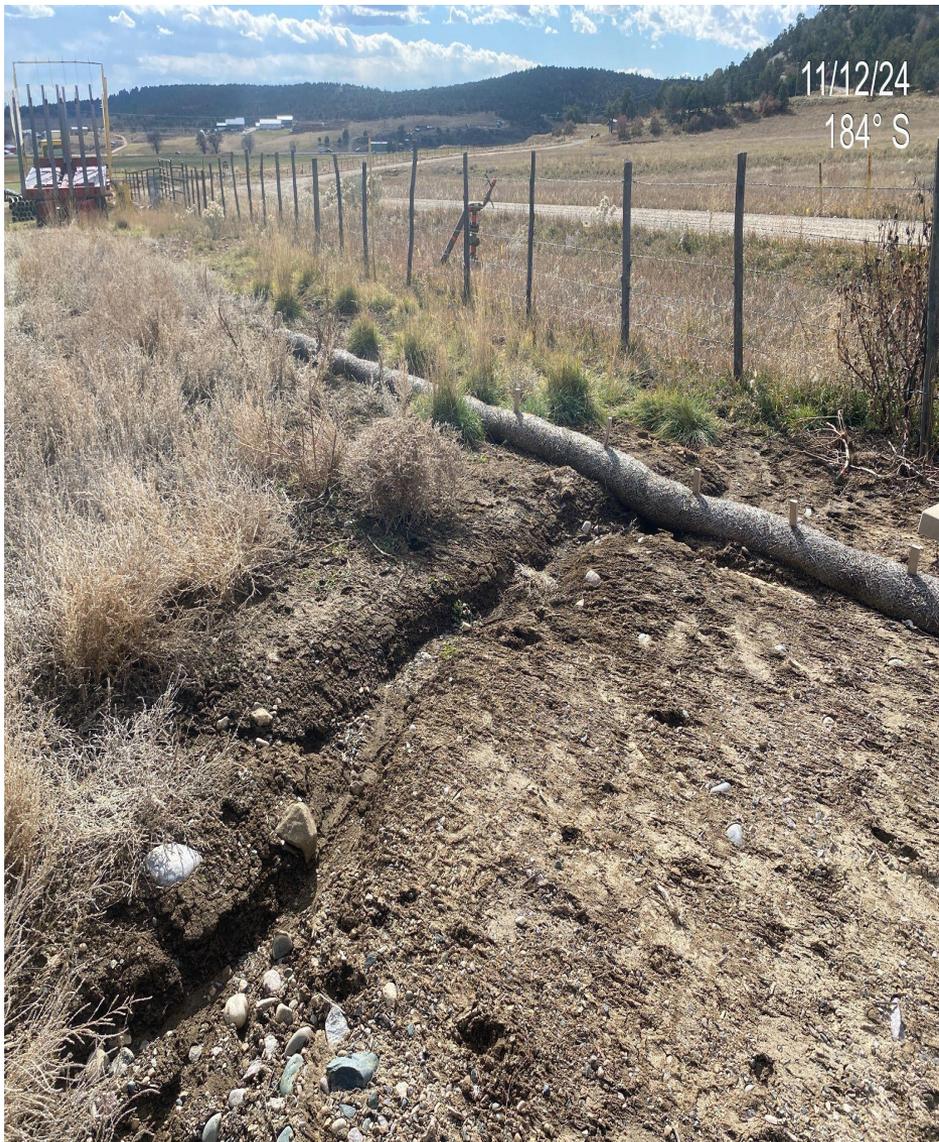
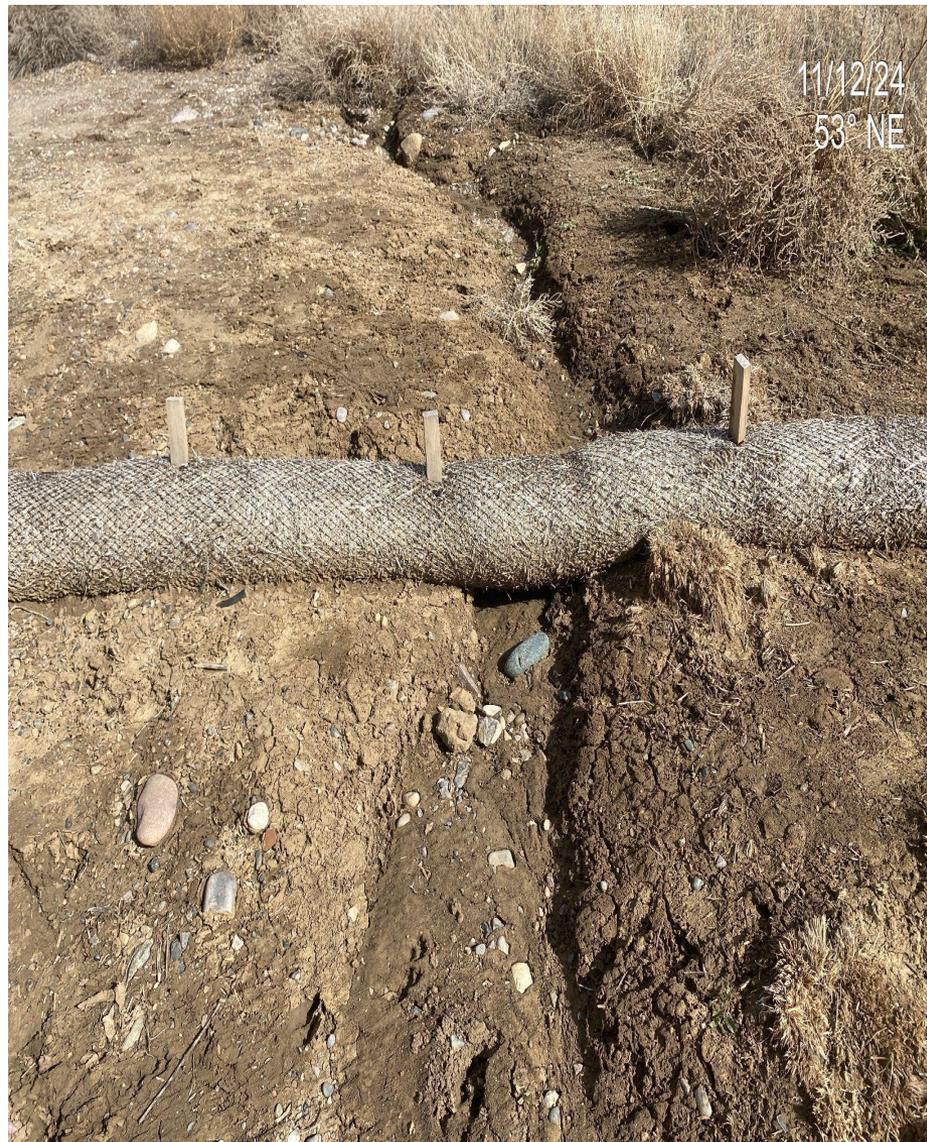
Photo 2. Erosion issues on location remain persistent. Stormwater BMPs have not been installed correctly, stormwater continues to flow under installed wattles.

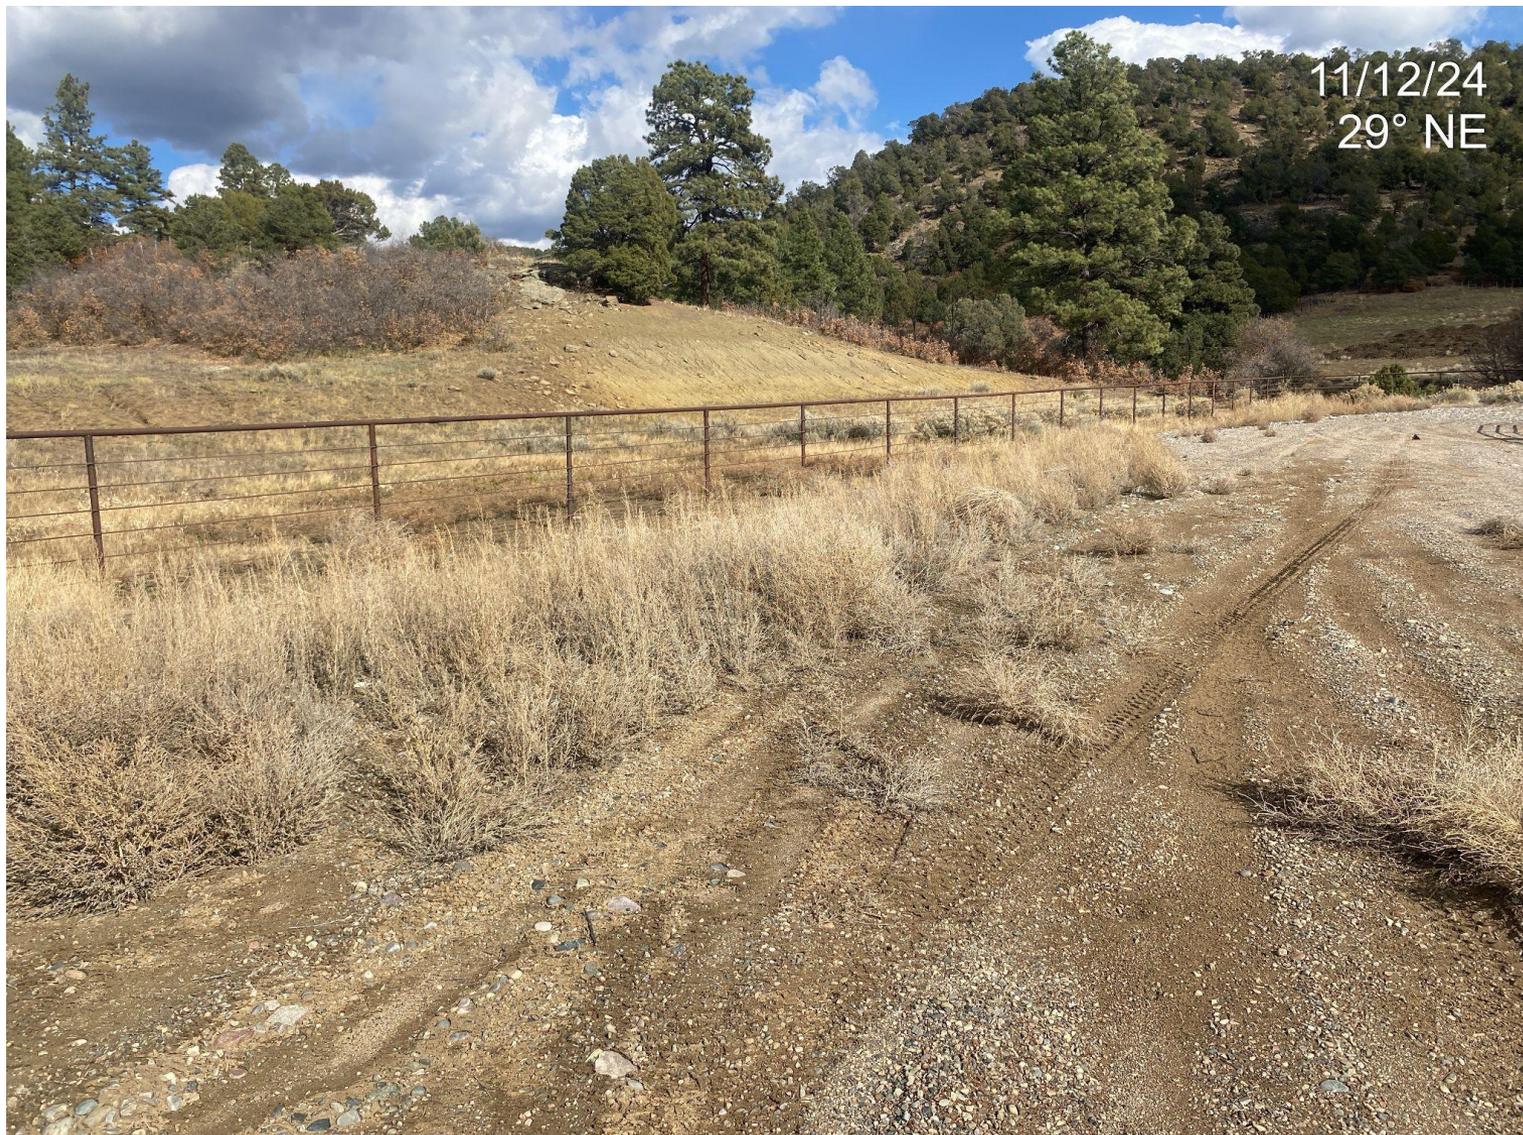
Photo 3. Additional view of weedy kochia debris observed along the northern edge of the disturbance.

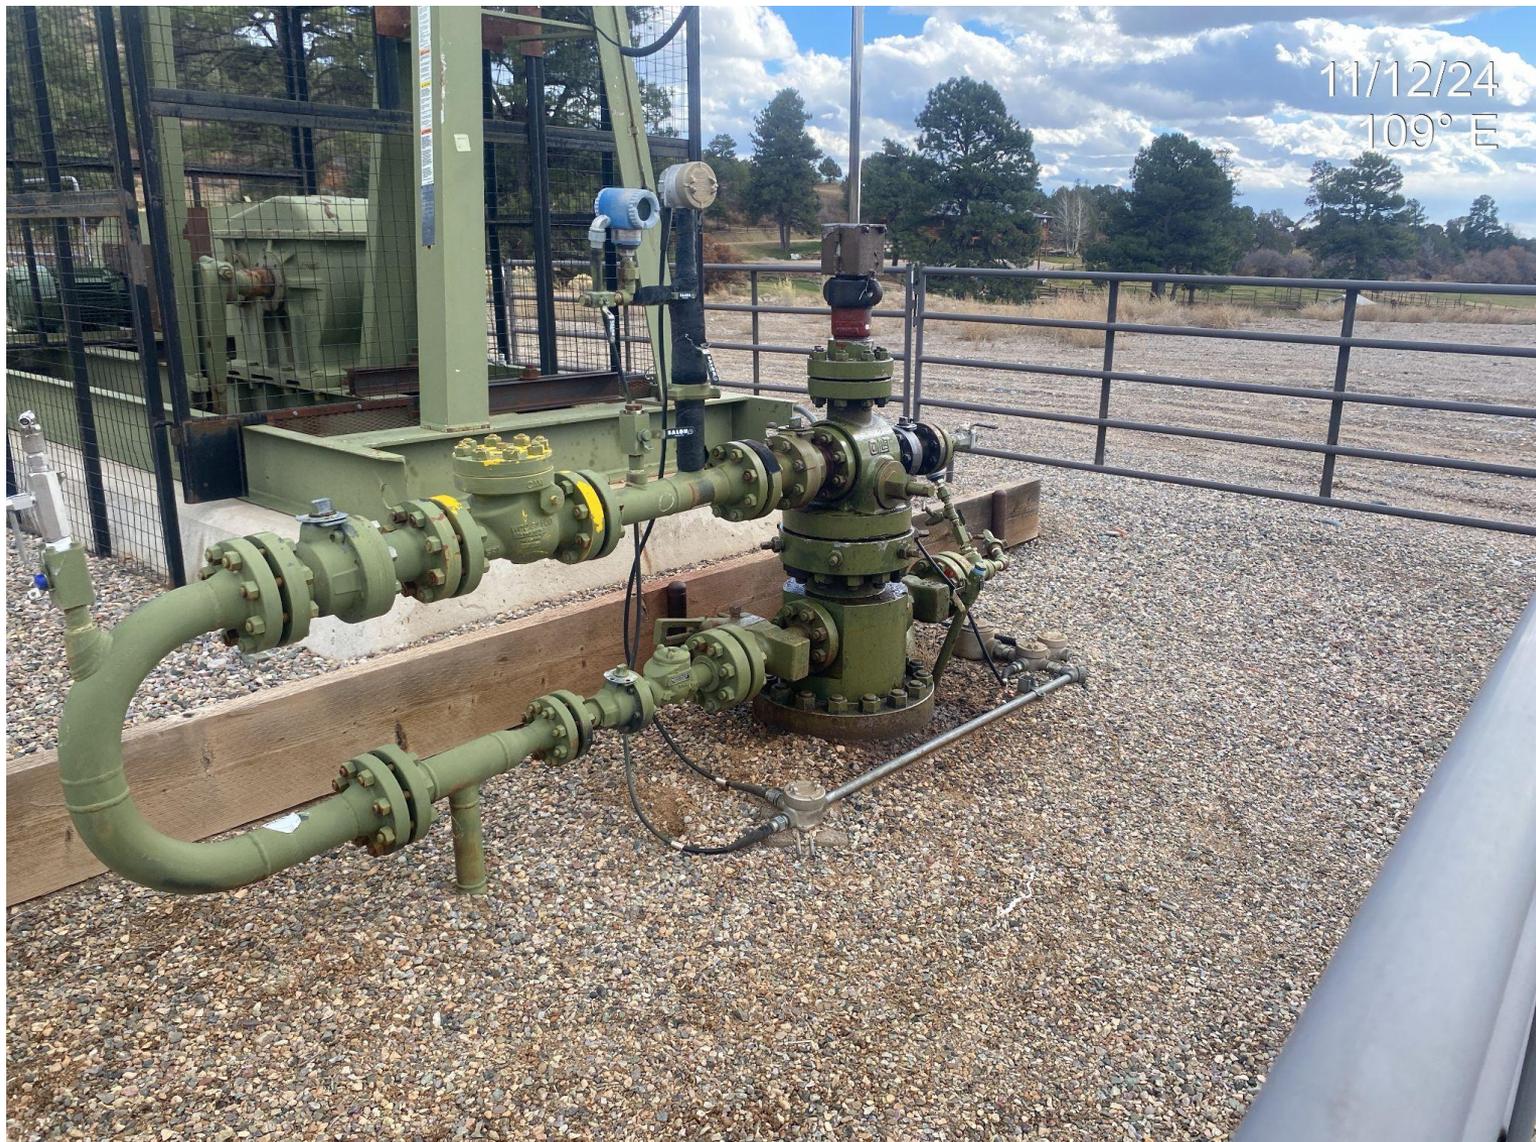
Photo 4. Impacted surface material observed at well head.
