Inspection Photos

API: 061-06806

Operator: NEWELL ENERGY LTD

Inspection Date: 11/20/2024

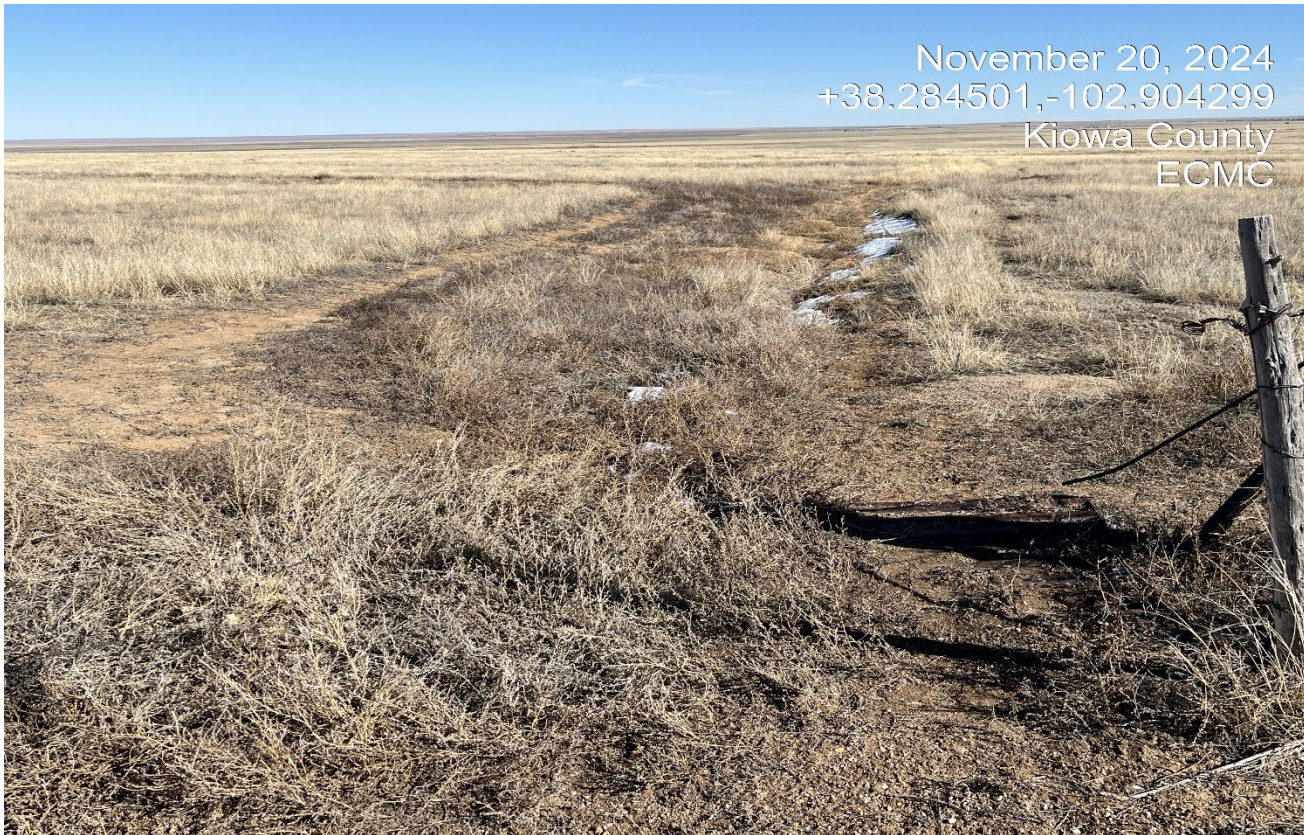
Photo 1. Facing east at the access road. The cattleguard has not been removed and has filled in with sediment. The access road has not been recontoured or reclaimed in this area.

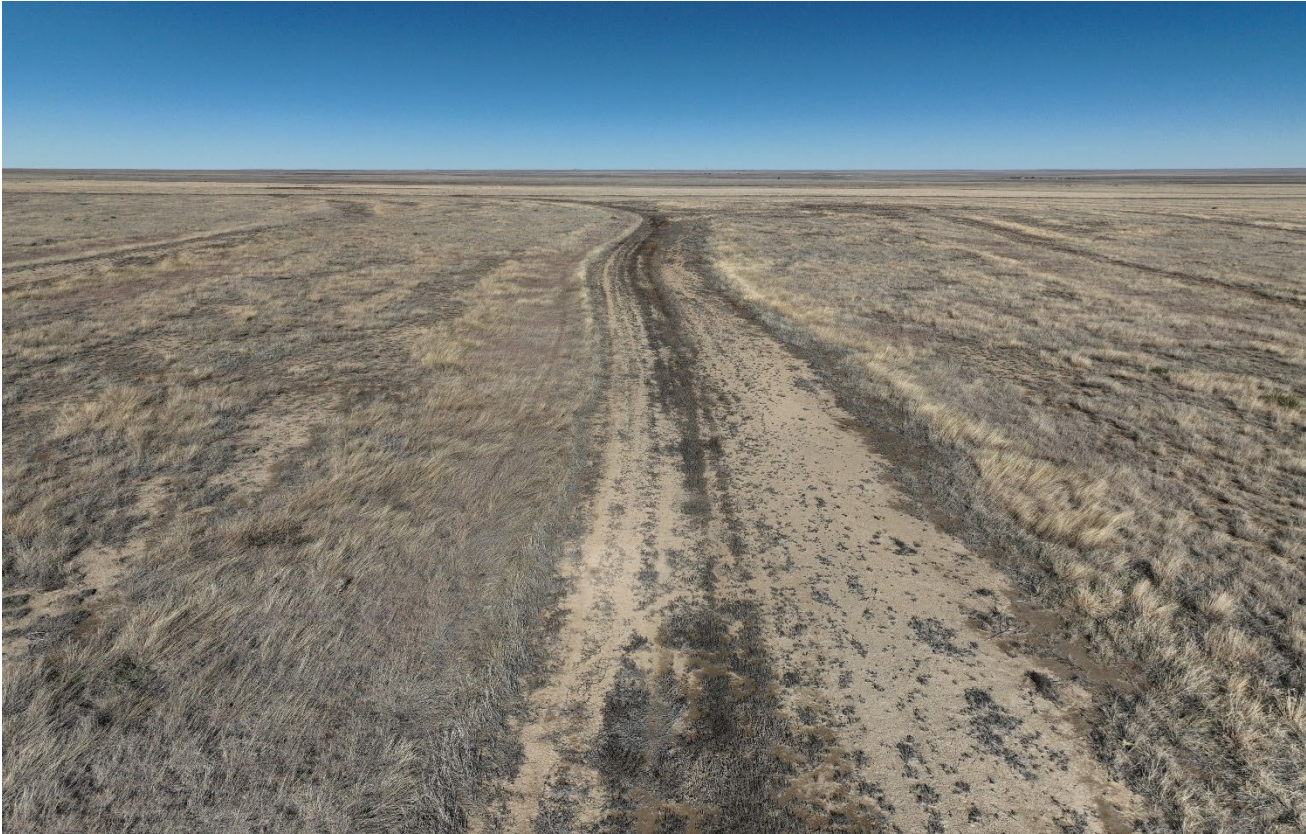
Photo 3. Drone aerial photo facing northeast along the former access road. The perennial vegetation does not appear to be establishing.

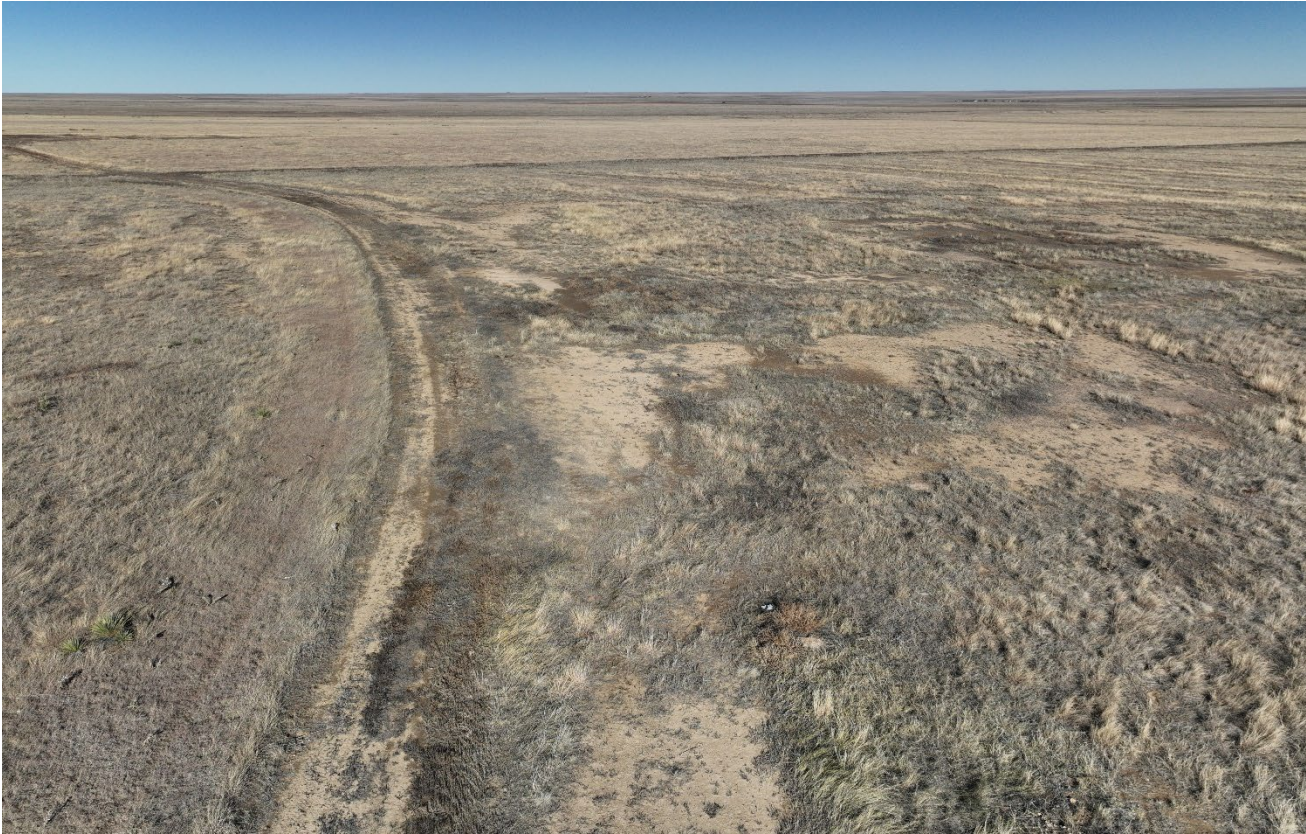
Photo 4. Drone aerial photo facing northeast overlooking the location. There are areas of the location with no vegetation that will need to be reseeded.

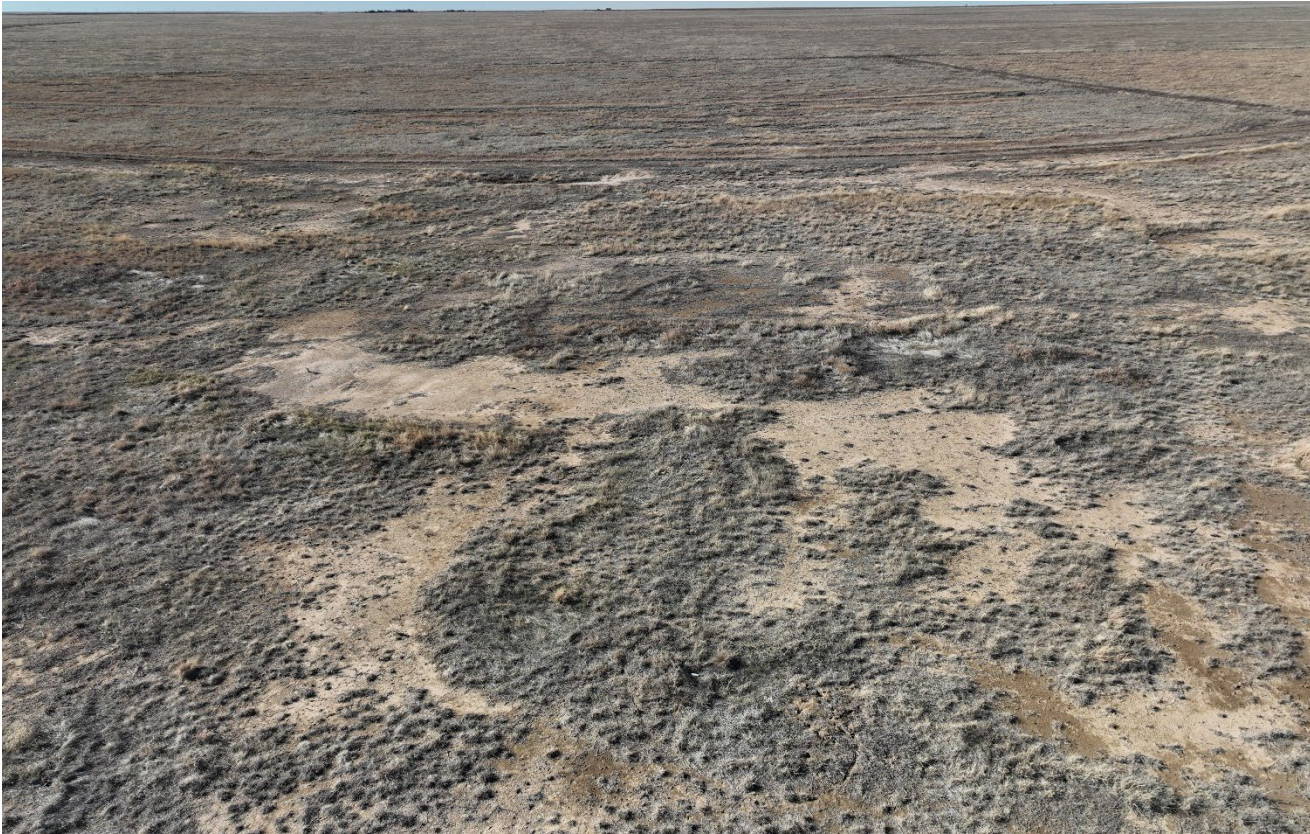
Photo 5. Drone aerial photo facing west overlooking the location. There are areas of the location with no vegetation that will need to be reseeded.

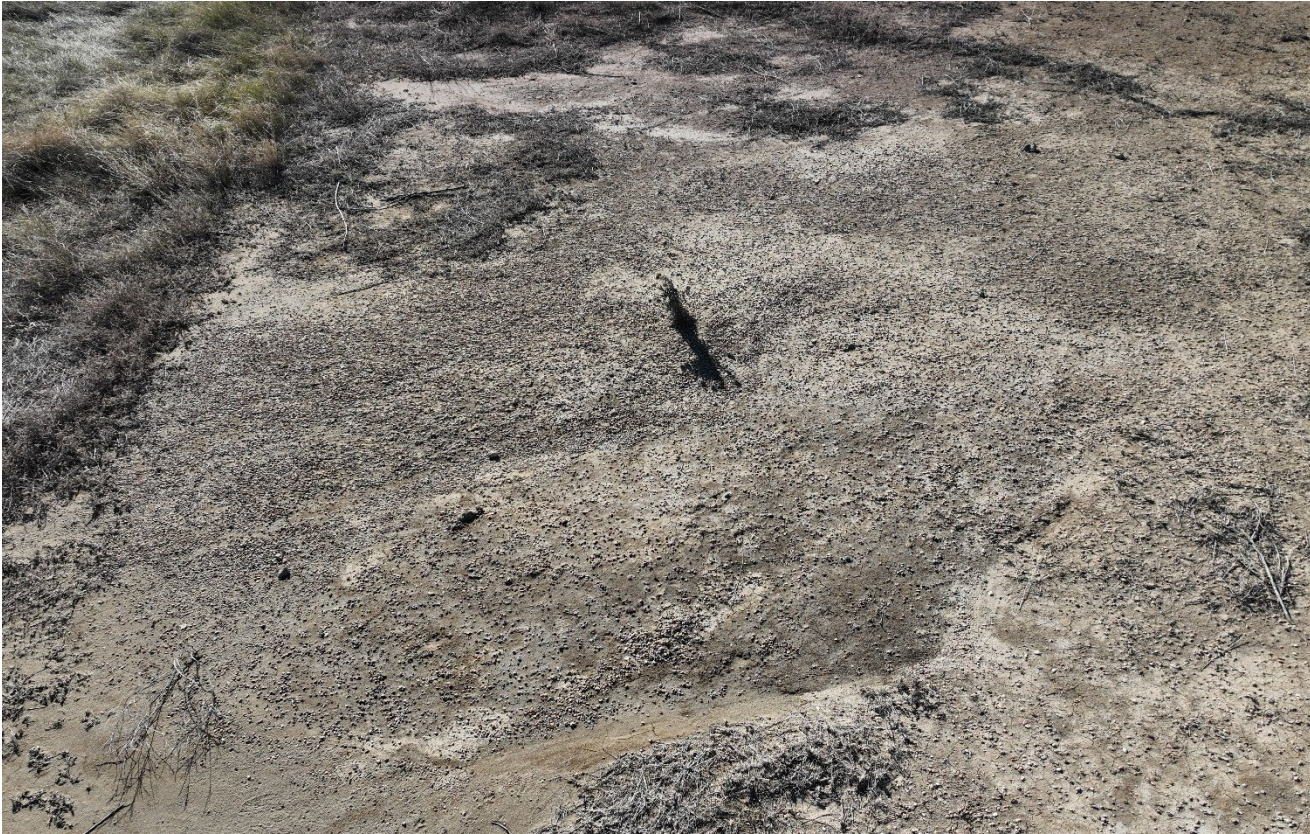
Photo 6. Drone aerial photo facing down toward the bare area with no vegetation.

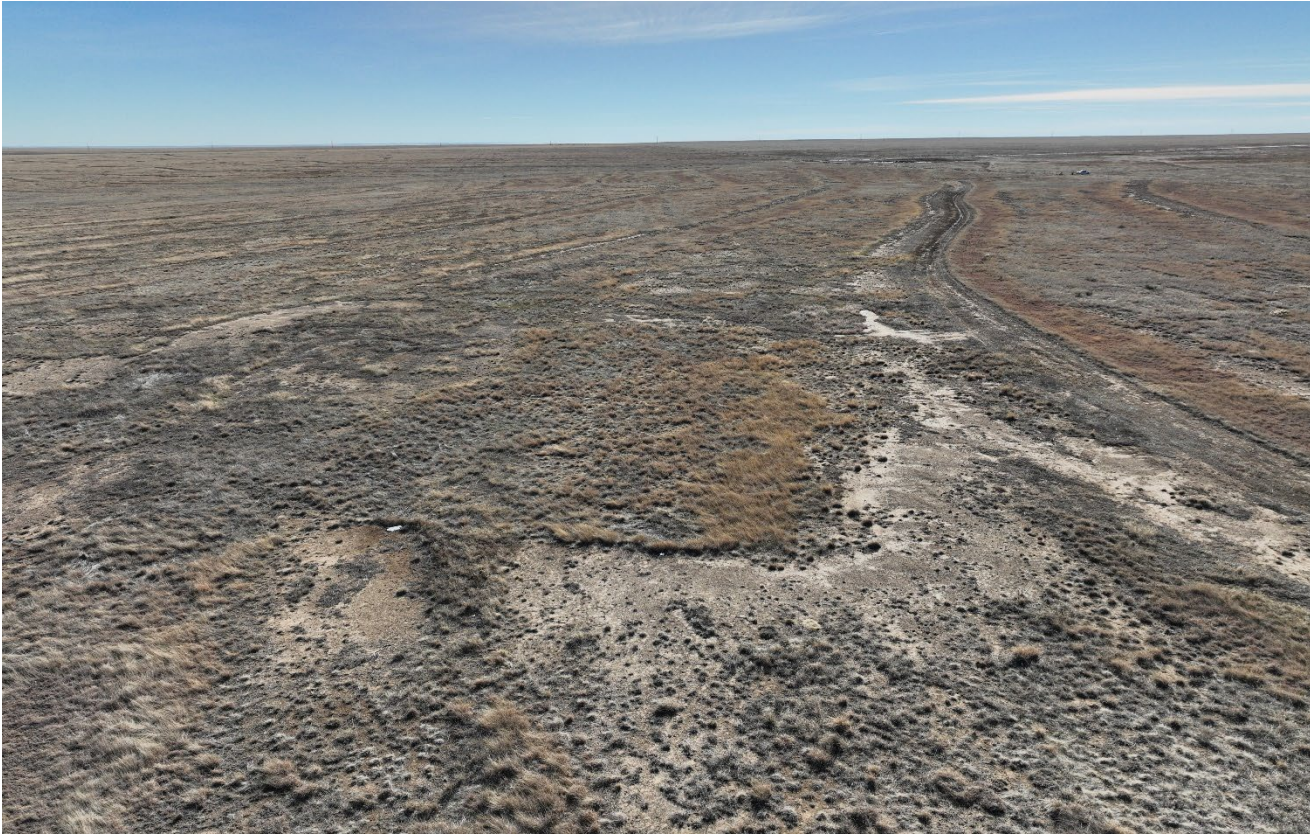
Photo 7. Drone aerial photo facing south overlooking the location. There are areas of the location with no vegetation that will need to be reseeded.
