Inspection Photos

API: 061-06742

Operator: NEWELL ENERGY LTD

Inspection Date: 11/20/2024

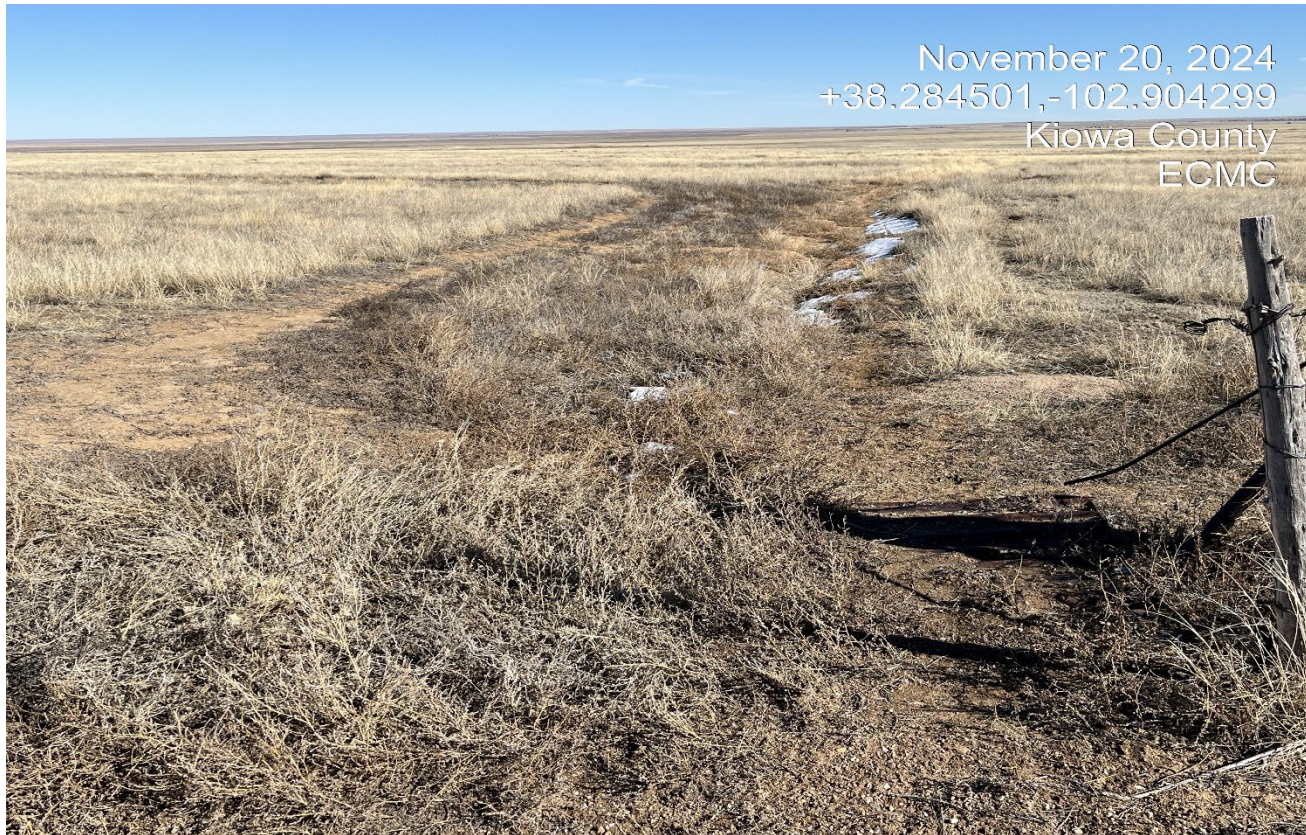
Photo 1. Facing east at the access road. The cattleguard has not been removed and has filled in with sediment. The access road has not been recontoured or reclaimed in this area.

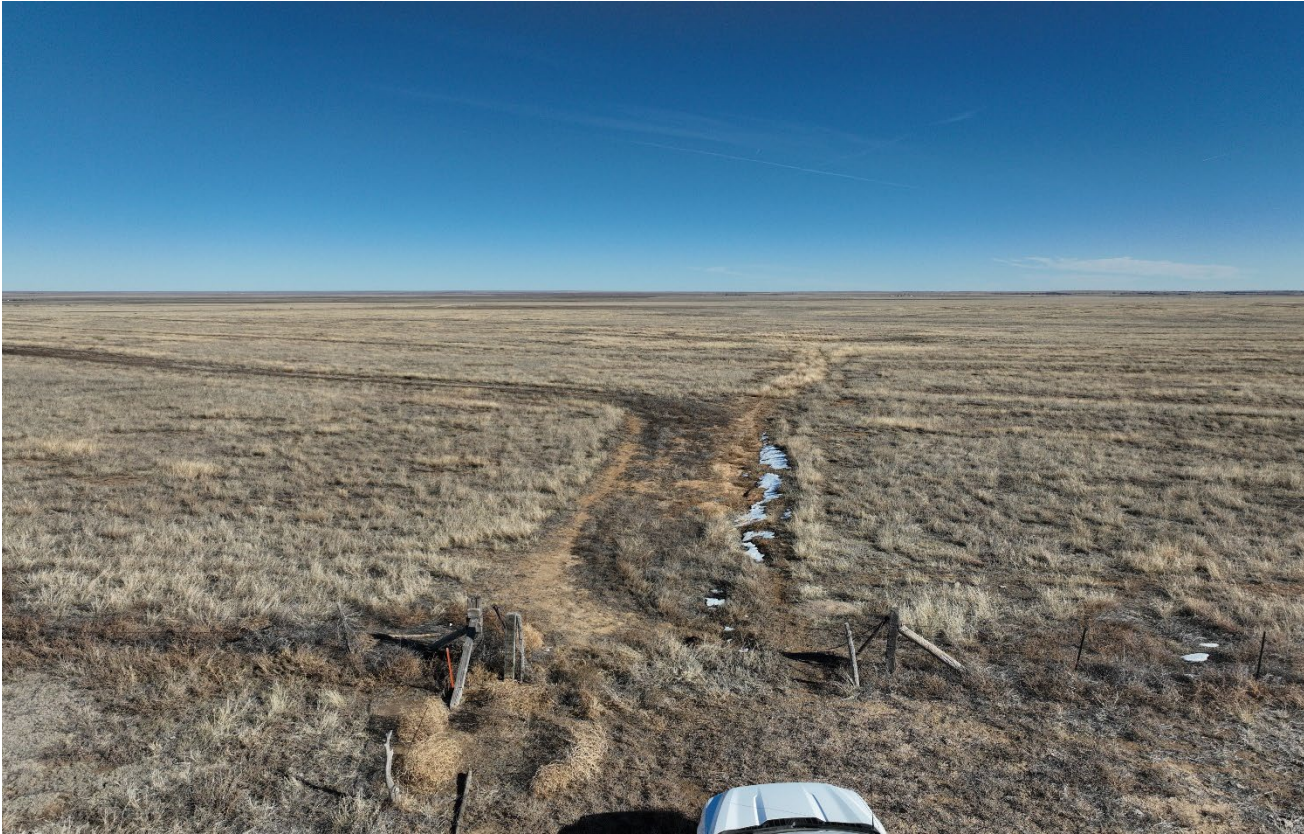
Photo 2. Drone aerial photo facing east at the access road. The cattleguard has not been removed and has filled in with sediment. The access road has not been recontoured or reclaimed in this area.

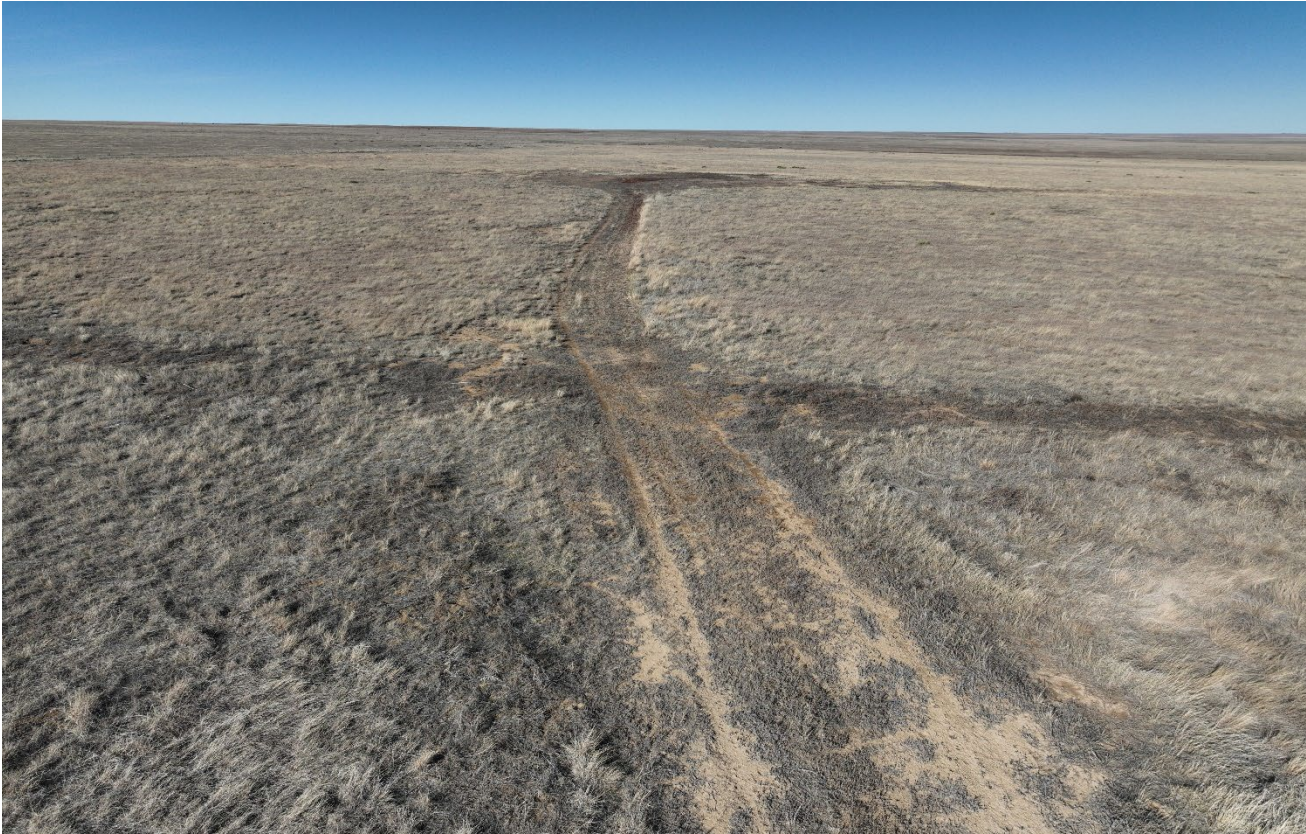
Photo 3. Drone aerial photo facing northeast along the former access road. The perennial vegetation does not appear to be establishing.

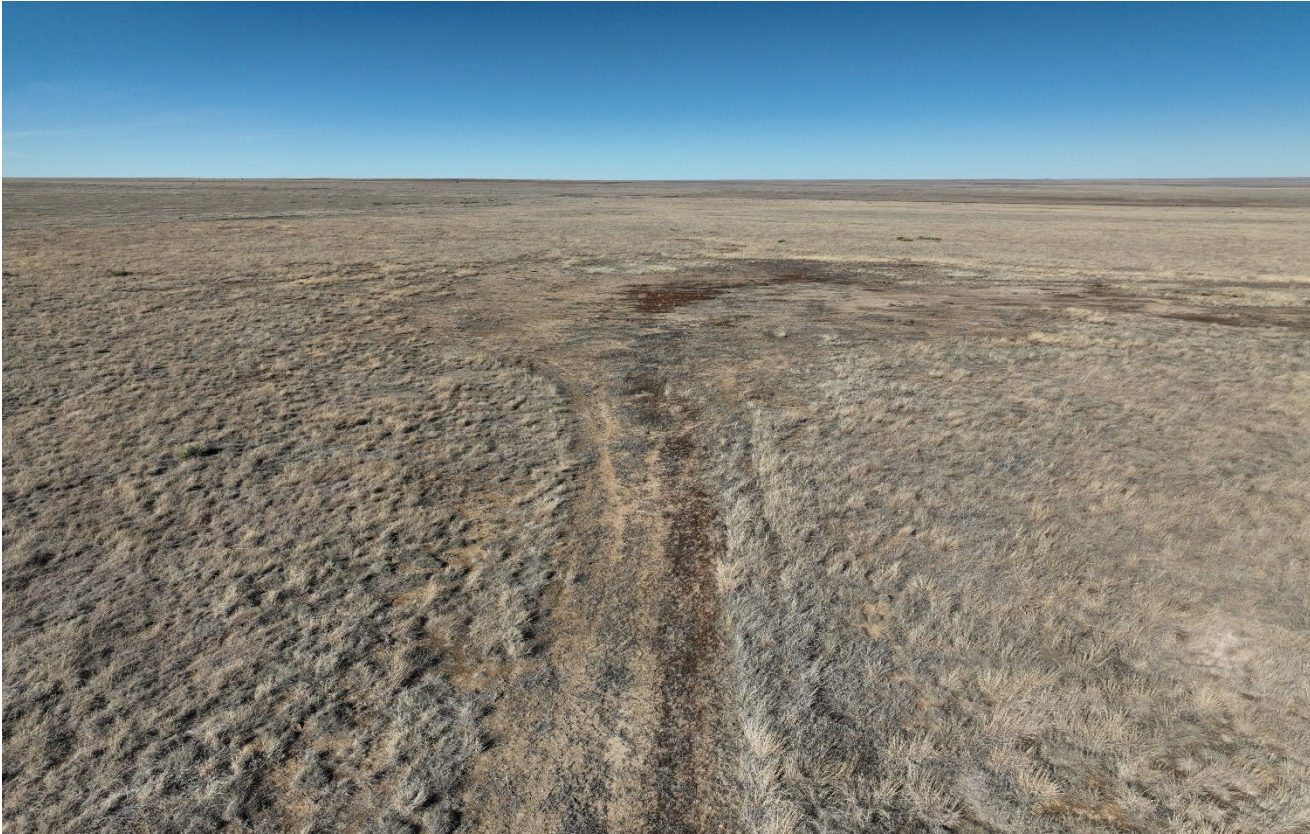
Photo 4. Drone aerial photo facing northeast overlooking the access road and the location.

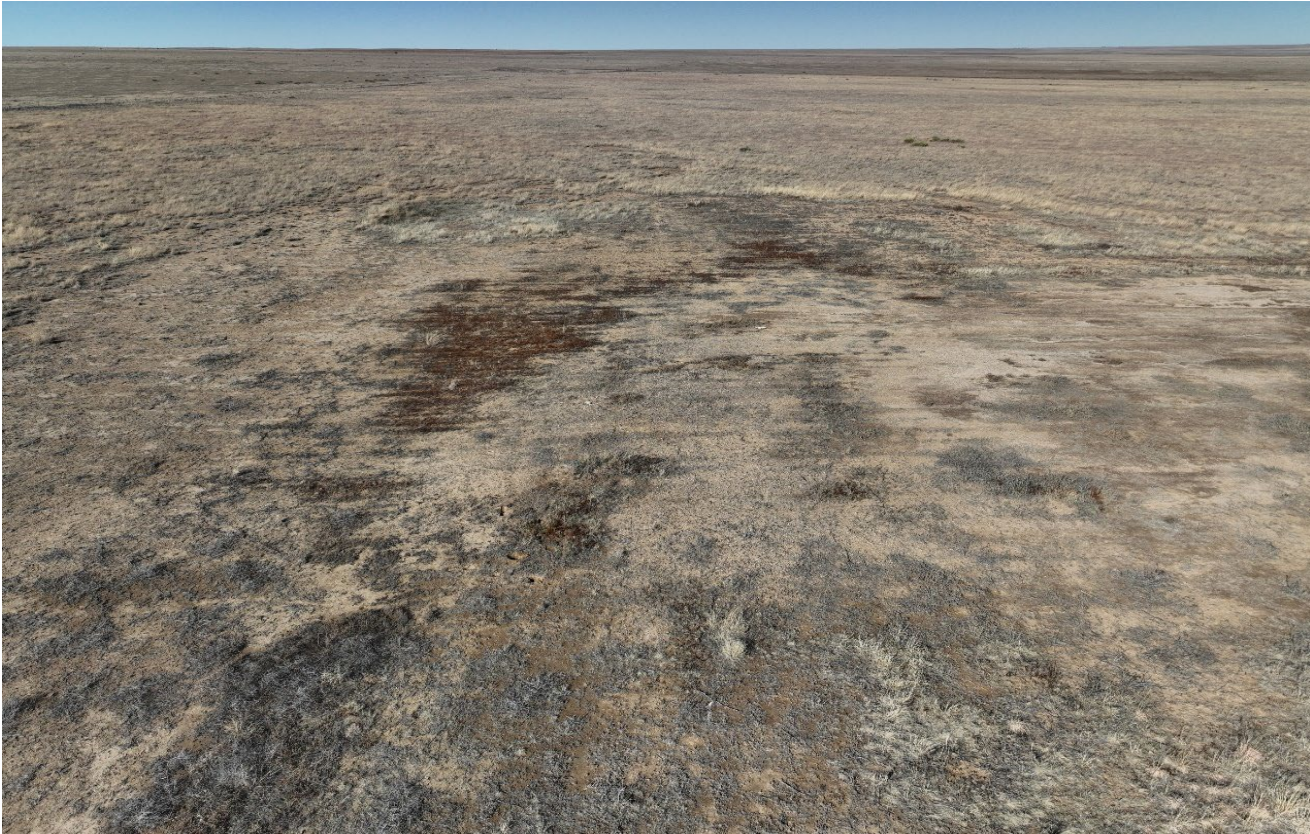
Photo 5. Drone aerial photo facing west overlooking the location. There are areas of the location with no vegetation that will need to be reseeded.

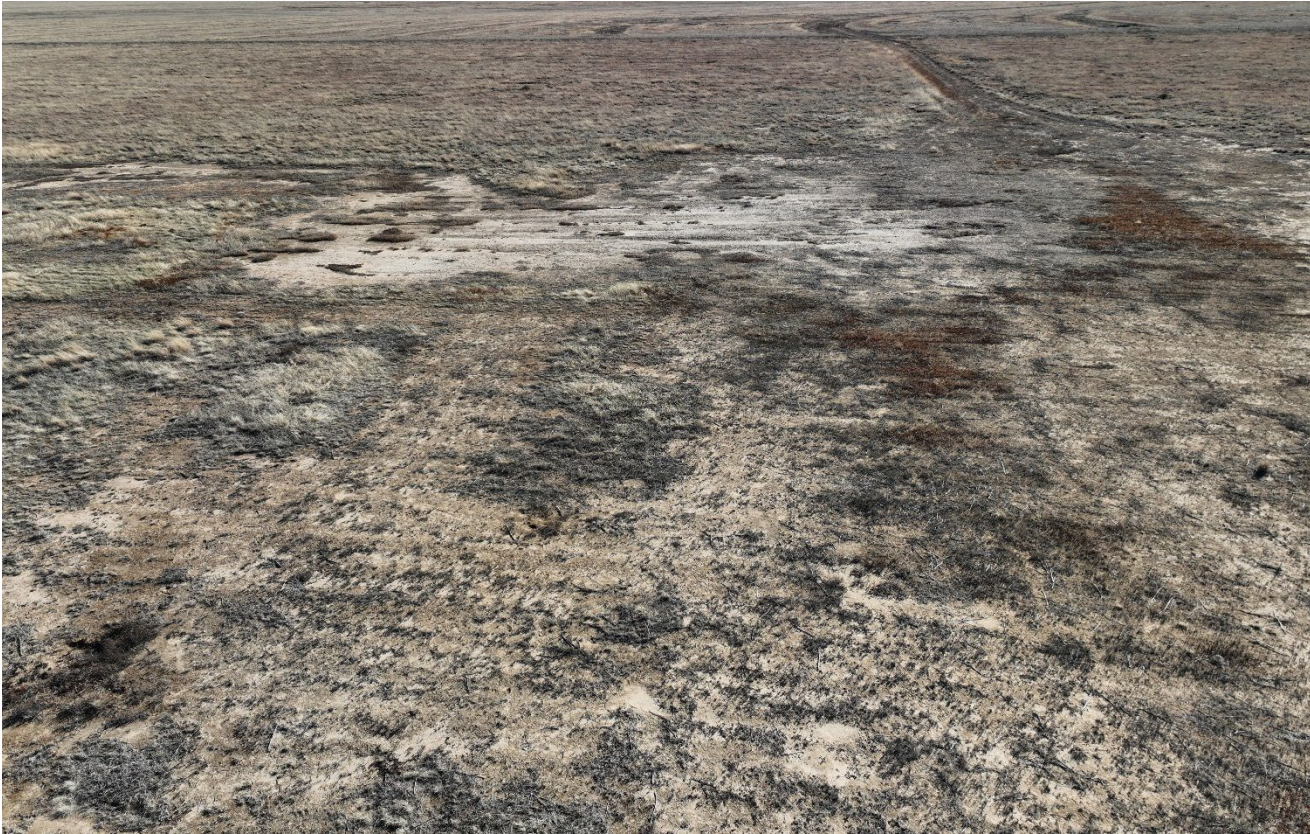
Photo 6. Drone aerial photo facing south overlooking the location. There are areas of the location with no vegetation that will need to be reseeded.

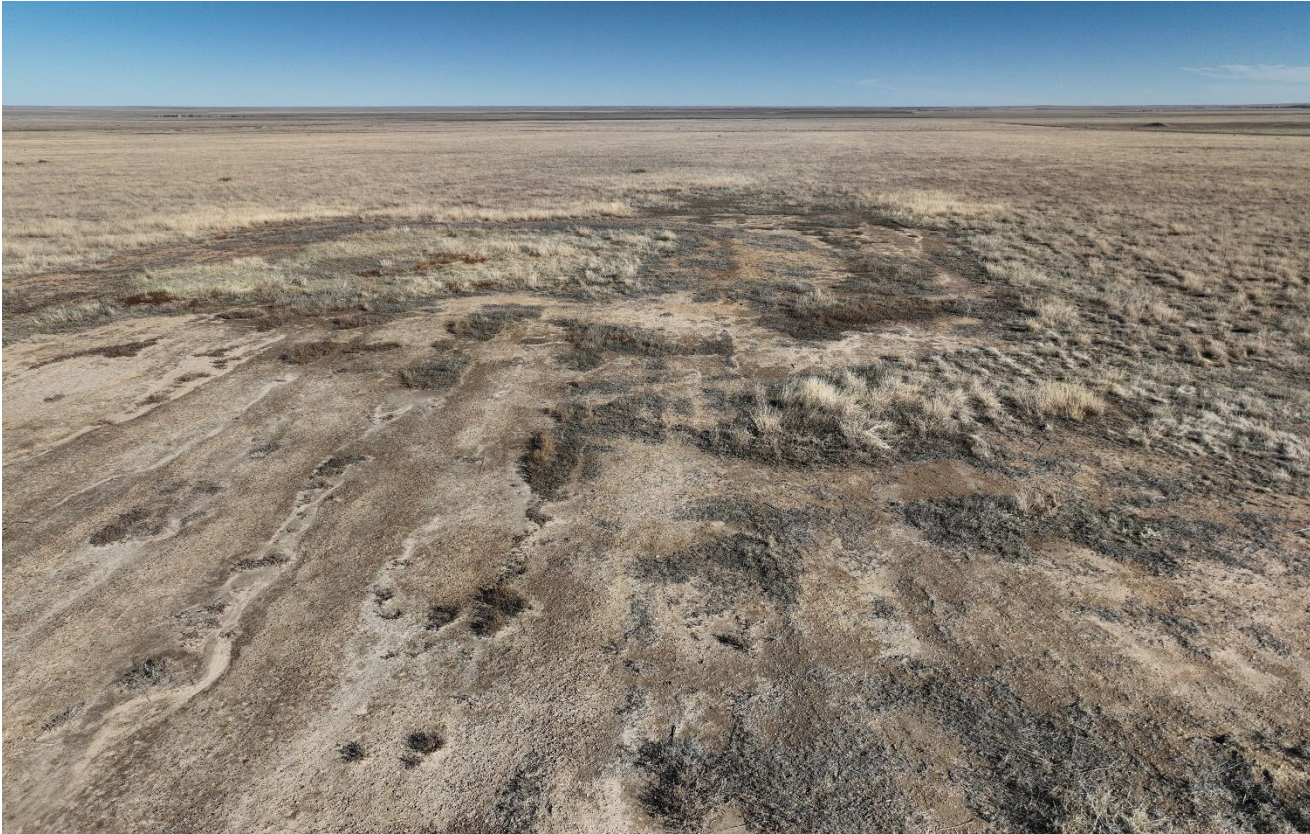
Photo 7. Drone aerial photo facing east toward the bare area with no vegetation.

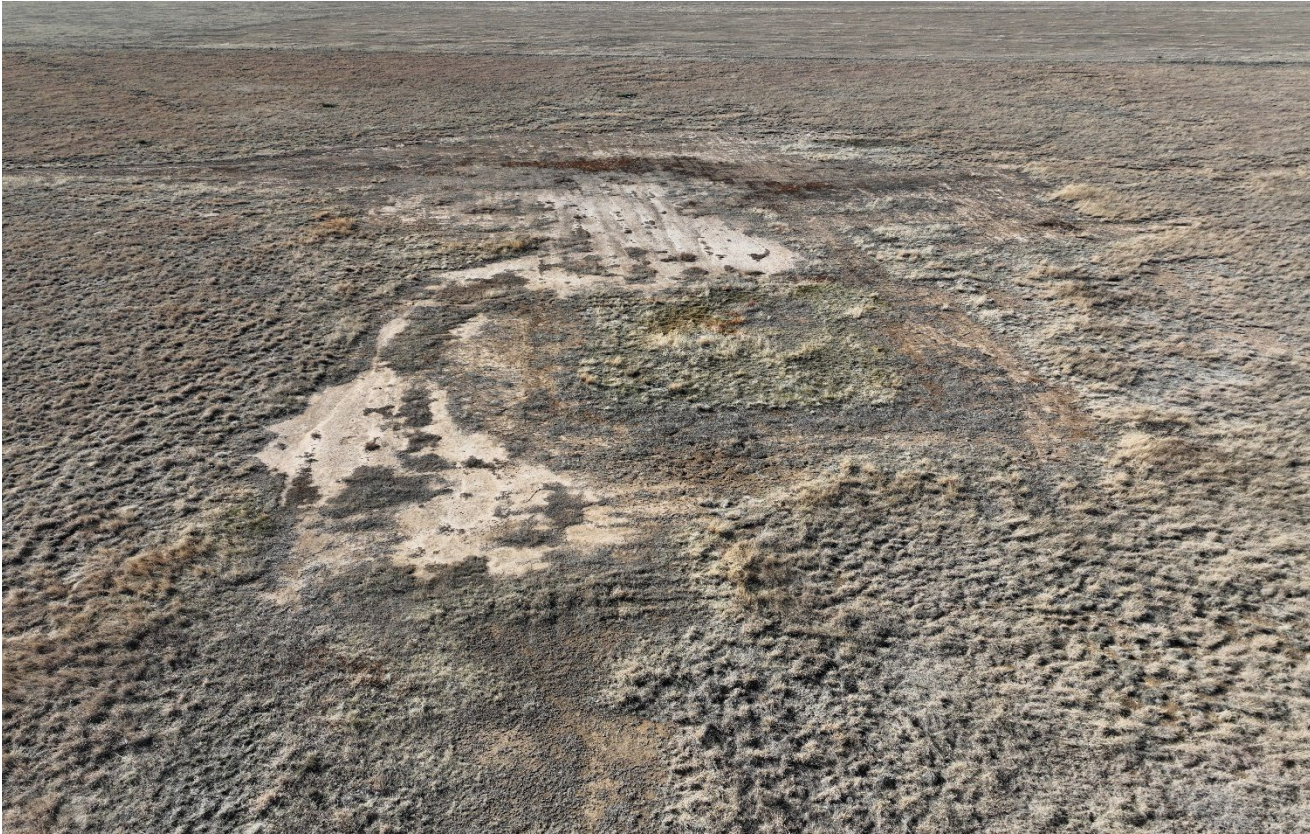
Photo 8. Drone aerial photo facing west overlooking the location. There are areas of the location with no vegetation that will need to be reseeded.

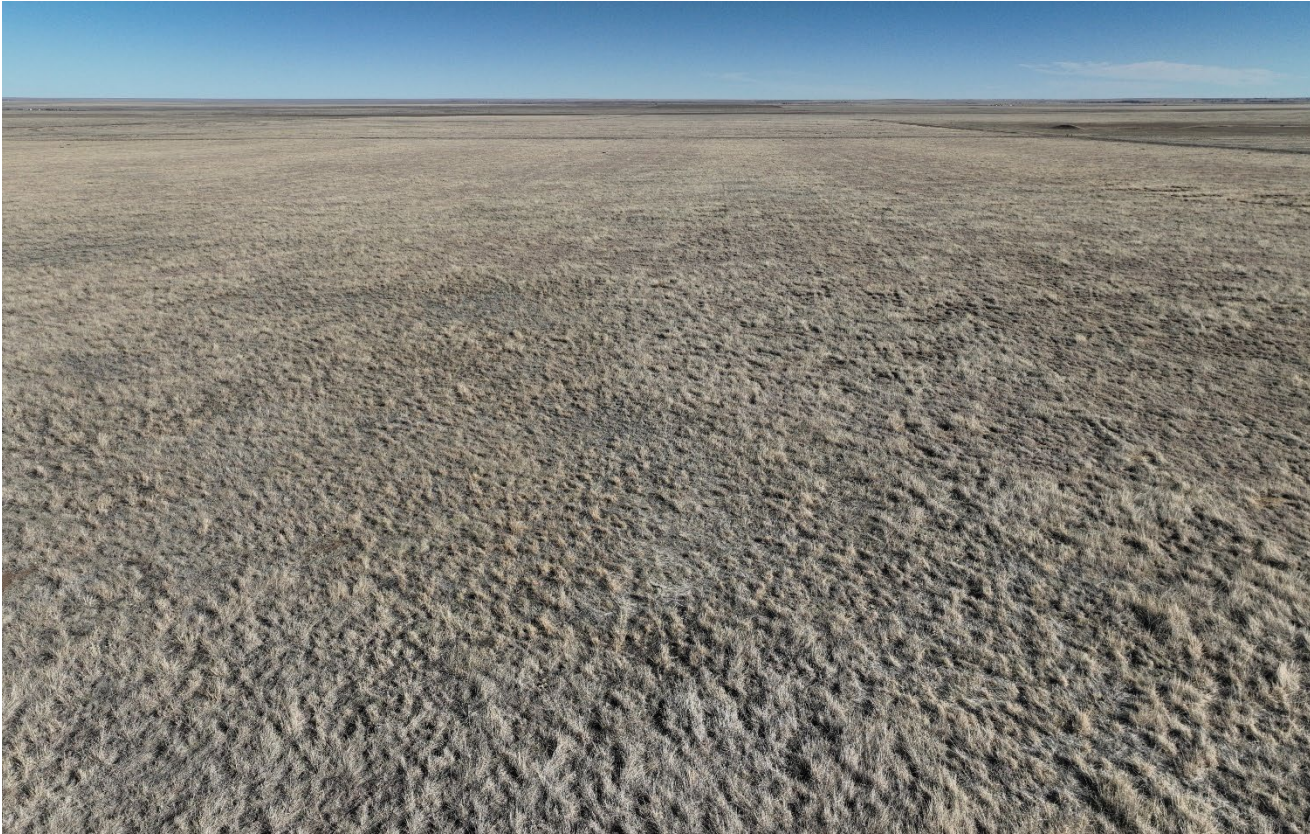
Photo 9. Drone aerial photo facing east toward the surrounding uniform vegetation in the reference area.
