Inspection Photos

Loc: 324505

Operator: **OXY USA INC**

Inspection Date: 11/25/2024

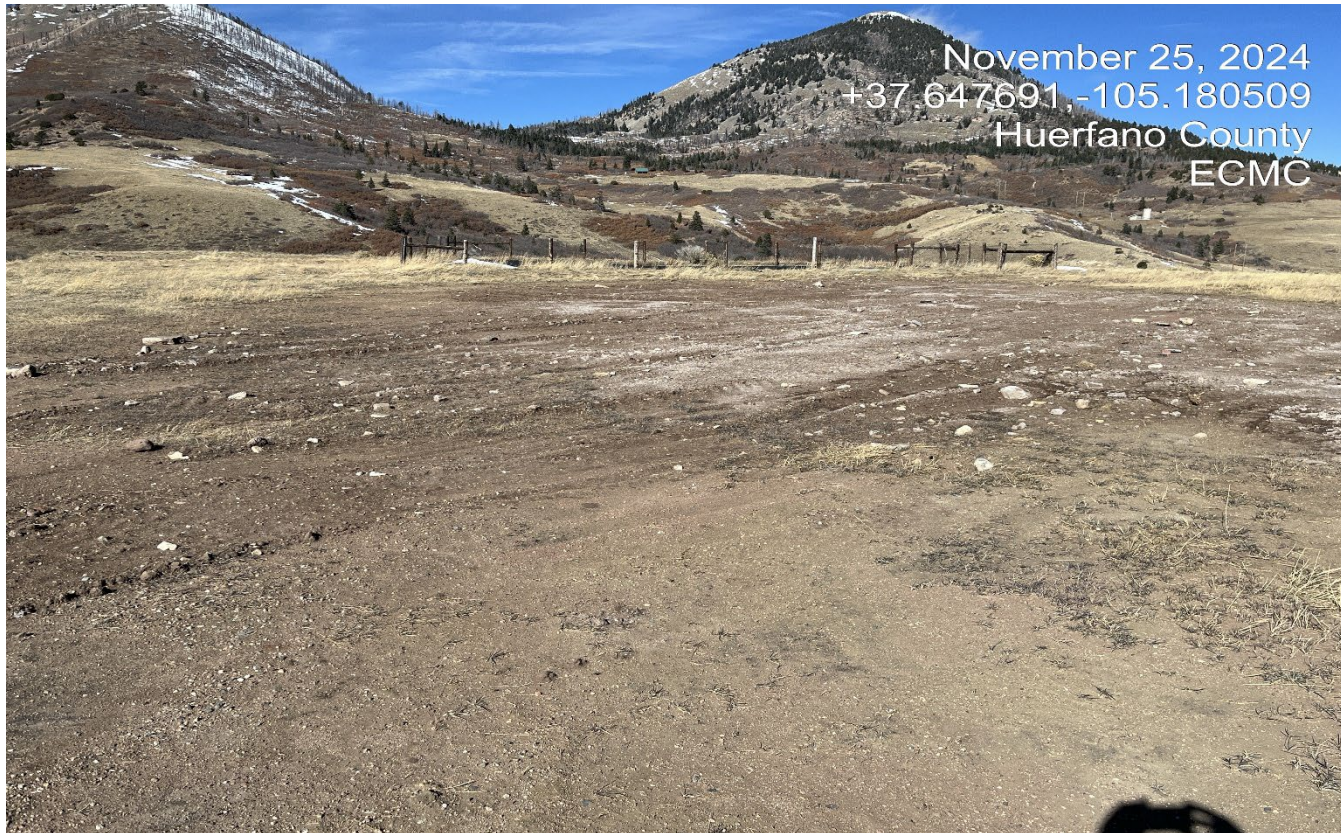
Photo 1. Facing north toward the location. The remediation project has been completed but final reclamation was not performed.

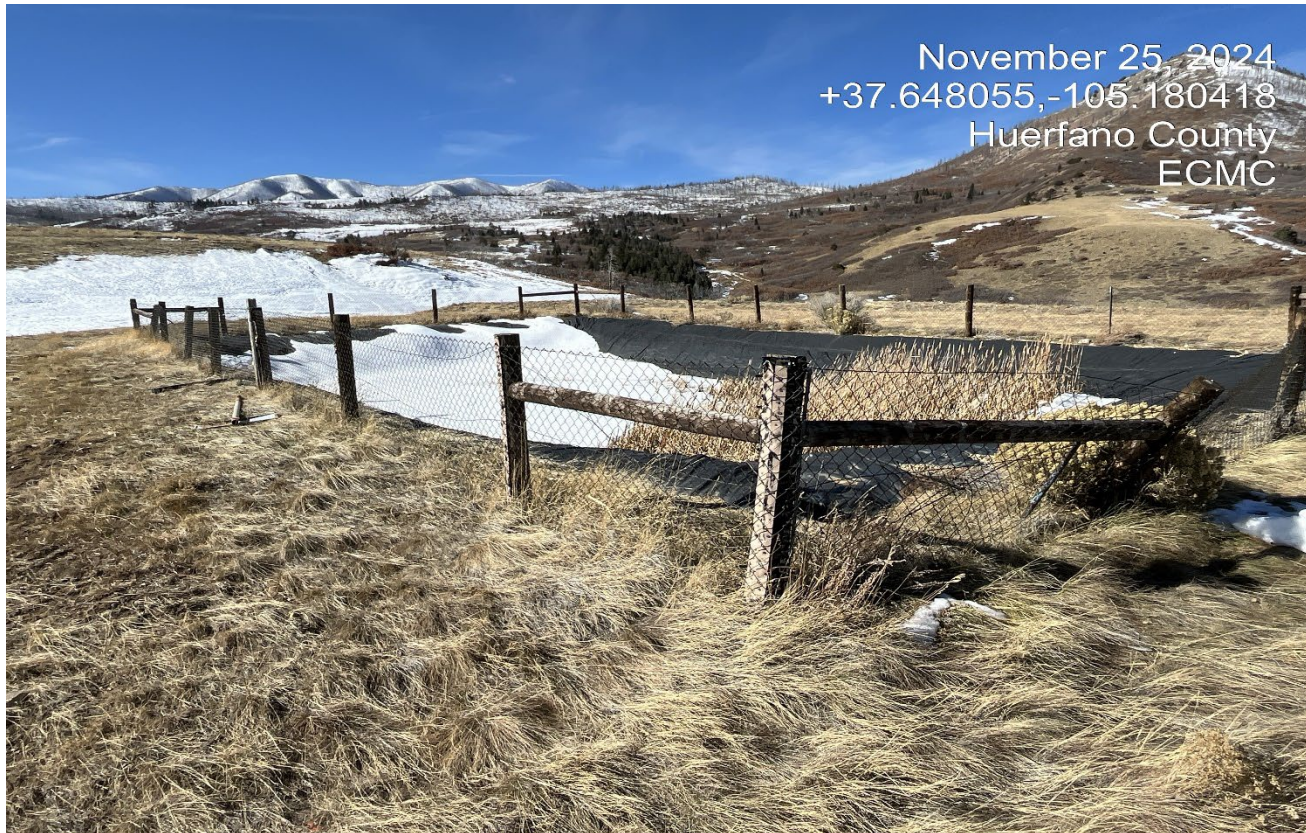
Photo 2. The lined pit remains at the location and must be closed per approved form 27.

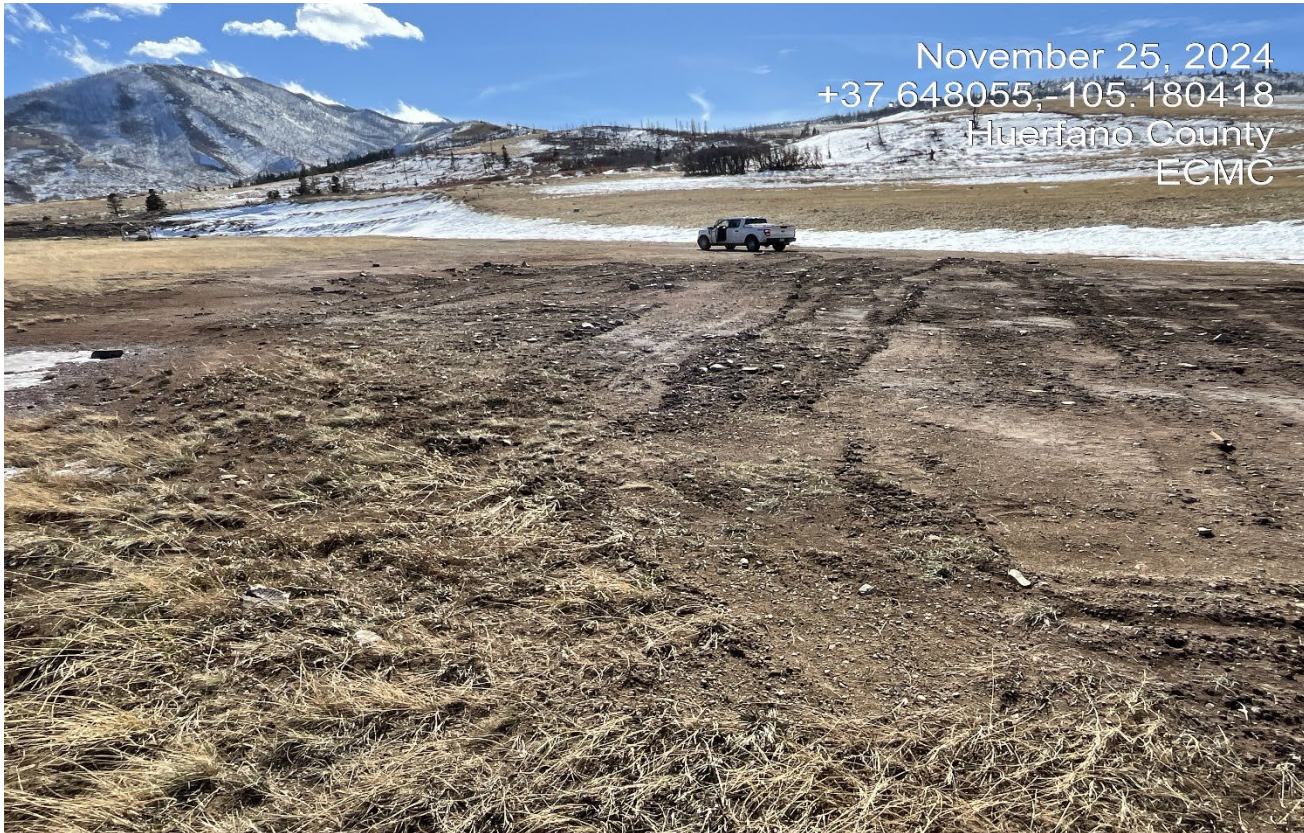
Photo 3. Facing south at the location. The location will need to be recontoured per 1004 Rule..

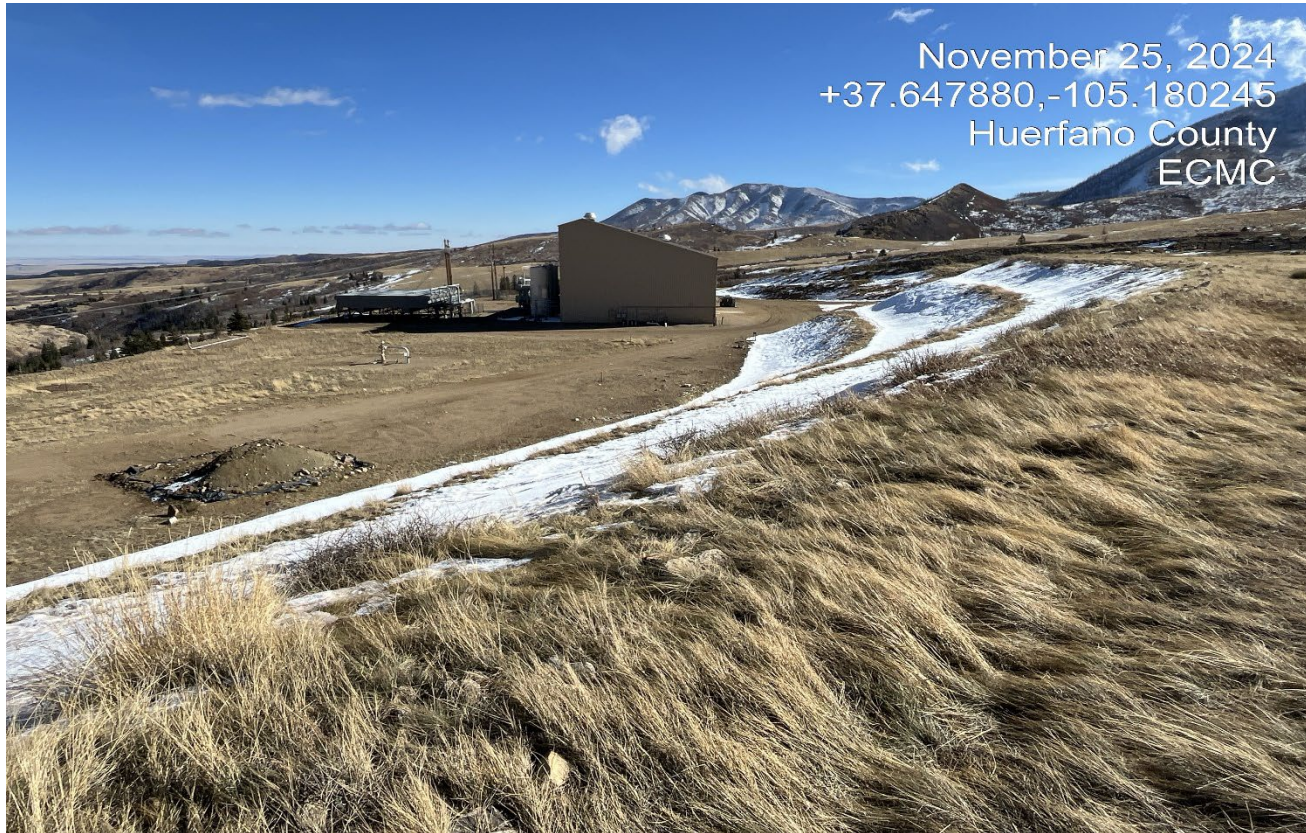
Photo 4. Facing southeast along the fill slope which will need to be partly recontoured. There are active wells that remain on the lower pad and far southeast side.
