# Site Specific Final Reclamation Completion Notice – Land Use Change Drone Imagery

## Permit Closure Report – Land Use Change

**Well Location ID:** 323660

**Well Location Name:** BRIGGS-65N66W/17SWSE

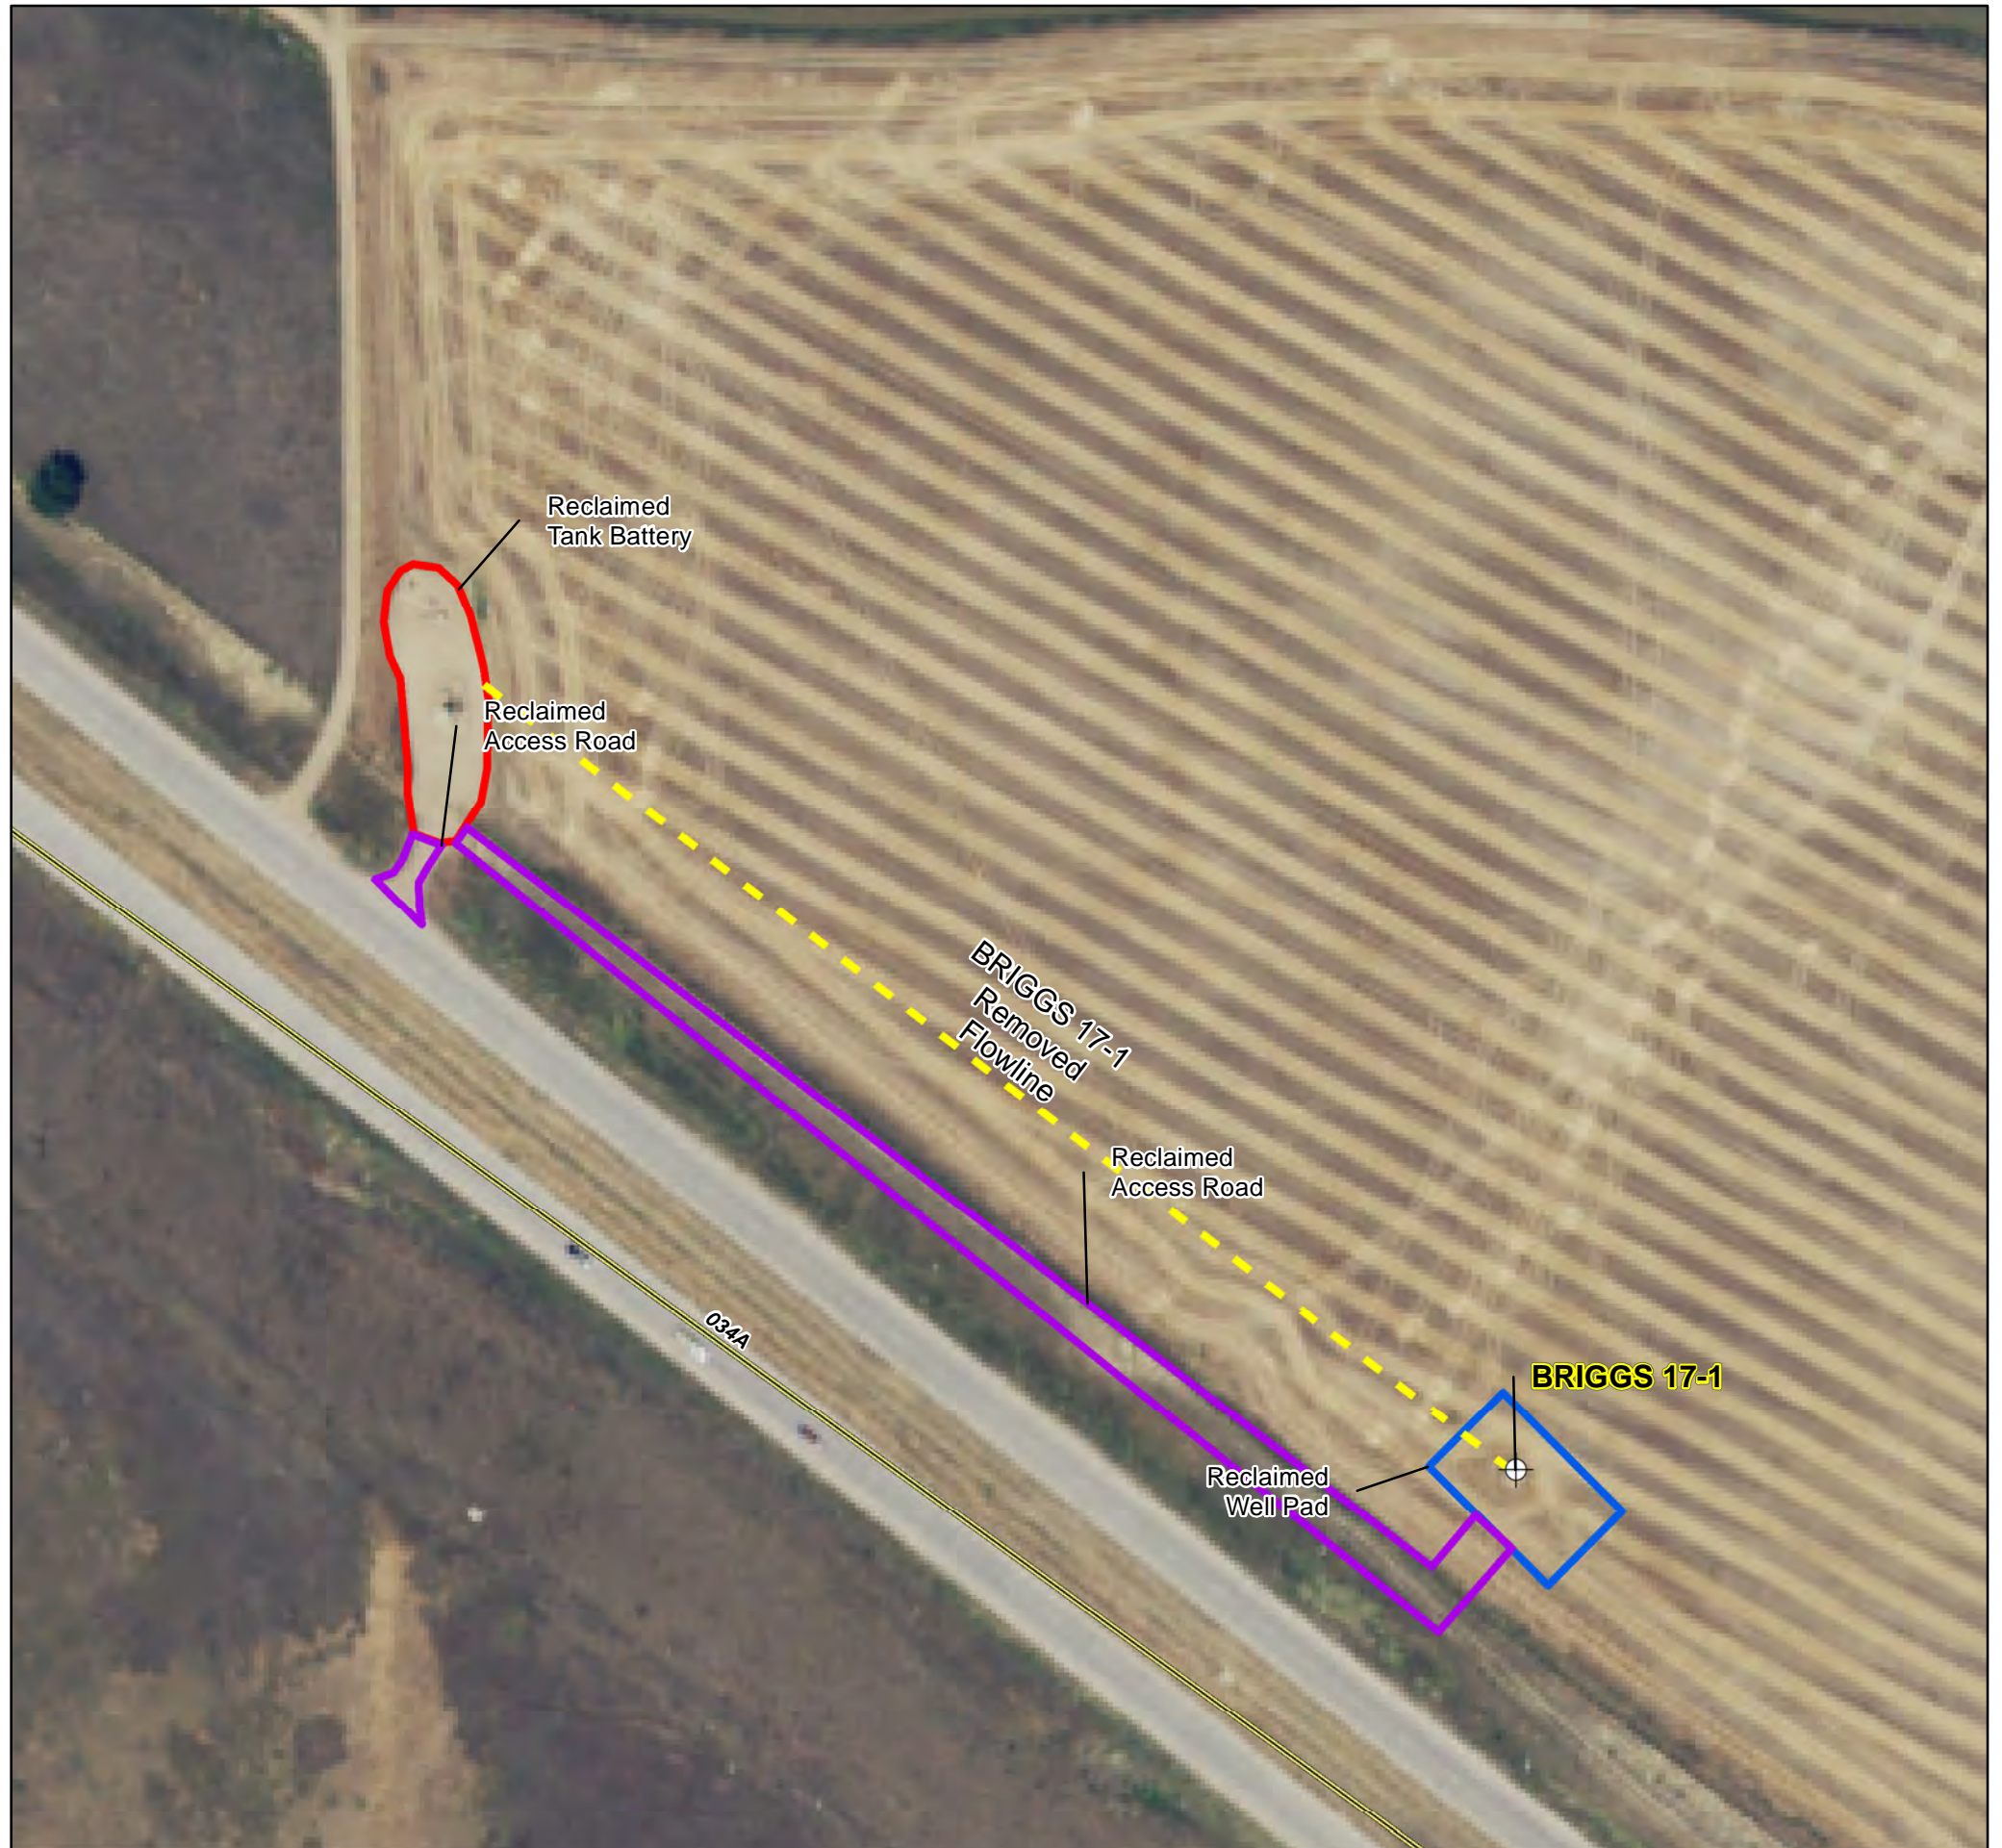
# PDC Form 4 Final Reclamation - Pre Plugging Overview

- Well Head
- Former Tank Battery Disturbance
- Reclaimed Well Pad Disturbance
- Reclaimed Access Road Disturbance
- Flowline - Removed
- Highway

NAIP 2015 Imagery

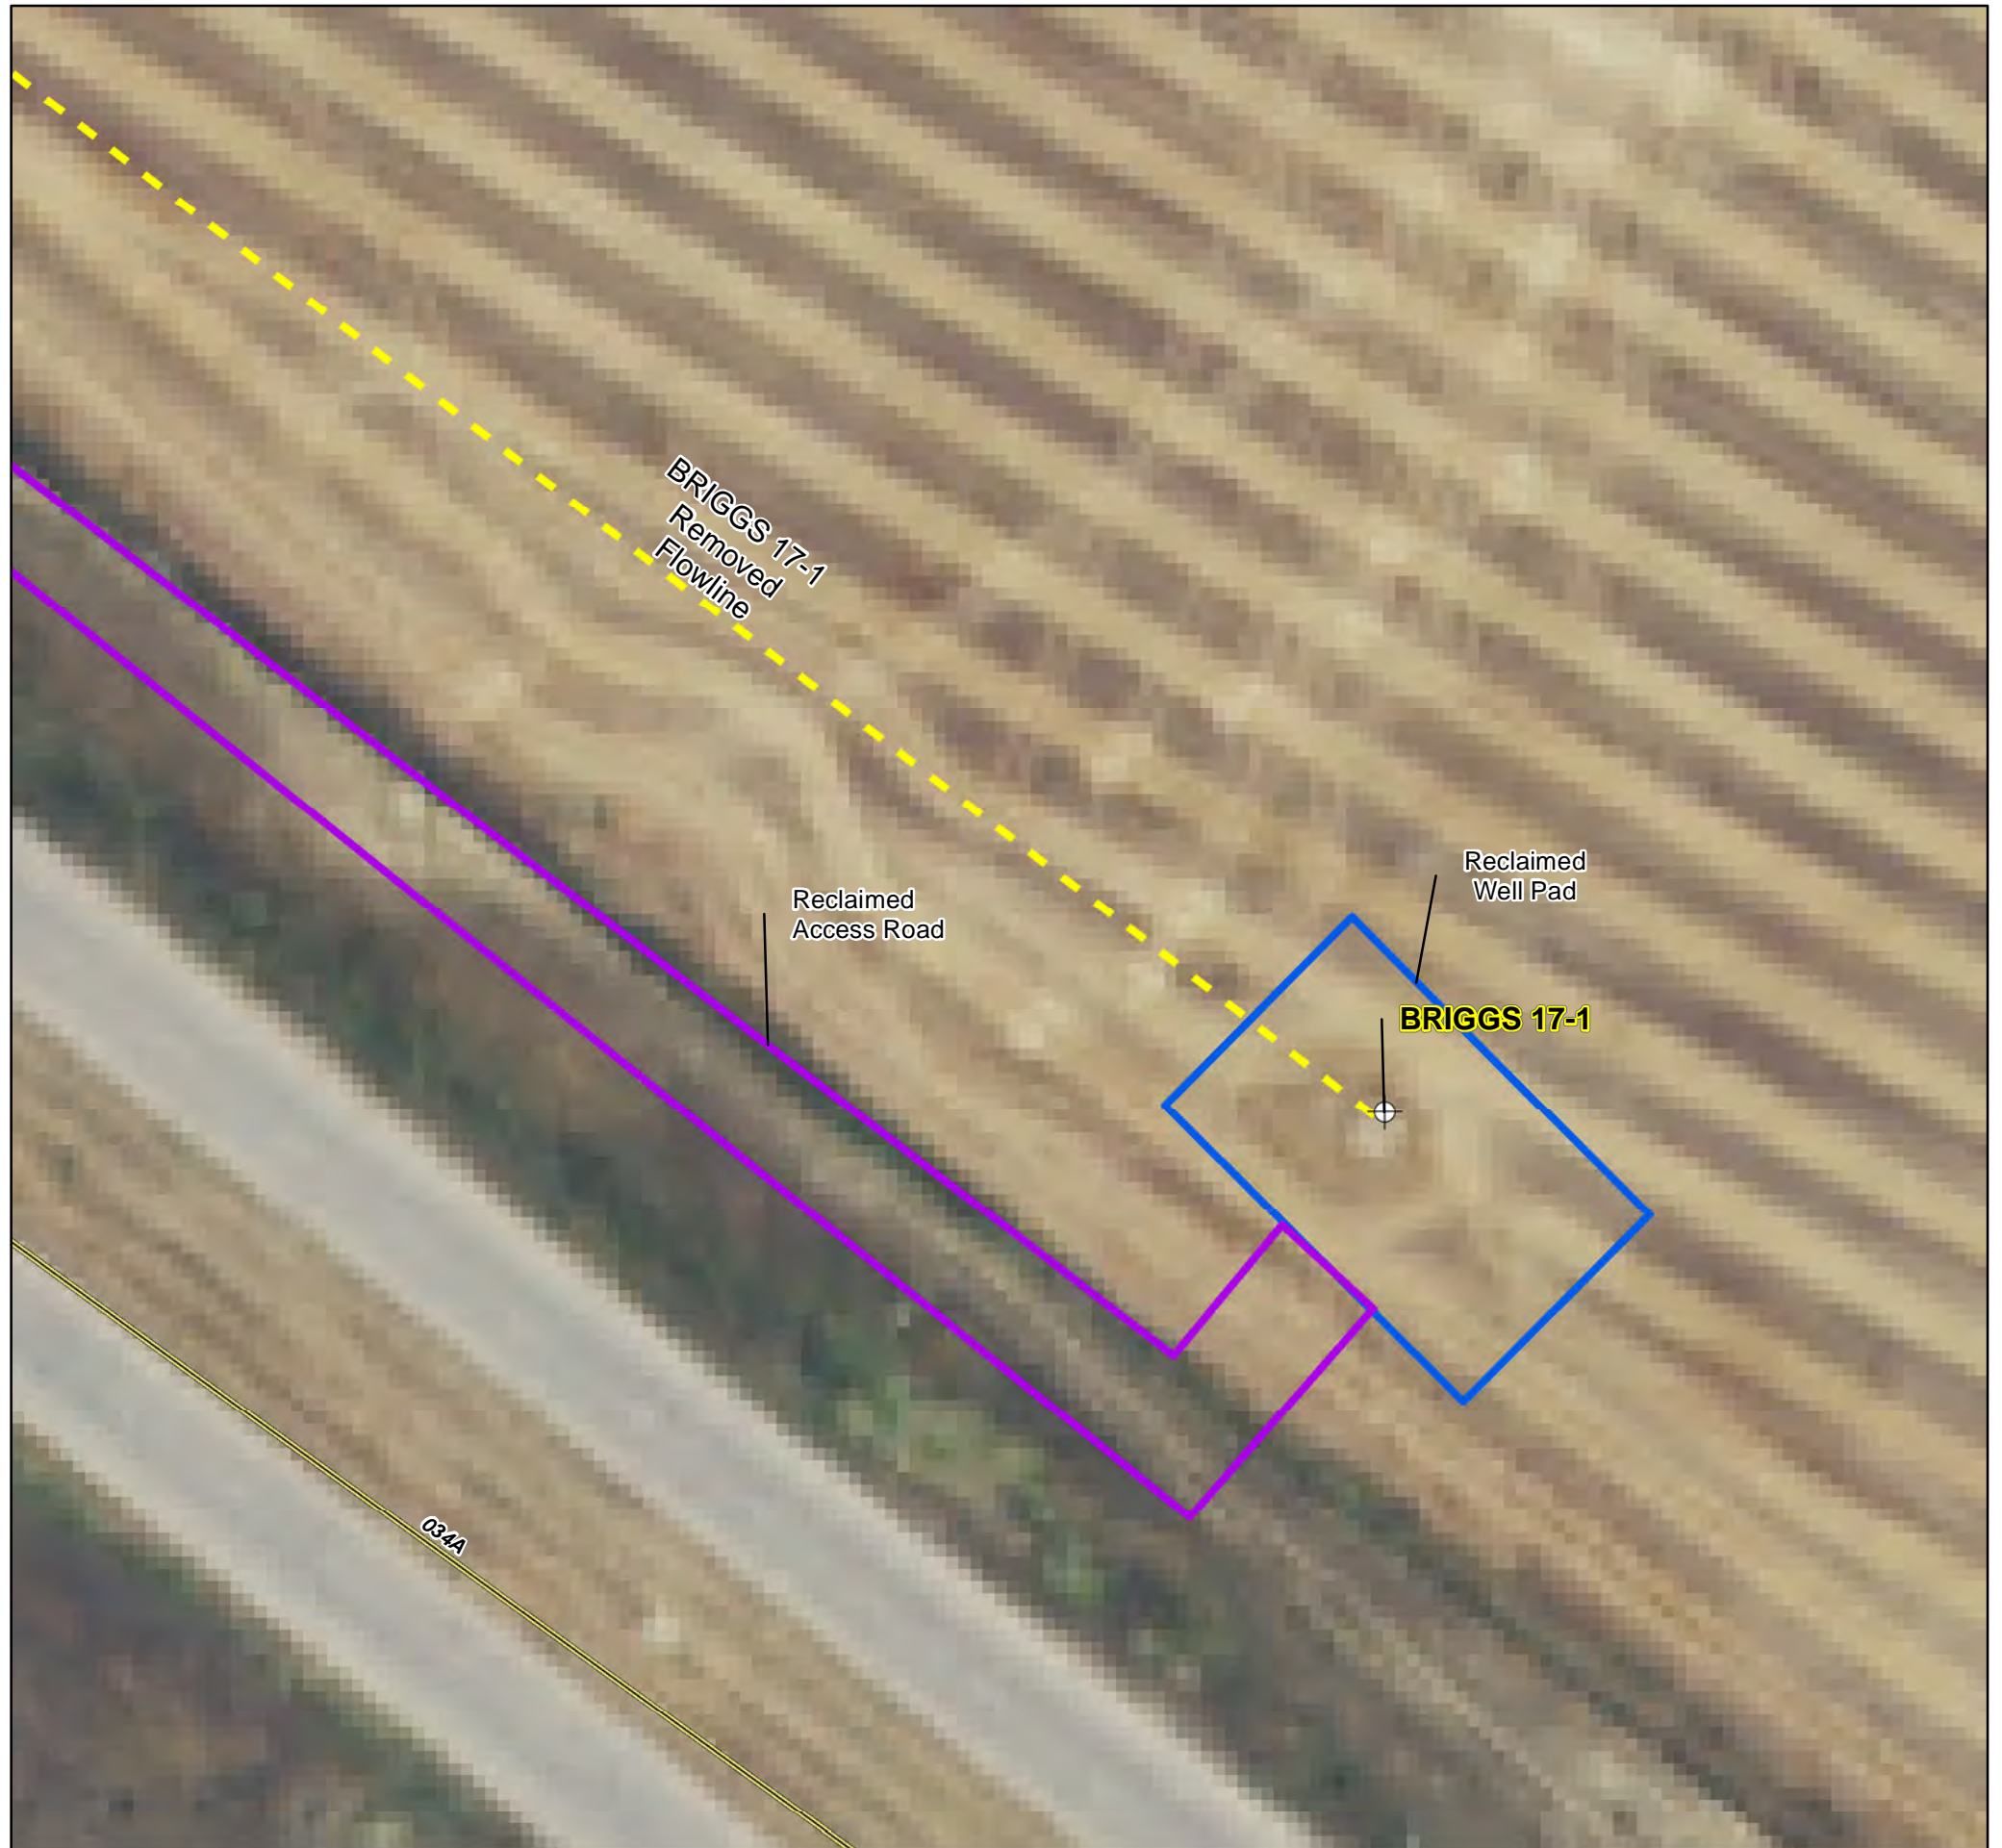
PDC Form 4 Final Reclamation - Pre Plugging Overview

- Well Head
- Reclaimed Well Pad Disturbance
- Reclaimed Access Road Disturbance
- Flowline - Removed
- Highway

NAIP 2015 Imagery

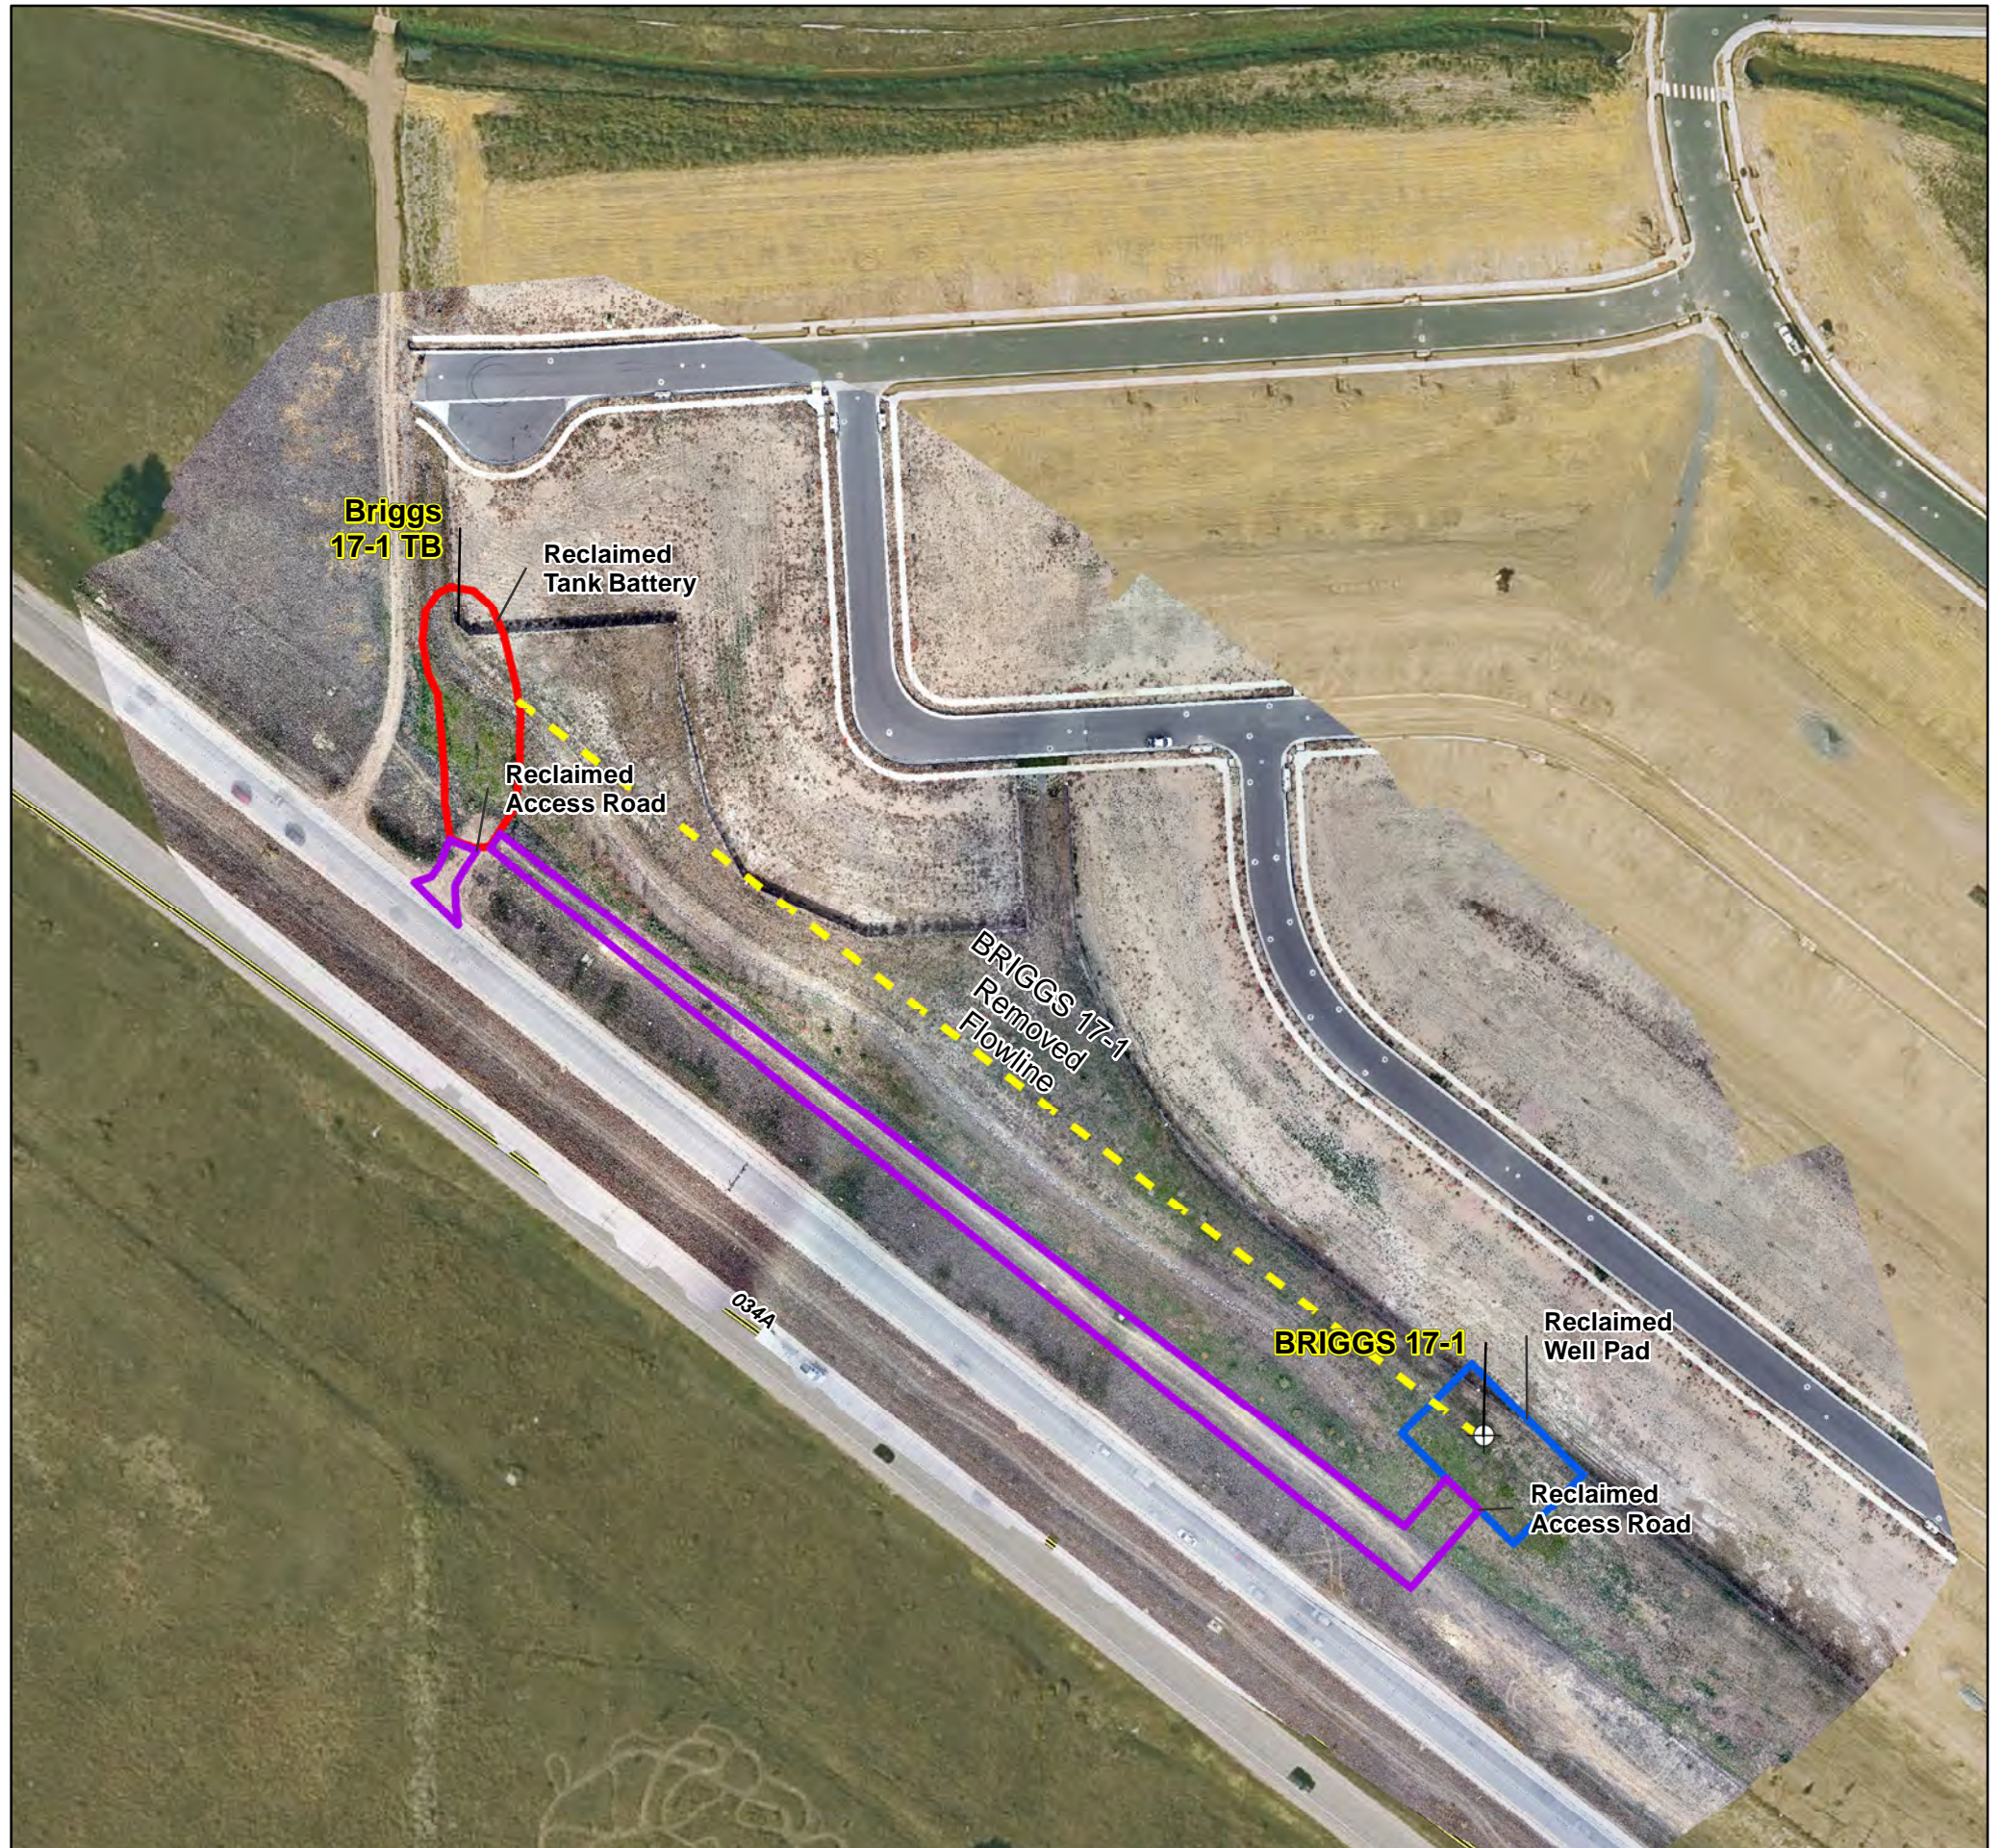
# PDC Form 4 Final Reclamation - Post Plugging Overview

- Well Head
- Reclaimed Tank Battery Disturbance
- Reclaimed Well Pad Disturbance
- Reclaimed Access Road Disturbance
- Flowline - Removed
- Highway

## 2024 Drone Imagery

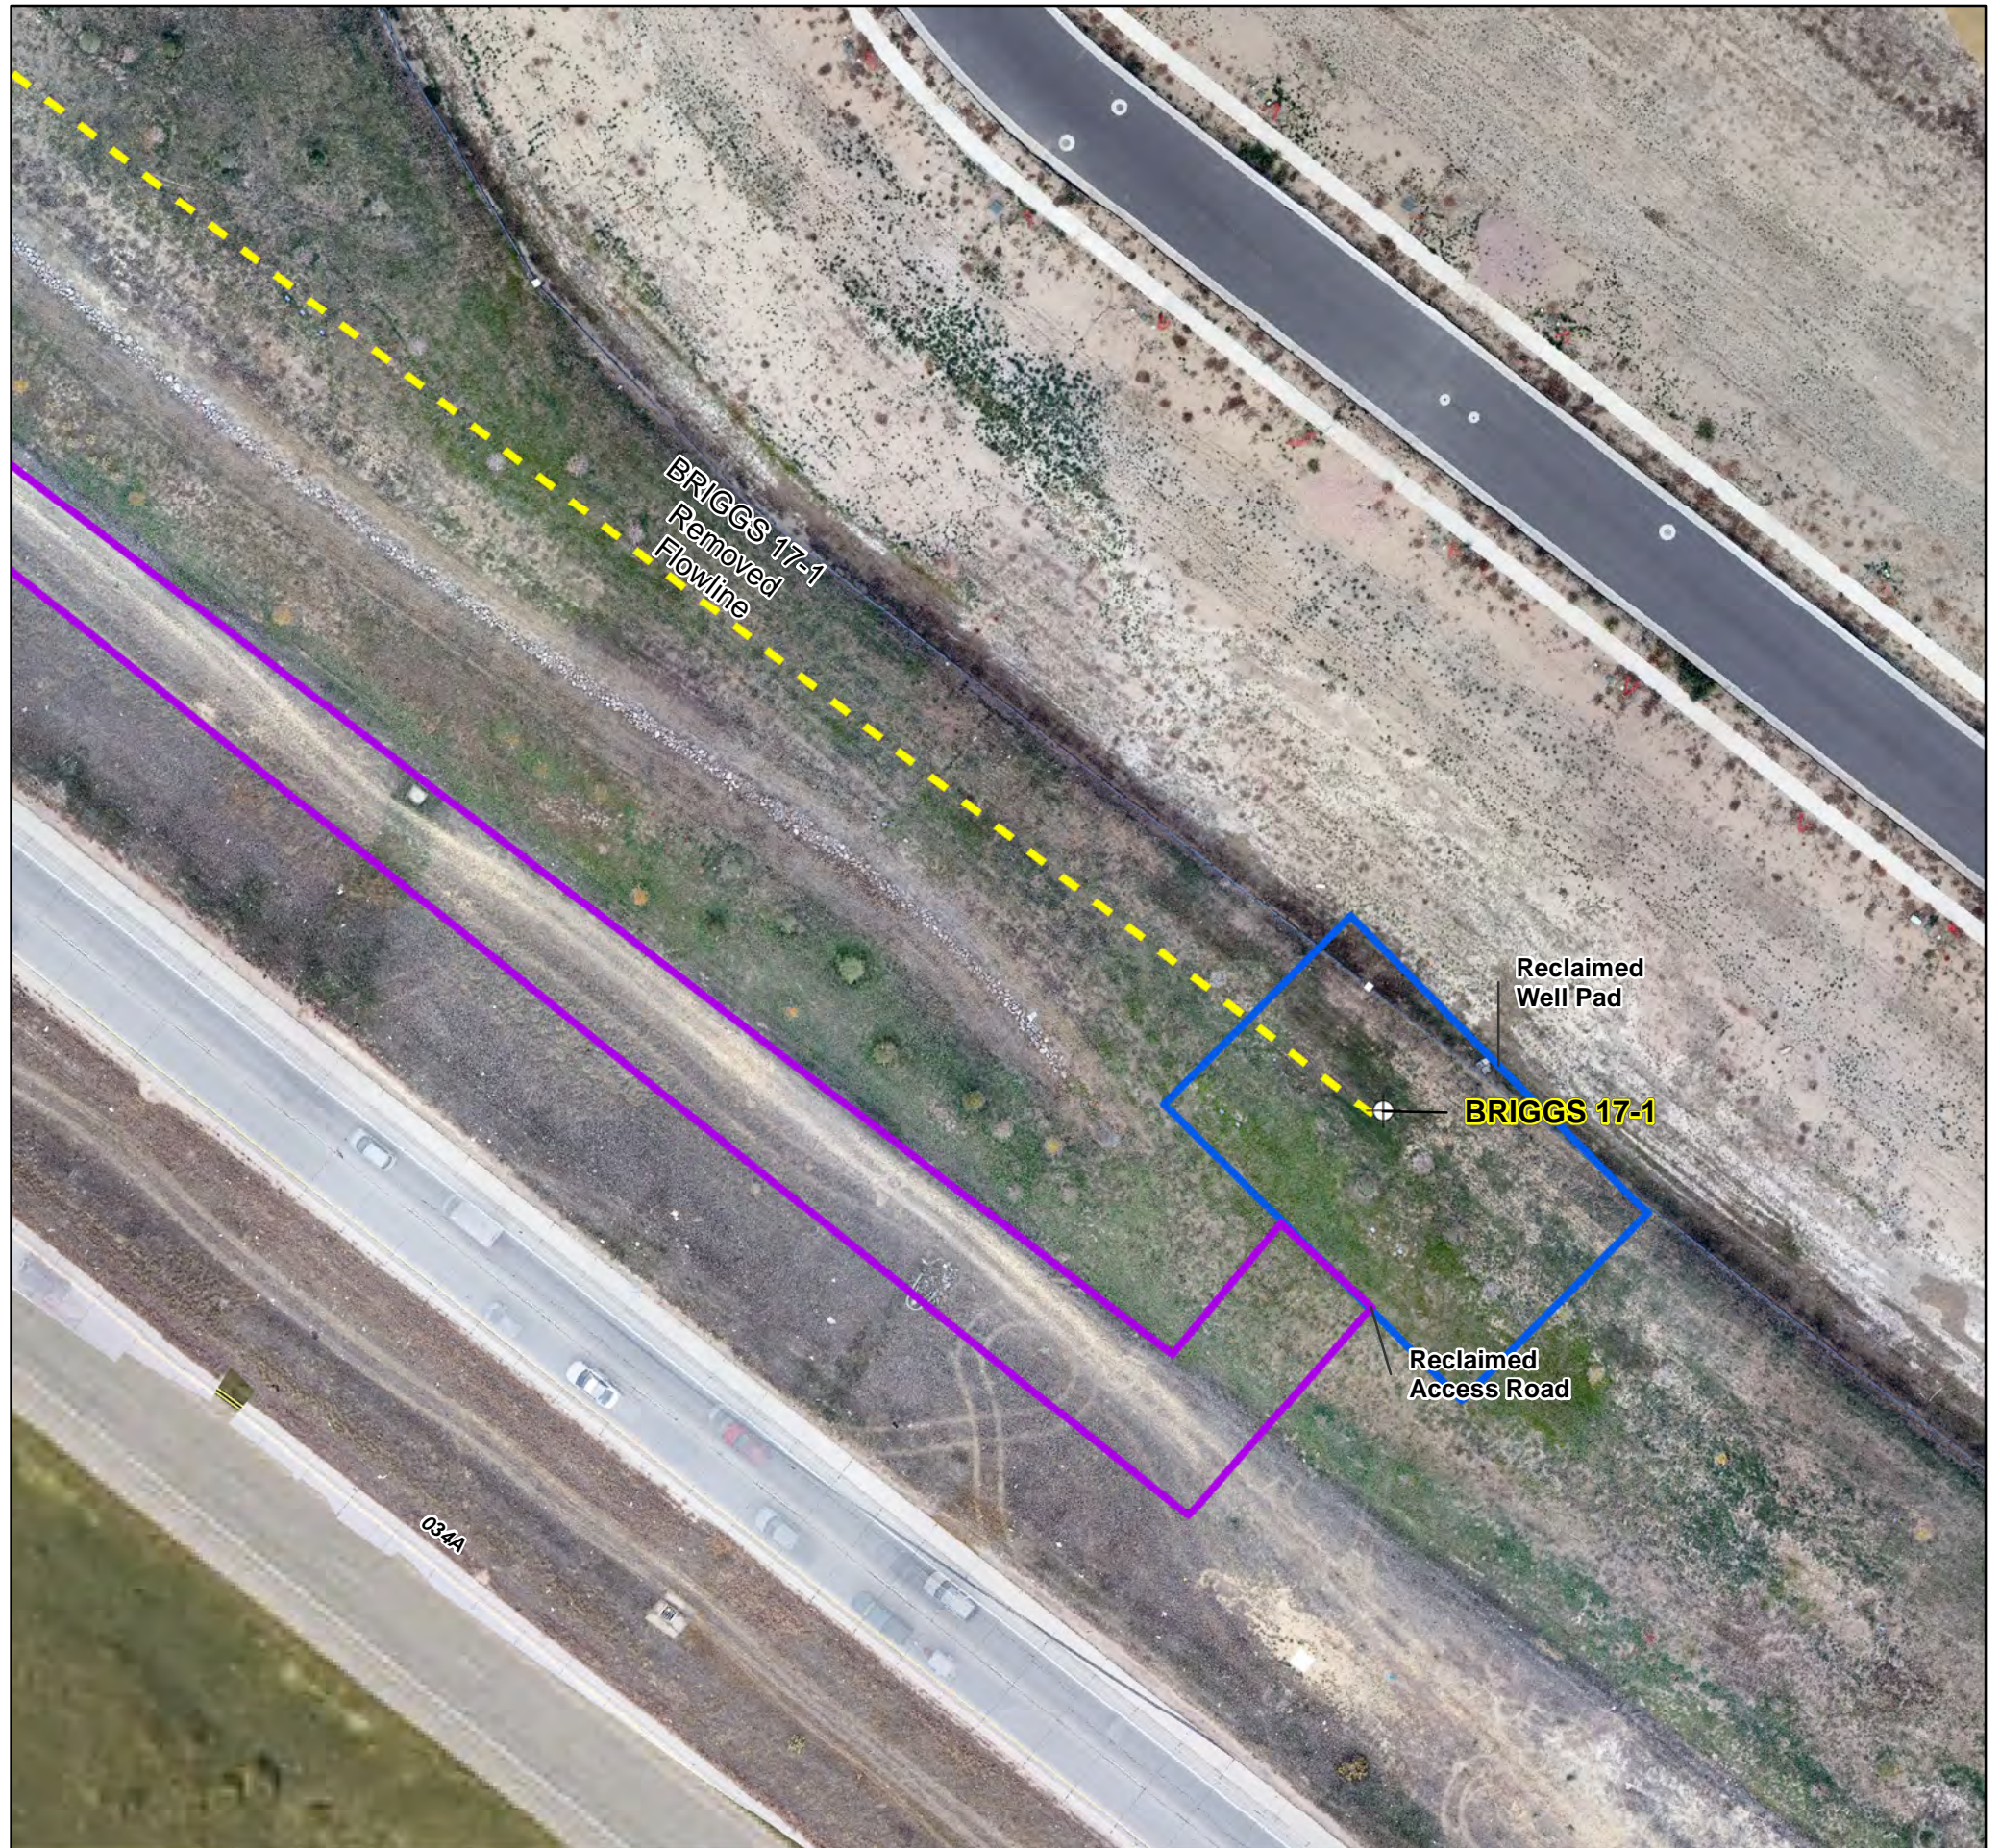
PDC Form 4 Final Reclamation - Post Plugging Overview

- Well Head
- Reclaimed Well Pad Disturbance
- Reclaimed Access Road Disturbance
- Flowline - Removed
- Highway

2024 Drone Imagery

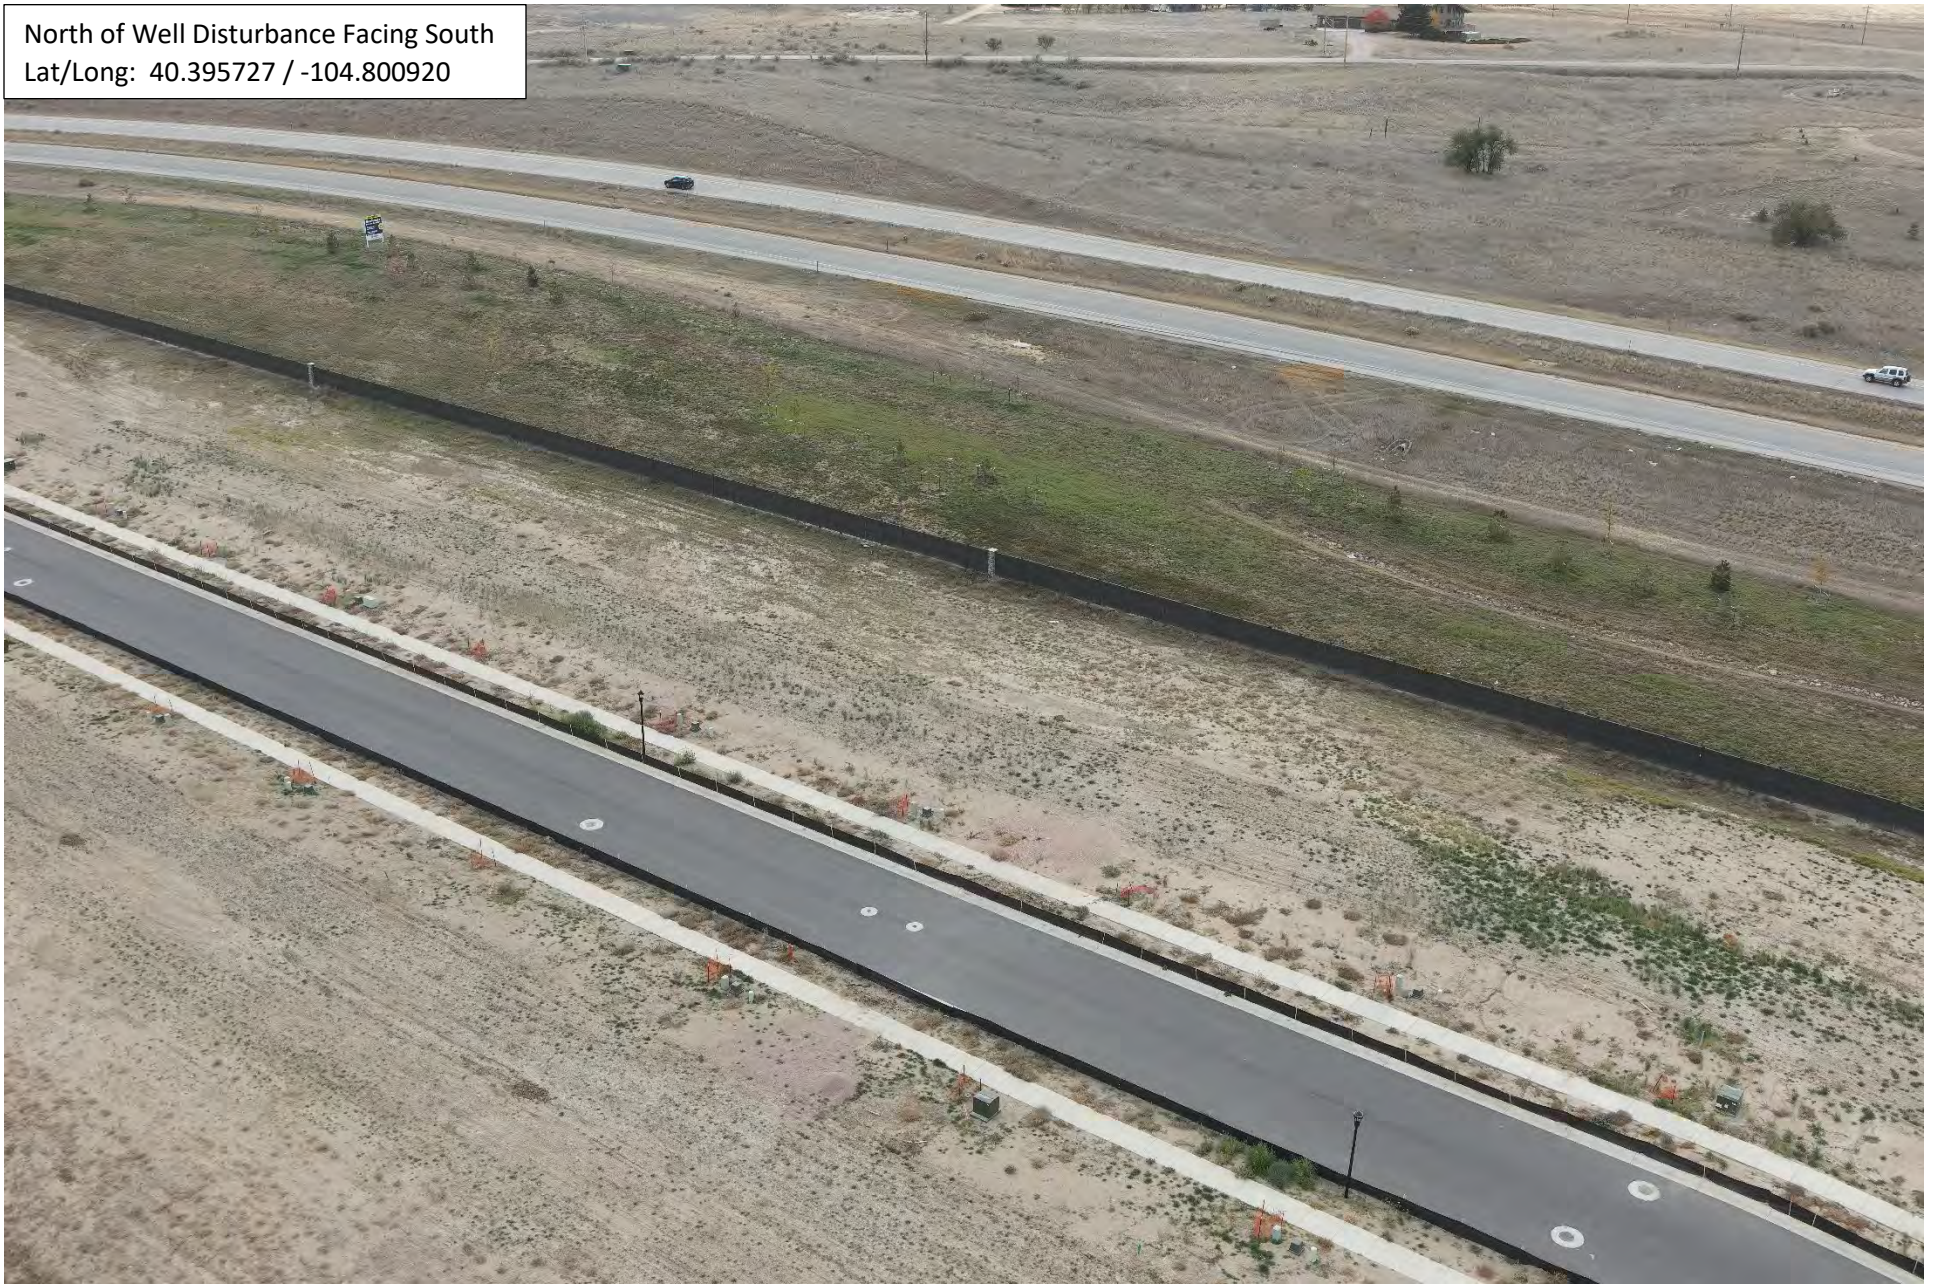
North of Well Disturbance Facing South  
Lat/Long: 40.395727 / -104.800920

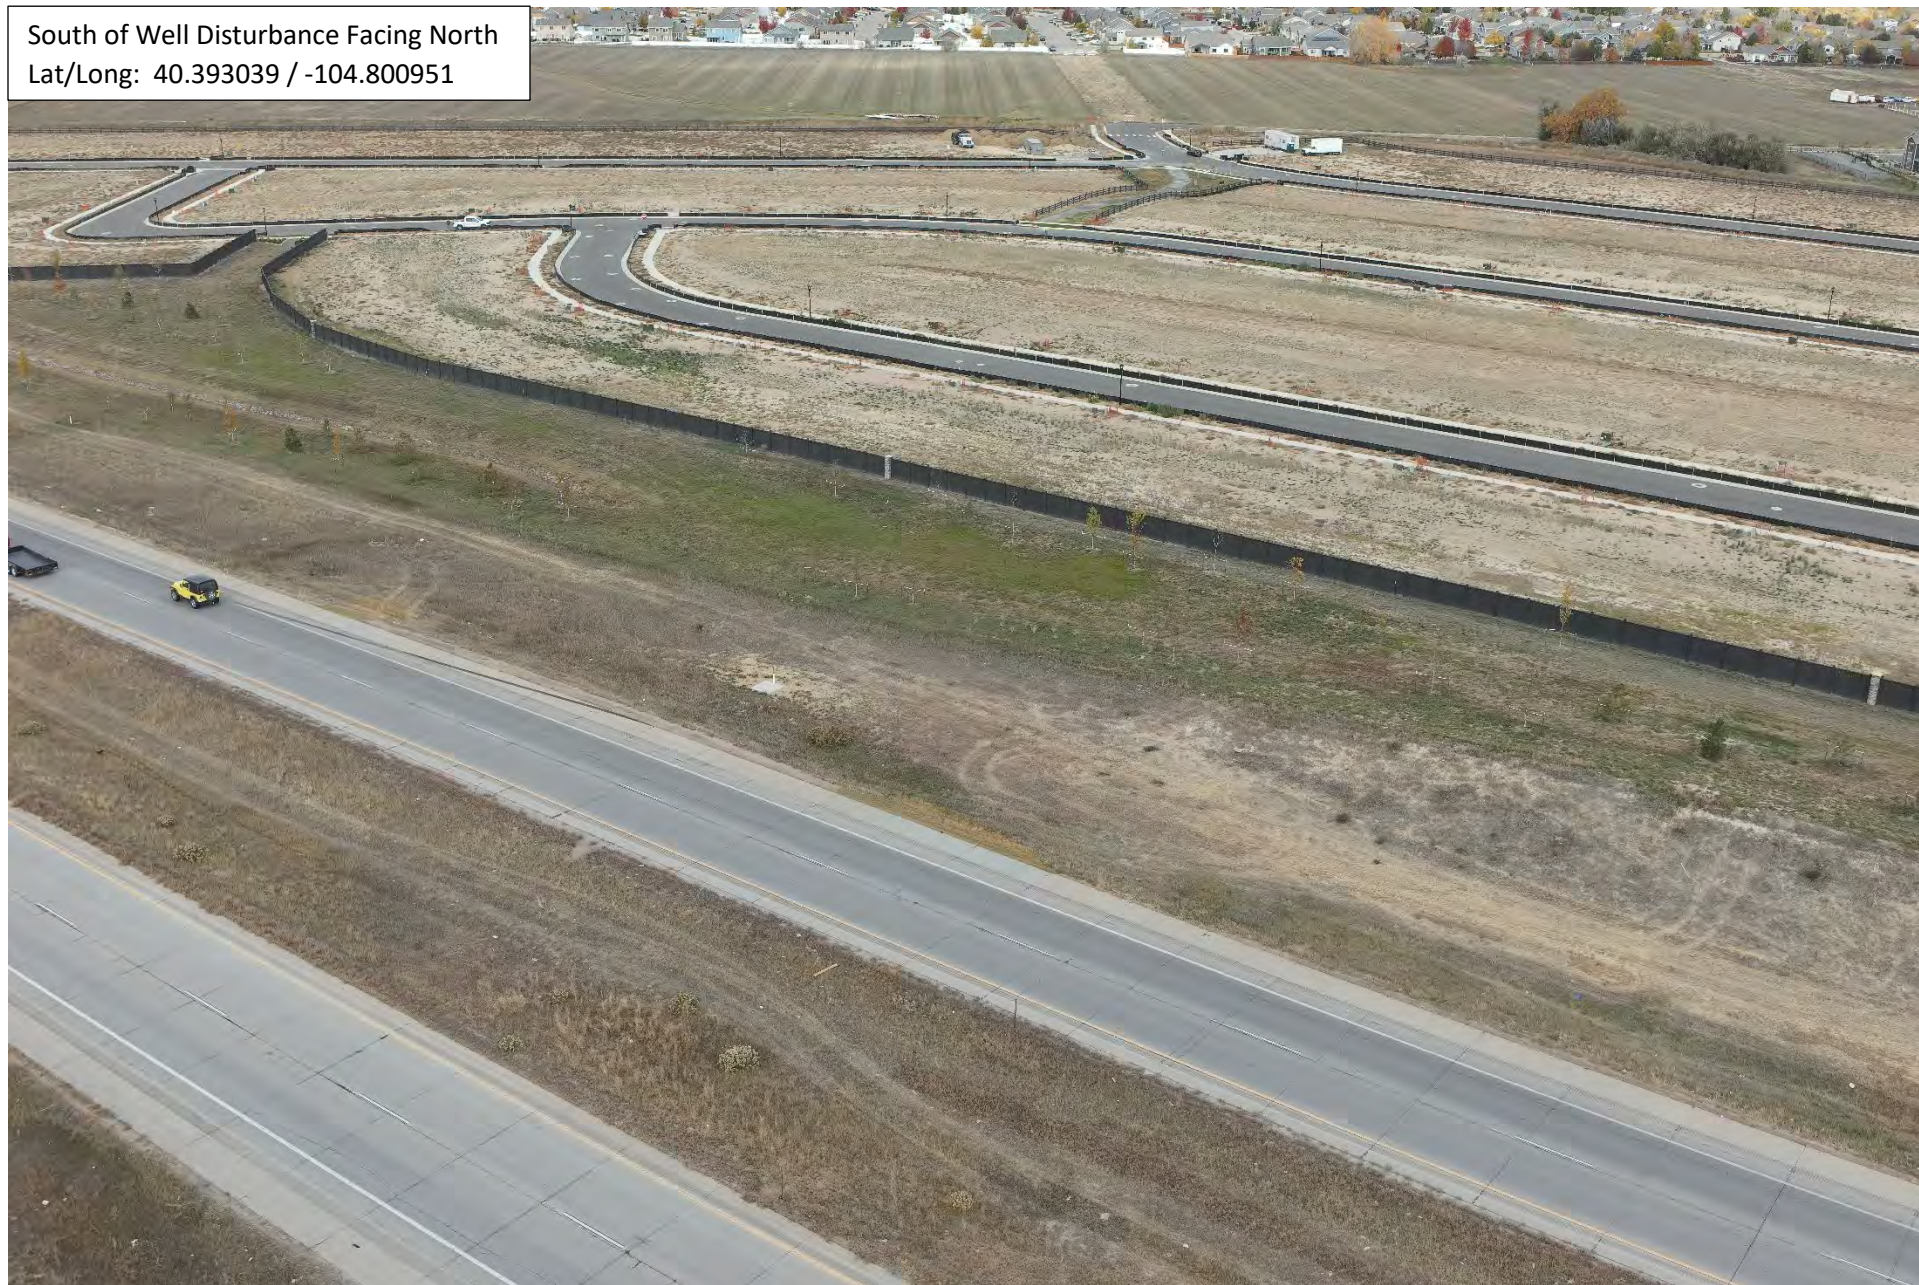
South of Well Disturbance Facing North  
Lat/Long: 40.393039 / -104.800951

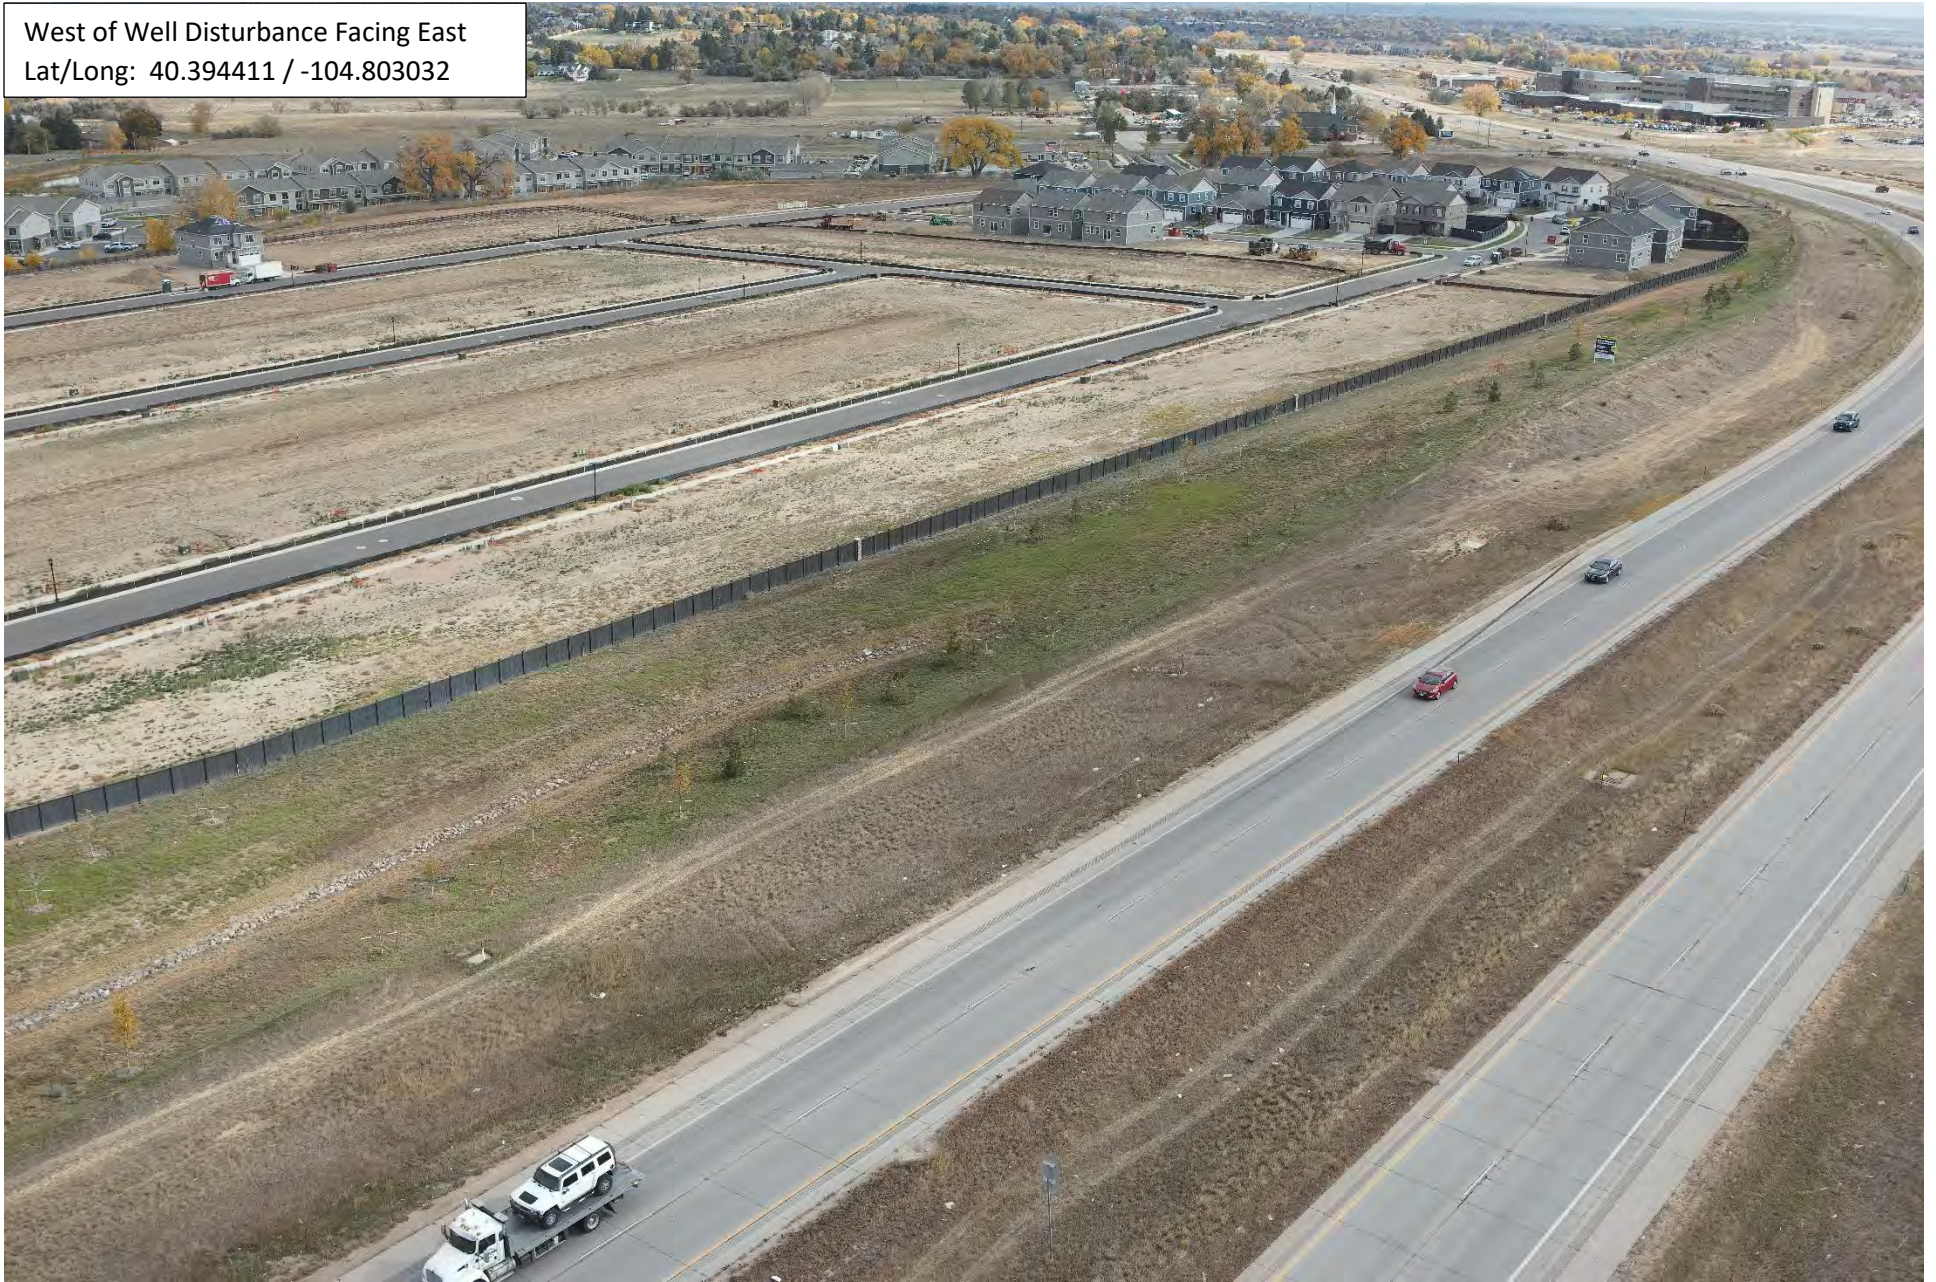
West of Well Disturbance Facing East  
Lat/Long: 40.394411 / -104.803032
