# Site Specific Final Reclamation Completion Notice – Land Use Change Drone Imagery

## Permit Closure Report – Land Use Change

**Well Location ID:** 323660

**Well Location Name:** BRIGGS-65N66W/17SWSE

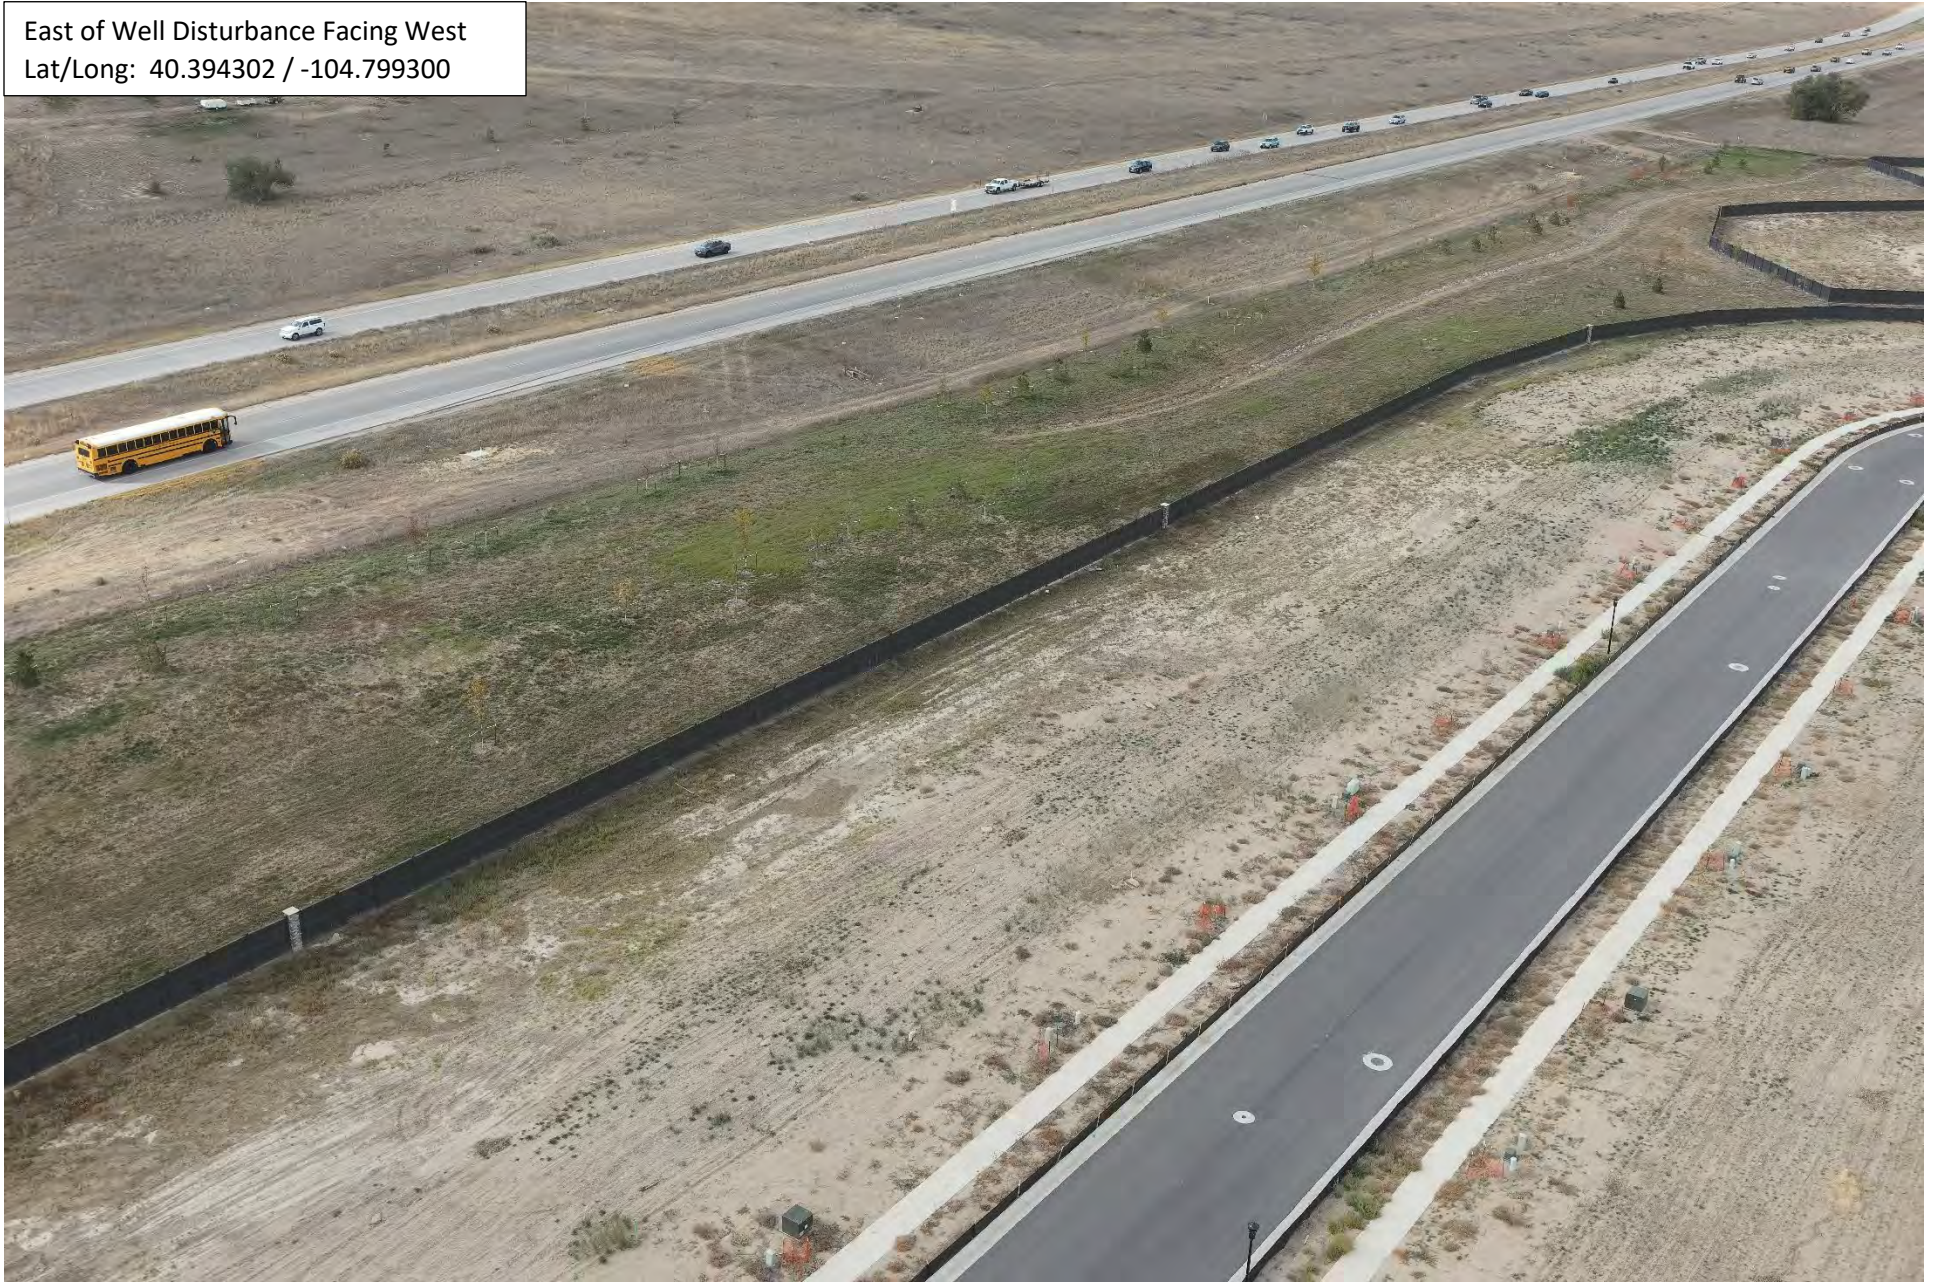
East of Well Disturbance Facing West  
Lat/Long: 40.394302 / -104.799300

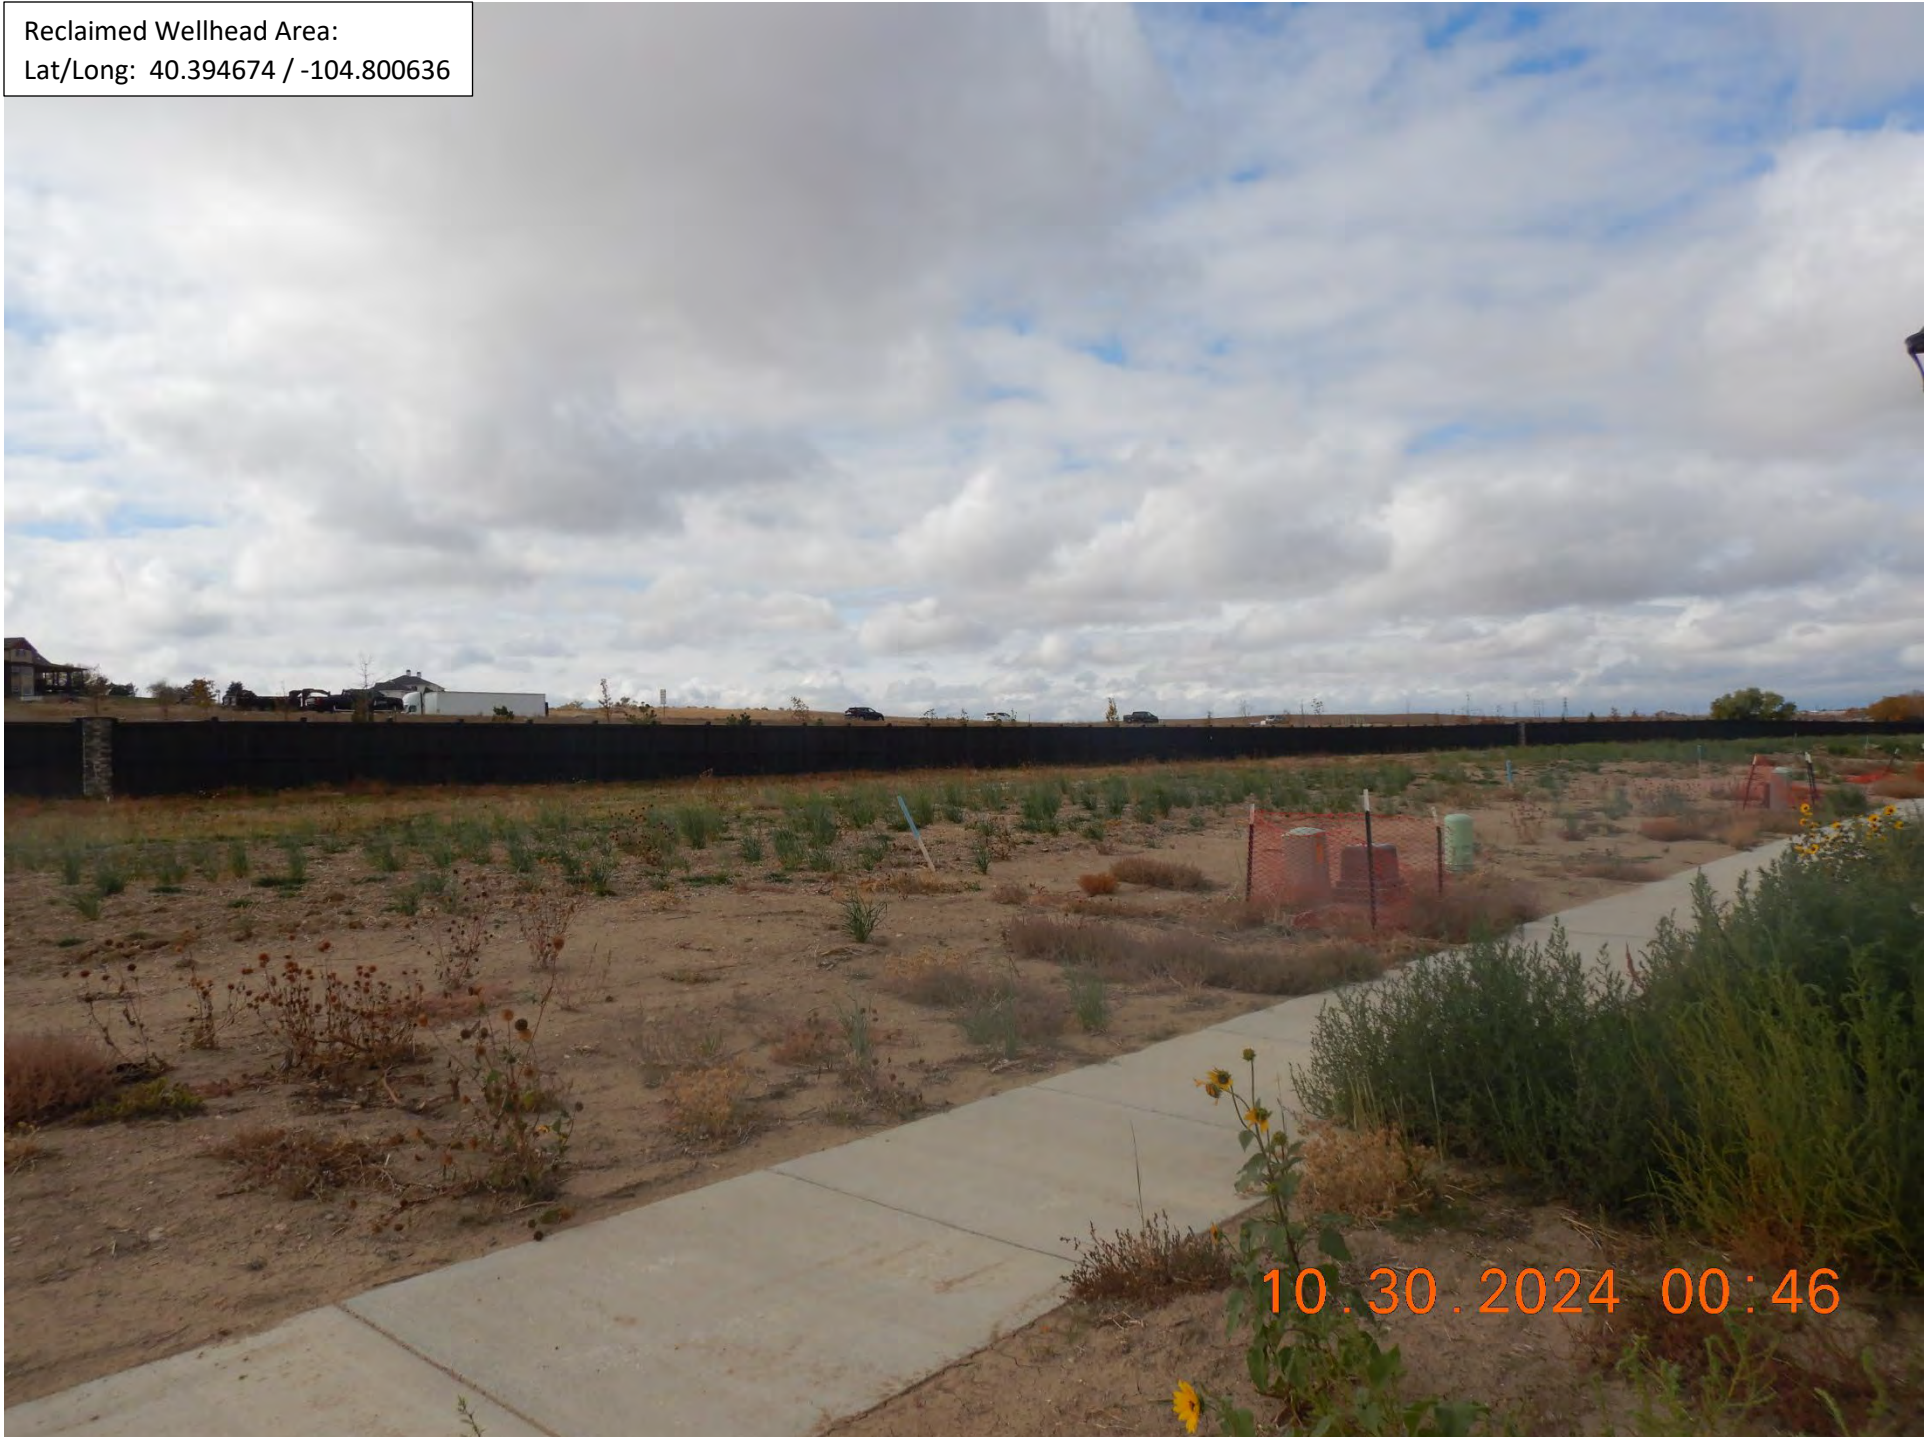
Reclaimed Wellhead Area:  
Lat/Long: 40.394674 / -104.800636
