Inspection Photos

Operator: LARAMIE ENERGY LLC #10433

Location ID: 334427

Inspection Doc: 718100022

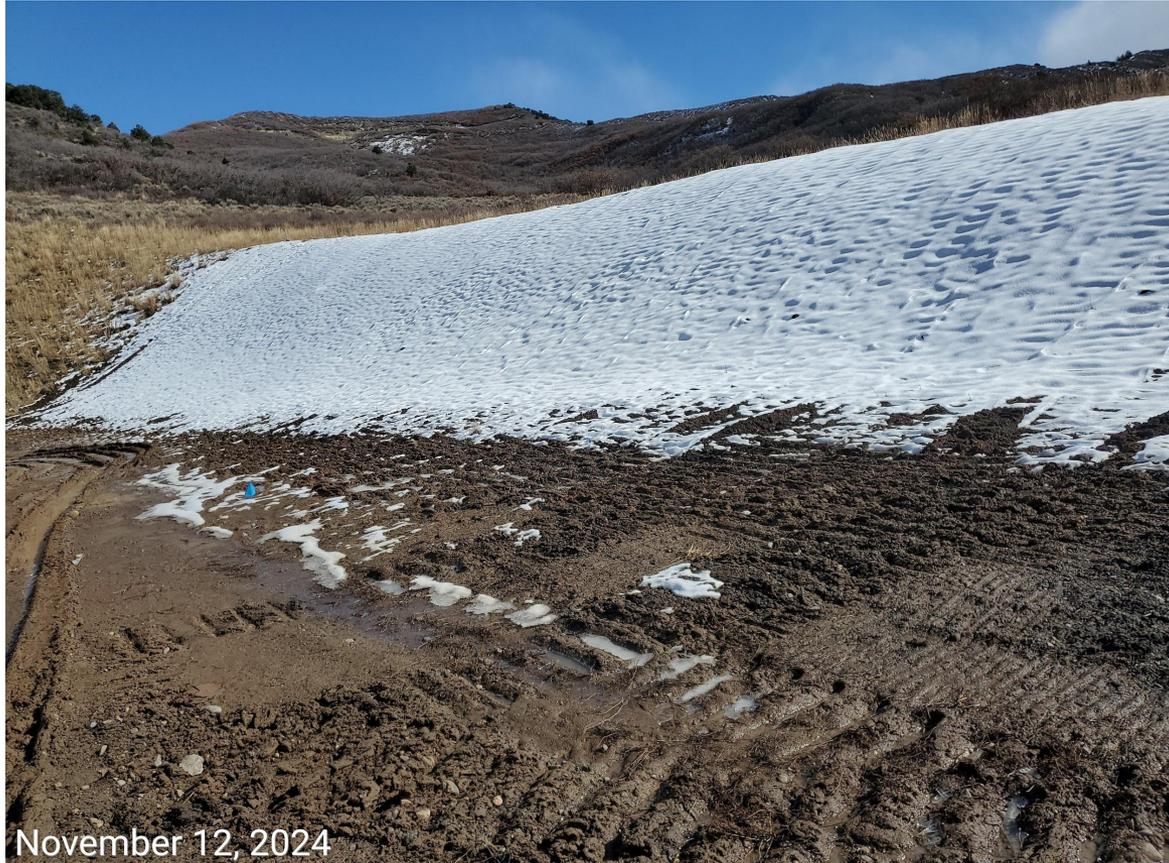
Photo 1: Photo taken from the cut slopes on the south end of the Location, facing east. Limited inspection due to snow cover, however work to address the stormwater and reclamation issues appears to have been performed.

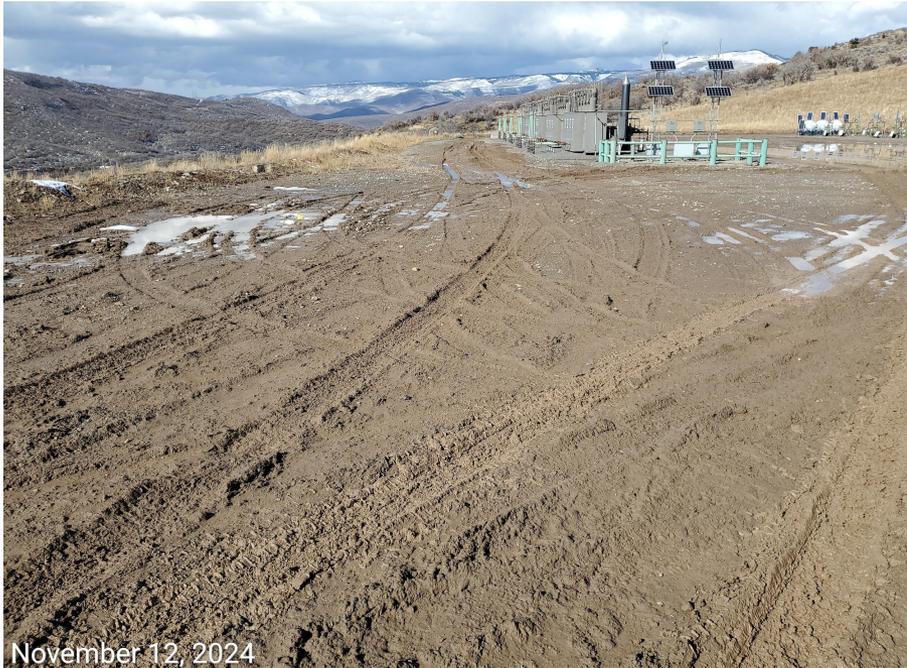
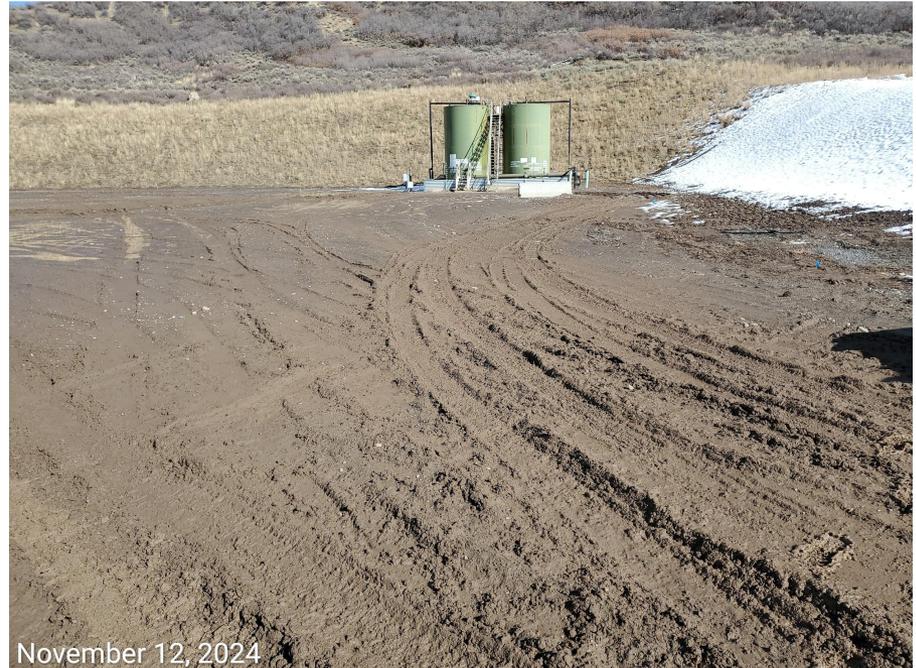
Photo 2: Photos 2-4 examples showing that the working pad surface lacks stabilization; BMPs to stabilize the pad, as well as to minimize erosion, degradation, and sediment transport have not been maintained in proper functioning condition.
