Inspection Photos

Operator: LARAMIE ENERGY LLC #10433

Location ID: 334426

Inspection Doc: 718100026

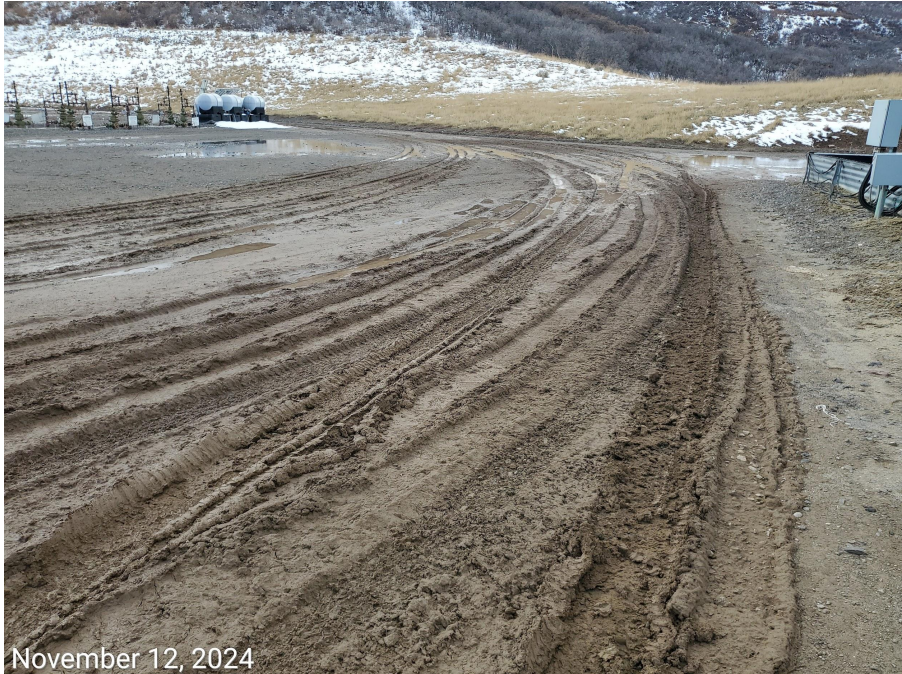
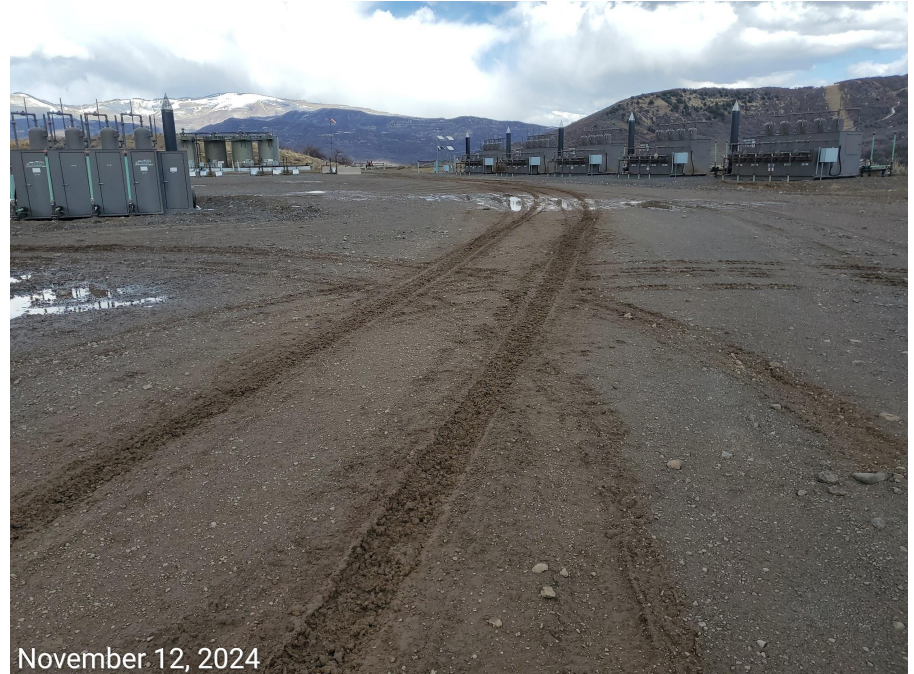
Photo 1: Photos examples showing that the BMPs to stabilize the working pad surface, as well as to minimize erosion, degradation, and sediment transport are in disrepair; tracking/degradation apparent.

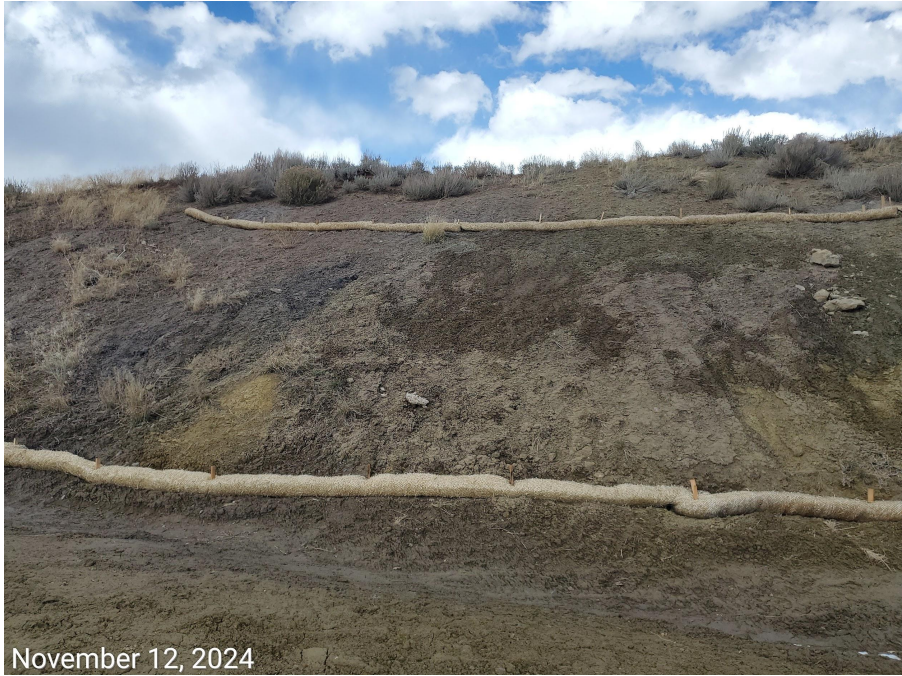
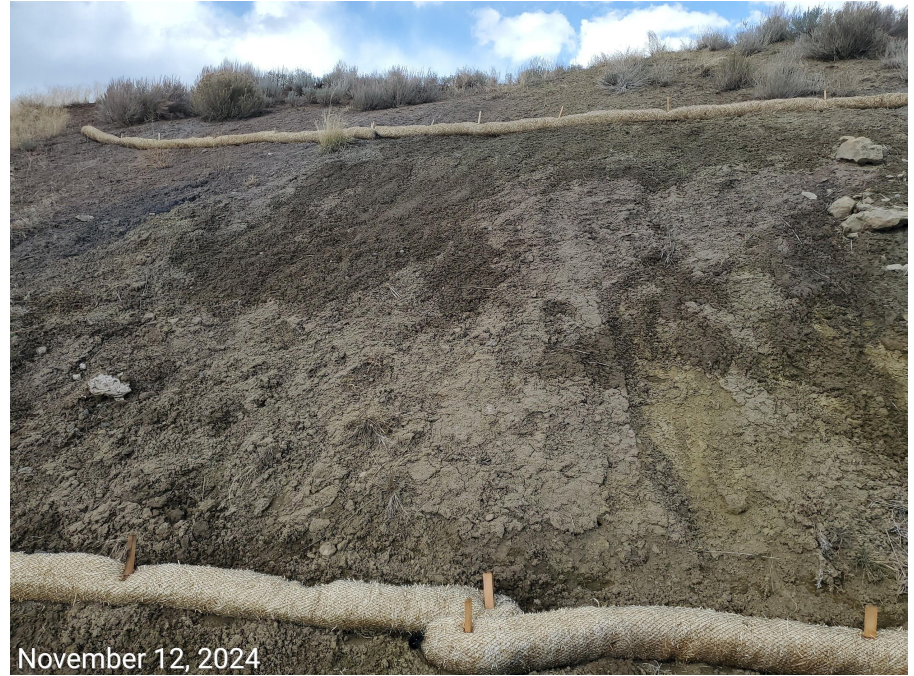
Photo 2: Photos taken from the slopes on the north end of the Location. Operator has installed two erosion logs along the contour of the slopes. No other control measures appear to have been implemented in conjunction with erosion logs per good engineering practice in order to stabilize the slopes, as well as to minimize erosion, degradation and to stabilize the seeded soils per the corrective actions; wattle BMPs alone are insufficient and erosion degradation is beginning to recur at slopes. Additionally, inspector was unable to observe evidence that additional reclamation/seeding efforts had been performed.

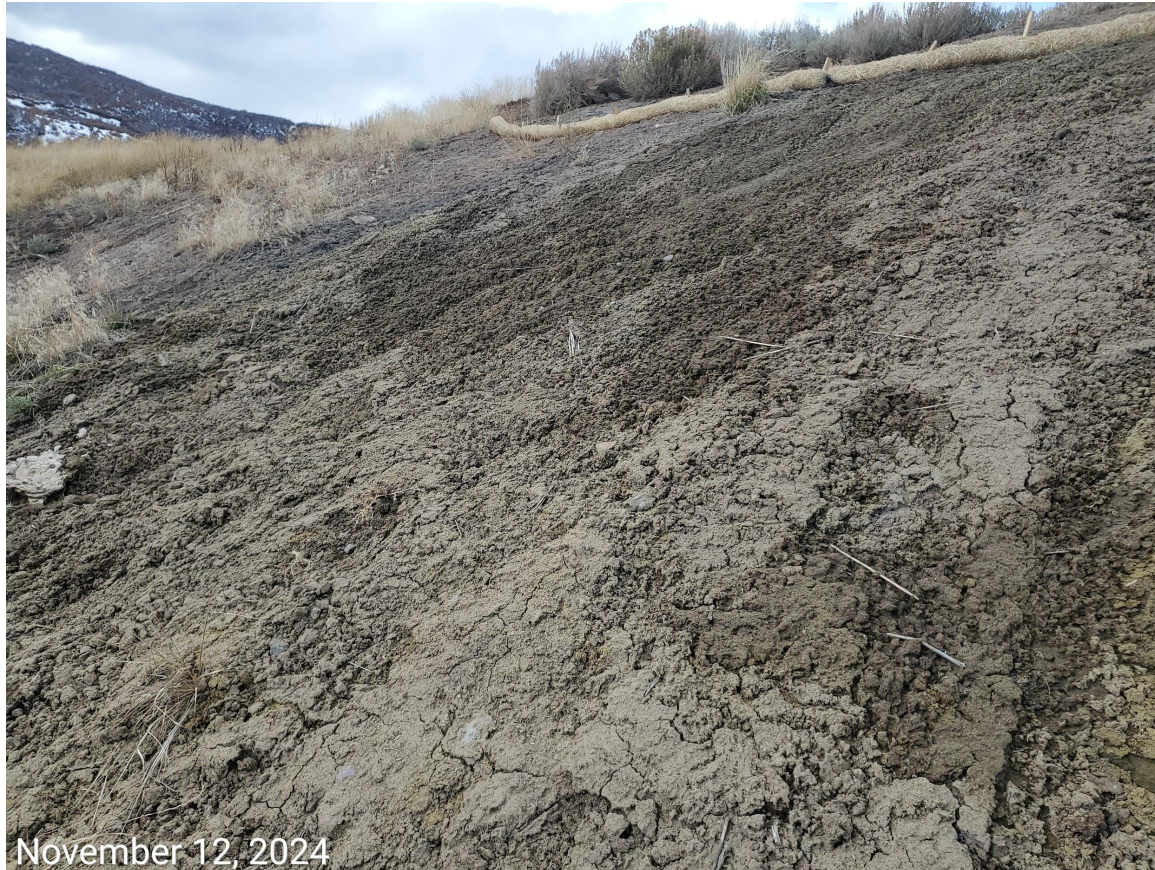
Photo 3: See comments under photo 2. Erosion degradation is recurring; unable to find evidence of seeding; BMPs to stabilize soils remain missing/insufficient.
