SITE-SPECIFIC QUALITY ASSURANCE & QUALITY CONTROL AUDIT

PERMIT CLOSURE REPORT – RANGELAND

Location Name COLORADO ENERGY FEDERAL-610N64W/14SWNW

SITE-SPECIFIC RECLAMATION PLAN

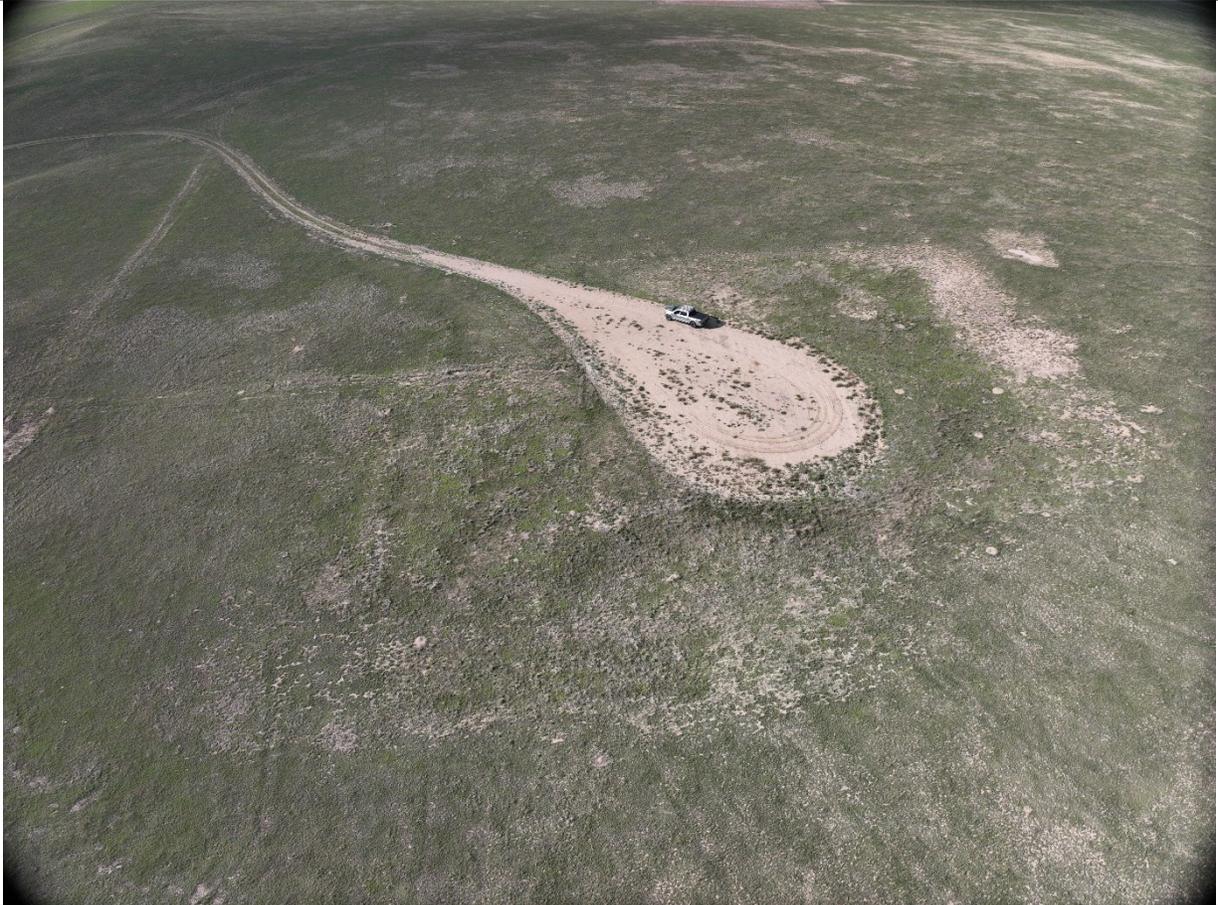
North

Cardinal directional photos of the site

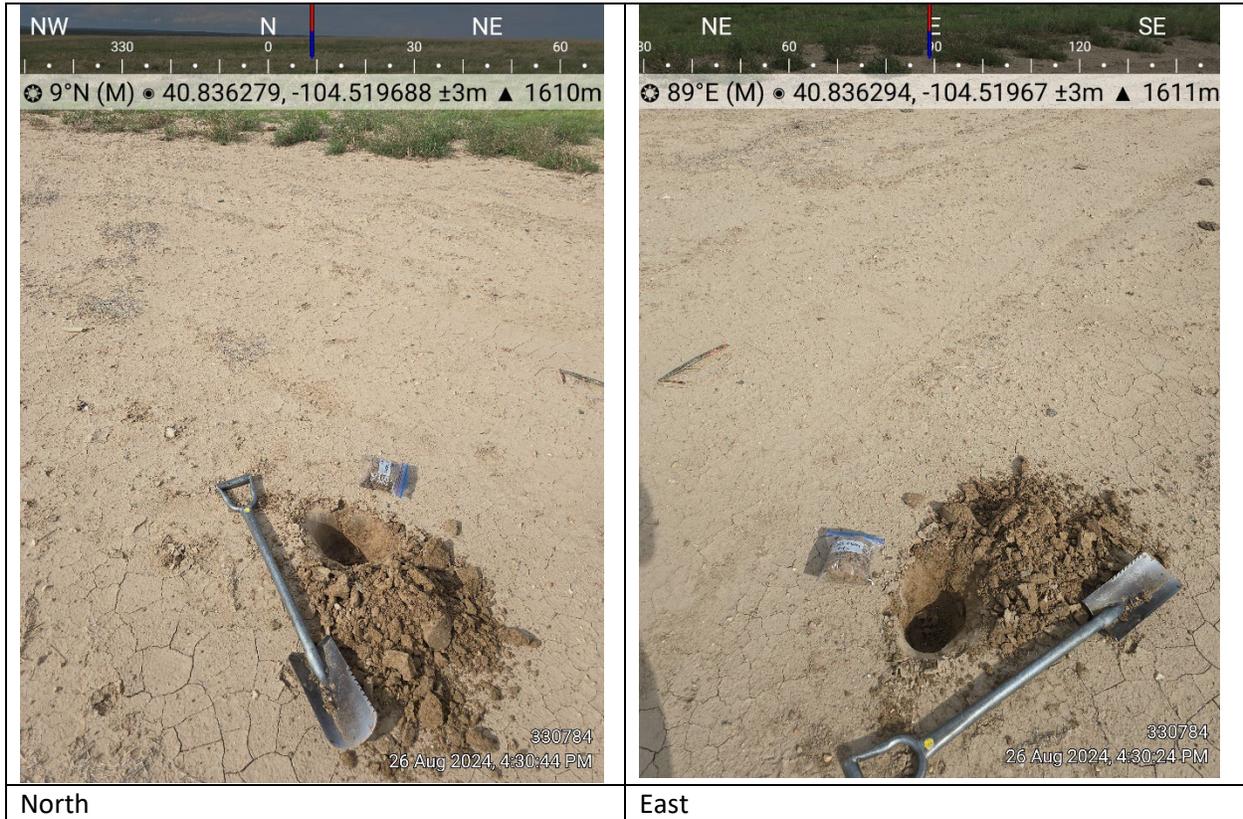
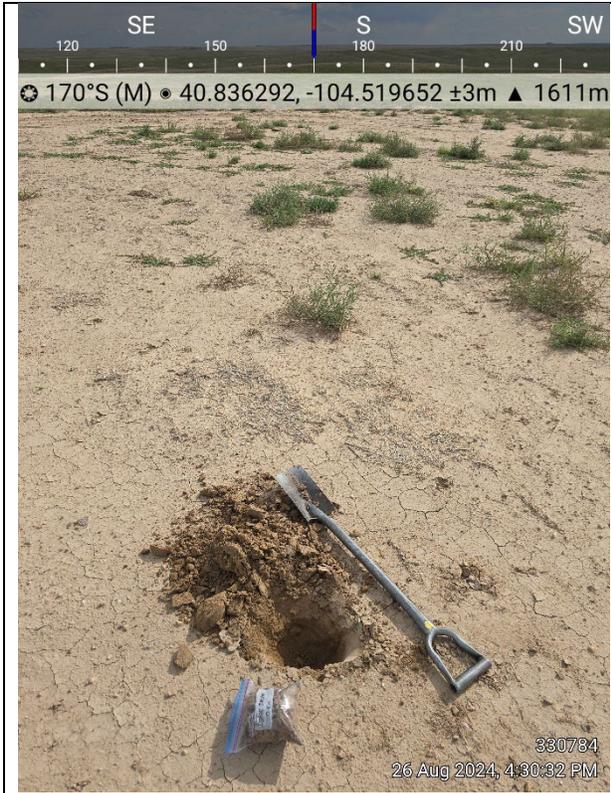
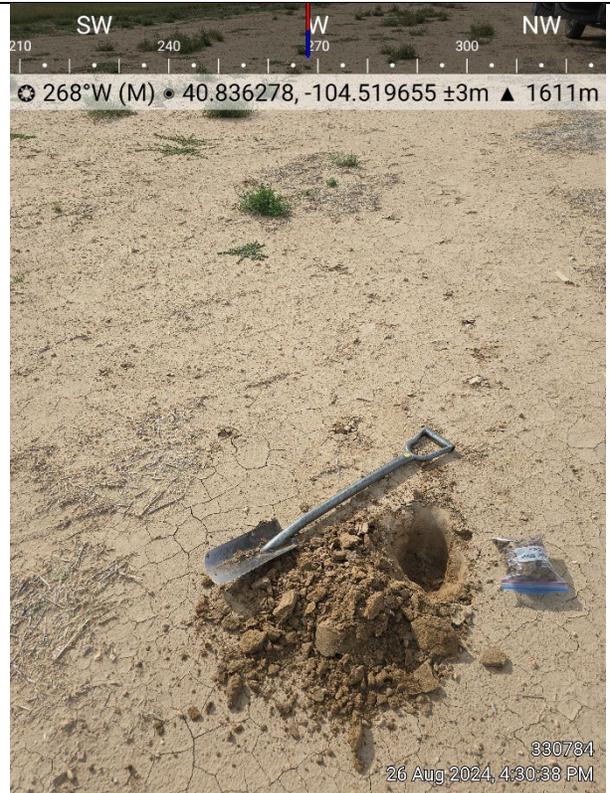
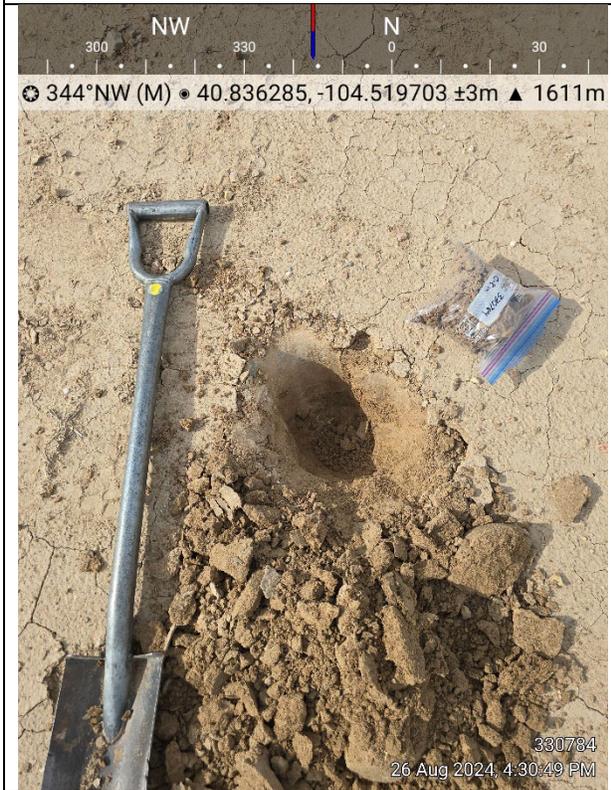
Site Photos – Soil 6 – 330784

- Continuous bare ground on road and pad
- Pad has surface gravel
- Low weed impact
- Recommendations
 - Remove, replace, decompact, disc, seed and straw crimp. Use USFS seed mix that is adjusted to work with the entire site

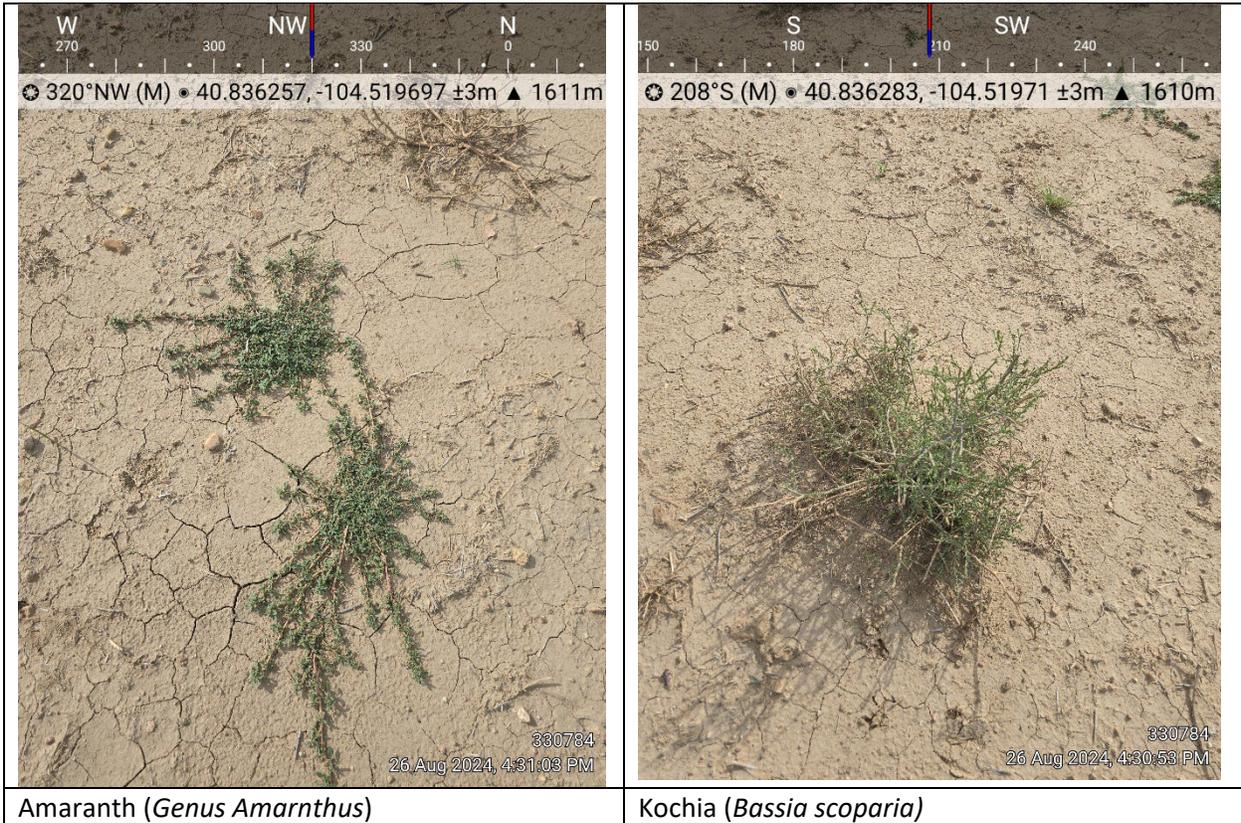
Site Photos – Vegetation – 330784

Site vegetation observations took place in Aug within the reclamation extent. Weeds are the primary vegetation during the site visit.

Amaranth (*Genus Amaranthus*)

Kochia (*Bassia scoparia*)

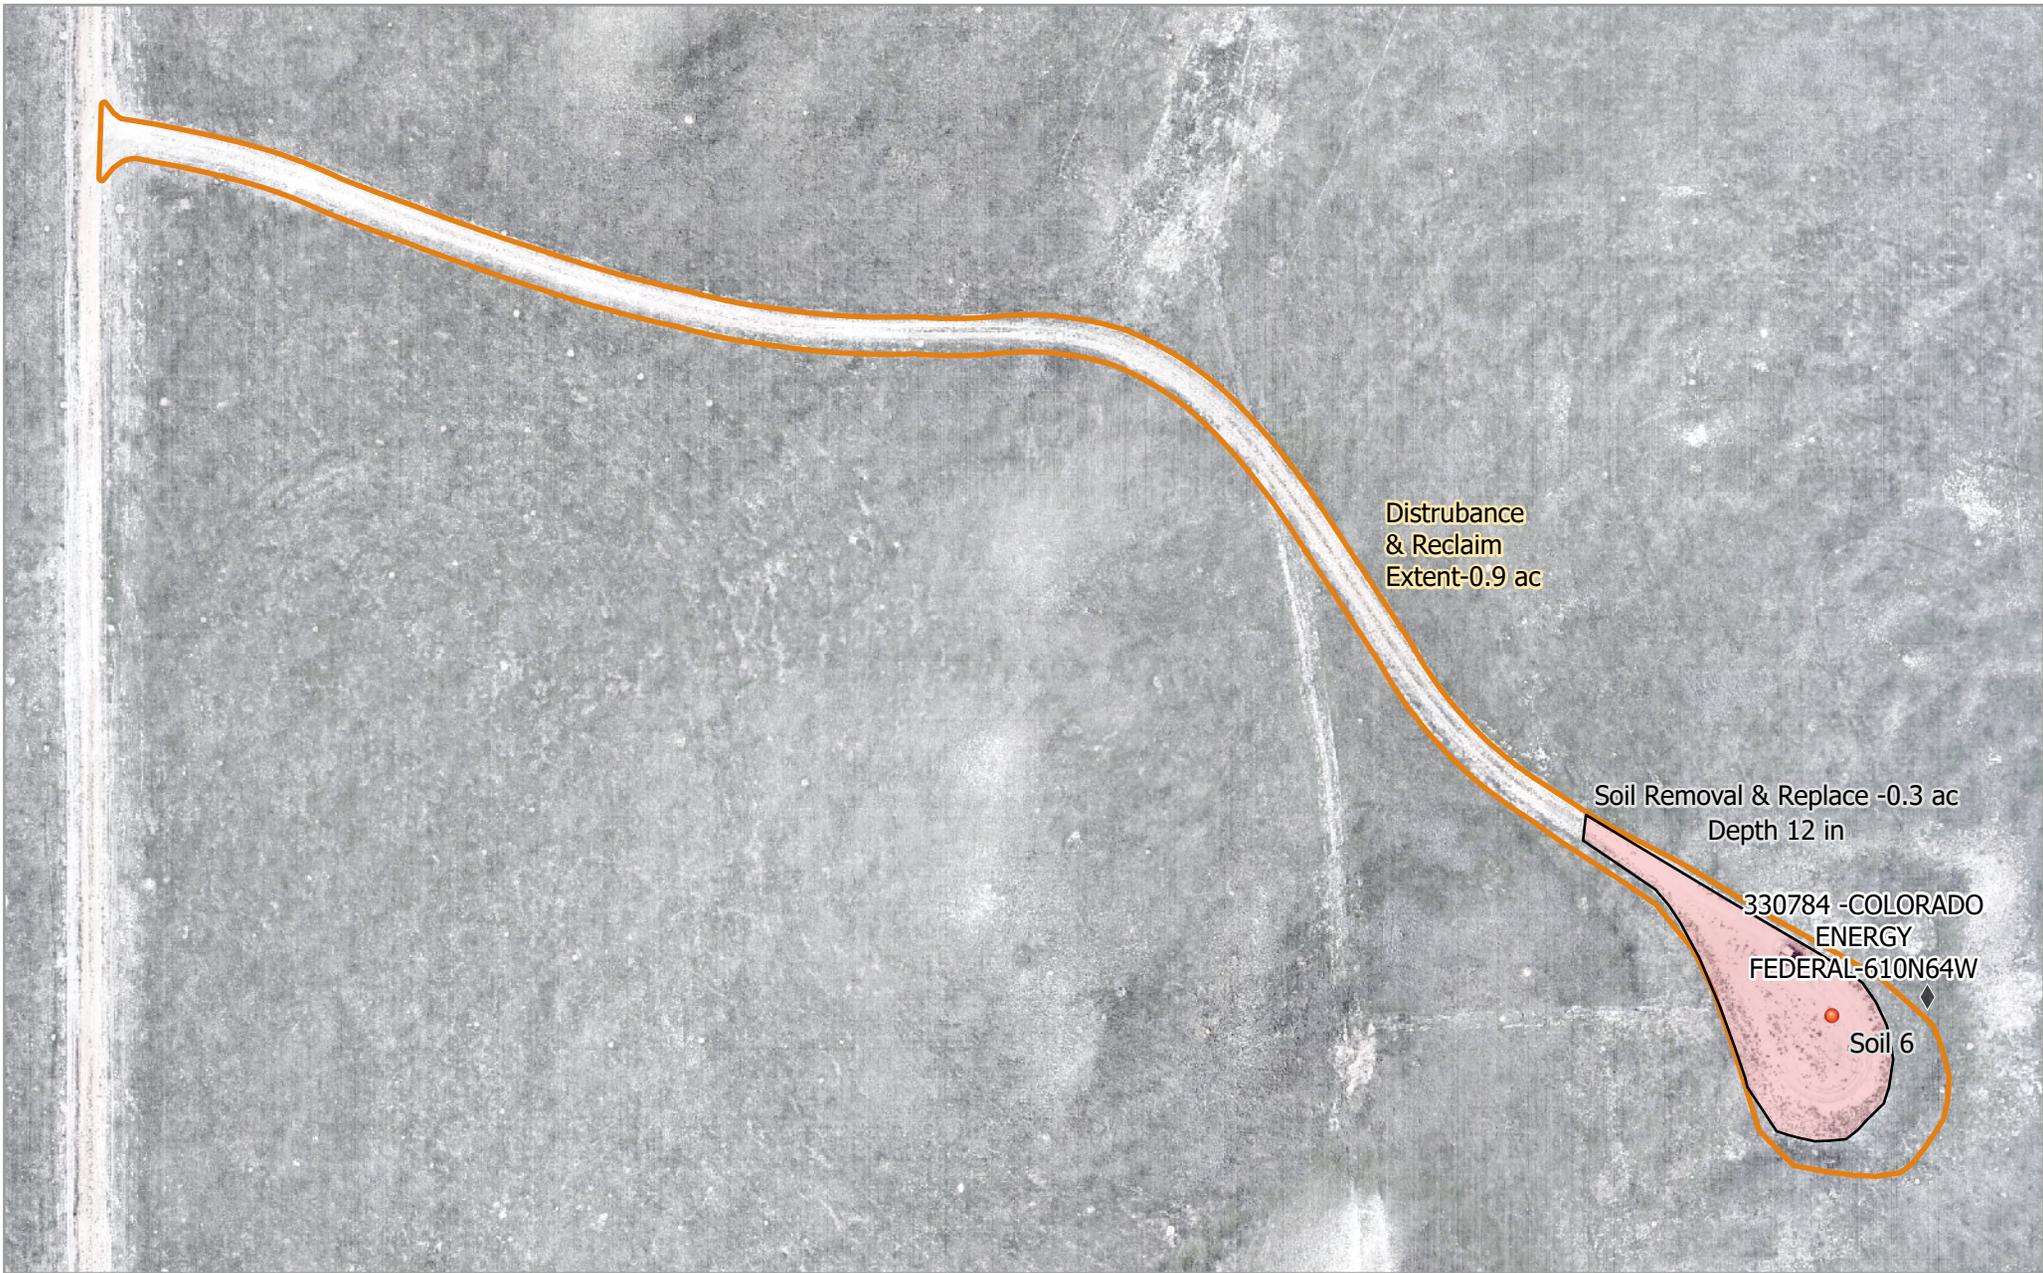
**CIV - 330784 - Colorado Energy Federal
610N64W/14SWNW
Map Extent - Reclaim Extent**

- ◆ Oil and Gas Locations
- Soil Sample Point
- ▭ Disturbance Boundary
- ▭ Soil Removal & Replace

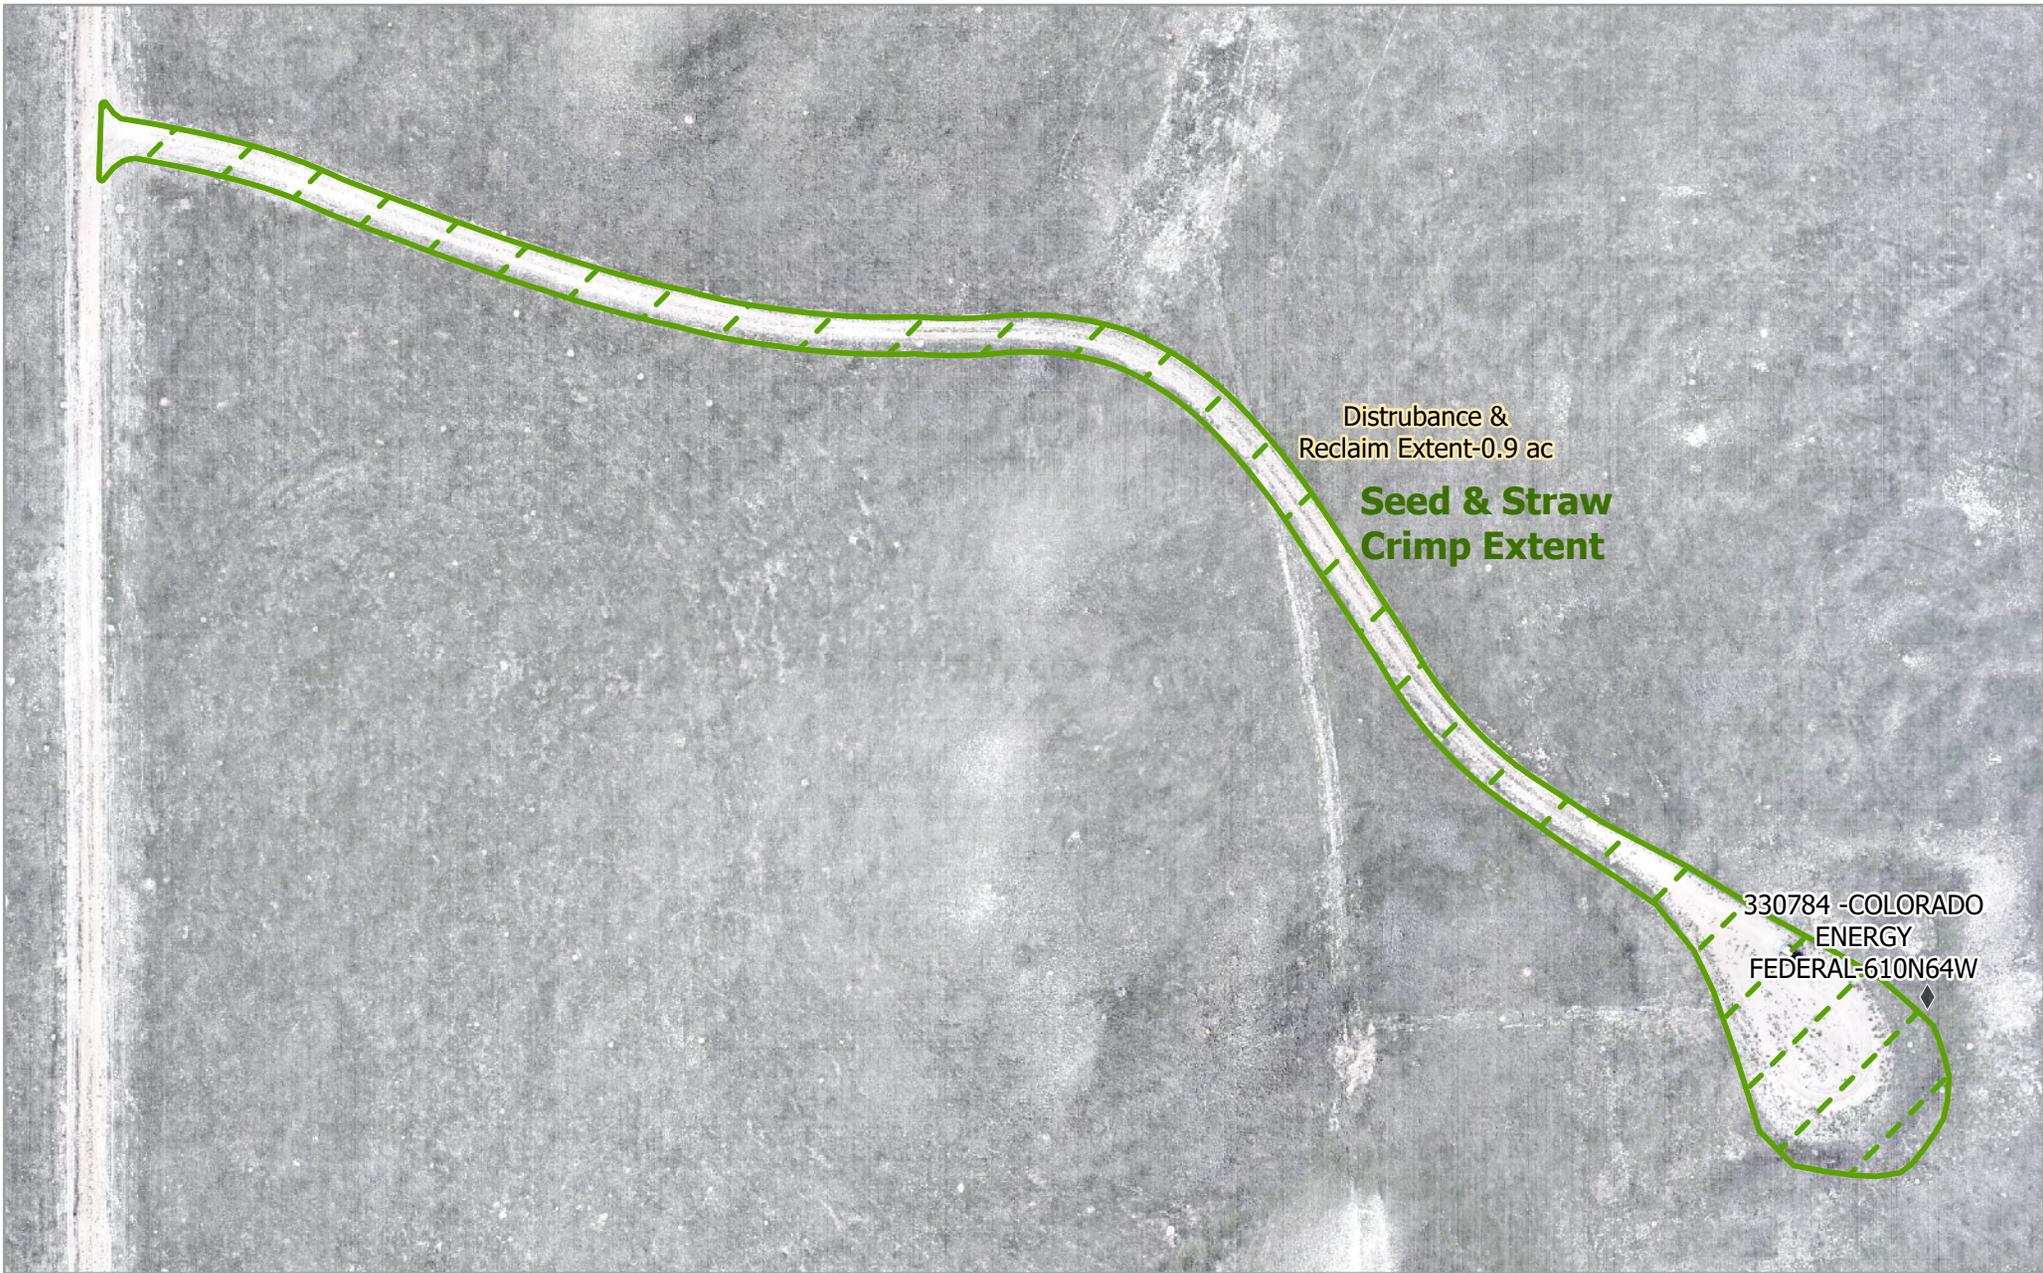
CIV - 330784 - Colorado Energy Federal 610N64W/14SWNW

- ◆ Oil and Gas Locations
- ▭ Disturbance Boundary
- ▭ Seed Boundary
