Wellhead Closure Checklist 2

| Site Name | | Canepa 6-13 |
| Remediation Project # | | 34590 |

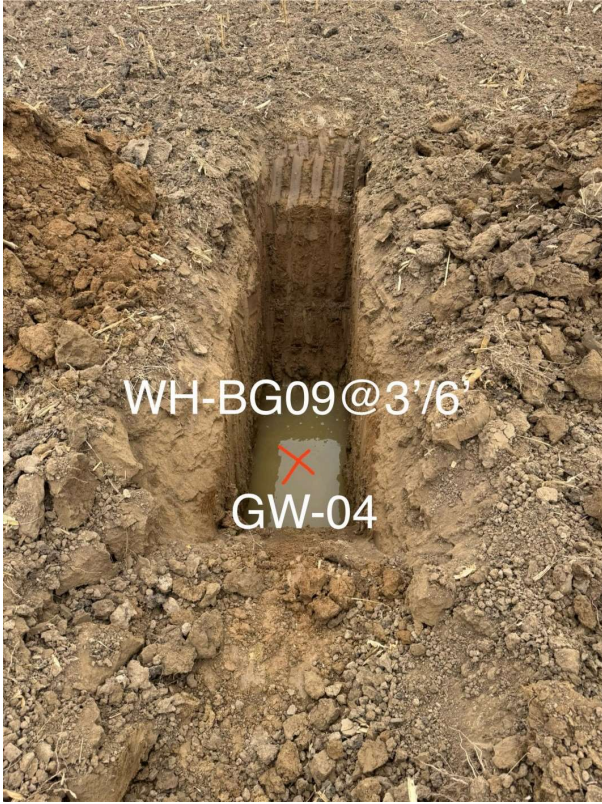
R1 - P1

| # | Sample Date | Sample Time | Soil Sample ID | PID Readings | Visual | Olfactory | Equipment Name |
|---|---|---|---|---|---|---|---|
| R1 | 11/04/2024 | 11:50 AM | WH-BG09@3' | 1.0 | N.S | N.O | Wellhead Background |

WH-BG09@3'6"

GW-04

facing north

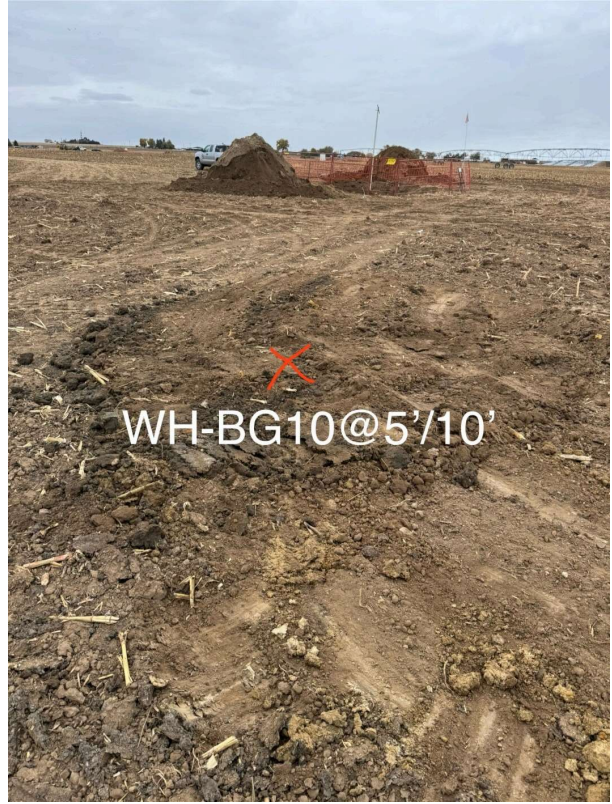
R3 - P1

| # | Sample Date | Sample Time | Soil Sample ID | PID Readings | Visual | Olfactory | Equipment Name |
|---|---|---|---|---|---|---|---|
| R3 | 11/04/2024 | 12:00 PM | WH-BG10@3' | 0.9 | N.S | N.O | Wellhead Background |

WH-BG10@5'10"

facing north

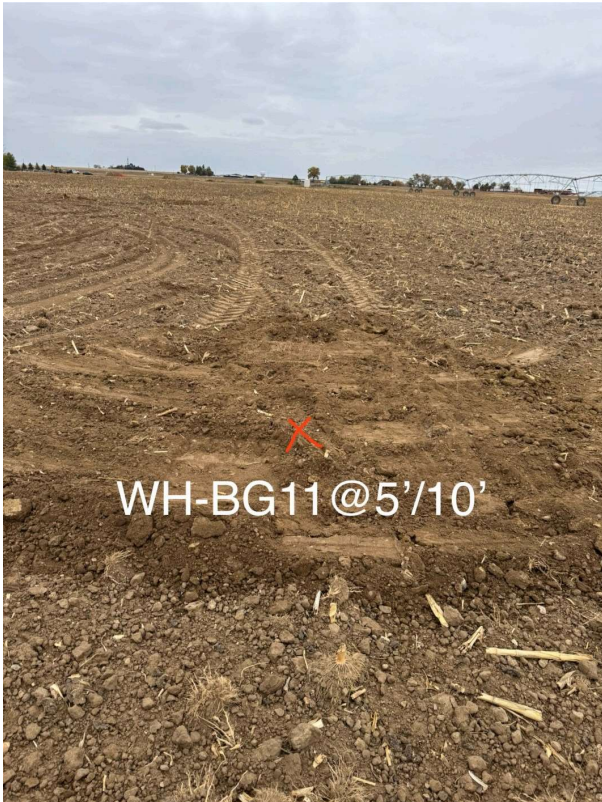
R5 - P1

| # | Sample Date | Sample Time | Soil Sample ID | PID Readings | Visual | Olfactory | Equipment Name |
|---|---|---|---|---|---|---|---|
| R5 | 11/04/2024 | 12:06 PM | WH-BG11@3' | 1.6 | N.S | N.O | Wellhead Background |

WH-BG11@5'10"

facing north

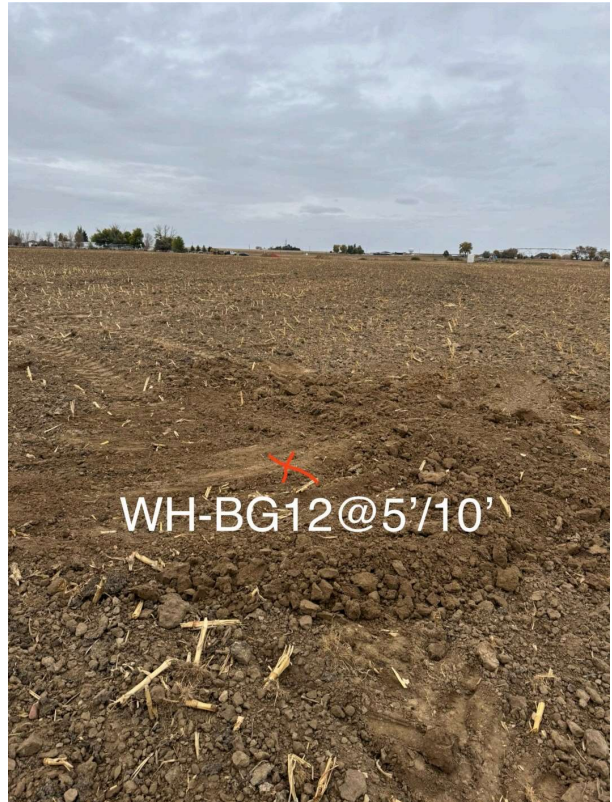
R7 - P1

| # | Sample Date | Sample Time | Soil Sample ID | PID Readings | Visual | Olfactory | Equipment Name |
|---|---|---|---|---|---|---|---|
| R7 | 11/04/2024 | 12:14 PM | WH-BG12@3' | 1.5 | N.S | N.O | Wellhead Background |

WH-BG12@5'10"

facing north

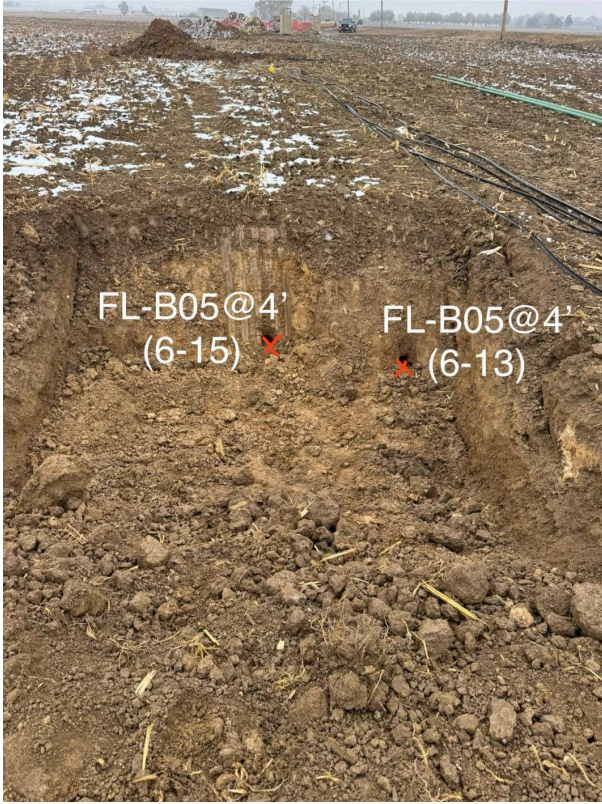
R24 - P1

| # | Sample Date | Sample Time | Soil Sample ID | PID Readings | Visual | Olfactory | Equipment Name |
|---|---|---|---|---|---|---|---|
| R24 | 11/07/2024 | 12:11 PM | FL-B05@4' | 0.7 | N.S | N.O | Flowline |

FL-B05@4'
(6-15) ✘

FL-B05@4'
✘ (6-13)

facing west

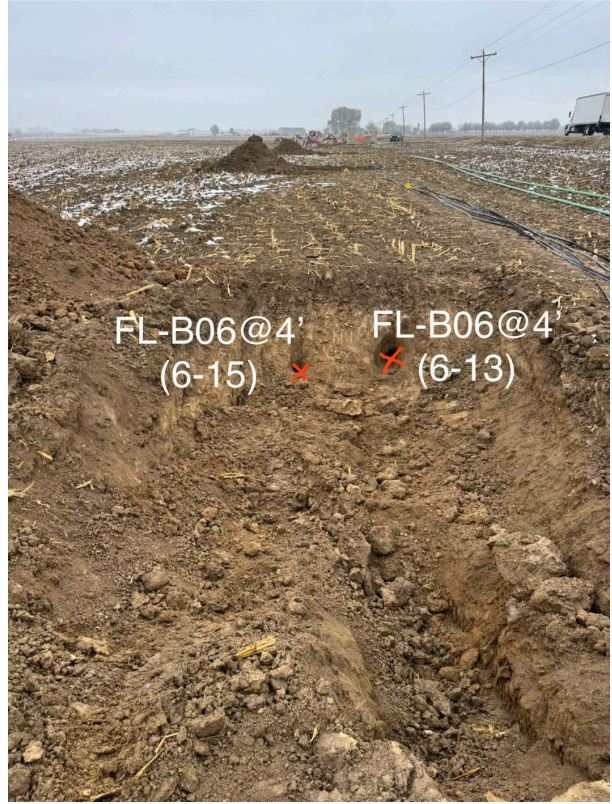
R25 - P1

| # | Sample Date | Sample Time | Soil Sample ID | PID Readings | Visual | Olfactory | Equipment Name |
|---|---|---|---|---|---|---|---|
| R25 | 11/07/2024 | 12:17 PM | FL-B06@4' | 0.5 | N.S | N.O | Flowline |

FL-B06@4'
(6-15) ✘

FL-B06@4'
✘ (6-13)

facing west

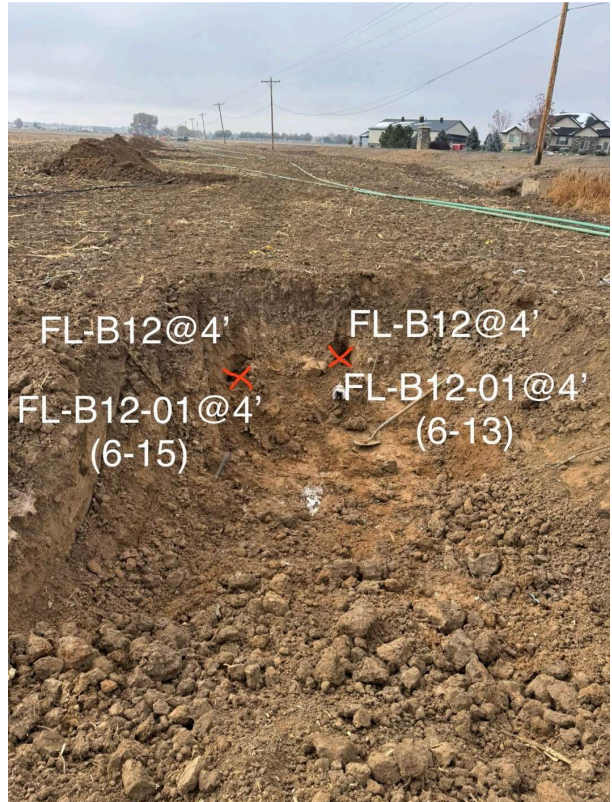
R31 - P1

| # | Sample Date | Sample Time | Soil Sample ID | PID Readings | Visual | Olfactory | Equipment Name |
|---|---|---|---|---|---|---|---|
| R31 | 11/07/2024 | 01:12 PM | FL-B12@4' | 0.5 | N.S | N.O | Flowline Directional Change |

facing west

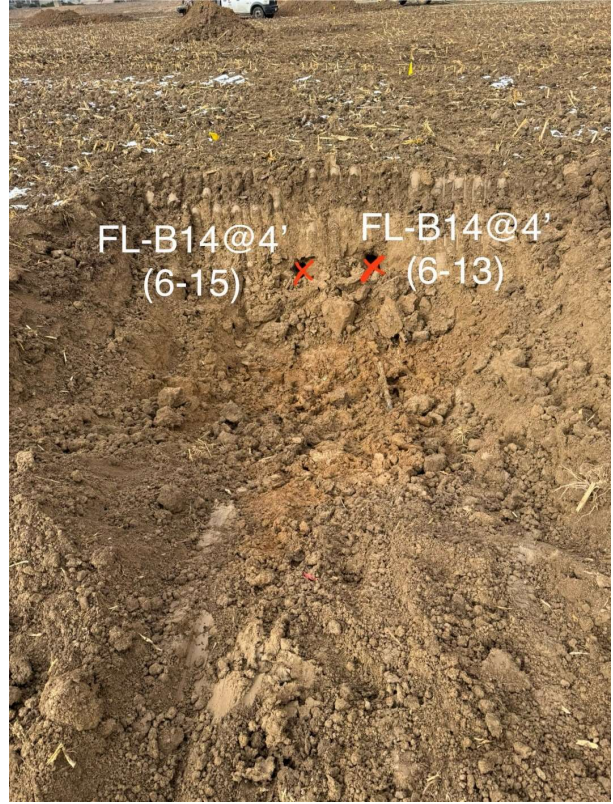
R34 - P1

| # | Sample Date | Sample Time | Soil Sample ID | PID Readings | Visual | Olfactory | Equipment Name |
|---|---|---|---|---|---|---|---|
| R34 | 11/07/2024 | 01:35 PM | FL-B14@4' | 0.9 | N.S | N.O | Flowline |

facing north

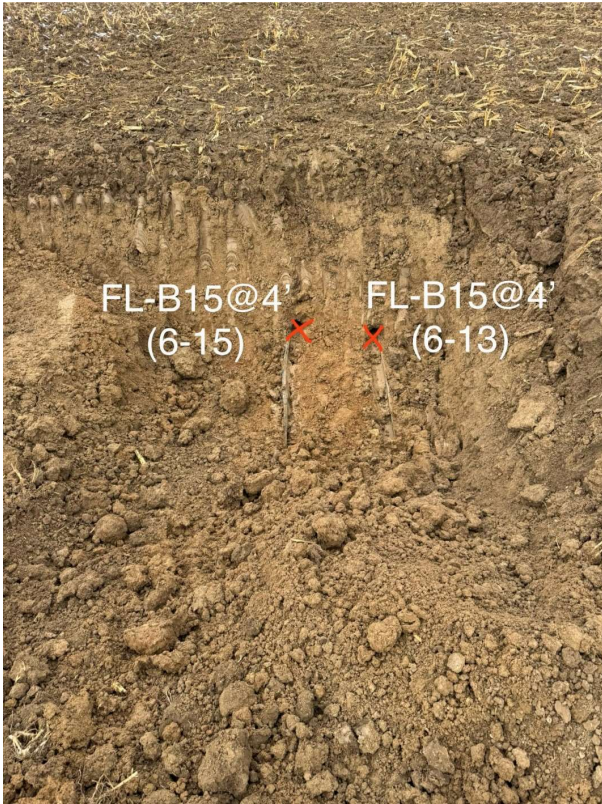
R35 - P1

| # | Sample Date | Sample Time | Soil Sample ID | PID Readings | Visual | Olfactory | Equipment Name |
|---|---|---|---|---|---|---|---|
| R35 | 11/07/2024 | 01:42 PM | FL-B15@4' | 0.7 | N.S | N.O | Flowline |

facing north
