Inspection Photos

ID: 478058

Operator: OGRIS OPERATING LLC

Inspection Date: 12/9/2024

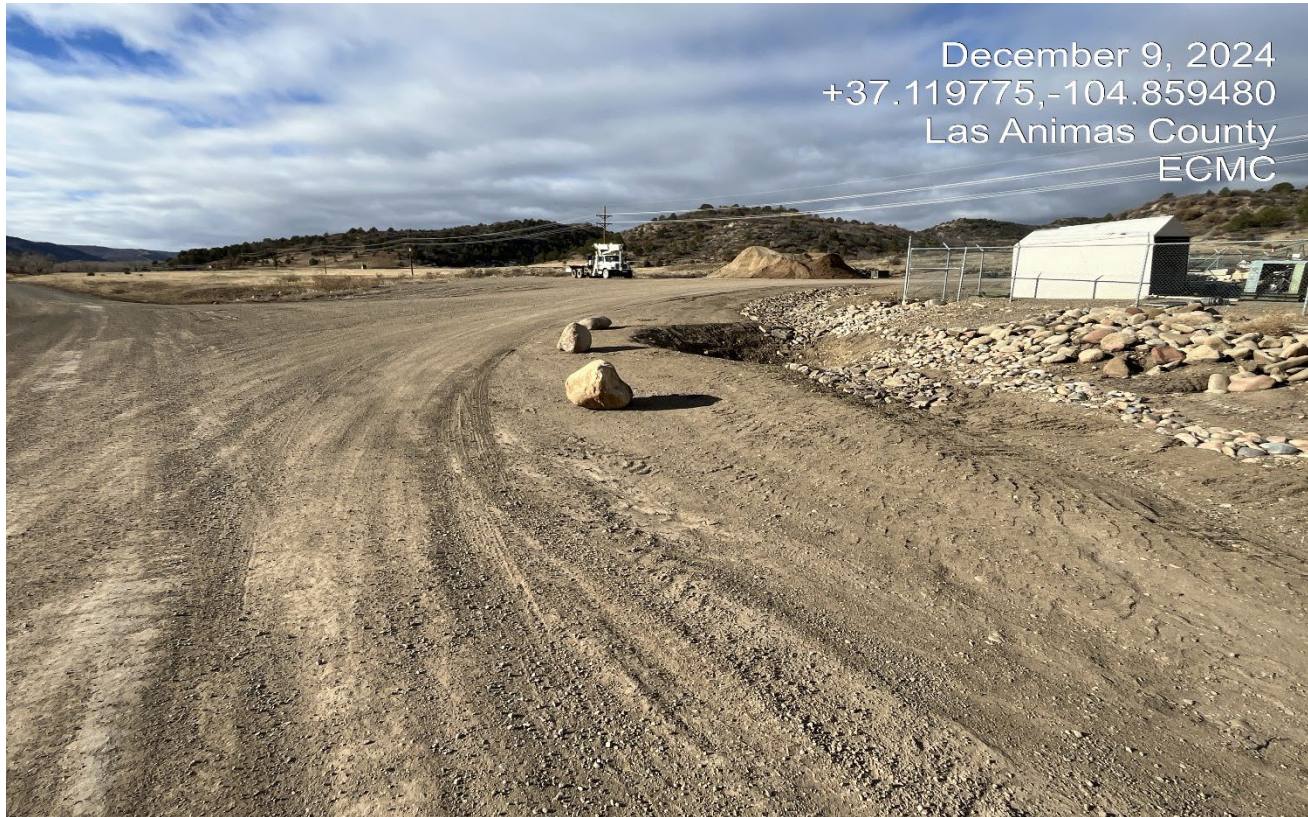
Photo 1. Facing southwest along the main road to the A.C. Tank Battery. A sediment ahs been installed along the road side. The rock barriers may be obscured during snow accumulation. Reflector markers may be more suited at this area.

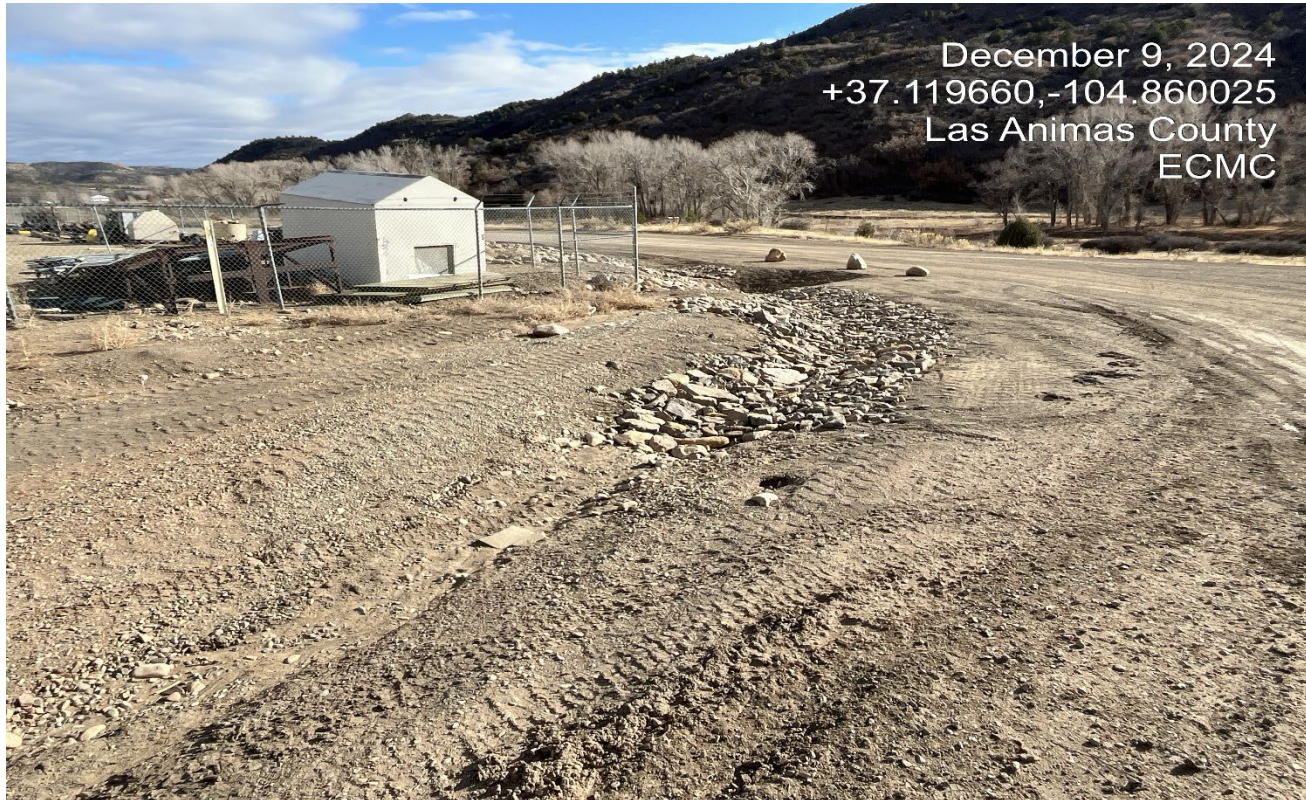
Photo 2. Facing southwest toward the access road adjacent to the main road. Additional rock rip rap has been installed to armor the roadside where erosion was occurring.

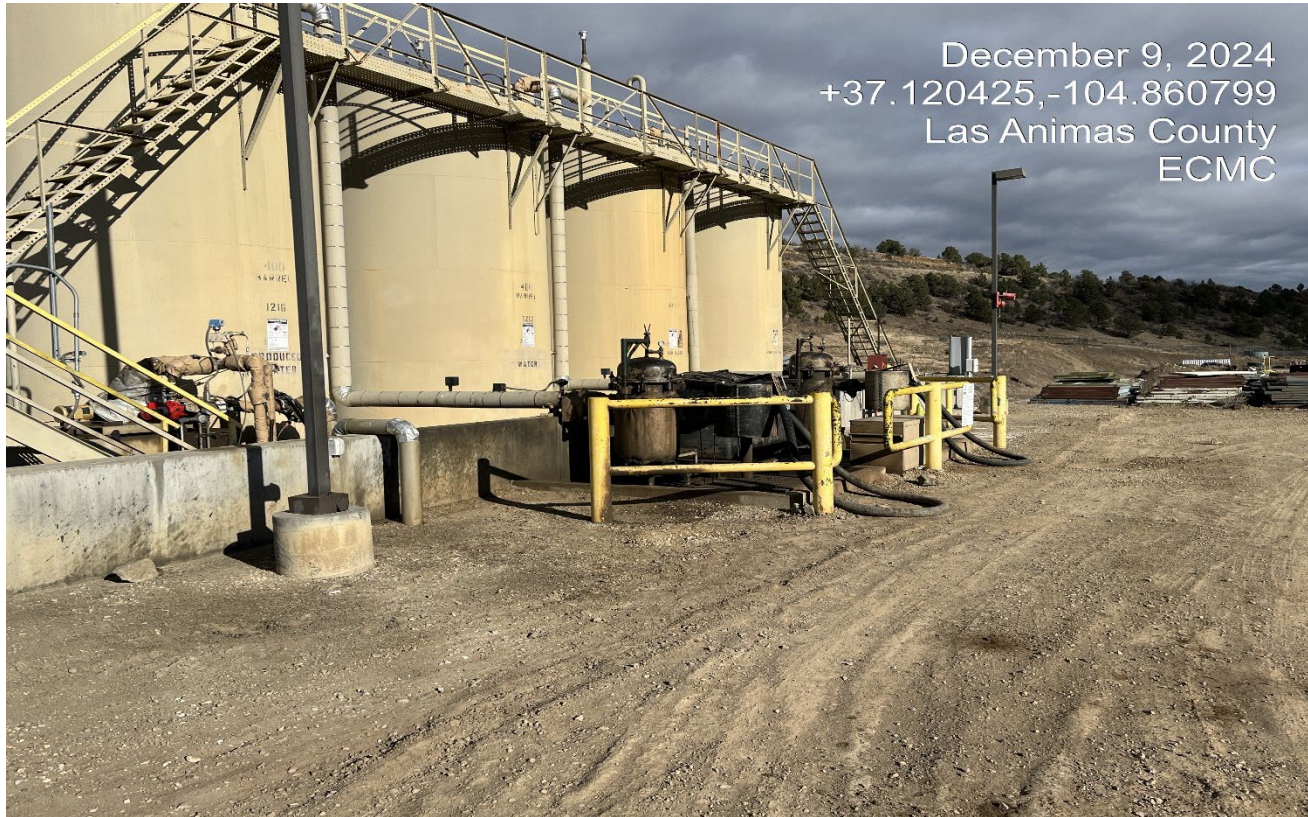
Photo 3. Facing northwest toward the tank battery. There are still some stained soils that will require cleanup. O

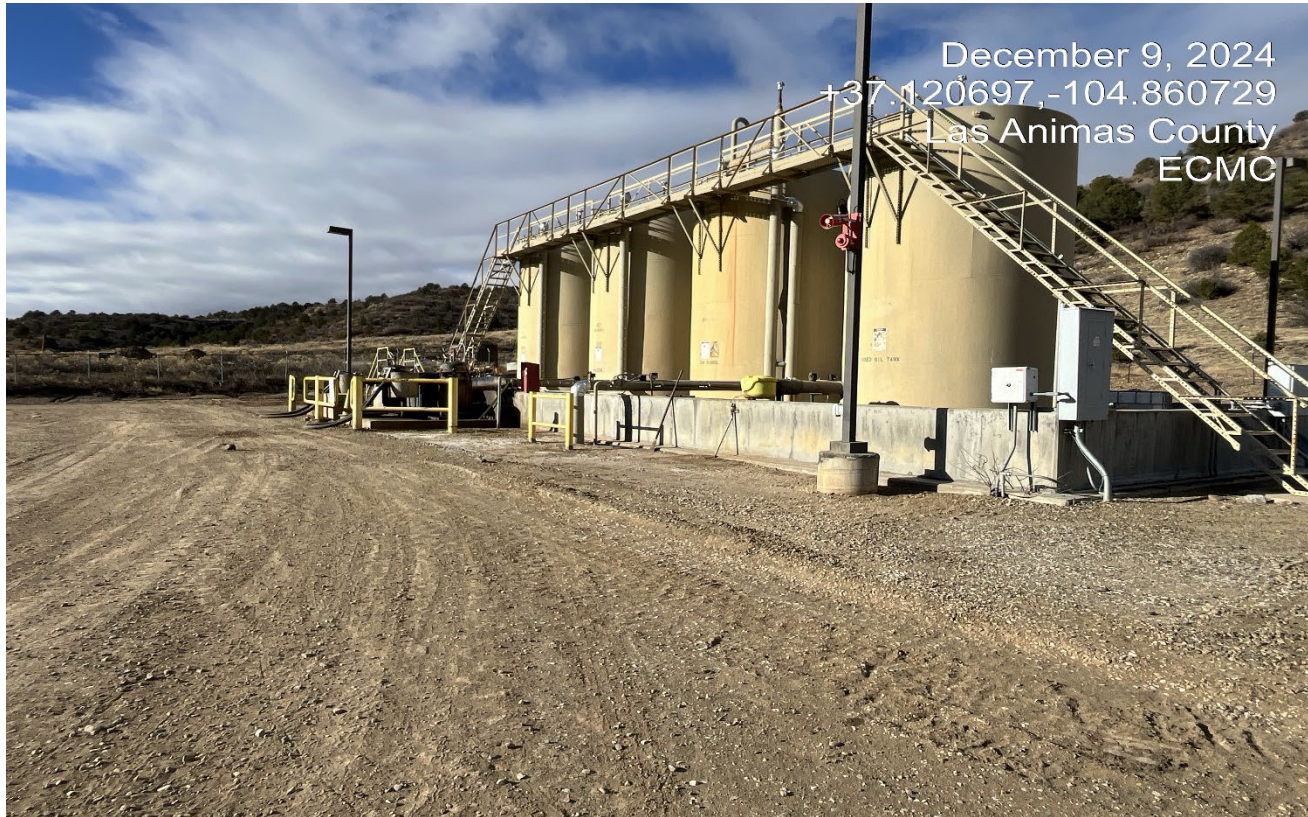
Photo 4. Facing toward the tank battery. The open top tank has been removed.
