Inspection Photos

Operator: TEP ROCKY MOUNTAIN LLC #96850

Location ID: 335053

Inspection Doc: 718100094

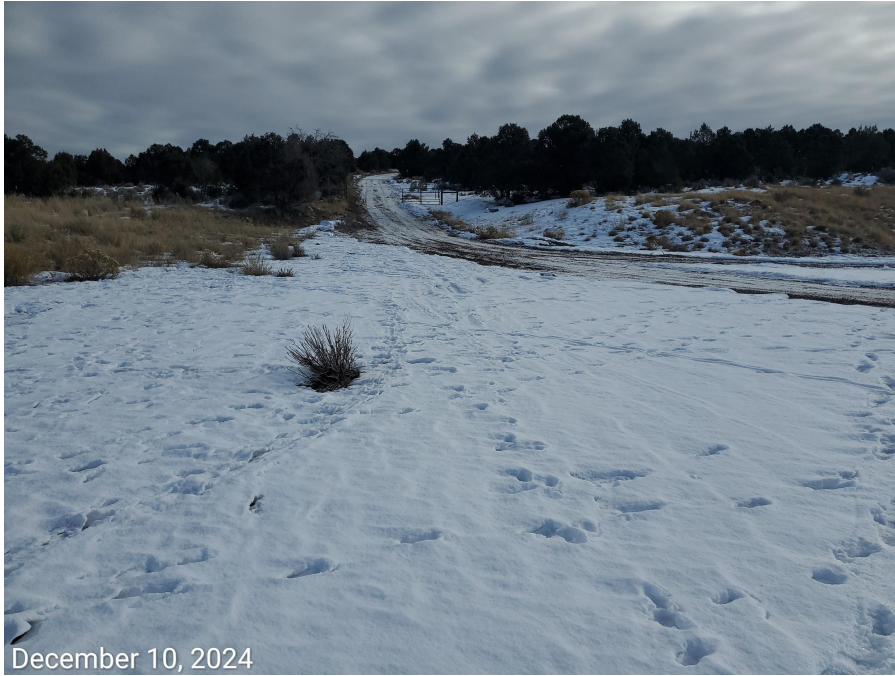
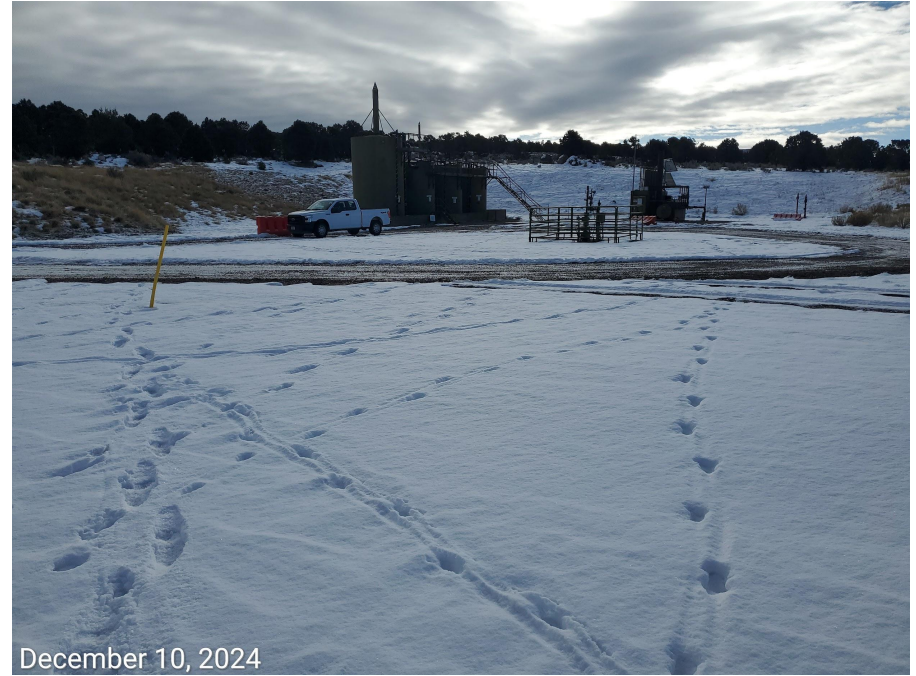
Photo 1: Photos 1-2 taken from the north end of the Location. Photos provide an overview of the Location from east, southeast, southwest to west.

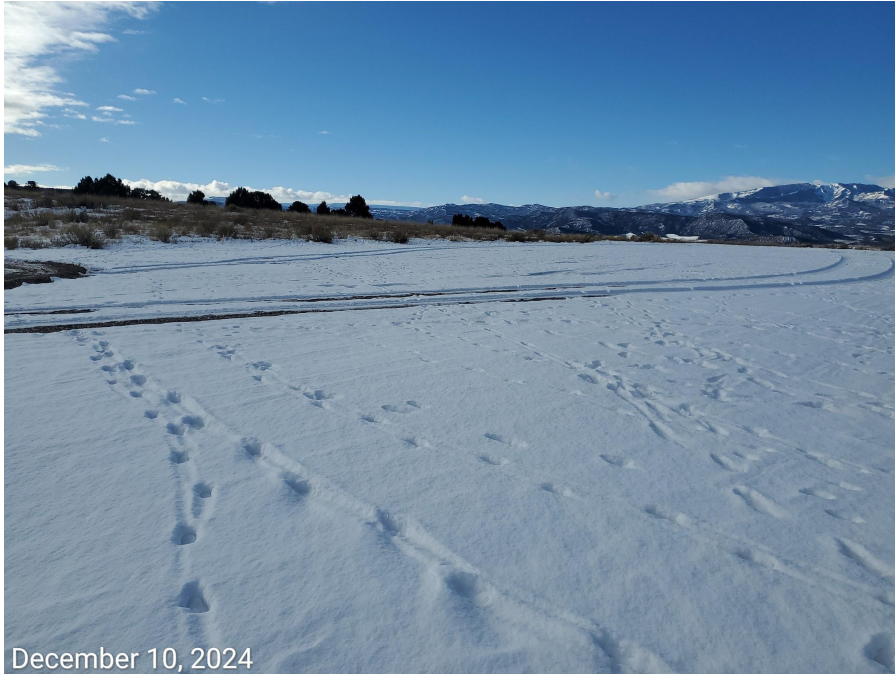
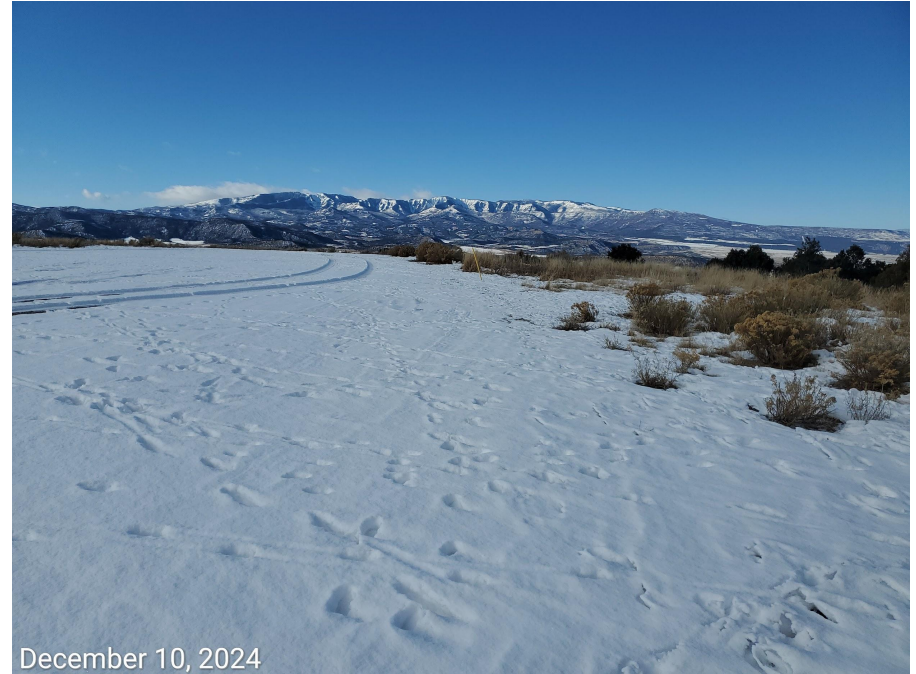
Photo 2: See comments under photo 1. Photos also show areas on the west end of the Location that or not necessary for production have not been reclaimed pursuant to 1003 requirements.

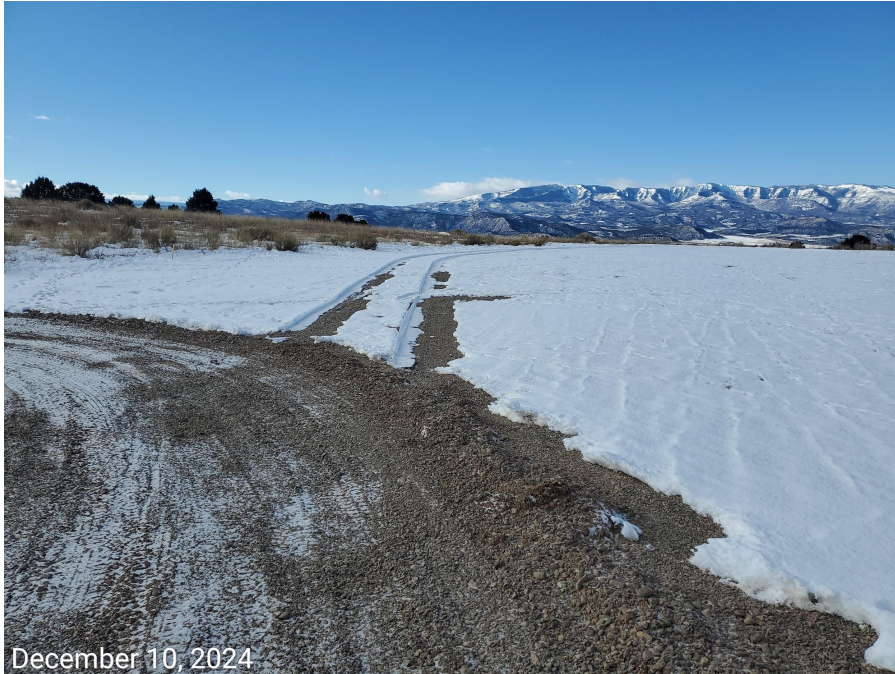
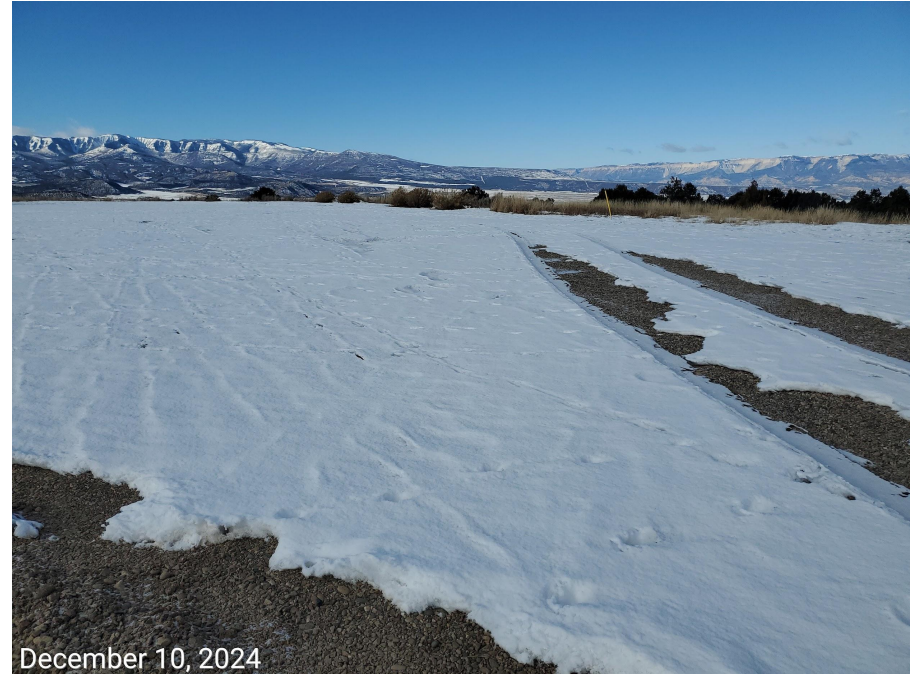
Photo 3: Photos taken from the central areas of the current pad, facing southwest and northwest. Photos show areas on the west end of the Location that or not necessary for production have not been reclaimed pursuant to 1003 requirements.

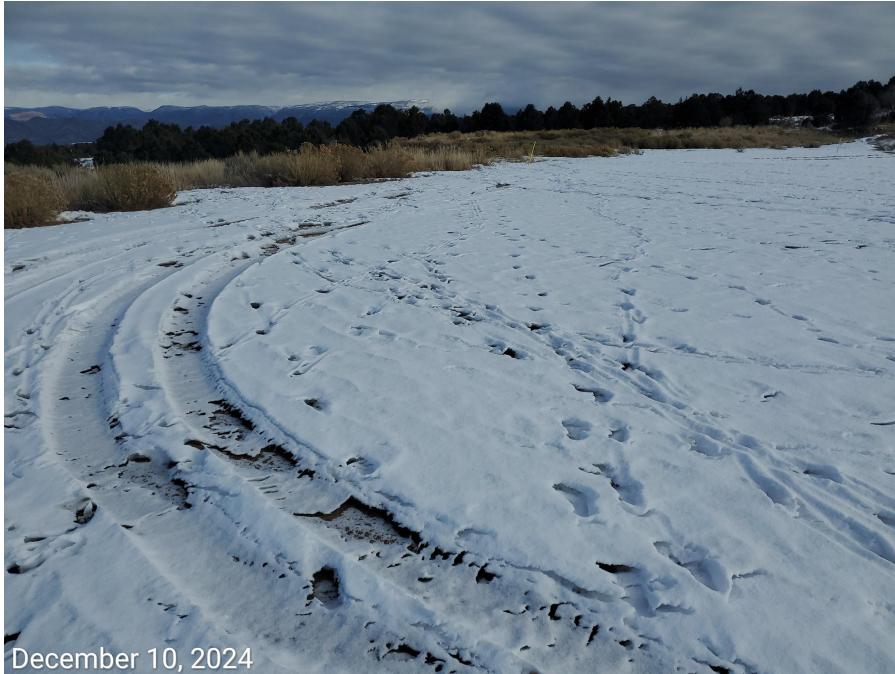
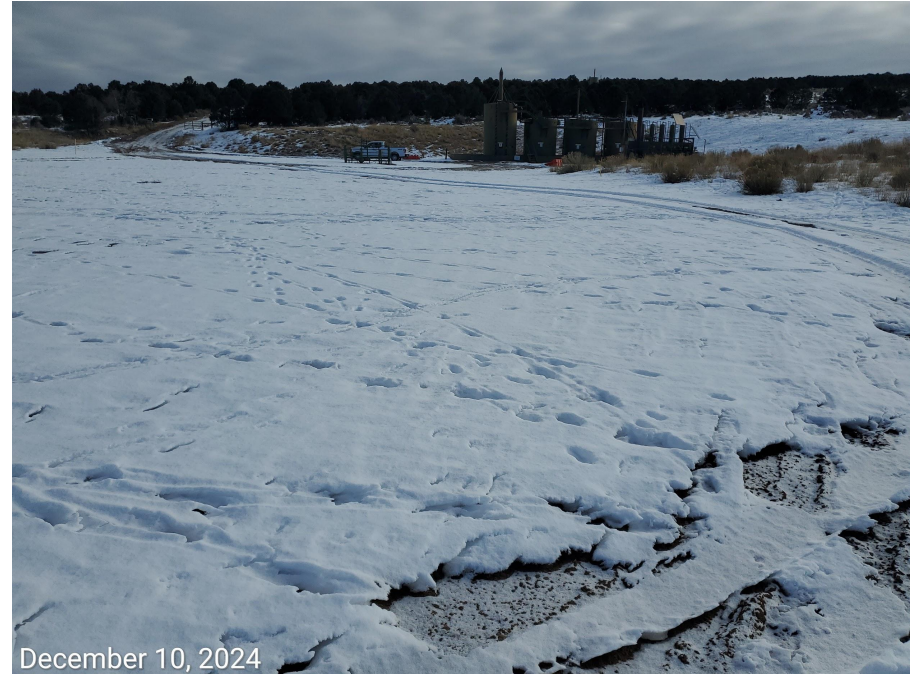
Photo 4: Photos taken from the west end of the Location, facing northeast and south east. Photos shows areas on the west end of the Location that or not necessary for production have not been reclaimed pursuant to 1003 requirements.

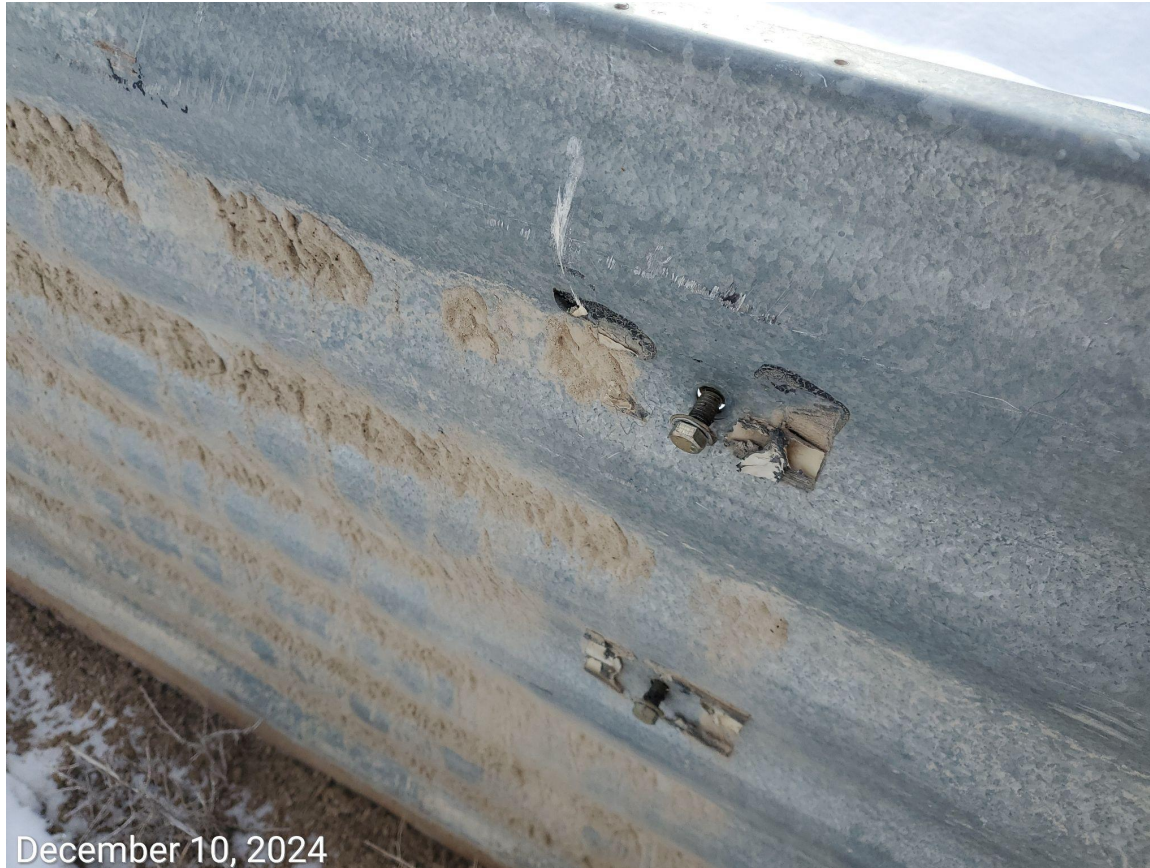
Photo 5: Photo taken from the secondary containment measure at the battery. Photo shows Operator has loosely placed bolts within the holes observed in the metal walls; BMP remains inadequate to contain a spill or release.

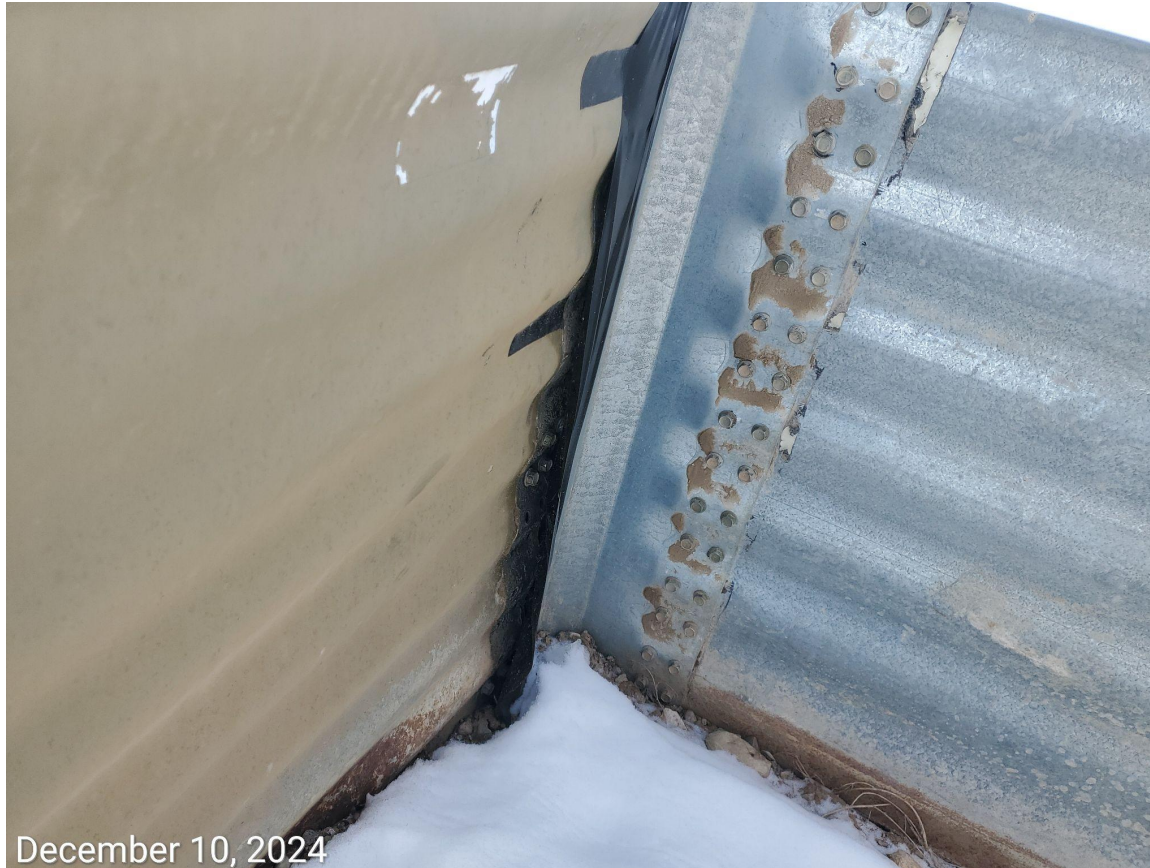
Photo 2: Photo taken from the secondary containment measure at the battery. Photo shows Operator appears to have placed electrical tape within compromised areas of at the containment BMP; tape is peeling from the metal; BMP remains inadequate to contain a spill or release.

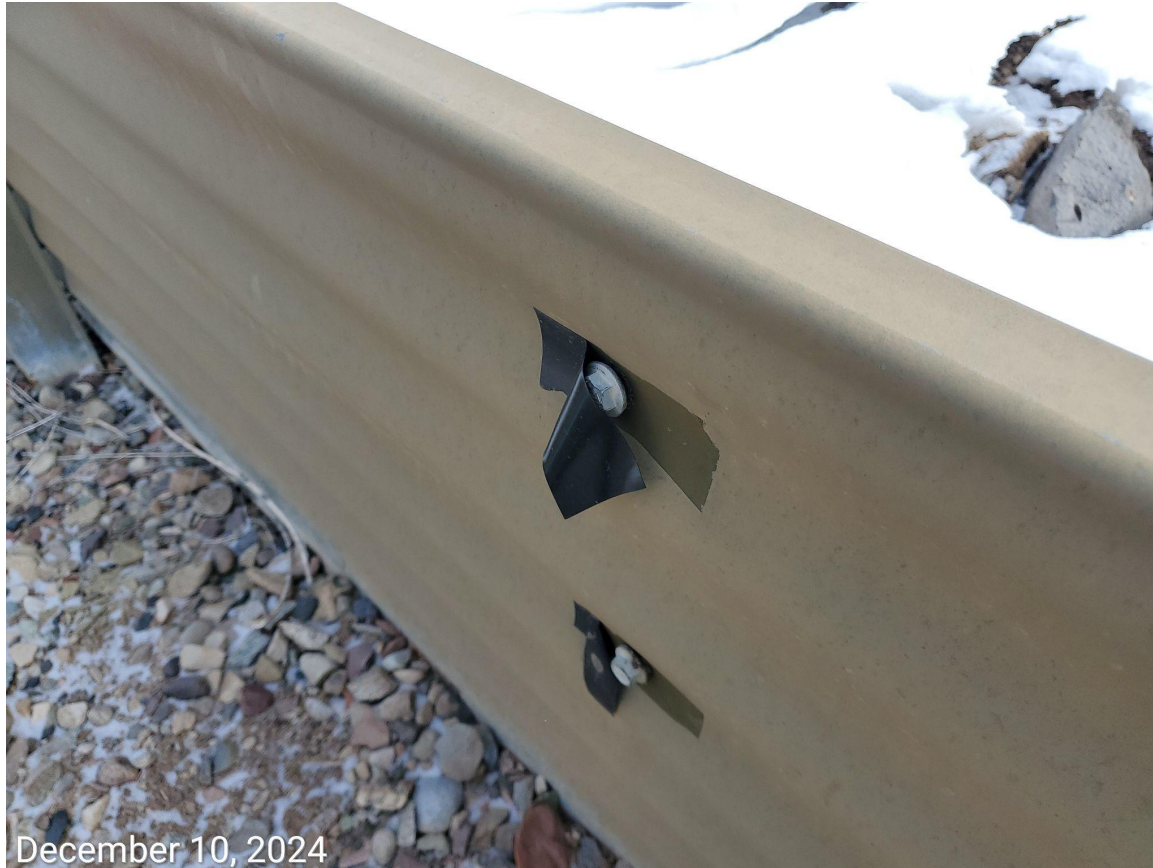
Photo 7: Photo taken from the secondary containment measure at the battery. Photo shows Operator has placed loose bolts within holes, and what appears electrical tape within compromised areas of at the containment BMP; BMP remains inadequate to contain a spill or release.
