Inspection Photos

Operator: TEP ROCKY MOUNTAIN LLC #96850

Location ID: 335055

Inspection Doc: 718100096

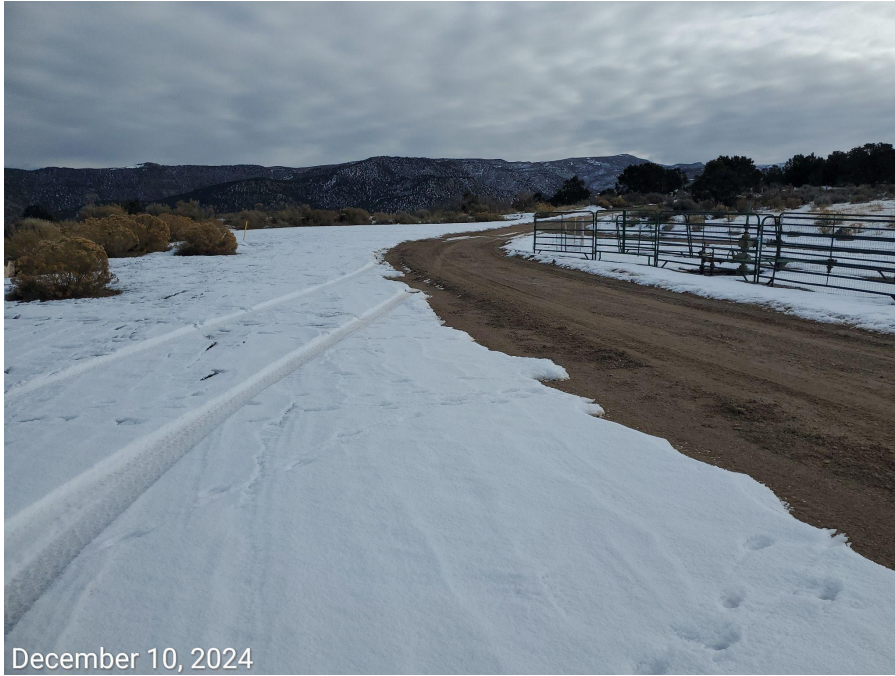
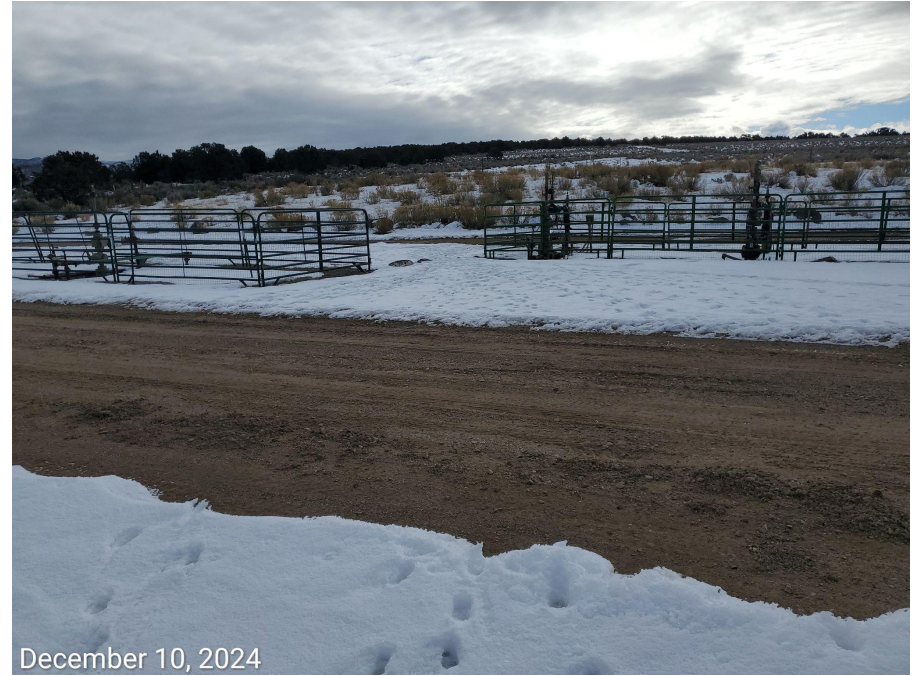
Photo 1: Photos 1-2 taken from the north end of the Location. Photos provide an overview of the Location from east, southeast, southwest to west.

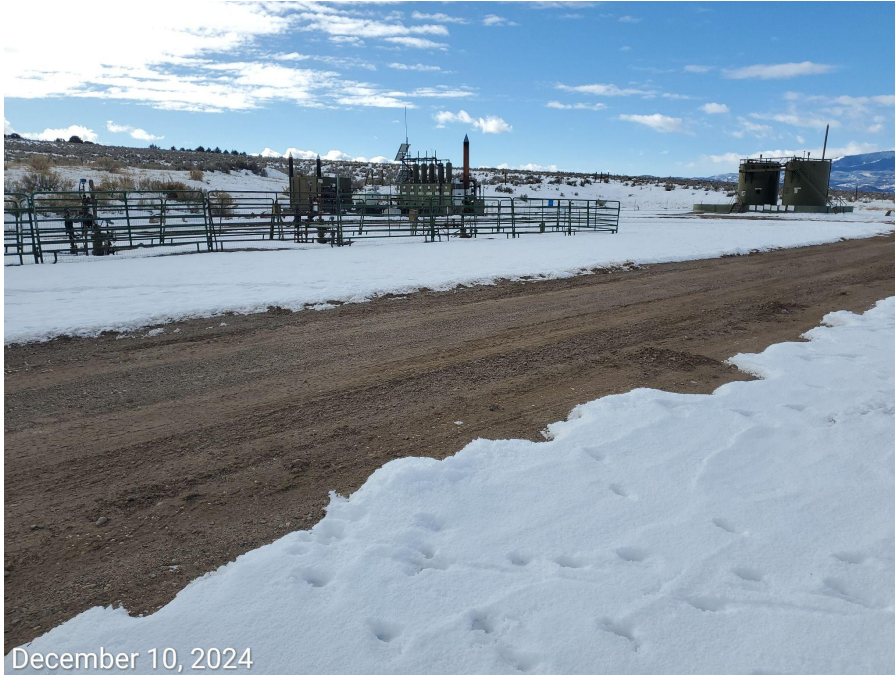
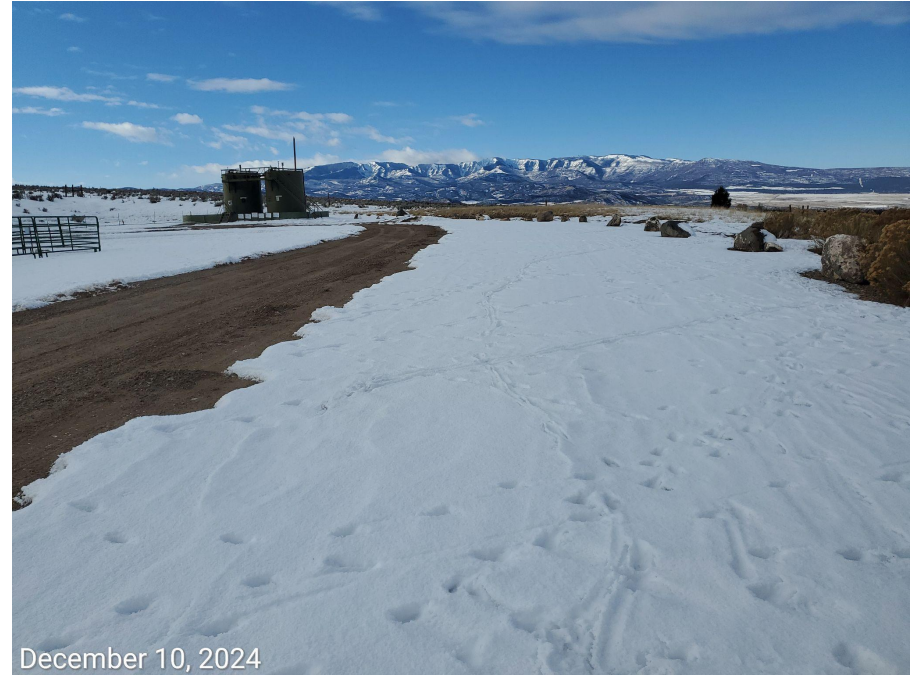
Photo 2: See comments under photo 1. Photos also show areas on the west end of the Location that or not necessary for production have not been reclaimed pursuant to 1003 requirements.

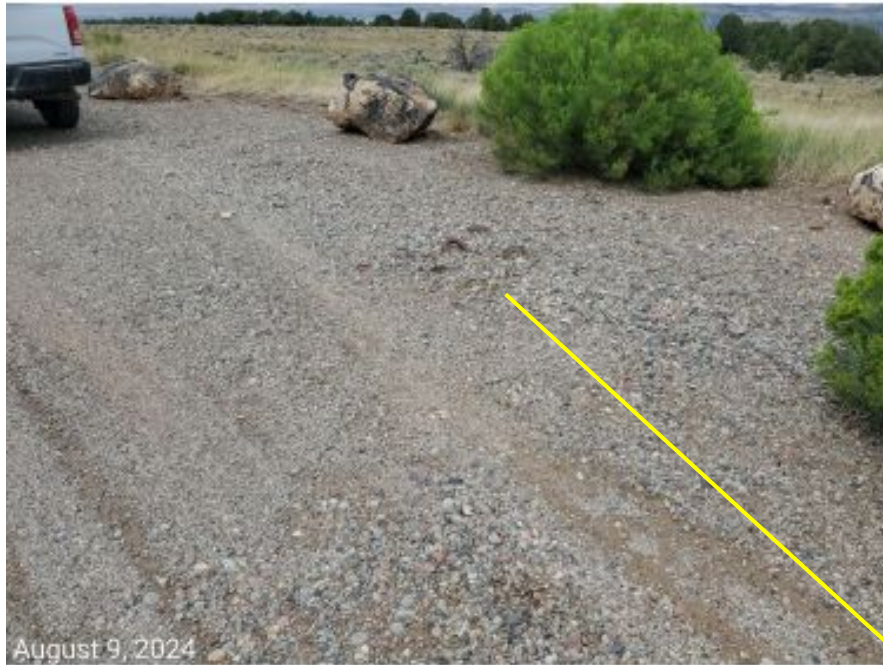
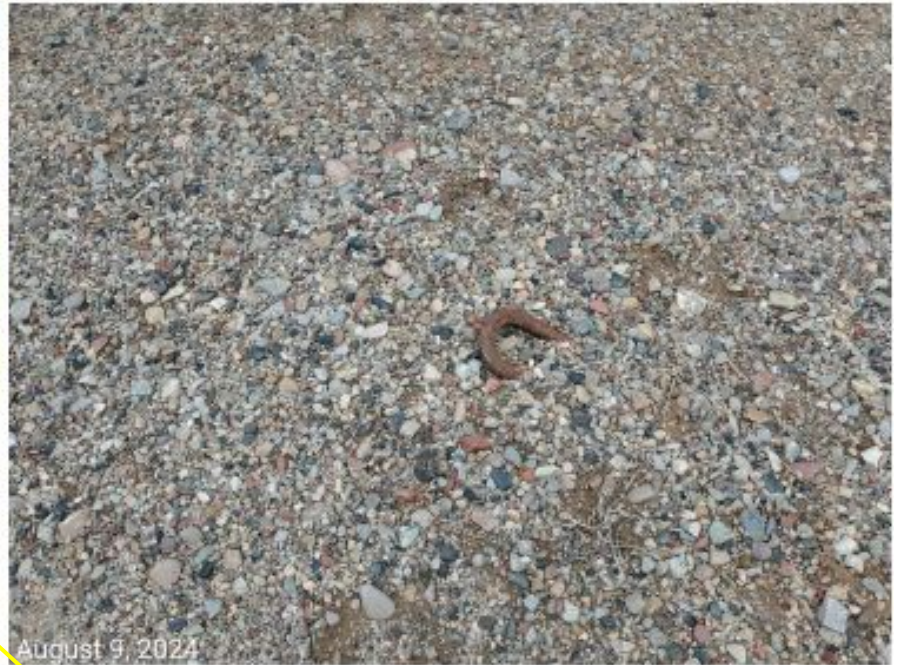
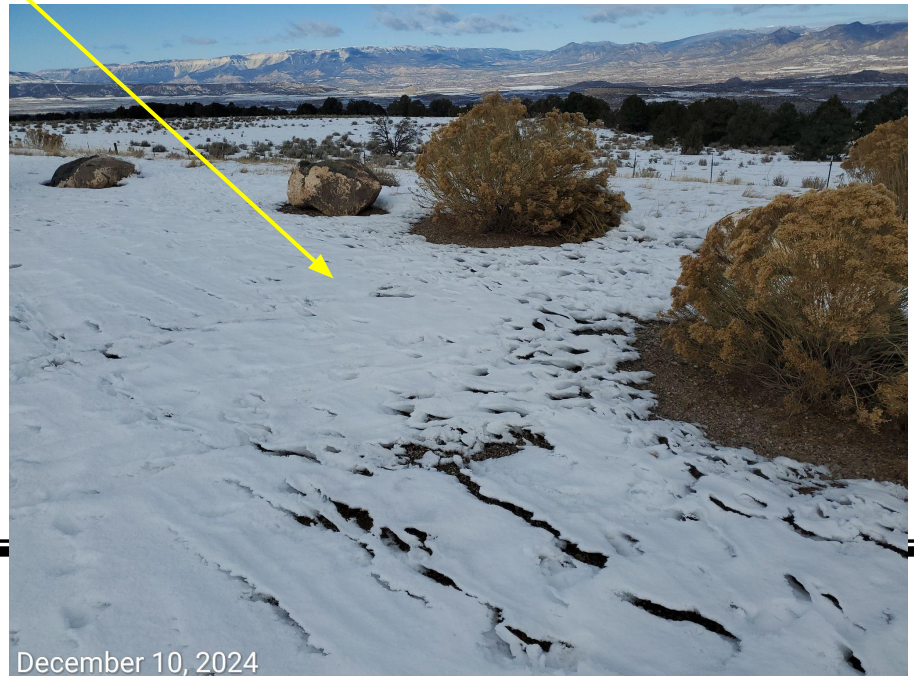
Photo 3: Photos top left/right from the 8/9/2024 inspection; photo right dated 12/10/2024. Photo shows marker remains missing. Photos examples showing missing markers identified on 8/9/2024 have not been installed.

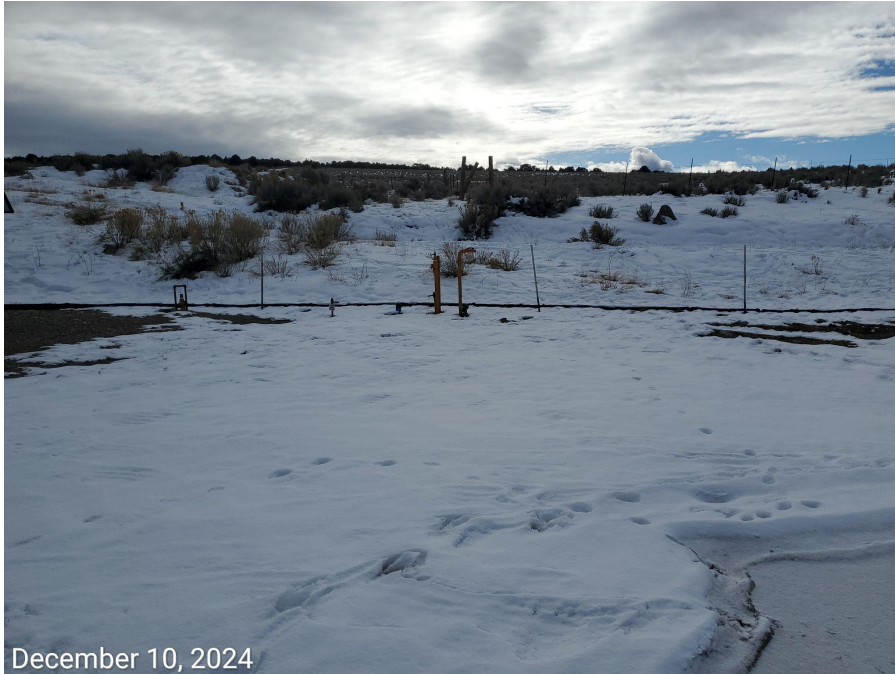
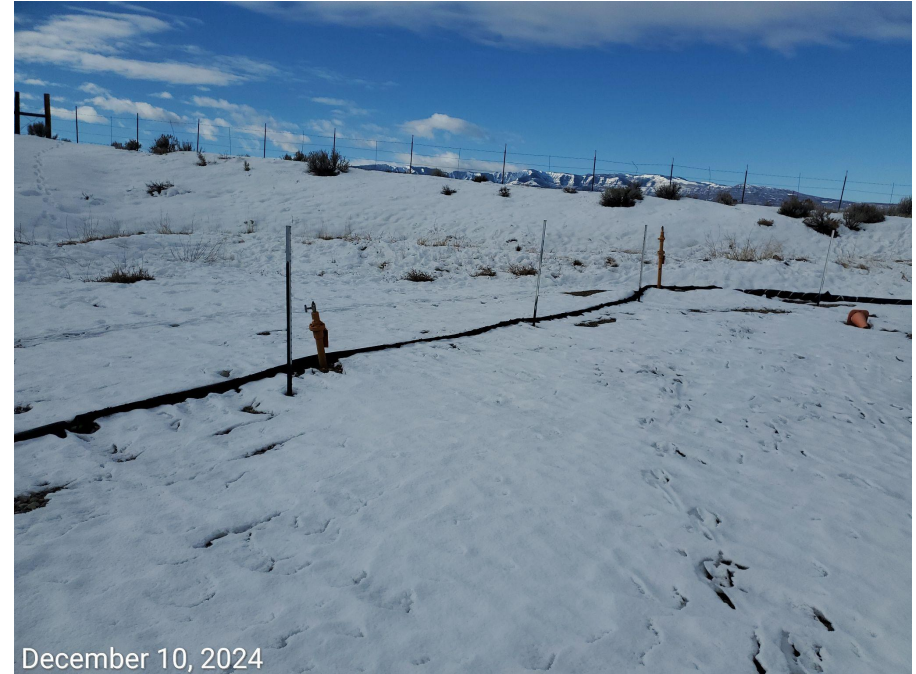
Photo 4: Photos examples showing risers remaining on Location.

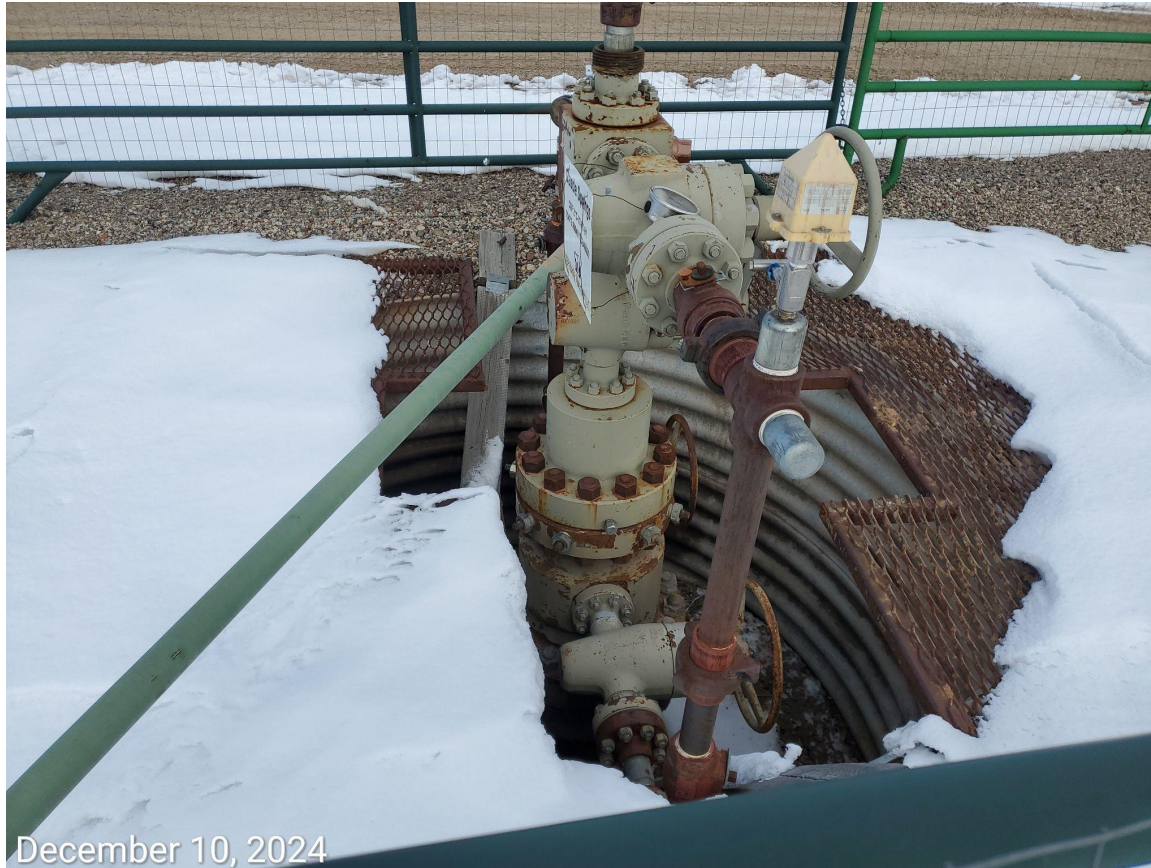
Photo 5: Photo examples showing cellars at wells have not been properly covered.
