Inspection Photos

Operator: TEP ROCKY MOUNTAIN LLC #96850

Location ID: 335054

Inspection Doc: 718100098

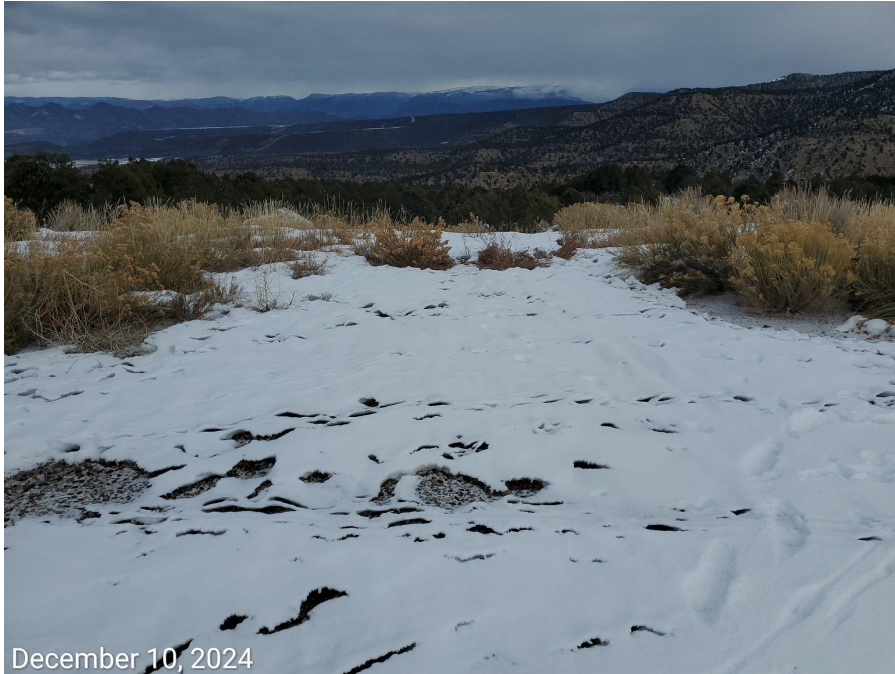
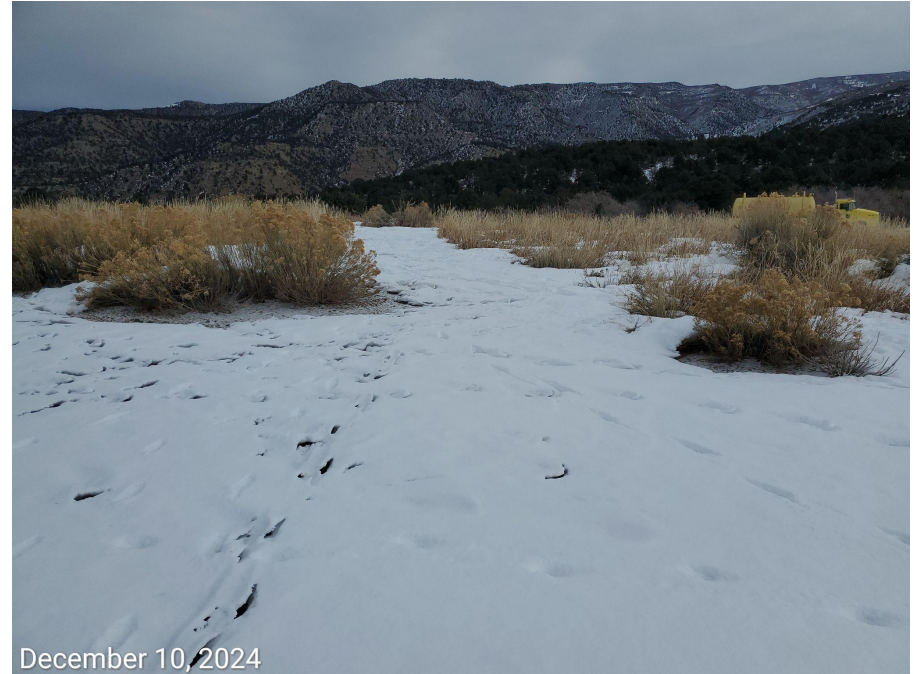
Photo 1: Photos taken from the north and east ends of the working pad surface. Photos show areas where stormwater runoff was document discharging from the working pad surface, resulting in sediment transport/deposition and degradation to the interim areas of the Location. Unable to find evidence that work to install or repair BMPs to properly manage runoff has been performed.

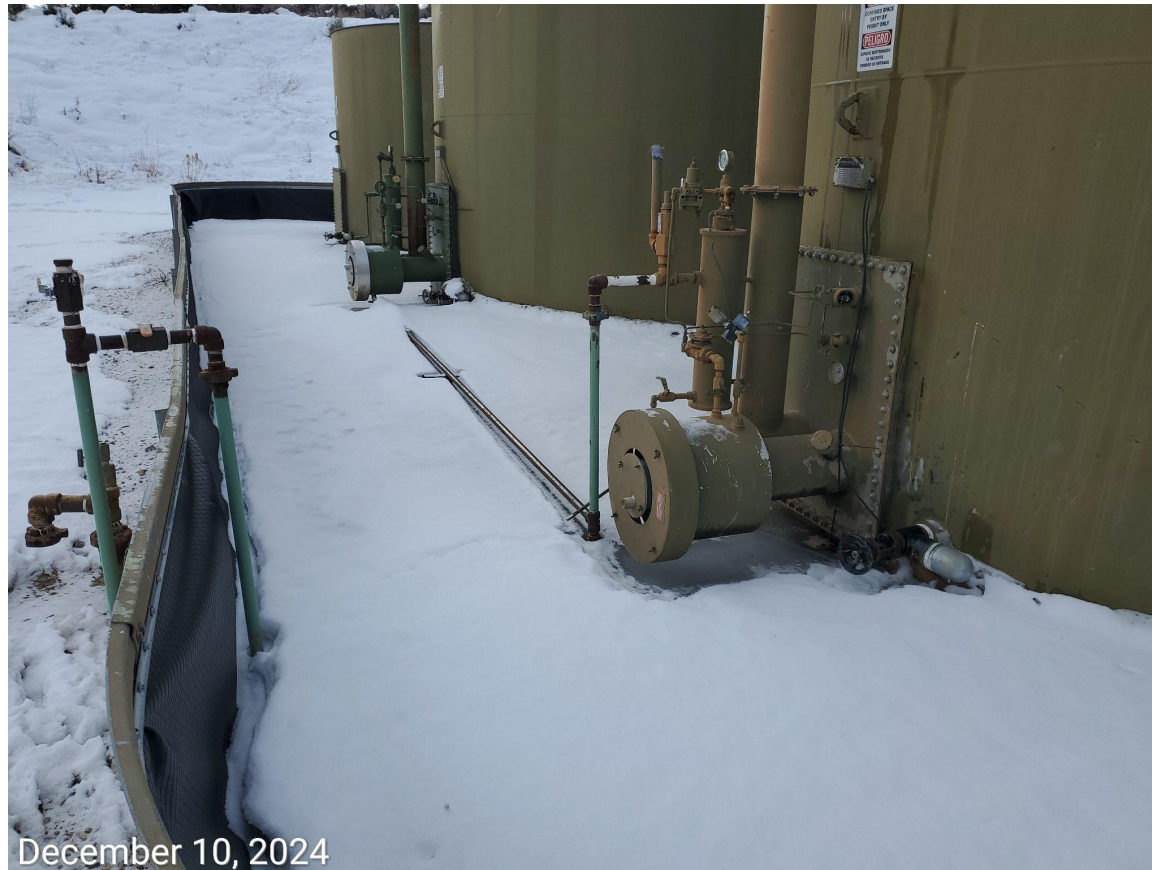
Photo 2: Lines at tanks have been capped/plugged.
