Inspection Photos

Loc: 484358

Operator: DESERT EAGLE OPERATING LLC

Inspection Date: 12/12/2024

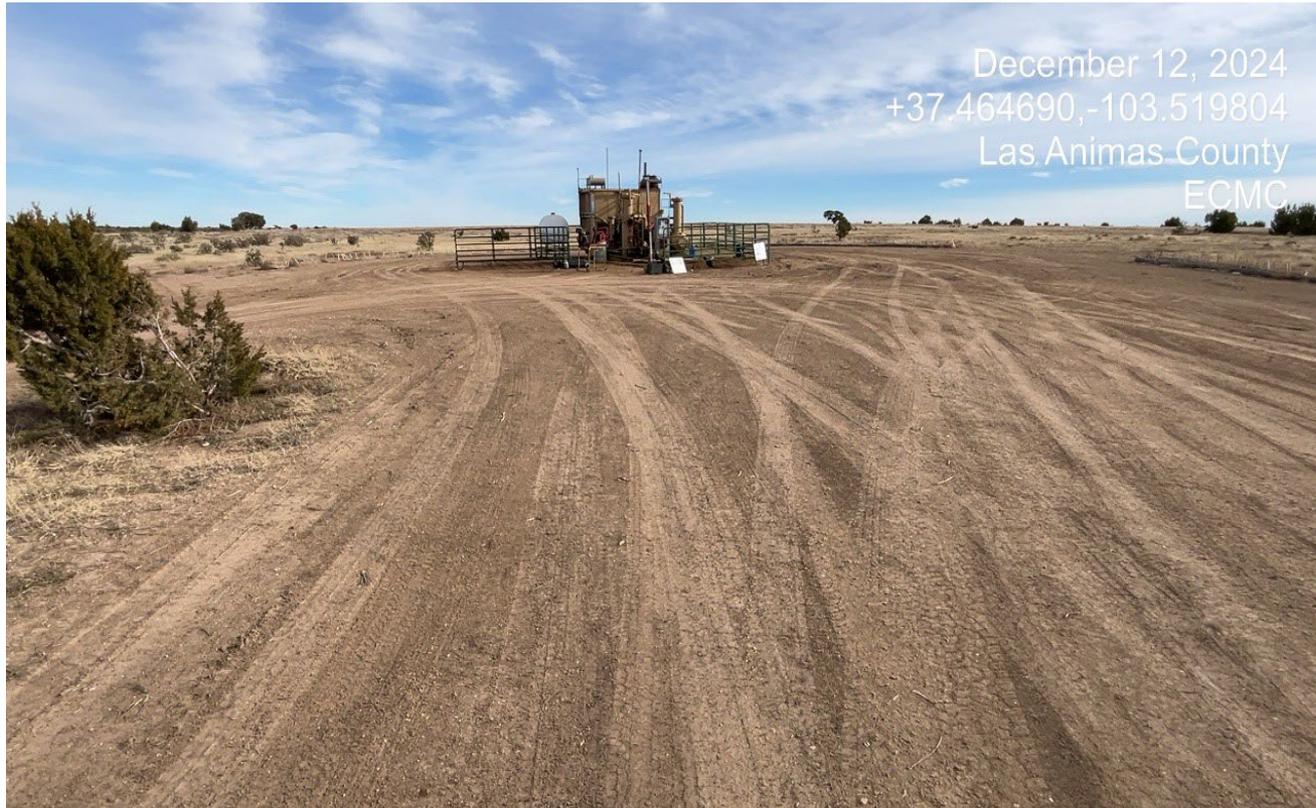
Photo 1. Facing east toward the wellsite.

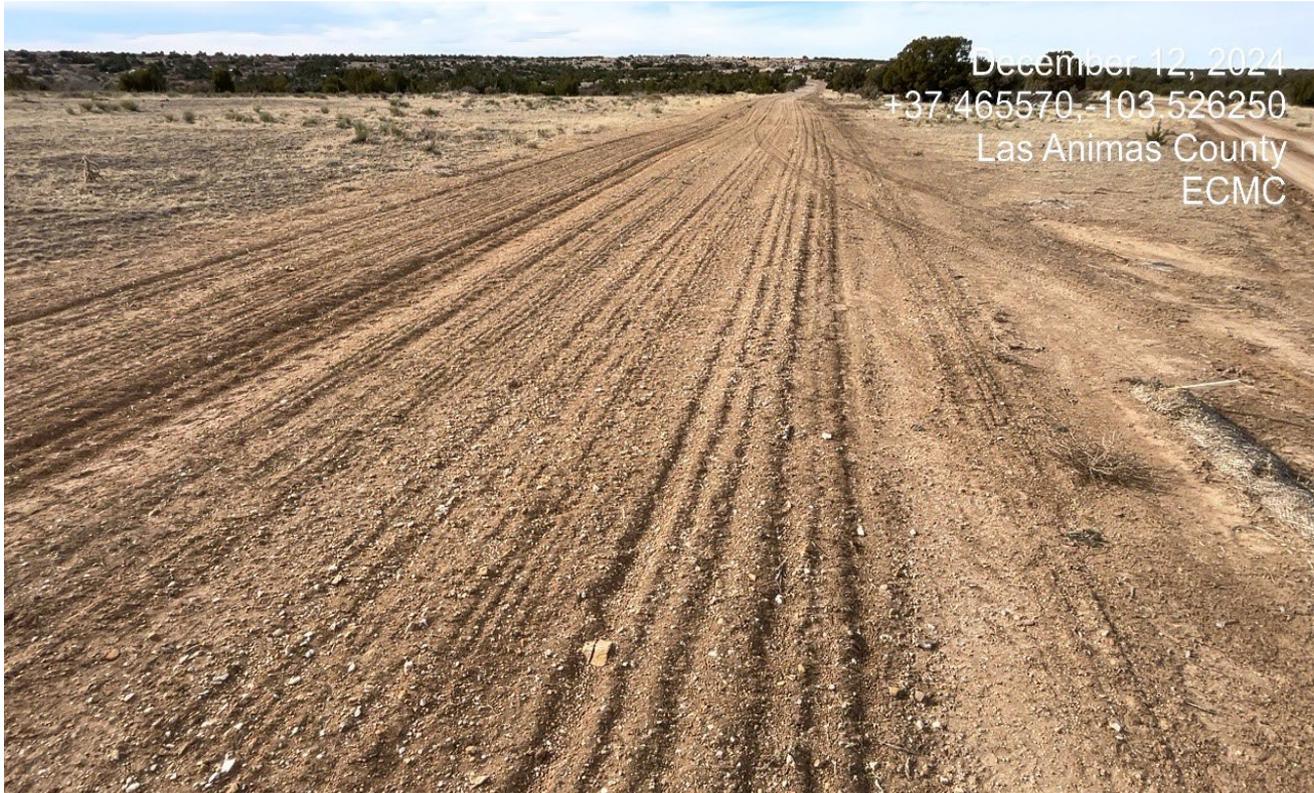
Photo 2. Facing back west toward the flowline disturbance. The vegetation is not establishing along the flowline. It appears this area was reseeded however, soils need to be stabilized with BMP's such as mulch ect.

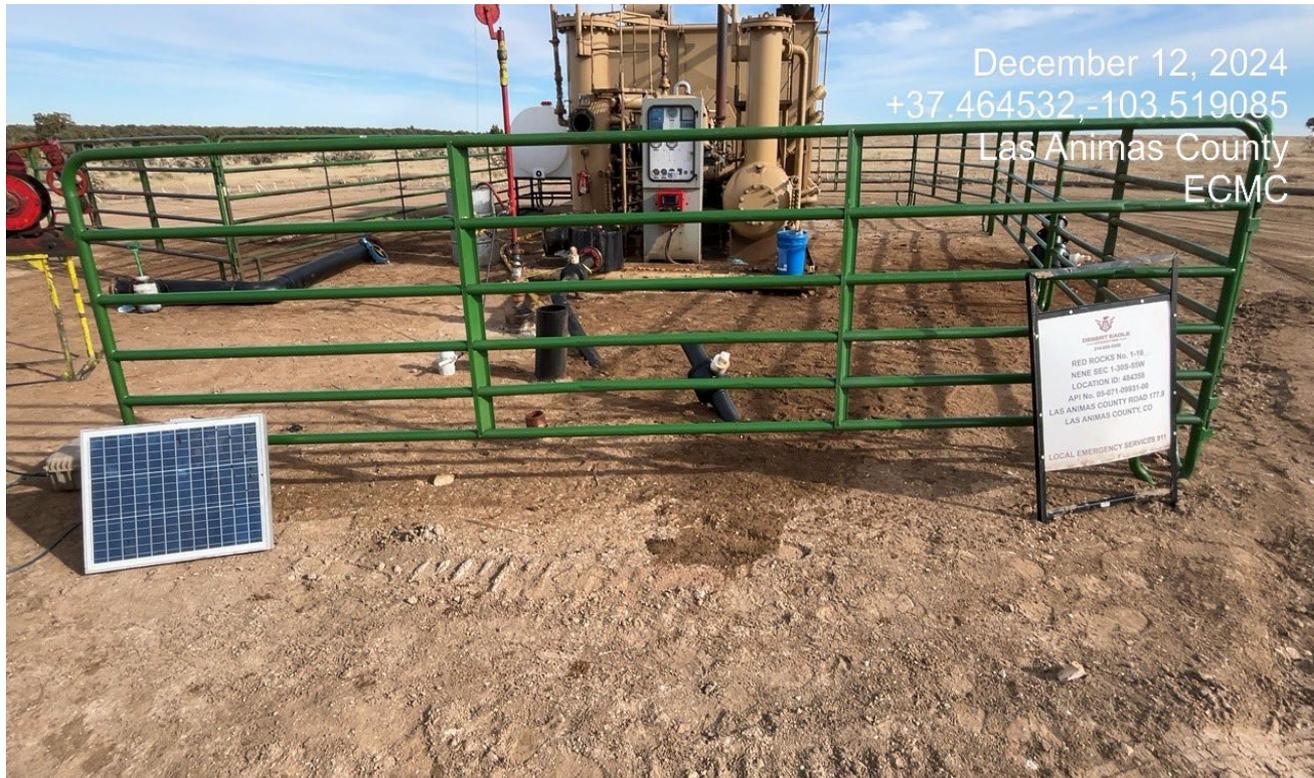
Photo 3. There is dark stained soils at the wellsite and engine compressor. Impacted soils need immediate clean up.

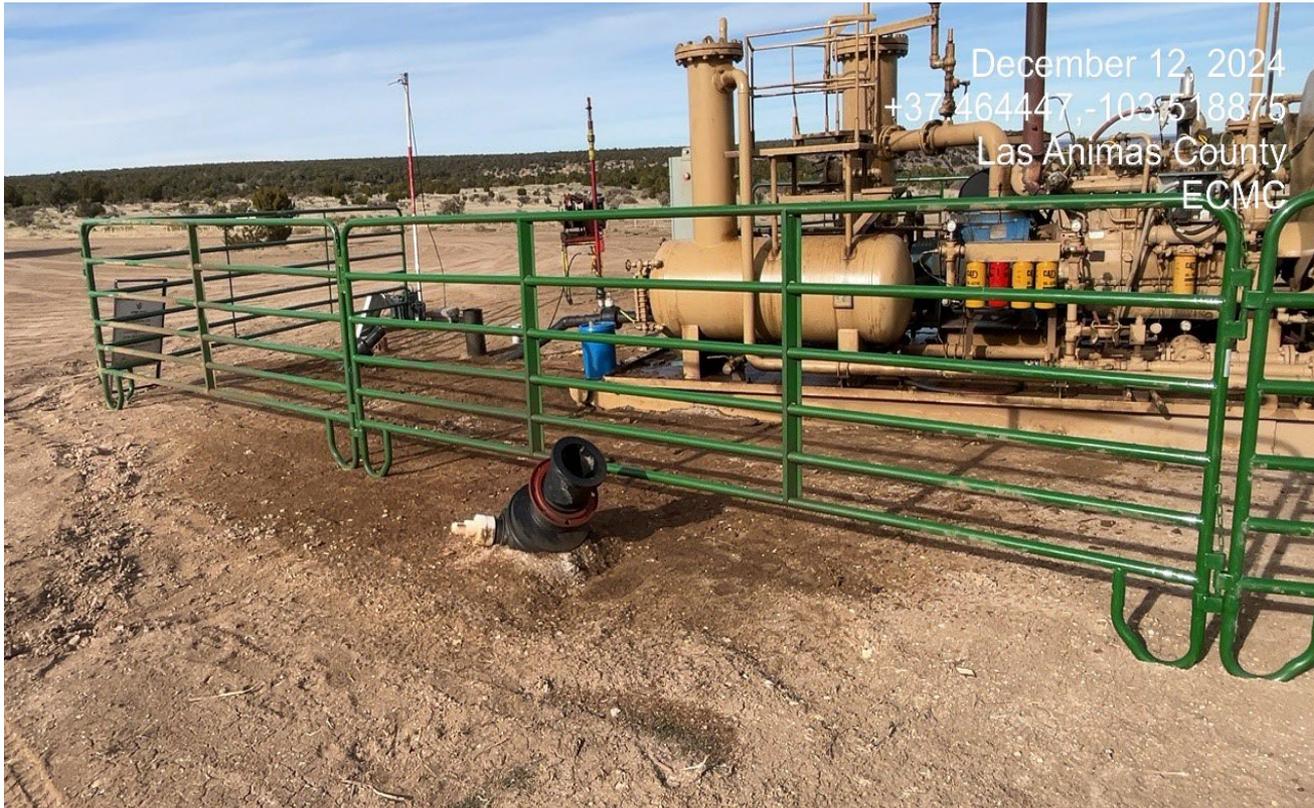
Photo 4. Facing northwest at the wellsite. Stained oily soils sprayed out on both side of the compressor.

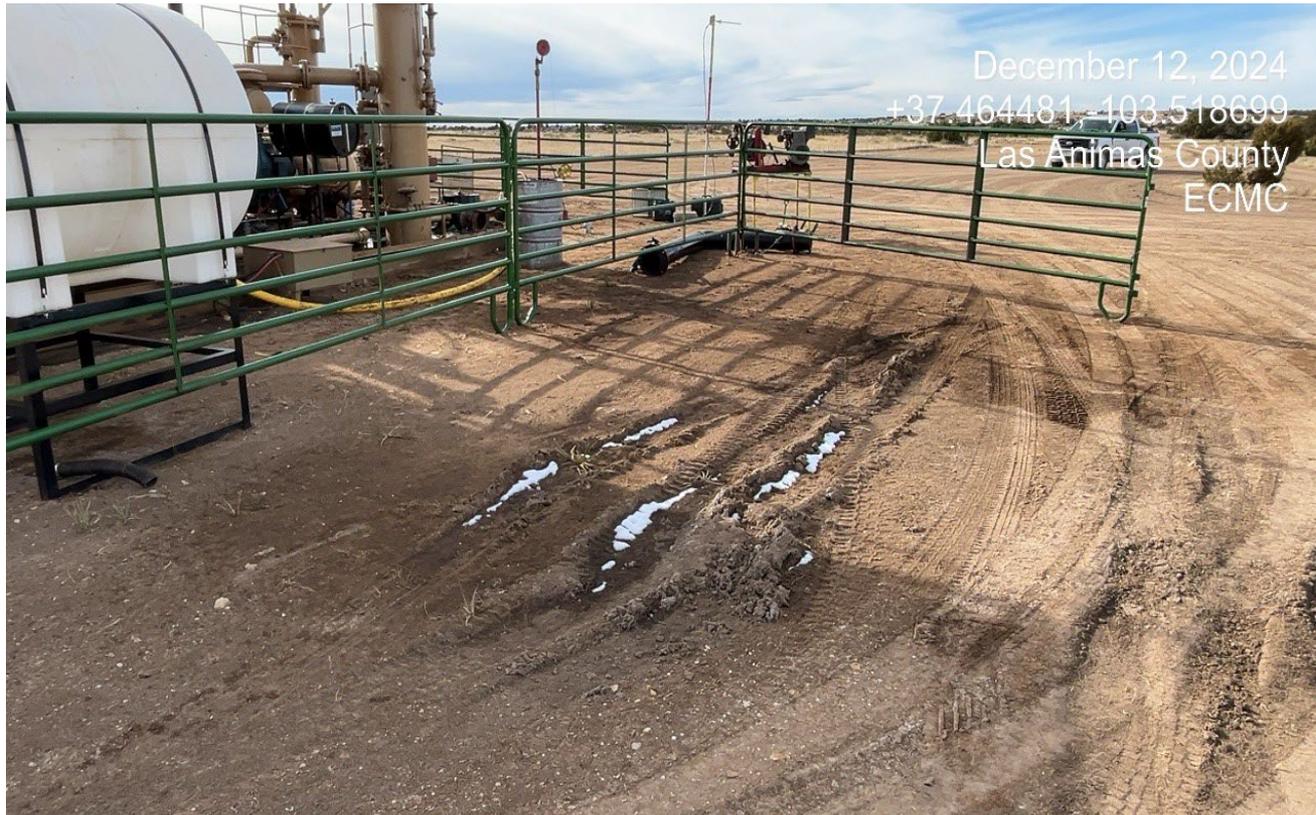
Photo 5. North side of the compressor facing west. Stained oily soils sprayed out on both side of the compressor. Vehicles are driving thru and tracking this area.

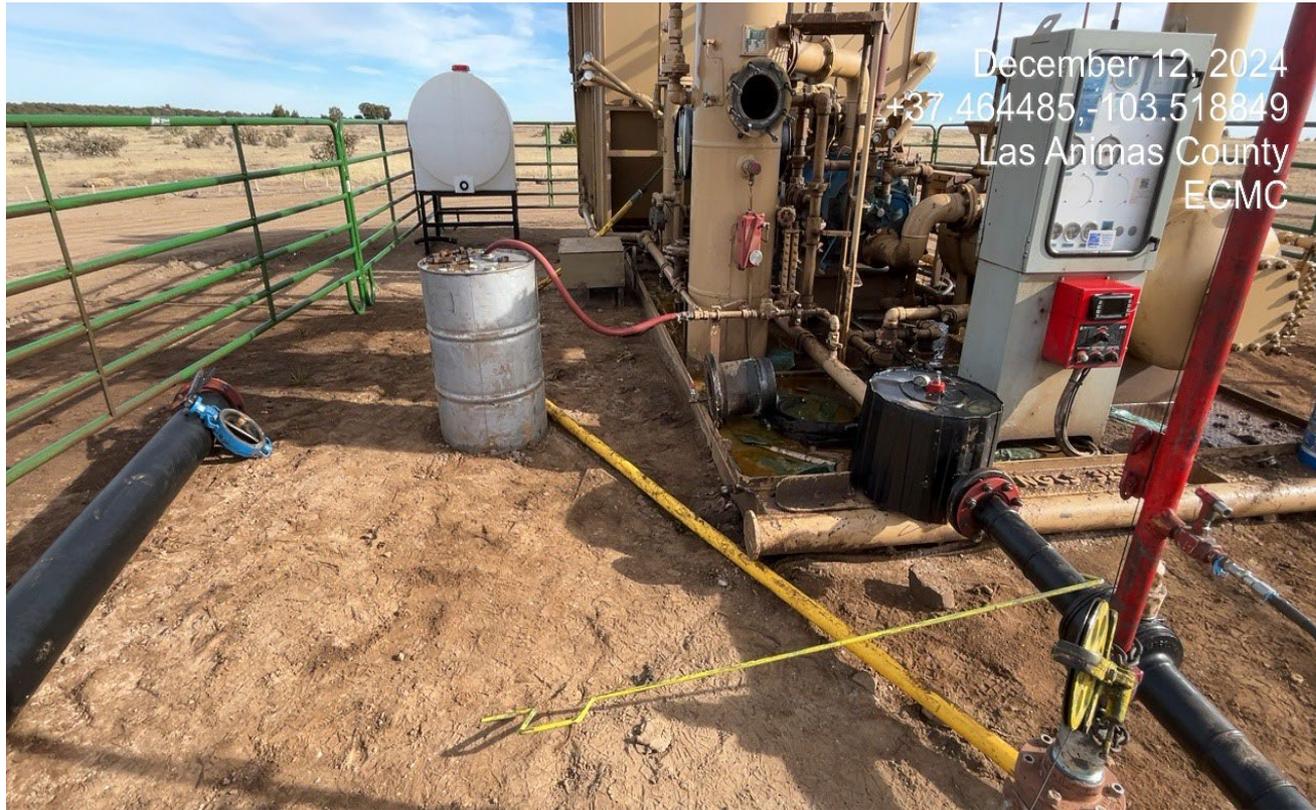
Photo 6. There is oil fluid inside the engine skid that must be cleaned up. The grey drum needs to be placed into secondary containment and labeled.

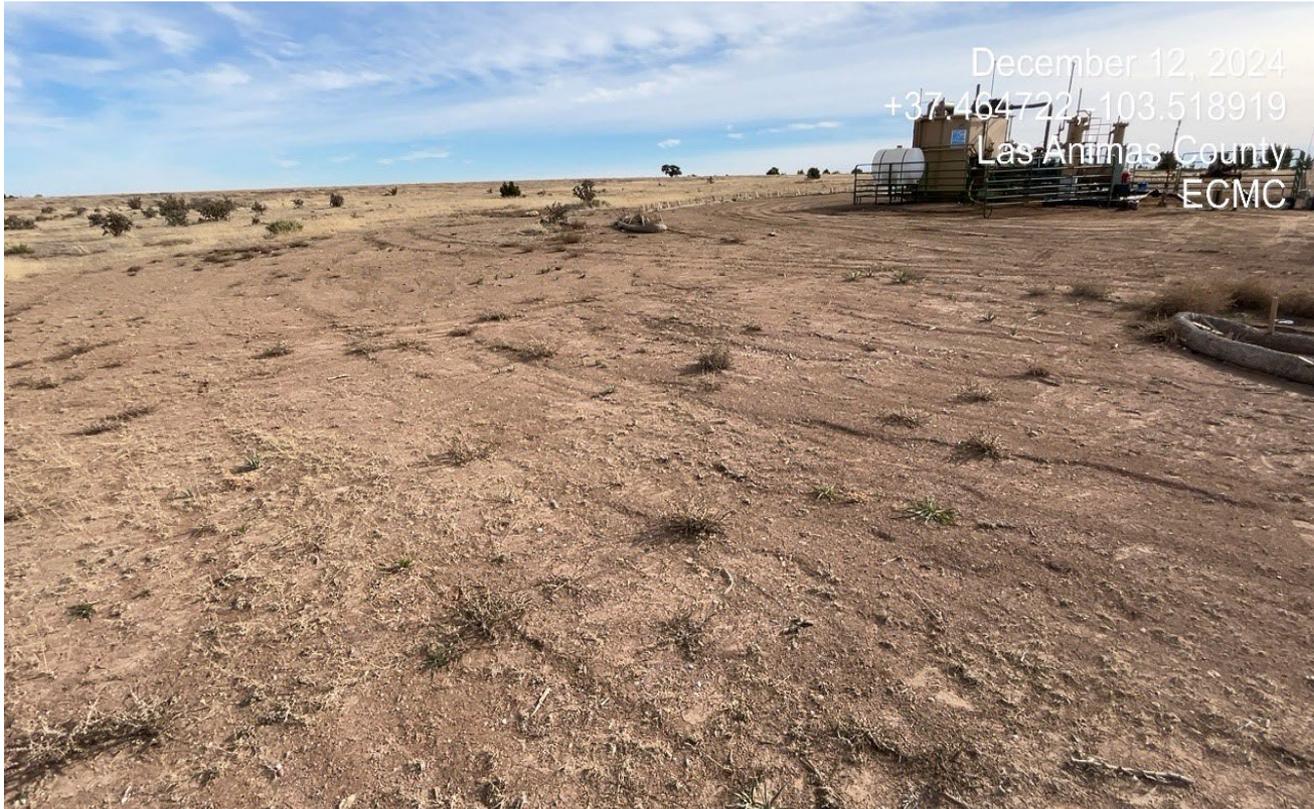
Photo 7. North side of the location facing southeast. The vegetation is not establishing in this area and will need to be reseeded before the upcoming growing season.

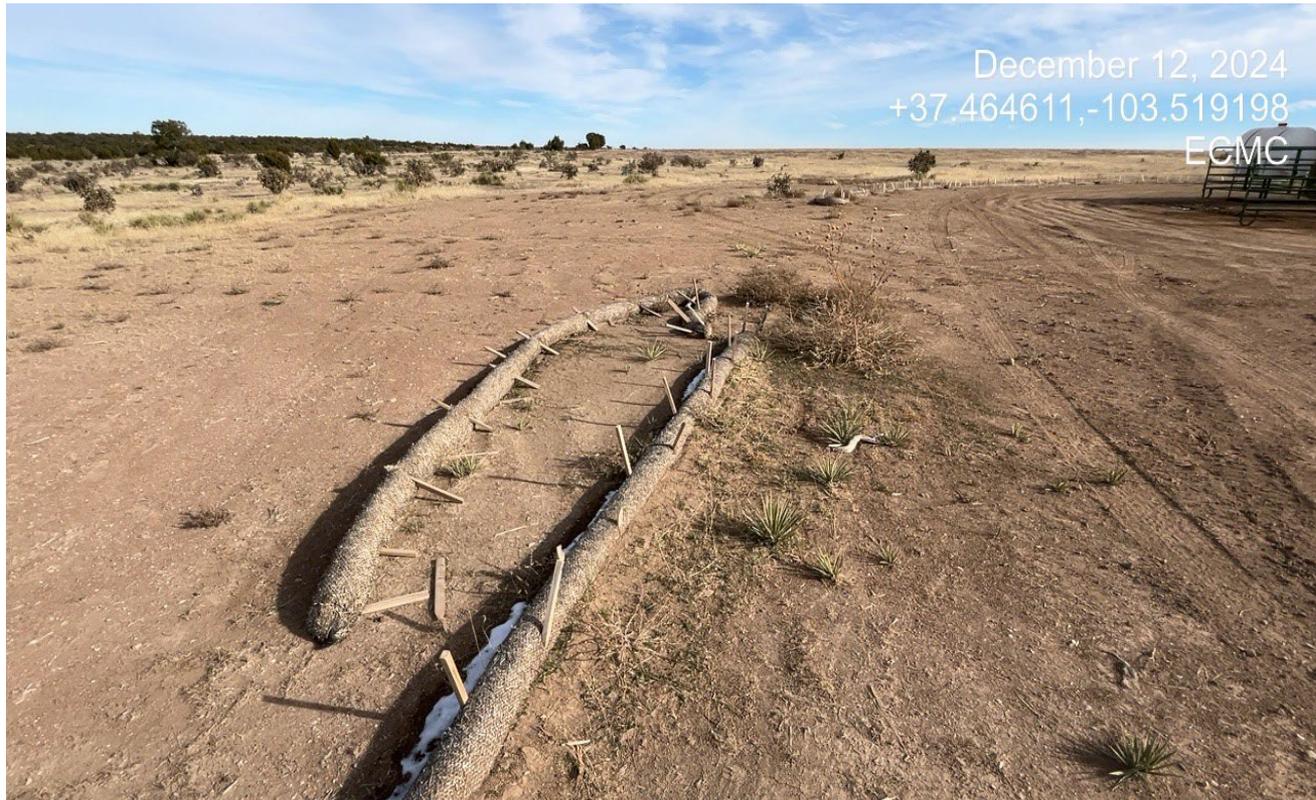
Photo 8. North side of the location facing east/ The wattles have been displaced and need to be reinstalled.
