Inspection Photos

Operator: TEP ROCKY MOUNTAIN LLC #96850

Location ID: 423439

Inspection Doc: 718100109

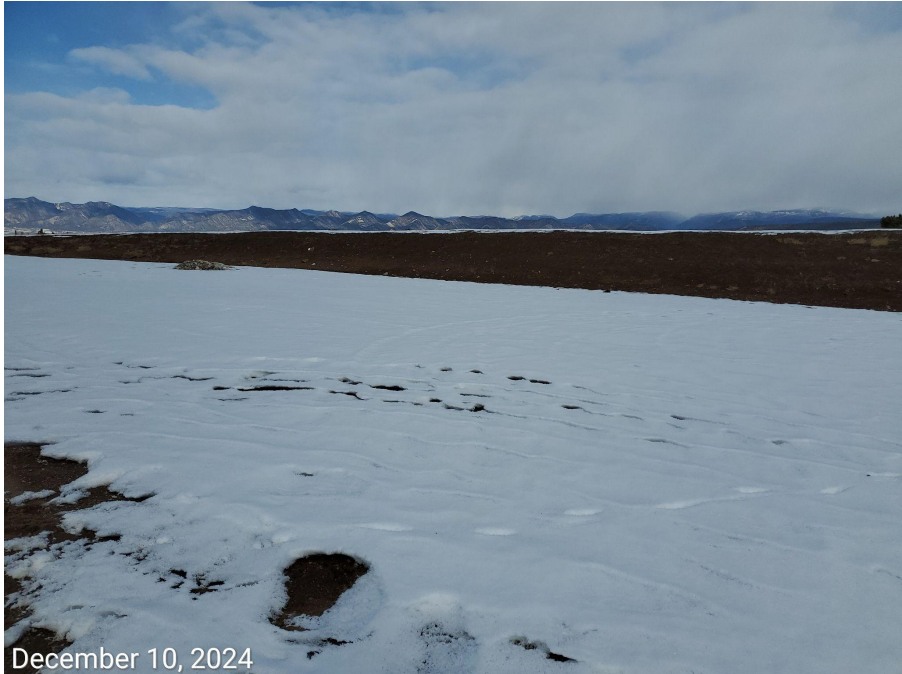
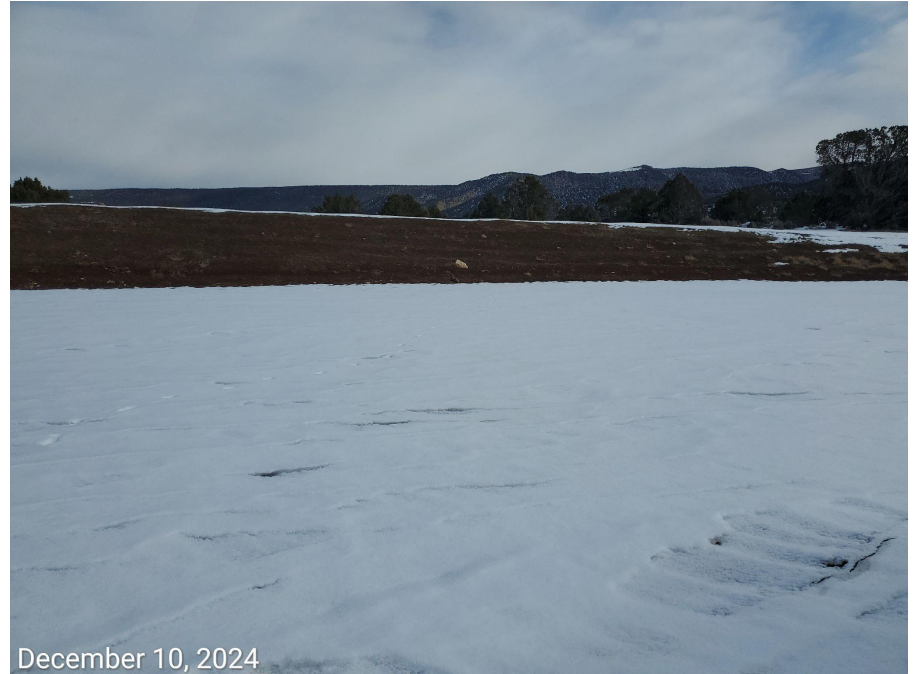
Photo 1: Limited inspection due to snow cover. Photo shows interim slopes of the Location that were observable during the inspection. Unable to find evidence that additional reclamation work has been performed, and BMPs to stabilize the seeded soils implemented.

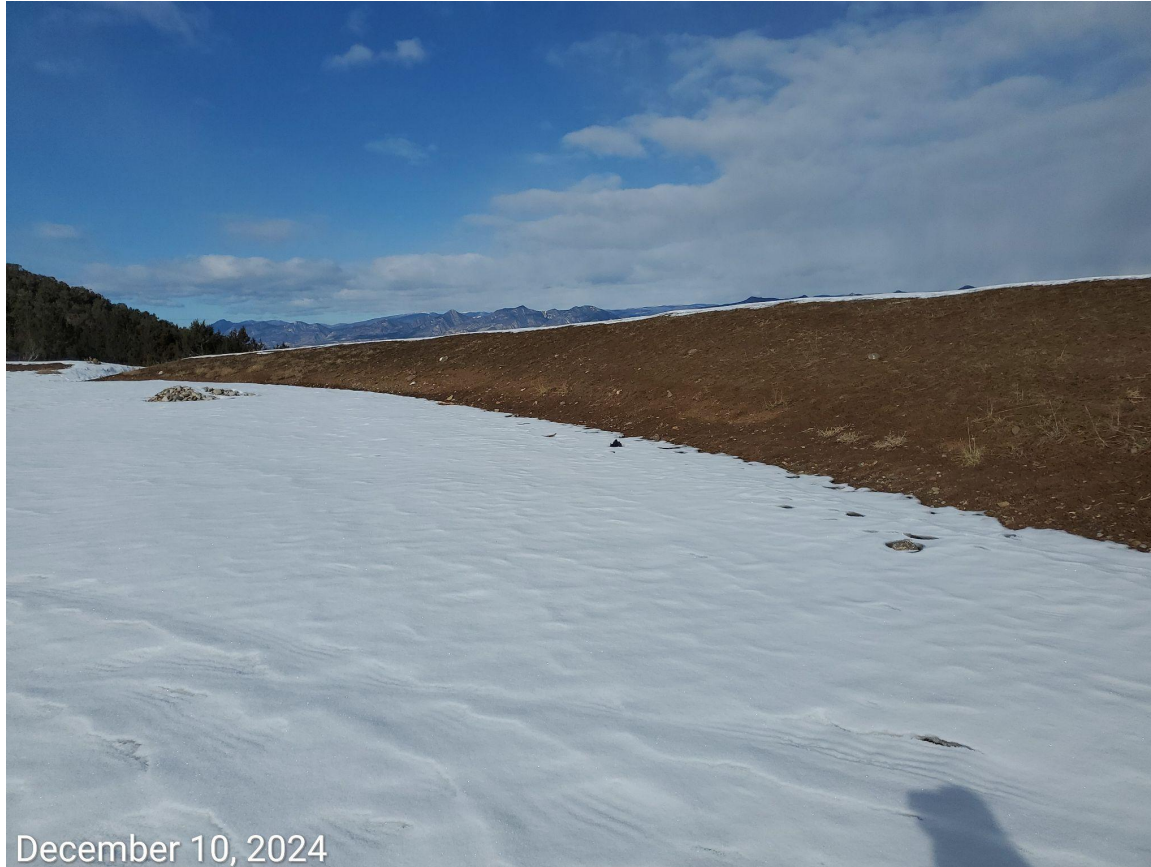
Photo 2: Limited inspection due to snow cover. Photo shows interim slopes of the Location that were observable during the inspection. Unable to find evidence that additional reclamation work has been performed, and BMPs to stabilize the seeded soils implemented.

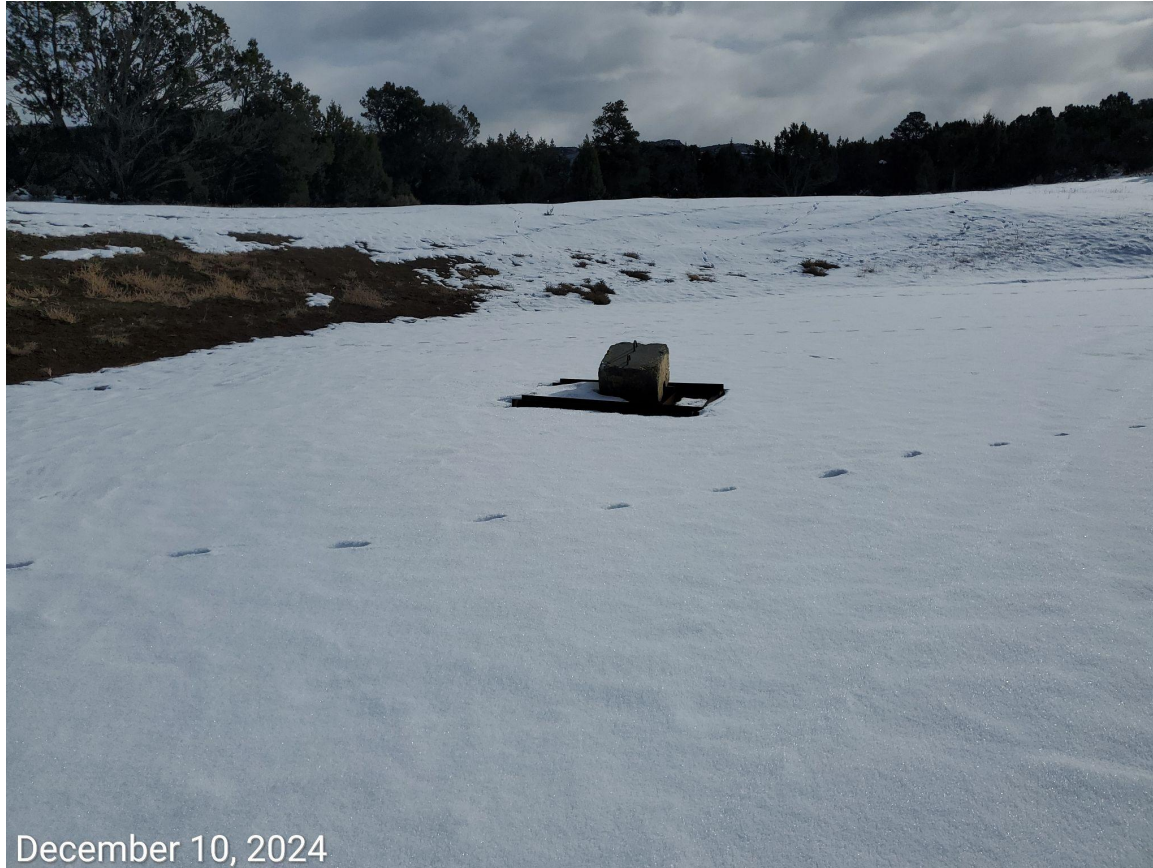
Photo 3: Unused equipment, or equipment not necessary for production stored on the east end of the Location.

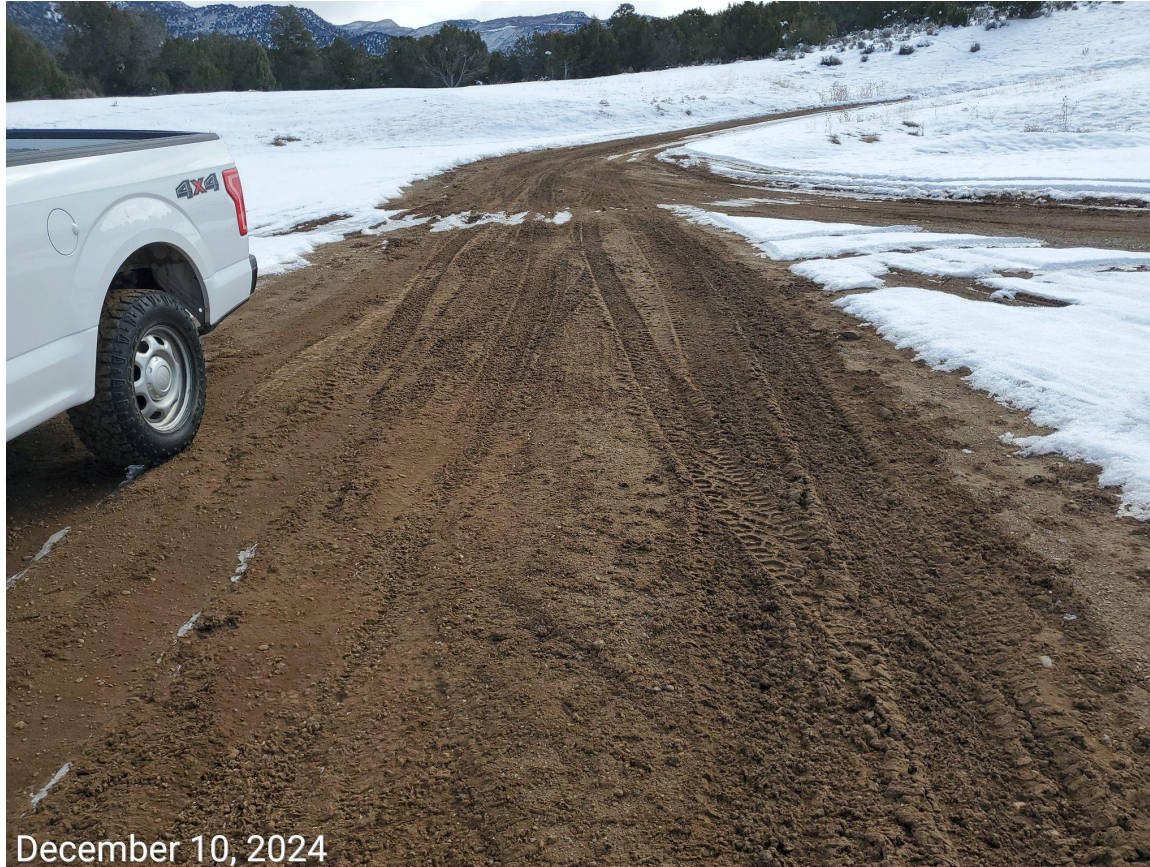
Photo 4: Tracking and stabilization BMP at the working pad surface show signs of disrepair. Maintenance advised to ensure control measures remain in proper functioning condition.
